SOIL LIQUEFACTION IN TOKYO BAY AREA DUE TO THE 2011 TOHOKU (JAPAN) EARTHQUAKE

Rolando Orense¹, Suguru Yamada² and Masahide Otsubo³

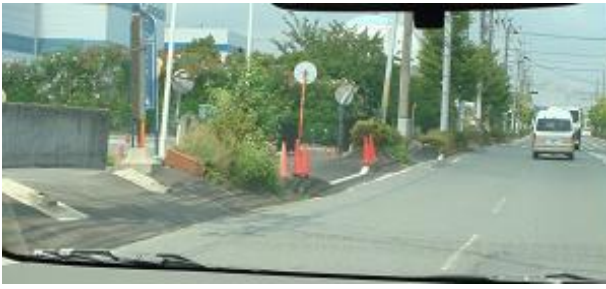
Figure 8: A section of the road which underwent settlement as a result of liquefaction.

During the reconnaissance visit, many roads in Shin-Urayasu were still under repair due to liquefaction-induced subsidence and buckling of road pavements. Figure 8 shows a road section which settled as a result of liquefaction.

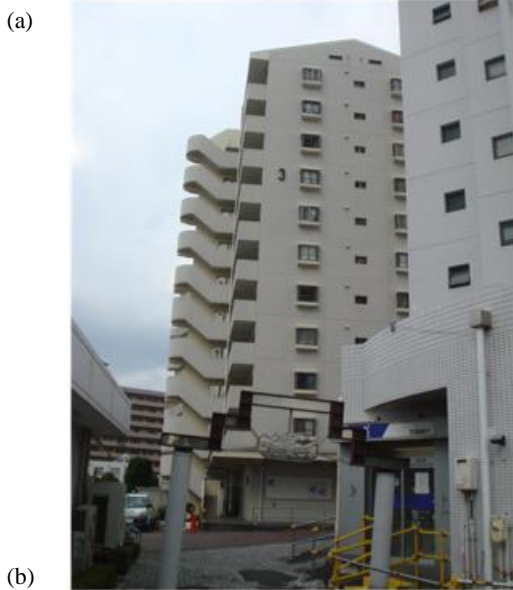
As mentioned earlier, Shin-Urayasu is home to many tall buildings, most of which were supported by pile foundations. Needless to say, these buildings were unscathed following the earthquake (see Figure 9a). However, the ground adjacent to these buildings subsided due to liquefaction, resulting in gaps between the buildings and the adjacent ground. In some

Figure 9: (a) Building supported by pile foundation. Note the vertical gap between the building entrance and adjacent ground; (b) A ramp constructed at building entrance due to 30 cm settlement of the adjacent ground.

buildings, man-made ramps were constructed to fill the gap, as in Figure 9b. Differential settlement, such as those between fire stations and the surrounding ground, as well as in bridge approaches, became a very important issue in the days following the earthquake because fire engines were not able to get out of the stations to respond to emergency cases.

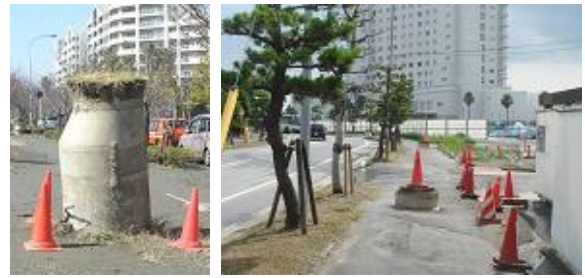
Figure 10: (a) A manhole uplifted by as much as 2 m (photo by I. Towhata); (b) several manholes protruding up from a street in Urayasu.

Manholes protruded above the ground, some as high as 2 m due to buoyancy effects (see Figure 10a). In other areas, such as in Hinode on the eastern side of Shin-Urayasu, the protruded height of the manhole was less severe, but almost all the manholes in the area were affected (see Figure 10b). From observation, the protruded height was affected not only by the uplift caused by buoyancy but also by the overall settlement of the surrounding ground. As a result, water and wastewater supplies to residential areas were affected, and it took several days before the services were fully restored.

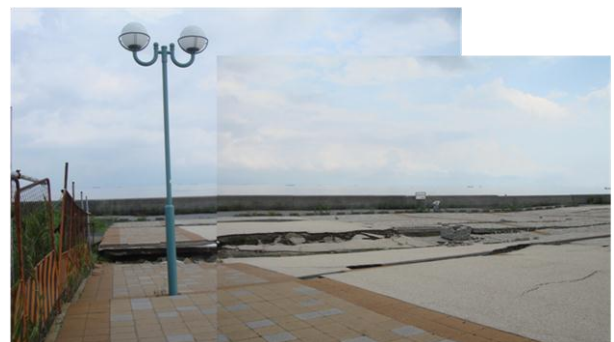
Lateral spreading of the quay wall was also observed in many locations. For example, the southeast quaywall of Hinode was displaced by about 20-30 cm towards the bay. Large ground cracks parallel to the wall were observed on the concrete portion of the backfill. Although most areas of Hinode were improved following its reclamation in 1978, especially in areas where buildings were constructed, the affected area was a park and ground improvement techniques were not implemented there.

Figure 11: Longitudinal cracks at the backfill of the quay wall due to lateral movement of the wall towards the bay.

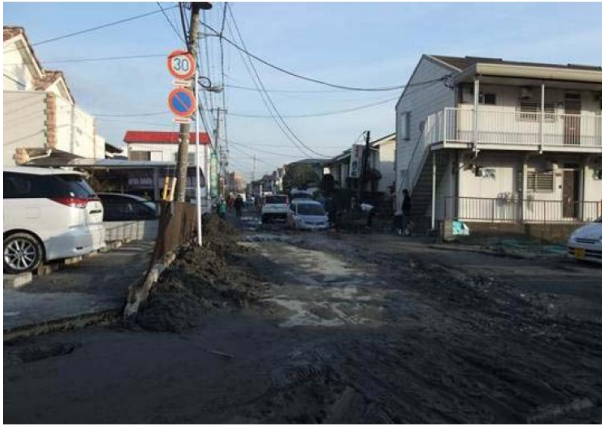
Many residential houses were affected by liquefaction and ground subsidence. Some houses tilted and sank by various degrees. Voluminous amount of ejected sands covered many streets and houses, in some areas as thick as 20-30 cm, as shown in Figure 12.

Figure 12: Residential houses in Hinode, Urayasu City land covered by ejected sands immediately after the earthquake (Photo by S. Yasuda).

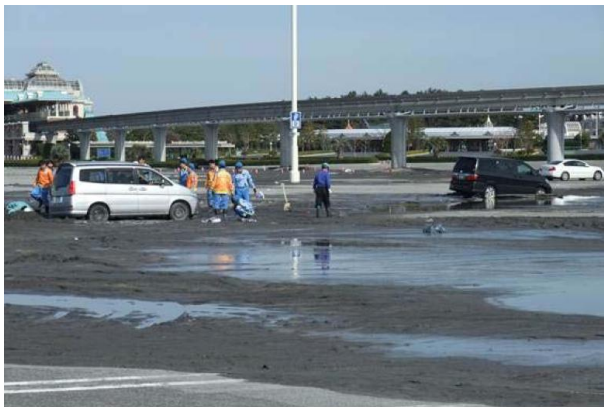
Figure 13: Parking areas in Tokyo Disney Resort covered by sand boils (Photo by S. Yasuda).

roads surrounding the theme parks were badly damaged due to buckling of pavements and ground subsidence. Immediately following the earthquake, the roads were covered by ejected materials (see Figure 13).

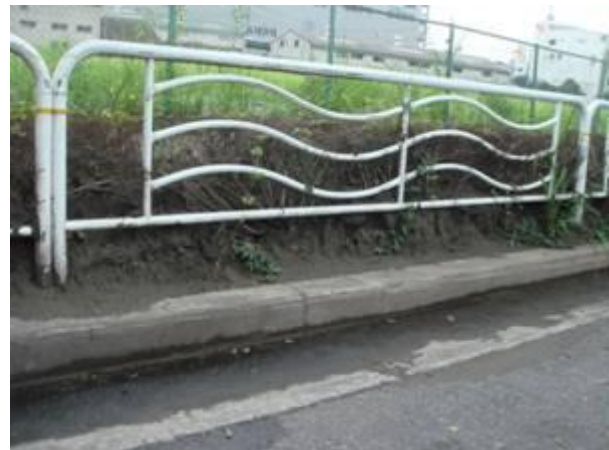
immediately after the earthquake. Traces of sand boils were still evident near the roads and in open spaces during the July visit (see Figure 15a), although most of the roads have been repaired. The damaged state of a police station remained in Shin-Kiba 1-chome, with the one-story structure tilted just as it was after the earthquake due to the liquefaction of the foundation ground (see Figure 15b). The adjacent ground also settled by 15-20 cm, causing concrete pavements near the

Figure 15: (a) Traces of ejected sands, as thick as 20-30 cm, were evident near the road; (b) Damaged police station.

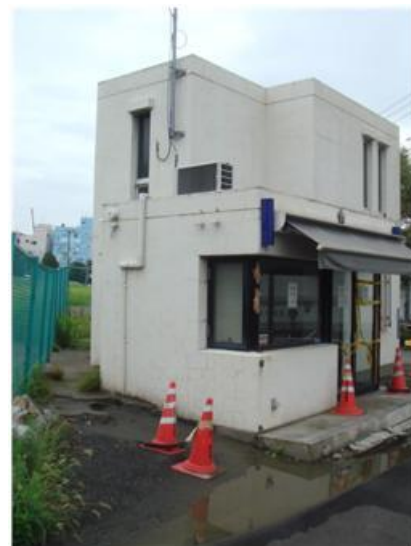
(b)

structure to crack. Large undisturbed amount of sand boils were still scattered in the open field behind the station.

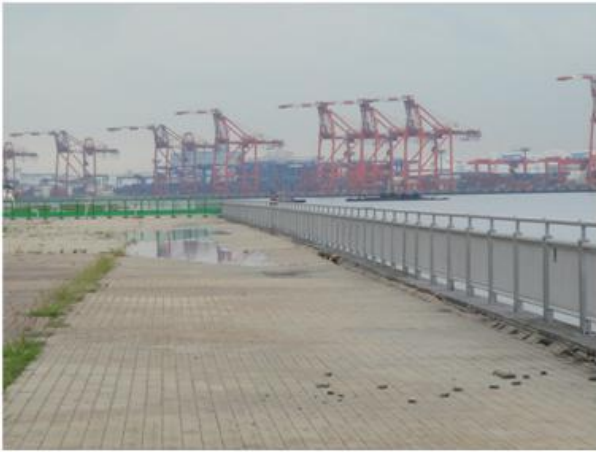
Figure 16: Lateral displacement of sheet pile quay wall in Shiokaze Park and associated deformation of the backfill.

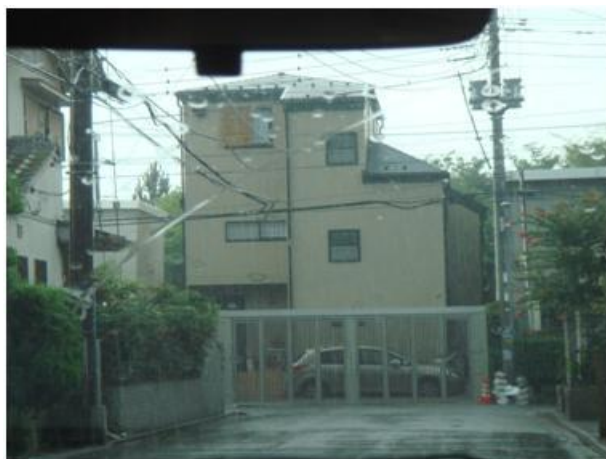
Figure 17: A tilted house in Mihama.

Unlike in Shin-Urayasu where liquefaction was extensive, traces of sand boils were observed only sporadically in Mihama. This is because most parts of the area were improved through sand compaction piles, sand drains, etc. In areas where liquefaction was observed, ground subsidence was evident, and some houses, such as that shown in Figure 17, tilted as a result of the loss in strength of the foundation ground.

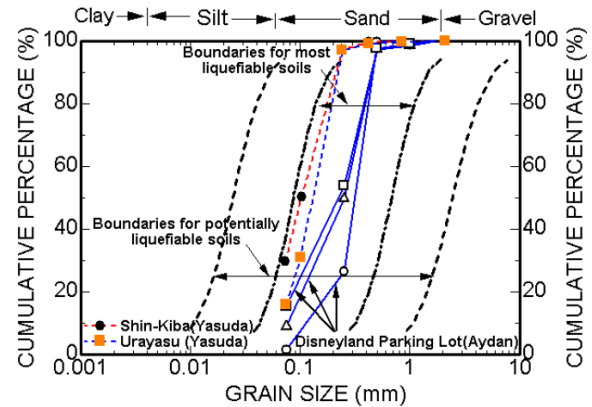
In all places visited, the appearance of the ejected sands as a result of liquefaction were very similar, typically grey to dark grey in colour and consisting of very fine sands. Samples were taken at various locations and the grain size distributions were obtained using sieve analysis. Figure 18 shows the grain size distribution curves of soil samples taken at Shin-Kiba, Urayasu and parking lot of Tokyo Disneyland. It can be observed that the distributions of grain sizes were fairly similar, and the fines contents were low, ranging from 2-30%.

Figure 18: Grain size distribution of ejected sands taken at various locations plotted with respect to distributions observed to be susceptible to liquefaction (data provided by O. Aydan).

Also shown in the figure are the range of grain size distributions of most liquefiable sands and those with potential to liquefy. These ranges were obtained from past historical earthquakes in Japan and stipulated in the Japanese design code for port and harbour facilities (PHRI, 1997). Note that there are problems associated with the use of compositional criteria, as a measure of liquefaction susceptibility, because there are no generally accepted criteria and the difference between natural and reclaimed deposits. Nevertheless, using these criteria, it can be seen that the ejected sands obtained at different locations in Tokyo Bay can be said to have high potential to liquefy.

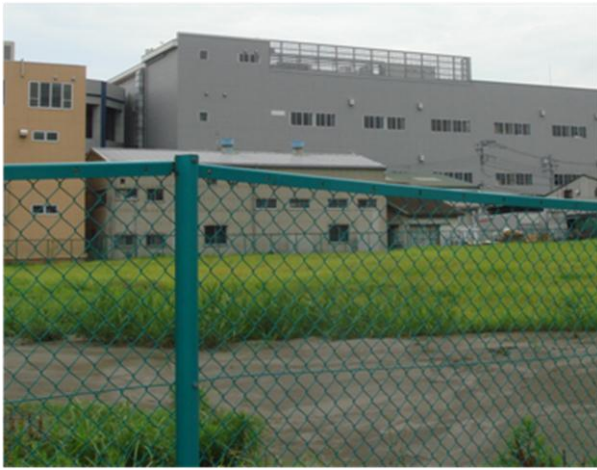
Figure 19: An undamaged building resting on improved foundation ground. Adjacent to it, sand boils were visible everywhere.

The excellent performance of grounds remediated through SCP, sand drains and other soil liquefaction countermeasure techniques have been illustrated in many parts of Tokyo Bay. For example, the foundation ground of the building shown in the background of Figure 19 was strengthened against liquefaction and the building was undamaged. Just a few meters away, sand boils were evident in the unimproved ground.

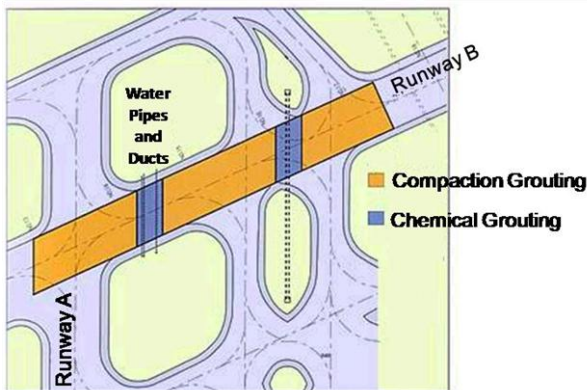
Figure 20: Portions of Haneda International Airport where compaction grouting and chemical grouting methods were implemented (figure courtesy of Sanshin Corporation).

Another example of excellent performance of improved ground is the the Haneda International Airport. In order to improve the seismic resistance of the foundation ground beneath the new runway of the airport, SCP method was employed in the late 1990s to densify the ground. As shown in Figure 20, compaction grouting was used to improve the ground at the intersection of the new Runway B and the existing Runway A, while chemical grouting was utilised near buried structures. Details of the compaction grouting implementation were discussed by Orense (2008). Needless to say, liquefaction did not occur at the airport, and the earthquake practically did not affect the airport operation, with flights resuming the very next day after the earthquake.
