# OBSERVATIONS OF THE PERFORMANCE OF EARTH BUILDINGS FOLLOWING THE FEBRUARY 2011 CHRISTCHURCH EARTHQUAKE

Hugh Morris<sup>1</sup> and Richard Walker<sup>2</sup>

## SUMMARY

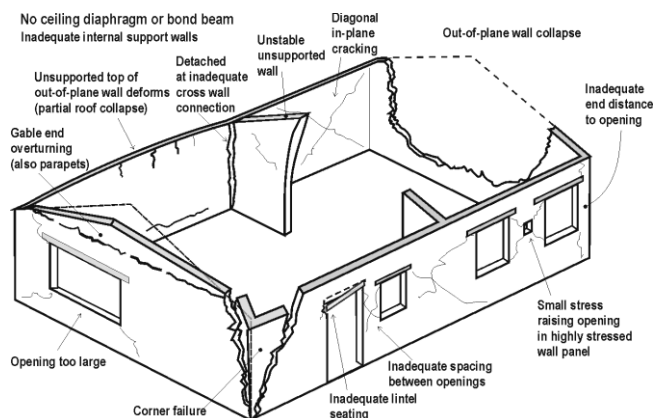
Some similar typical types of seismic damage experienced in unreinforced earth houses are shown in Figure 2.

**Figure 2: Typical earthquake damage in unreinforced houses.** © Morris

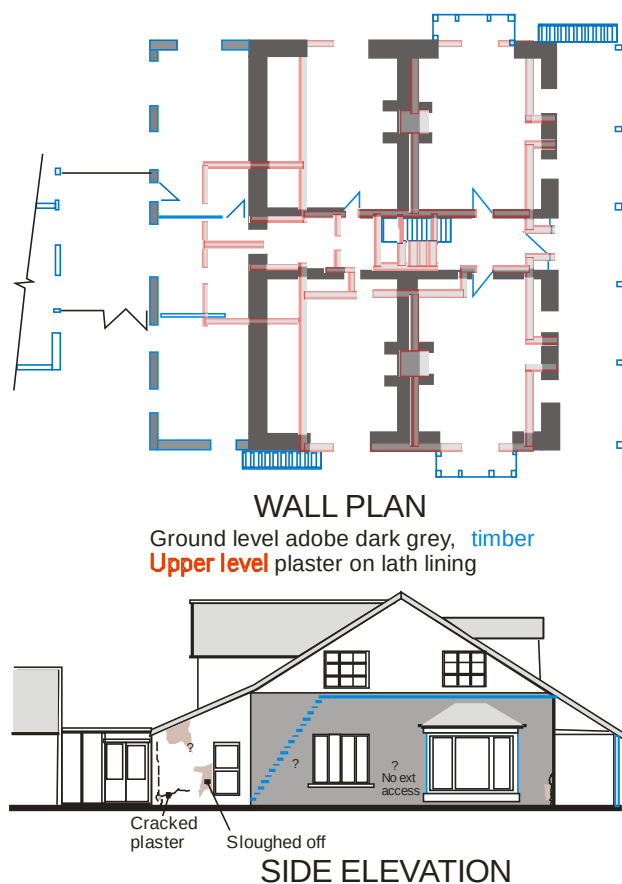
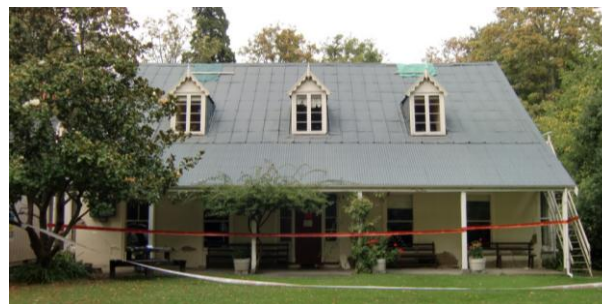
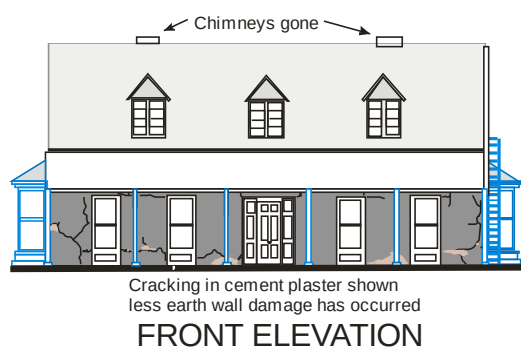
**Figure 3: Cracroft House drawings illustrating the visible exterior damage, photograph of front at top right. (Photo G North)**

Some of the adobe structure has been repaired with burnt brick and plastered with a cement plaster. The cracking in the plaster indicated significant deformation while the underlying adobe has suffered significant fracture it appeared to be to a lesser extent than the plaster. Figure 3 illustrates the overall house and crack damage, in particular on the front wall.

Figure 3 also shows the very symmetrical plan configuration of the original adobe. It provides a good basis for restoration and provision of a floor diaphragm if this is economic.

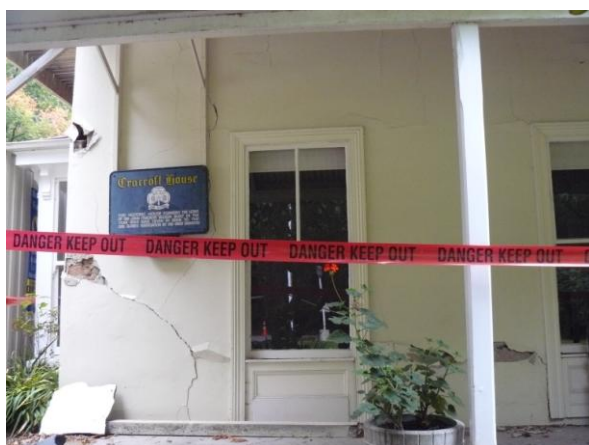
**Figure 4: Cracroft House front corner with plaster cracks. The small plaster drop out revealed burnt brick repairs.**

Figures 4 and 5 show detail of the front wall damage. Where the walls were visible inside the structure, significant movement was evident as shown in figure 6.

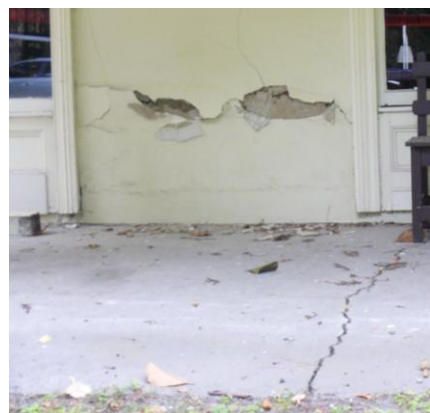
**Figure 5: Cracroft House front wall plaster cracks and minor lateral spreading damage to the concrete porch.**

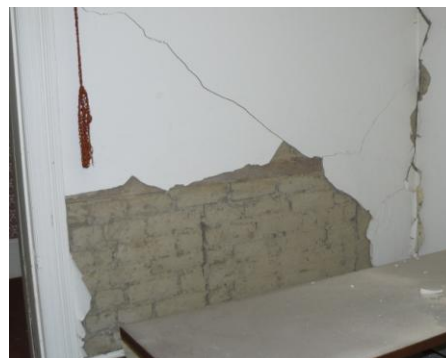
**Figure 6: Cracroft House interior plaster with significant damage, underlying adobe wall showing less damage.**

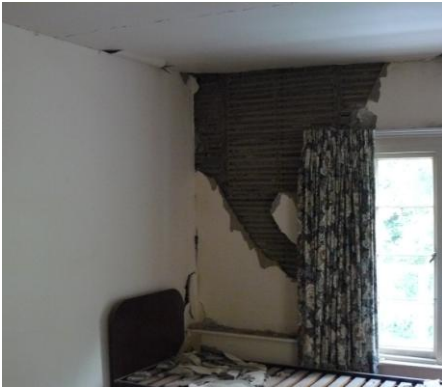
The upper level was light construction with mud plaster on lath for both walls and ceilings. This suffered significant damage as shown in Figure 7.

**Figure 7:** Cracroft House damage to upper level walls of plaster and lath.

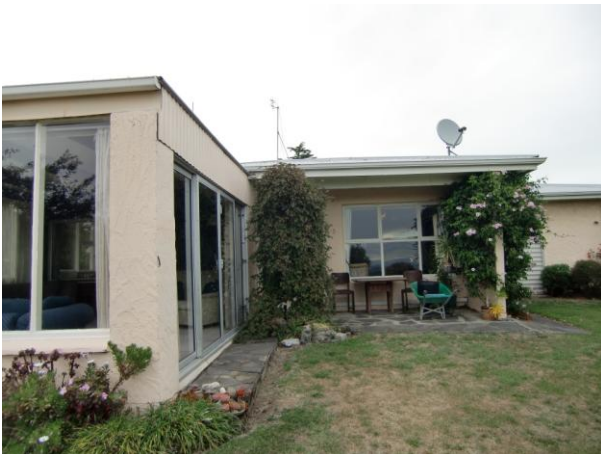
**Figure 8:** Unreinforced Rammed Earth Kennedy's Bush Road (Building 23) showing overall layout. New conventional addition to left front.

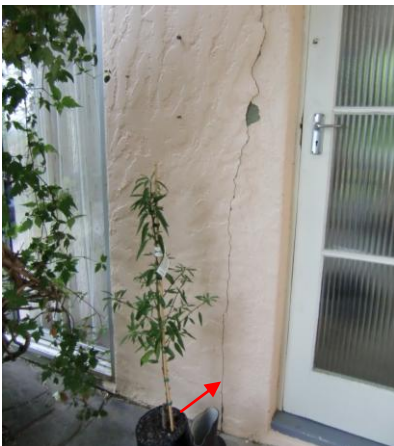
**Figure 9:** Unreinforced Rammed Earth Kennedy's Bush Road (House 23) showing a minor vertical crack.

House 23 had only suffered moderate shaking of about MM V. Some internal walls were less than 150 mm thickness and additional restraint should be considered.

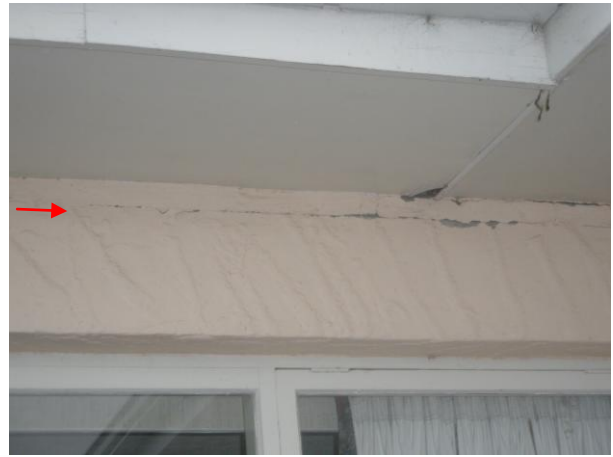
**Figure 10:** Unreinforced Rammed Earth Kennedy's Bush Road (House 23) showing damage at the bond beam interface over a lintel. (Photo Drupsteen)

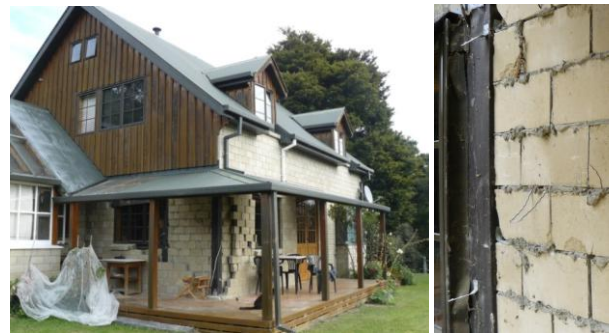
Little River was over 20 km from the epicentre where moderate shaking of approximately MM VI experienced. This house was timber post and beam construction with unreinforced pressed earth brick double skin infill panels on the lower floor. It suffered major damage and the overall structure lost most of its lateral strength expected from the infill panels (see Figure 10).

**Figure 10:** Little River House 17 post and beam construction supporting upper storey, detail view showing ties pulled out of mortar.

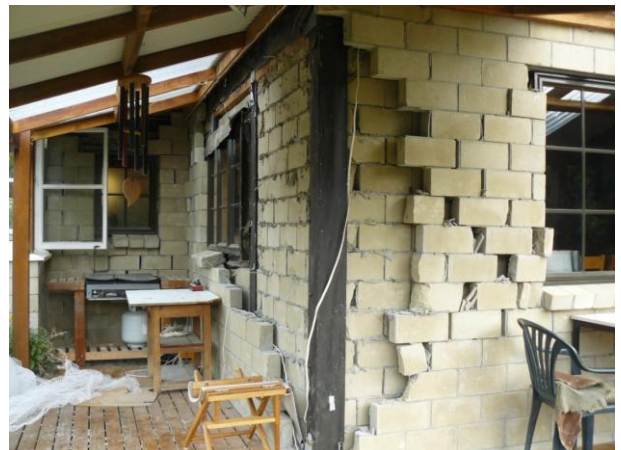
**Figure 11:** Little River House 17 showing major damage to outer skin of pressed earth brick and significant damage to the inner skin.

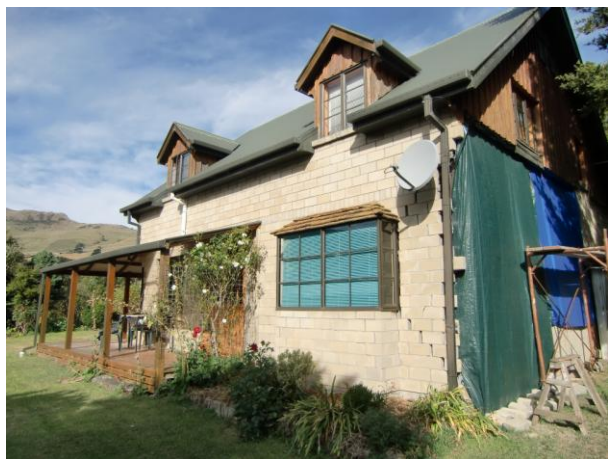
**Figure 12:** Little River House 17 showing overall house, some minor in-plane cracking and out-of plane failure of the inner and outer skin. (G North)

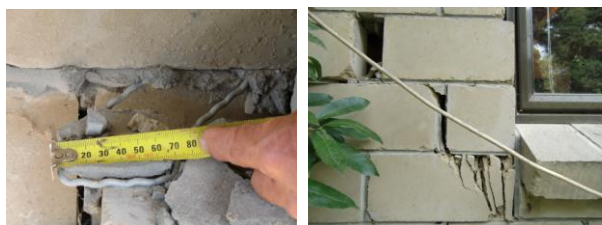
**Figure 13:** Little River House 17 showing detail of the distorted masonry tie that has failed due to mortar bond. On the right in plane rupture showing mortar failure and crushing of the pressed earth masonry. (G North)

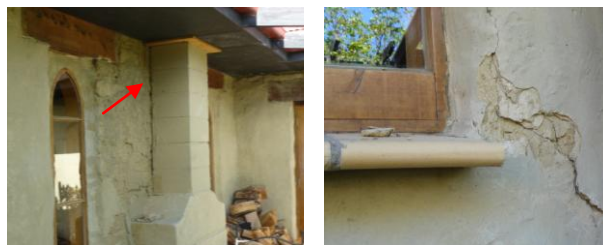
**Figure 16:** Diamond Harbour reinforced adobe house showing detachment of inadequately reinforced concrete chimney and crack damage at south window.

This adobe house experienced MM VII shaking. The most significant damage was to the concrete chimney (Figure 16) which had been reinforced only part height. There was considerable minor cracking that spalled small plaster fragments, cracked window corners (Figure 16 right), and hairline cracks in the adobe brickwork as visible in Figure 17.

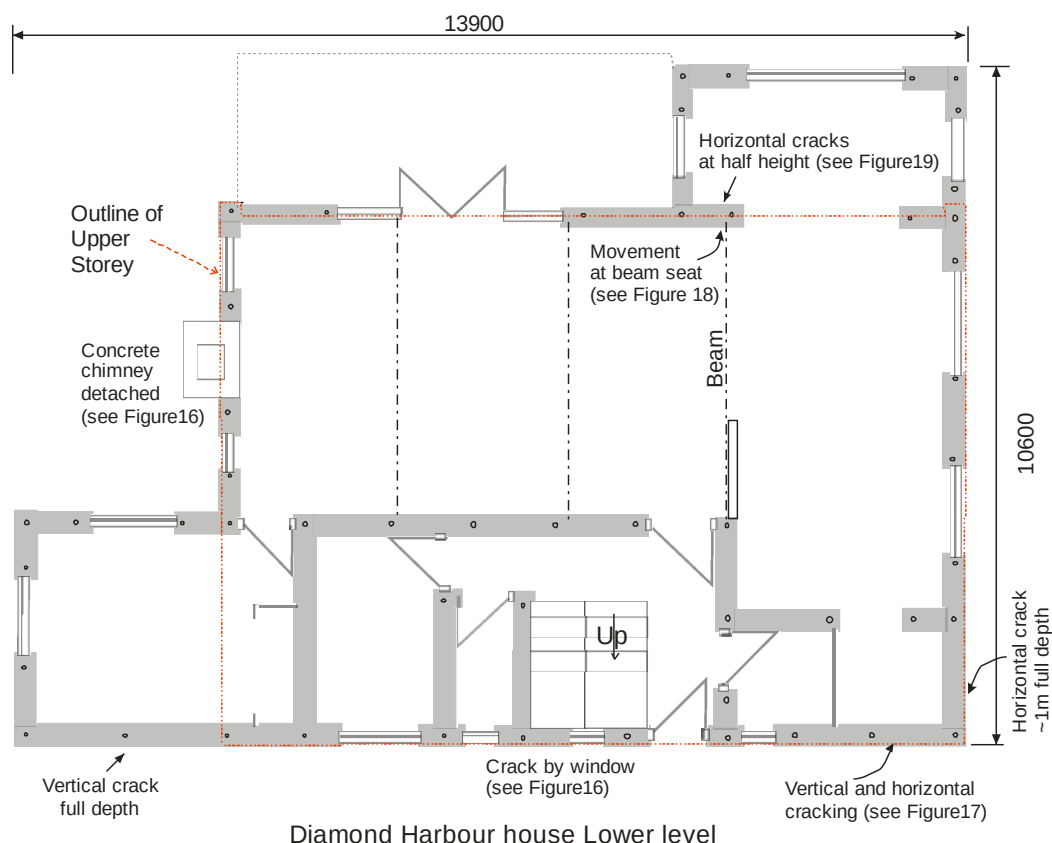
**Diamond Harbour house Lower level**

**Figure 14:** Diamond Harbour adobe house plan showing location of damage observed and vertical reinforcement.

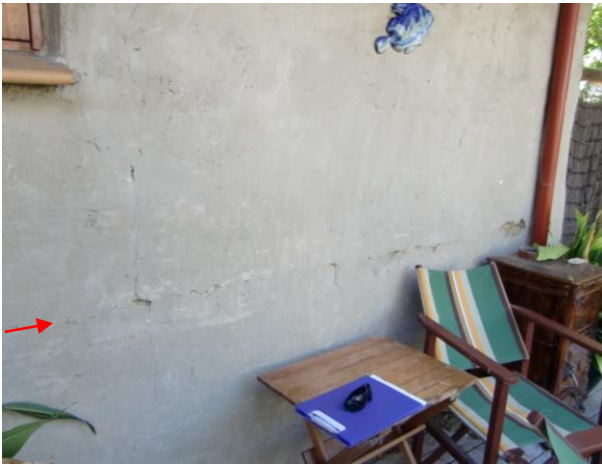
**Figure 17:** *Diamond Harbour house showing cracks on south wall adjacent to entry. (G North)*

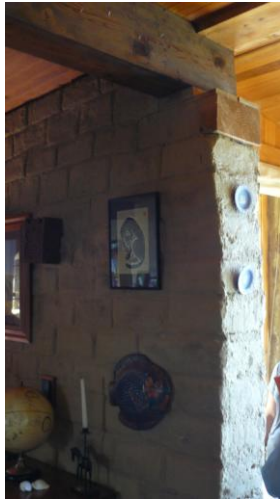
The main item of structural interest was the stub wall supporting a beam which fractured at about half height as shown in figures 18 and 19.

**Figure 18:** *Diamond Harbour house showing beam landing on the stub wall.*

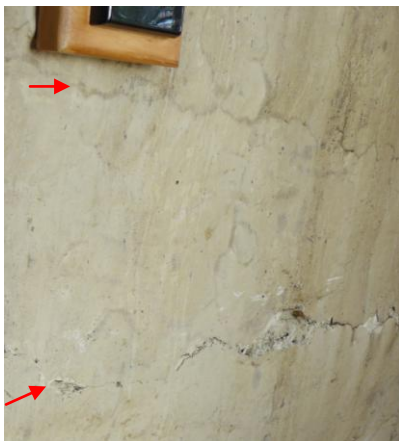
**Figure 19:** *Diamond Harbour house showing the stub wall mid height horizontal cracks due to out-of-plane flexure.*

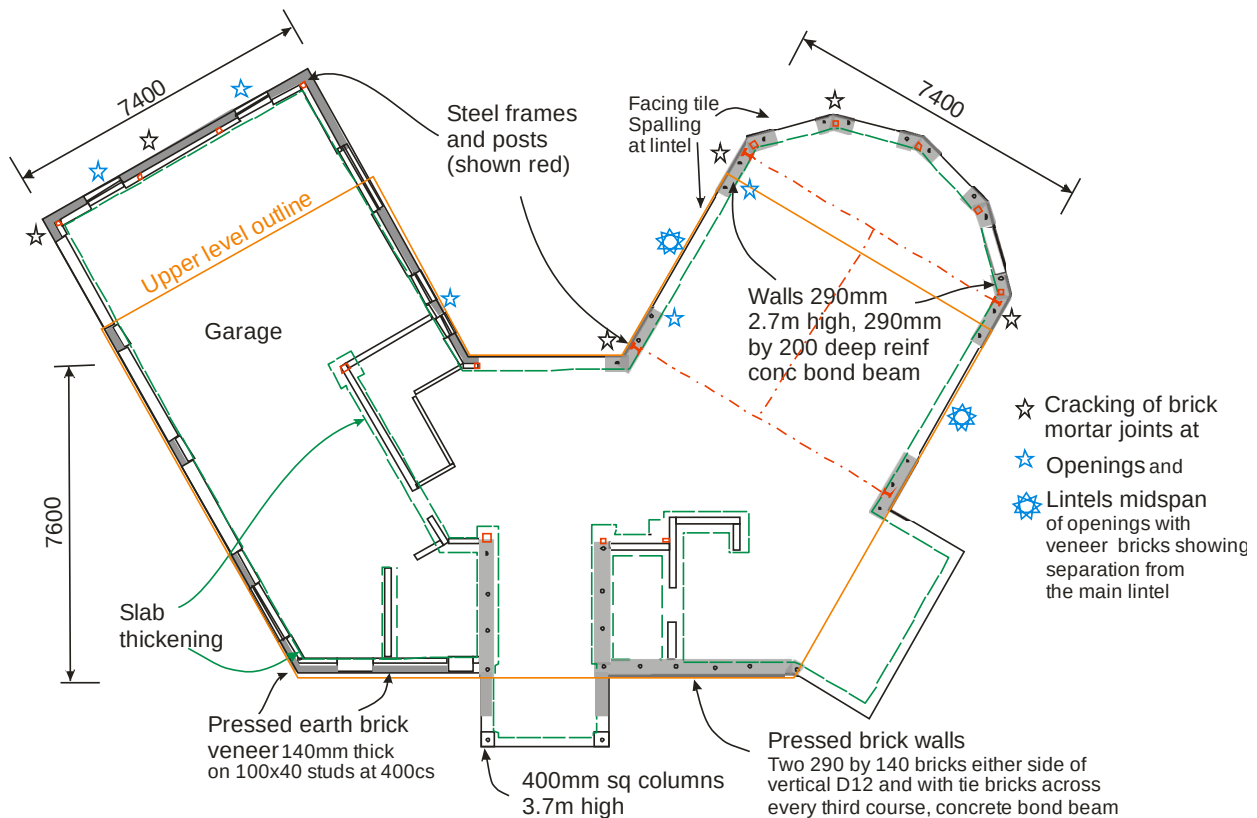
**Figure 23: Little River pressed earth House 18 ground floor plan showing foundation thickening, lower level reinforced double skin and single skin veneer walls. Upper level outline shown orange.**

The Little River pressed earth brick house shown in Figures 23-25 had double skin reinforced pressed brick lower storey and performed well under the moderate shaking and significant lateral seismic loads generated by the large second floor and roof and large span beams, and was basically in good shape. Most cracking was reported to have been initiated in the September 2010 earthquake or earlier. No vertical control joints provided for the pressed brick walls, if these were provided there may have been less cracking.

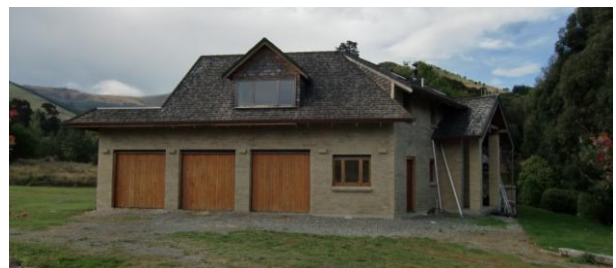
**Figure 25: Little River pressed earth house 18 side view showing garages with insufficient adjacent bracing walls. (G North)**

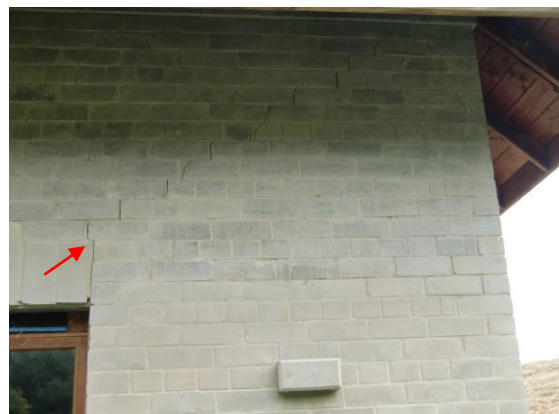
Figures 26 and 27 show the types of cracking adjacent to openings at the locations highlighted in Figure 23.

**Figure 26: Little River pressed earth house 18 showing cracking of the pressed brick veneer.**

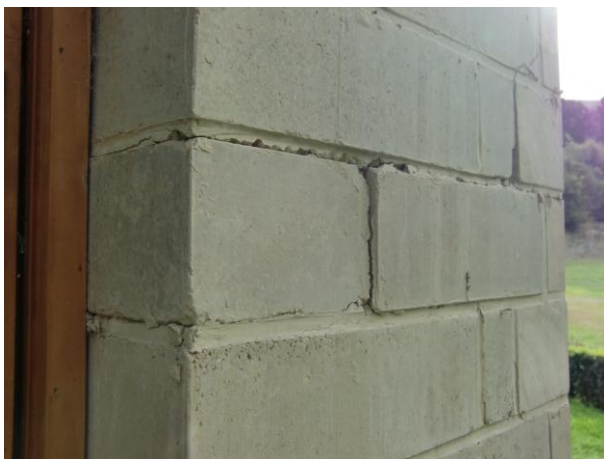
**Figure 27: Little River pressed earth house 18 showing cracking of veneer.**
