IMPACT OF THE CHRISTCHURCH EARTHQUAKES ON THE ELECTRICAL POWER SYSTEM INFRASTRUCTURE

Andrew Massie¹ & Neville R. Watson²

This paper gives a brief summary of the performance of the electrical infrastructure in the earthquakes that struck Christchurch and surrounding regions in 2011, with particular reference to the 22 February 2011 earthquake which was the most devastating.

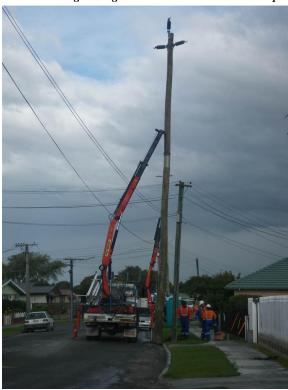
Figure 8: A 66 kV pole being inserted (Note the height difference to the LV pole).

A second 66 kV overhead circuit was commissioned in April to feed the Dallington substation, once again completed in two weeks with 81 poles measuring 15.5 m in length and sunk 3.5 m deep in the ground.

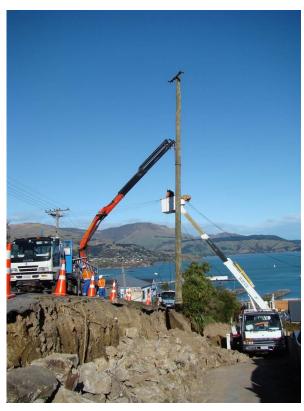
Figure 15: An LV pole in Lyttelton is replaced after the retaining wall collapsed.

In Lyttelton volcanic rock walls collapsed which were supporting some LV poles. Fig. 15 shows these LV poles being replaced.
