# OBSERVATIONS OF THE PERFORMANCE OF EARTH BUILDINGS FOLLOWING THE SEPTEMBER 2010 DARFIELD EARTHQUAKE

**Hugh Morris<sup>1</sup>, Richard Walker<sup>2</sup> and Thijs Drupsteen<sup>3</sup>**

A reconnaissance survey of earth walled buildings in the Canterbury area was carried out in mid October 2010 following the Darfield Earthquake. Fifteen earth walled buildings were inspected during the survey including historic earthbuildings and recently constructed reinforced earthbuildings.

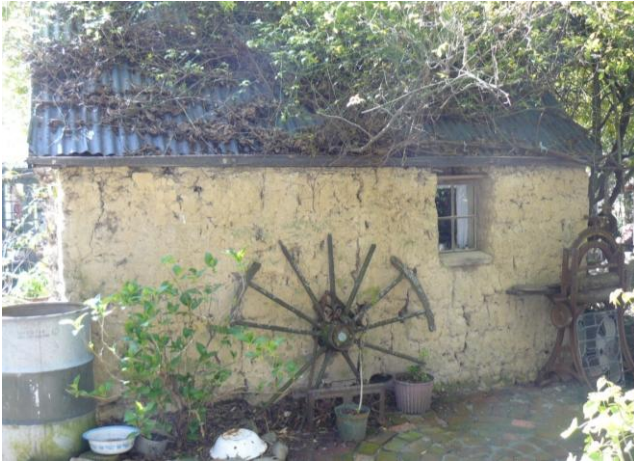
*a) Front of cottage showing corner crack at left (surface erosion is also visible).*

**Figure 1: Hororata Cob Cottage, (Building 2) unreinforced walls with horizontal cracking and wall intersection cracks.**

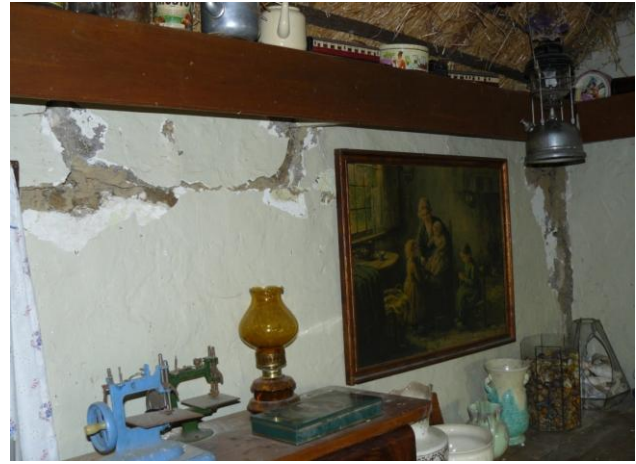
*b) Interior of same wall with the corner crack visible.*

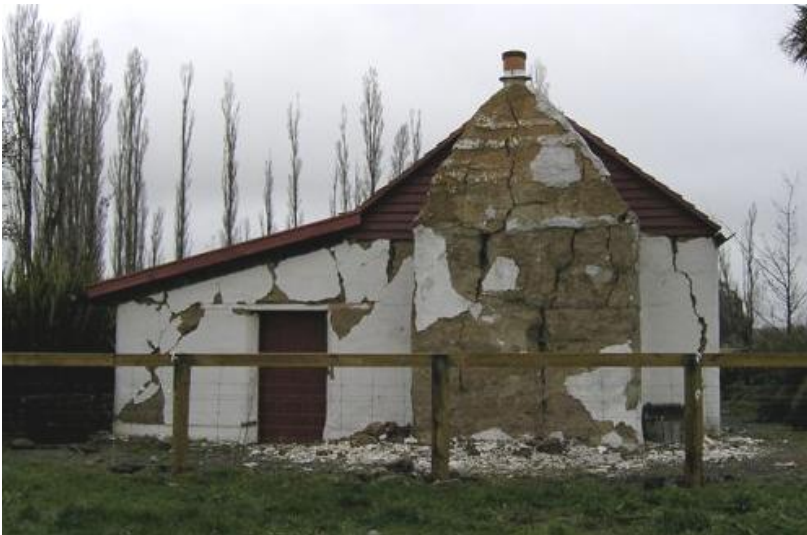
*a) North wall of cottage showing major chimney damage after initial event .  
(Photos John Le Harivel Historic Places Trust)*

Penfolds Sod Cottage in Ferrymead (Figure 3) which has both sod and cob walls. Cotton's cob cottage (Figure 2) had very extensive damage with all walls suffering some damage. There was major collapse of part of the end wall and several walls were damaged beyond reasonable repair.

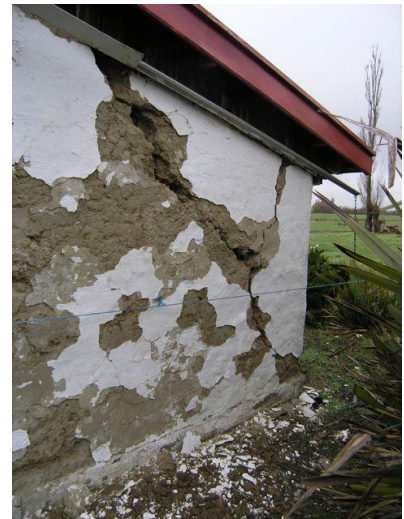
*b) South wall, east corner failure.*

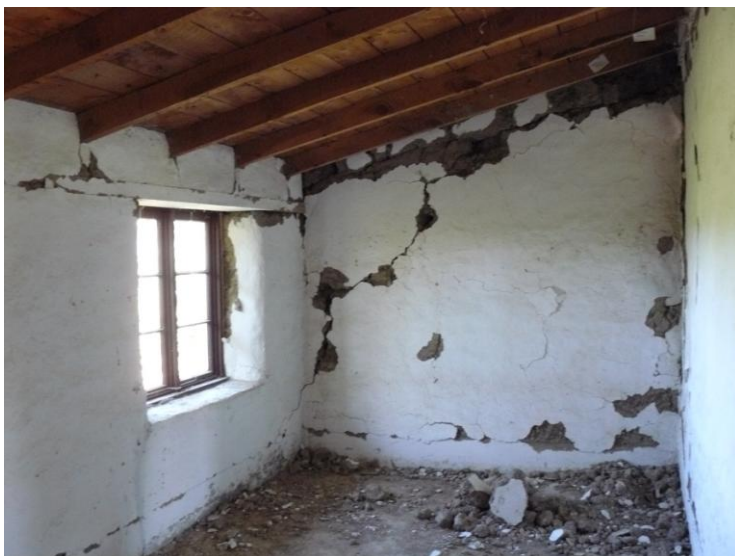
*c) Internal view showing complex damage of south wall, east corner .*

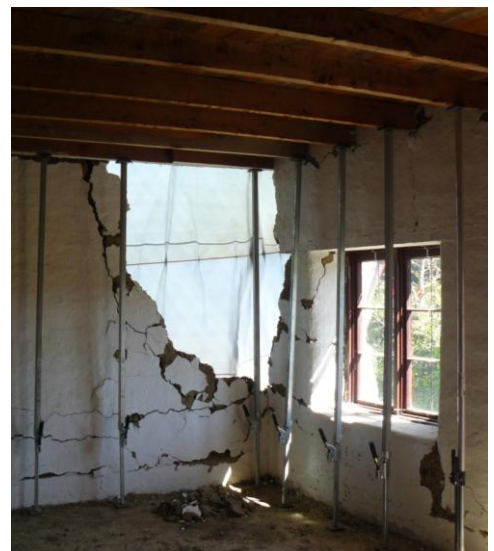
*d) South wall collapse, west corner.*

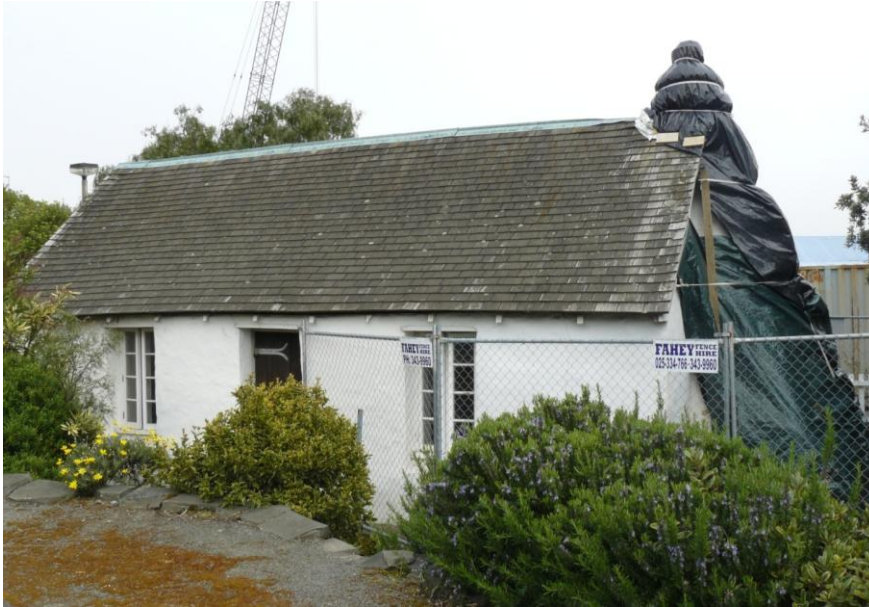
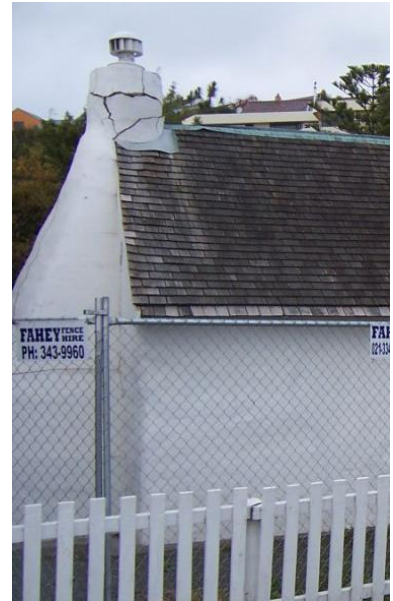
**a) Lower parts of walls made of sod, upper walls predominantly cob, cement plaster. Exterior cracking of plaster in a number of places.** **b) Chimney damage from initial event.**  
 Maria Adamski Christchurch City Council

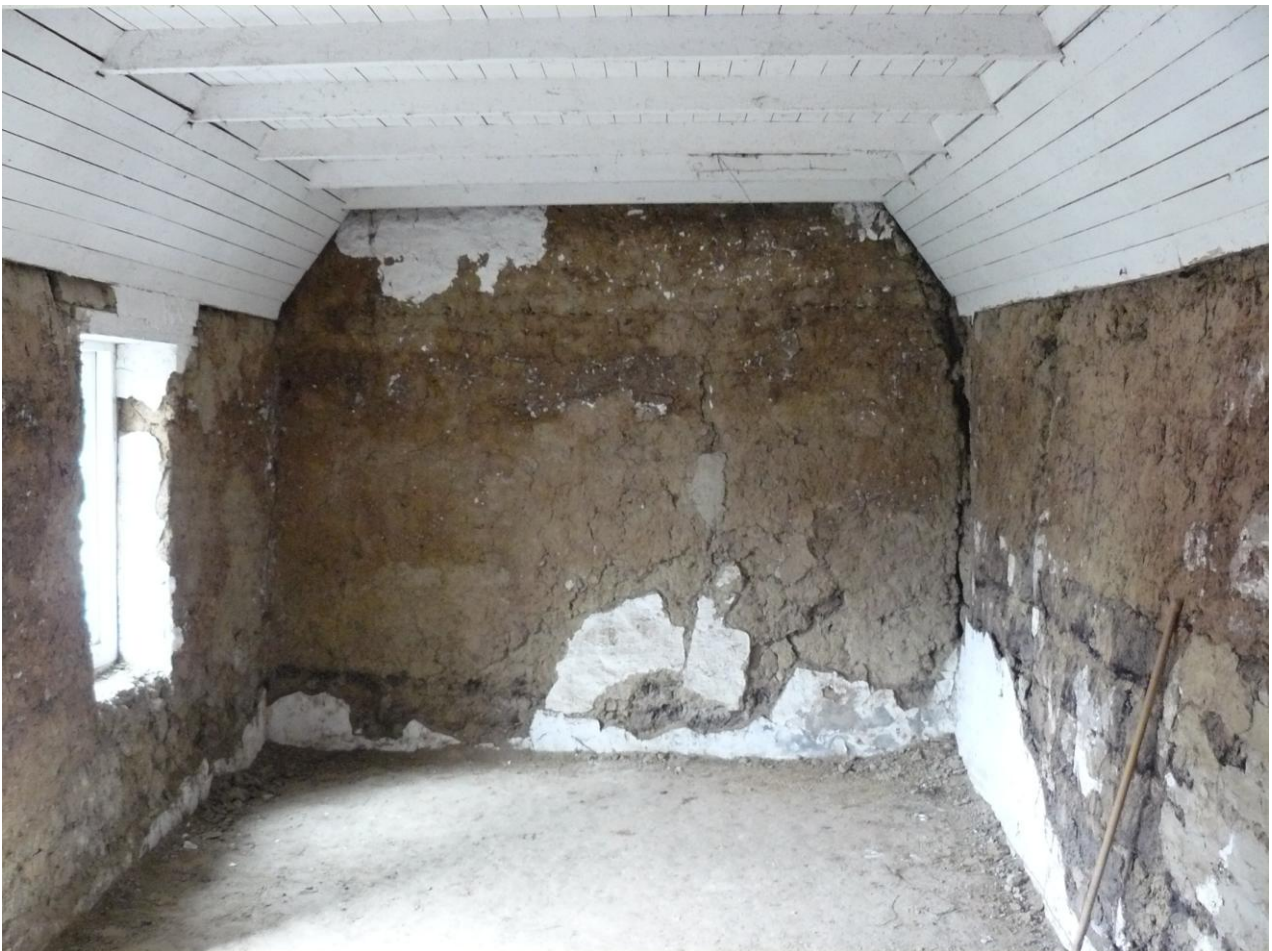
**c) Interior showing end wall separation and side wall vertical crack with out-of-plane offset. The interface of the 1860s sod with 1950s cob can be seen on the right hand wall.**

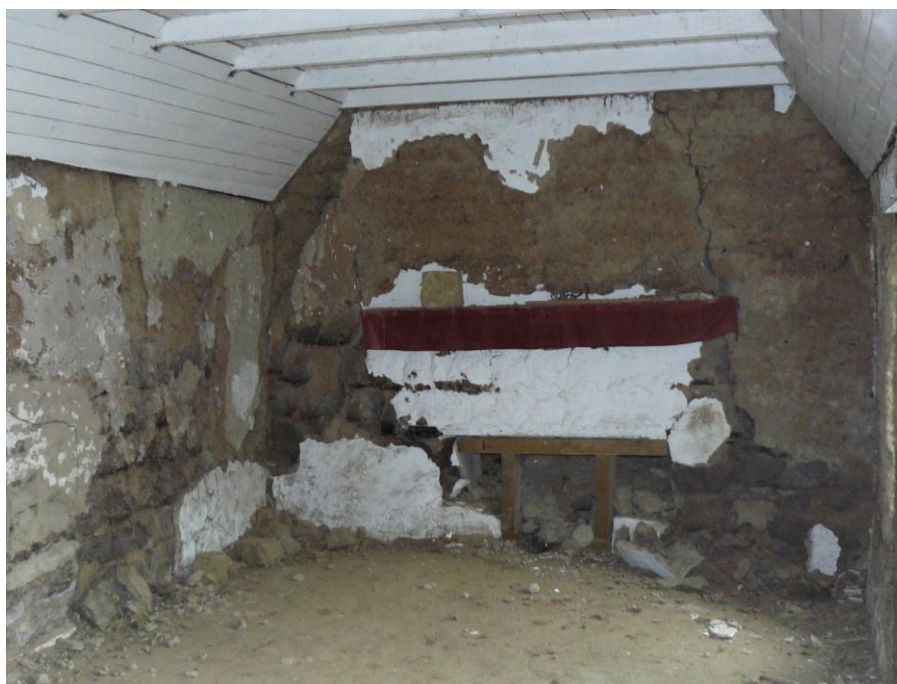
*d) Interior damage at the interface with the chimney.*

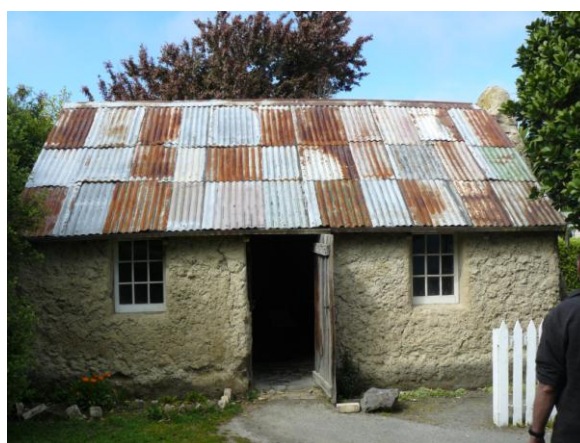
A reconstruction cob cottage in the Ferrymead historic village is shown in figure 4. It is unreinforced cob construction built in 1982, it suffered some corner cracking and other minor damage. It has a low 1.8 m walls with small window openings and a substantial chimney.

**Figure 4: Ferrymead Sod Cottage (building 13) most minor damage was internal – pre-existing crack at doorway opened.**

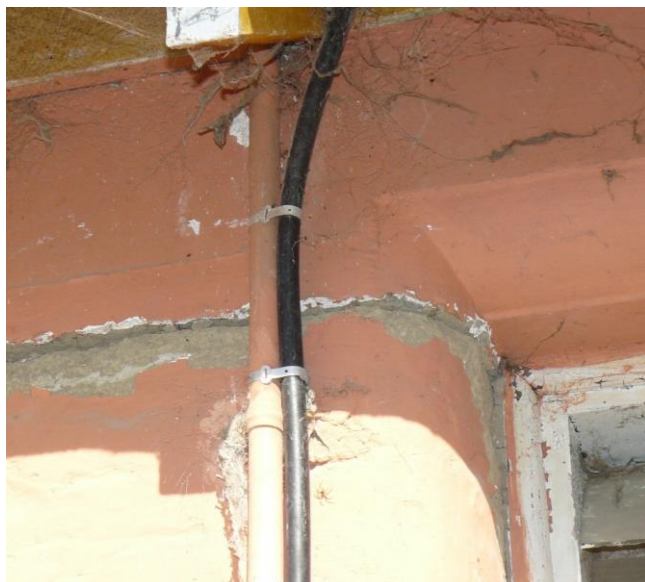
*a) Detail of the displacement of the concrete bond beam relative to the unreinforced soil-cement wall.*

The house suffered moderate new cracking, and the bond beam, which stayed intact, moved horizontally along the walls by approximately 6mm. Movement of the bond beam relative to the wall caused diagonal cracking in the rammed earth wall adjacent to a window.

Cracking in a large event would be more widespread in older unreinforced earth buildings with possibly greater structural significance. For example the bond beam would need to be properly fixed along the wall length in the Hororata house to avoid in-plane cracking that would result in falling material.

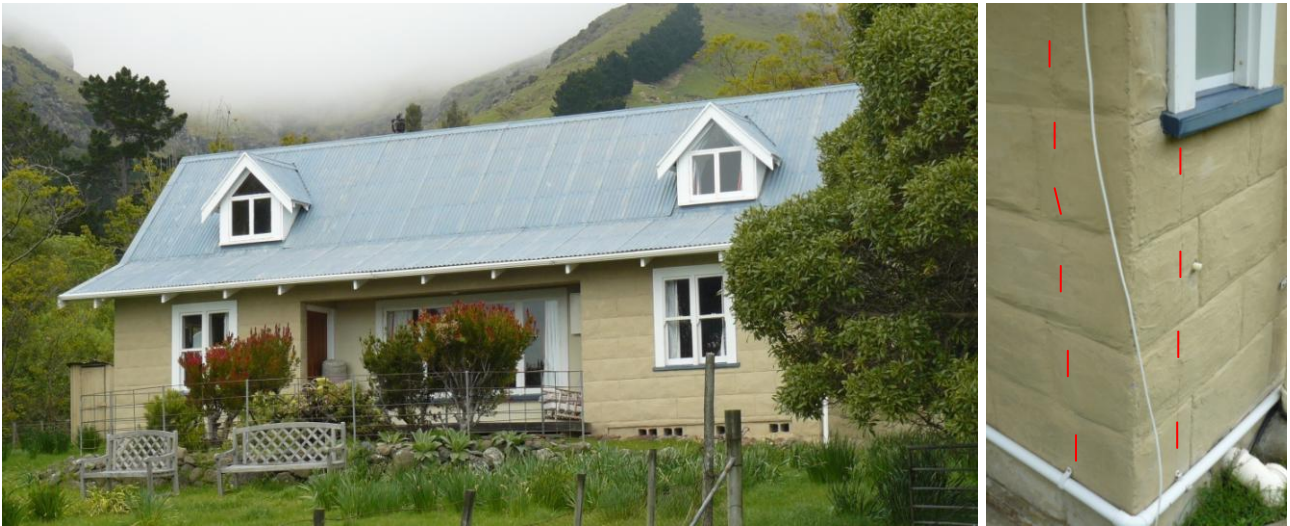
**a) Lower storey rammed earth wall panels between reinforced concrete foundations, bond beams, and columns. Rammed earth walls plastered and scribed to appear as blocks. b) Minor wall and plaster cracking at interface to the concrete column.**

Buildings at Camp Bay (Figure 6) and Beckenham (Figure 7) were constructed between 1950 and 1980 and have unreinforced rammed earth walls, reinforced concrete foundations and reinforced concrete bond beams that connect to lintels at the tops of walls. Both these buildings experienced strong shaking but performed quite well with slight cracking damage to the rammed earth walls particularly adjacent to window and door openings.

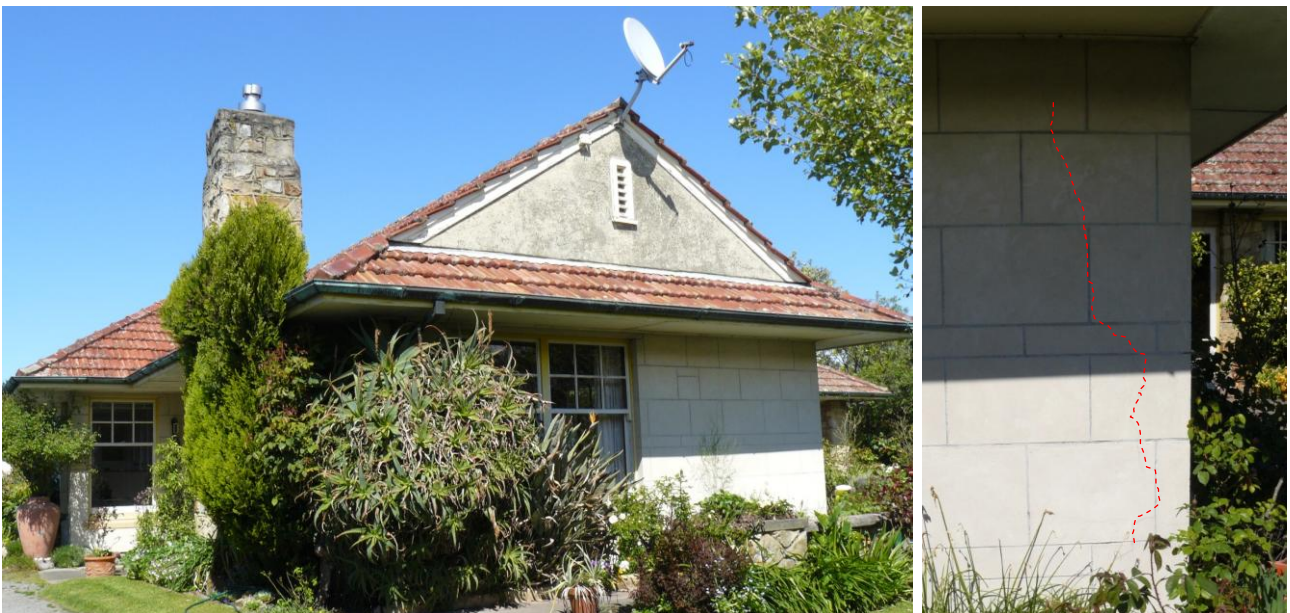
**a) Rammed earth house surface plastered – Reinforced concrete bond beam, L shape plan. b) Fine crack full wall thickness.**

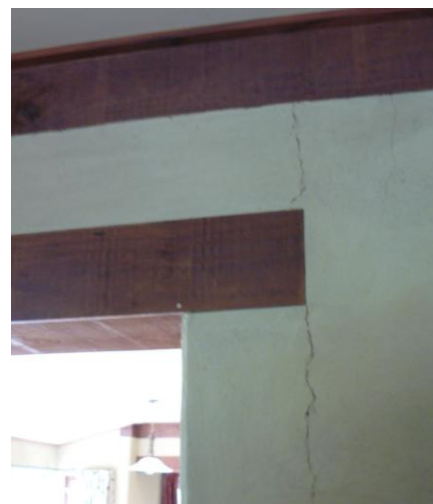
**b) Cracks adjacent to the wood faced concrete lintel.**

The Sefton house has single storey rammed earth walls with vertical steel reinforcing. The vertical reinforcing was located at each end of the rammed earth wall panels similar to the details for partially reinforced earth walls in NZS 4299[9]. There was some slight cracking adjacent to some openings. One short internal wall had some minor horizontal cracking which the owner advised occurred during construction.

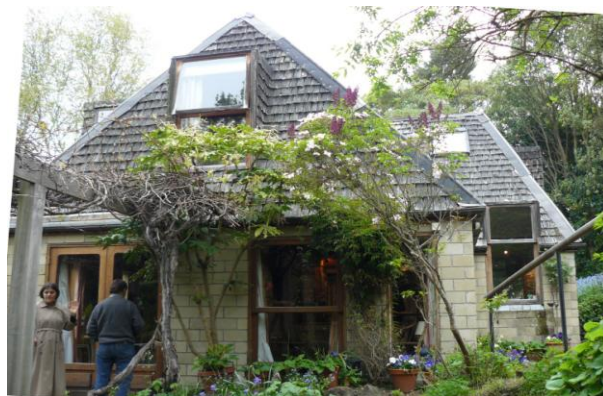
Figure 9 shows a house constructed in 1978 with double skin pressed earth brick load bearing external walls with a reinforced concrete core and single skin pressed brick internal walls and reinforced concrete foundations and bond beam and a timber framed upper storey. This building experienced strong shaking but generally performed well with slight diagonal cracking along mortar joints particularly near door and window openings. There was moderate cracking to two exterior unreinforced cantilever pressed brick walls and some separation of the fireplace structure from the main house walls.

**Figure 9: Governors Bay Double Skin Cinva Brick House (Building 8). Subject to strong shaking but with minor damage.**

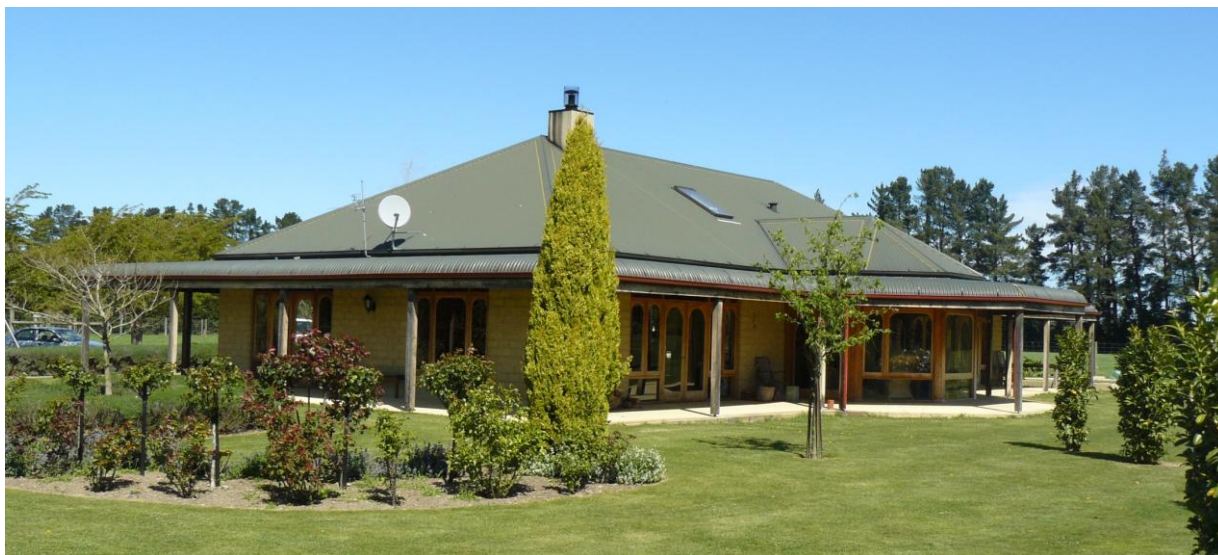
**Figure 10: Charing Cross Adobe House (Building 4) 1999. Located between the epicentre and major fault rupture. Reinforcing similar to that specified in the NZ Earth Building Standards. Minor cracking mostly due to differential ground movement.**

The Charing Cross house performed very well given the proximity to the fault and level of shaking and suffered only slight damage. This comprised some minor cracking adjacent to doorways and openings and lintels. There were some hairline cracks in the concrete foundations reinforced with 1-D16 bar top and bottom. NZ Earth Building Standard NZS 4299 [9] specifies 2-D16 bars top and bottom for the concrete foundations.

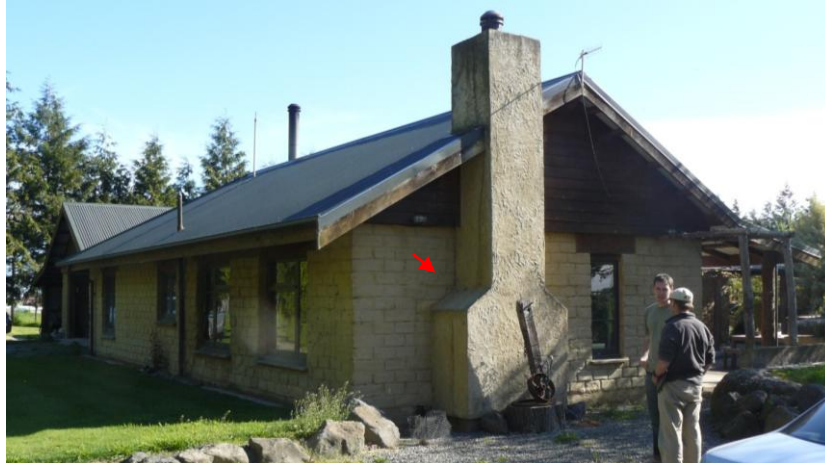
**a) Adobe house L shape plan, garage attached by timber infill, arrow shows cracking at chimney interface.**

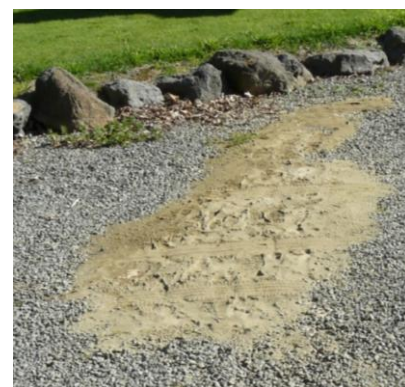
**b) Evidence of liquefaction related to differential movement in foundations and cracked paths.**

An adobe house near Leeston (Figure 11) experienced strong shaking with ground accelerations of approximately 0.3 g and estimated MMI of VII. There was evidence of ground liquefaction at the site. This single storey house was constructed in 1999 with mainly 2,250 mm high and 275 mm thick adobe walls with both vertical and horizontal steel reinforcing, reinforced concrete foundations, timber top plate and timber ceiling diaphragms. The building performed well generally. There was some slight cracking adjacent to doorways and openings and some minor gaps at ends of lintels and more significant cracking at a very high 4.1 m high adobe wall. There was some slight horizontal cracking at the top course of adobe bricks at some locations. This was considered to be due to insufficient connection of adjacent timber top-plates and insufficient anchorage between the top course of adobe bricks and the underside of the timber top-plate.

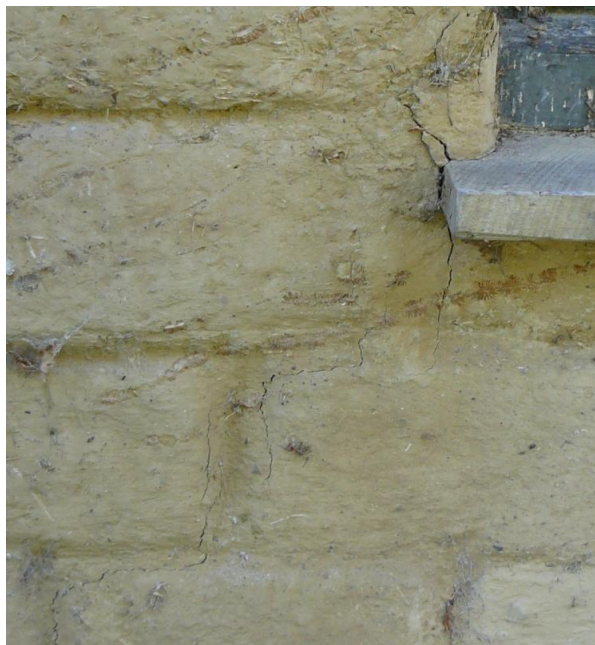
*c) Cracking in adobe joints adjacent to windows.*

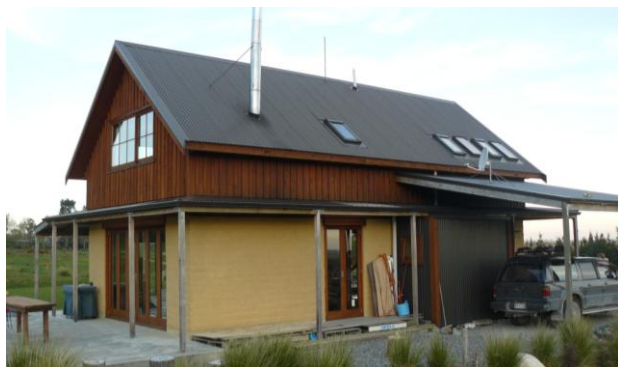
**Figure 12: Staveley Adobe House (Building 7) 2008**  
*Structural cracking in short return walls.*

on the ground floor and a timber framed second storey. The adobe walls were reinforced. The detailing of the reinforcing and overall wall bracing was not in accordance with NZS 4299. There was horizontal cracking in the mortar joints of the adobe walls at one end of the building where the reconnaissance team considered the wall bracing and reinforcement fixing is likely to be insufficient.

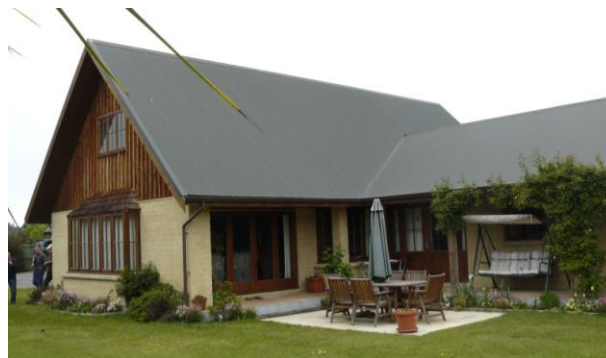
The veneer walls in the house generally performed well but had some slight cracking under most of the window openings. The support timber frame for the pressed brick fireplace had separated 15 mm from the main timber framed wall for the house. This was considered to be due to inadequate connection of the fireplace to the wall.

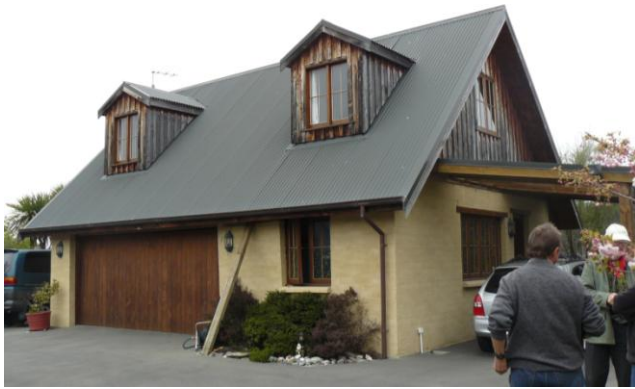
There was a major failure of the support system for the veneer walls on the south side of the garage. This is considered to be due to the pullout of the ties from the mortar. This will be checked when the walls of the garage are demolished and reconstructed.

a) Garage with upper level timber, veneer detached adjacent to garage door, significant cracks over end wall lintel.

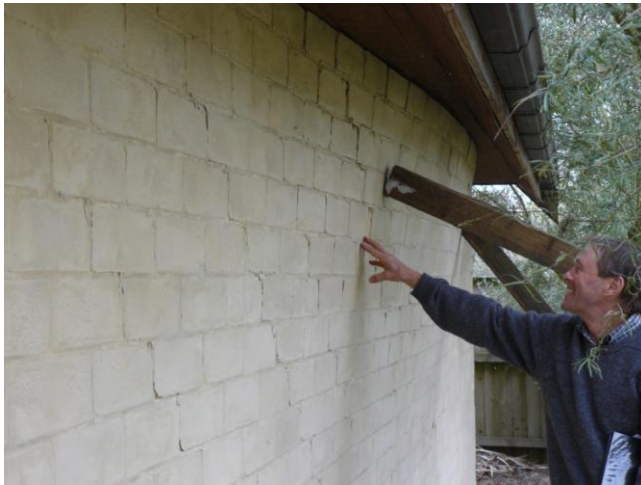
b) Rear wall of garage showing out of plane deformation assumed to be due to veneer ties inadequately anchored into the bricks.
