# DAMAGE TO NON-STRUCTURAL COMPONENTS AND CONTENTS IN 2010 DARFIELD EARTHQUAKE

**Rajesh P. Dhakal<sup>1</sup>**

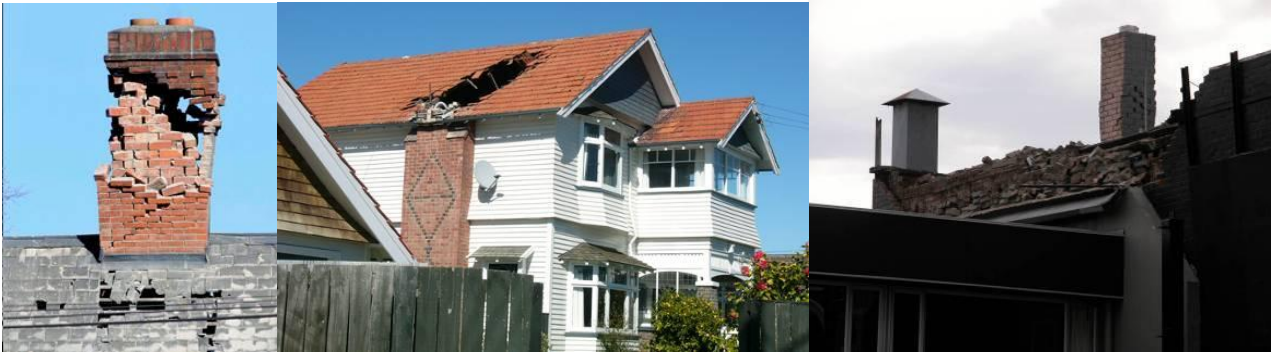
Damage to chimneys was very common in all areas of Christchurch in this earthquake. In general, brick chimneys damaged most severely (see Figure 1), whereas chimneys made of other materials (even brick chimneys that were plastered outside) damaged to a much lesser extent and light metal chimneys did not seem to have suffered any damage whatsoever. The damage to brick chimneys ranged from minor cracking to the collapse of the whole chimney. In many cases, falling down of the collapsed chimneys resulted in secondary damage to roofs; especially those made of tiles (see Figure 1). A crude survey indicated that more than half of brick chimneys damaged in residential buildings in Christchurch, and the extent of damage did not show any specific correlation with the age and type of the building.

**Figure 1: Typical chimney damage.**

- Brick chimneys are very vulnerable and should not be used in new constructions. Even in existing buildings, brick chimneys should ideally be properly braced or replaced. Bracing is challenging as the chimneys tend to be very heavy and any bracing will have to anchor to very light wood roof framing members. A viable option may be to remove the chimneys down to the roof line,

provide a concrete confining cap at the roof line, anchor to the roof at that point and replace with a properly engineered light chimney above the roof line.

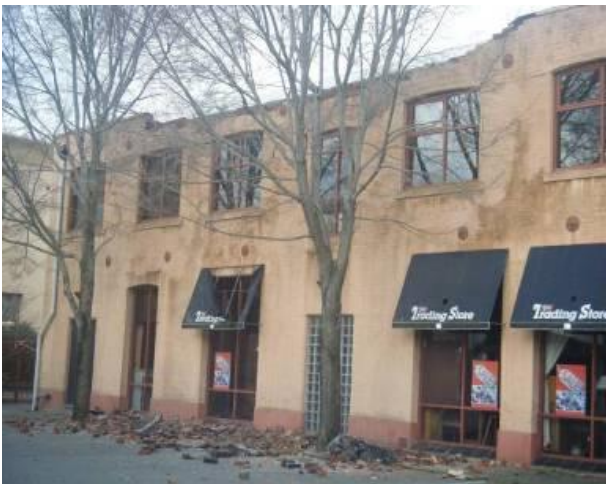
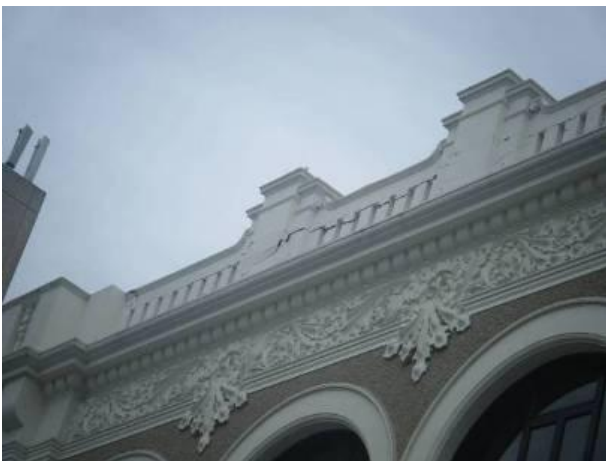
Brick parapets (not retrofitted for earthquakes) are common features in URM, confined masonry and concrete frame/wall buildings. The majority of parapets in buildings in Christchurch were damaged to different extent in this earthquake; parapet with no damage whatsoever was a rare sight. The damage included cracking, some bricks being dislodged and a segment of (in some cases the whole of) parapet falling down (see Figure 2). In several cases, the detached parapet blocks fell and damaged building parts in lower storeys and in a couple of locations squashed cars parked in the roadside underneath. Collapsed parapets in the roadside buildings could easily have caused injury/casualty if the earthquake had struck during the day.

Some URM buildings had parapet bracing measures prior to the earthquake. In many cases, these parapets performed well in clear contrast to severe damage of nearby unbraced parapets in buildings with similar original construction. Even in buildings with the walls anchored to the roof/floor, parapets were found severely damaged (see Figure 2). This was particularly common in buildings where the height of parapet above the anchor line was significant. In a few cases, the parapets on the front elevation of buildings were braced but not on the side and back elevations which experienced severe damage. Also in many cases, damaged parapets were typically removed from tops of URM walls in the clean-up efforts, but the integrity of the connections of the walls to roofs were still compromised by the damage. As a result, tops of some remaining damaged walls will need to be further stabilized with reliable restraints before repairs commence. In some cases, severely damaged parapets collapsed during the aftershocks.

**Figure 2: Typical parapet damage.**

- Unsecured parapets are highly susceptible to severe damage, potentially leading to collapse in earthquakes. They should be braced to the buildings to prevent collapse.

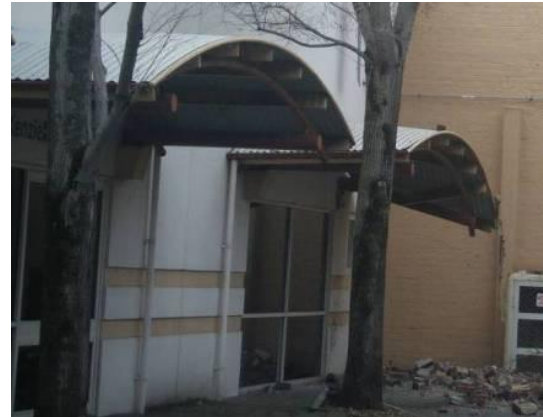
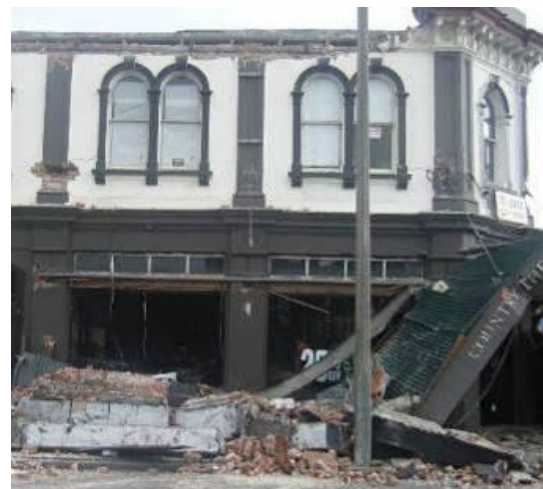
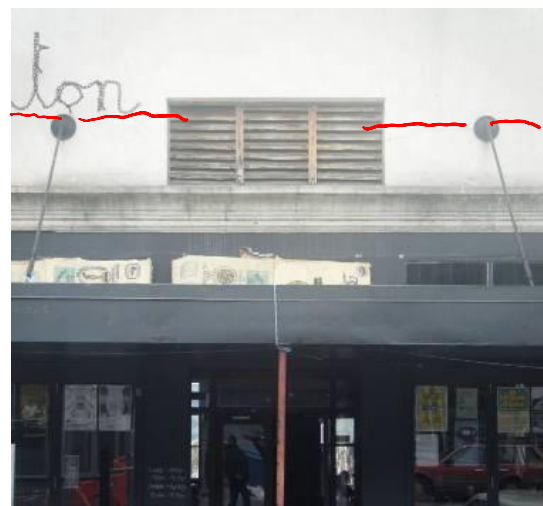
**Figure 3: Typical canopy damage: (i) Supported canopy; (ii) Anchorage failure of suspended canopy; (iii) Cracked wall due to canopy anchorage.**

In several buildings, the canopy was damaged. A subjective approximation is that between 10% and 20% canopies were damaged. Some canopies which were secured to the building by ties (anchored to the wall) caused stress concentration around the anchorage, which resulted in cracks in the walls (see Figure 3). In some buildings, these anchors were unable to resist the extra force generated by the shaking, which caused punching shear failure of the walls around the anchor (see Figure 3). Needless to mention, this resulted in complete collapse of the canopy. In many cases the canopy was damaged because of the impact caused by falling parapets or

facades from storeys above. Even canopies supported by light truss suffered damage in some cases (see Figure 3).

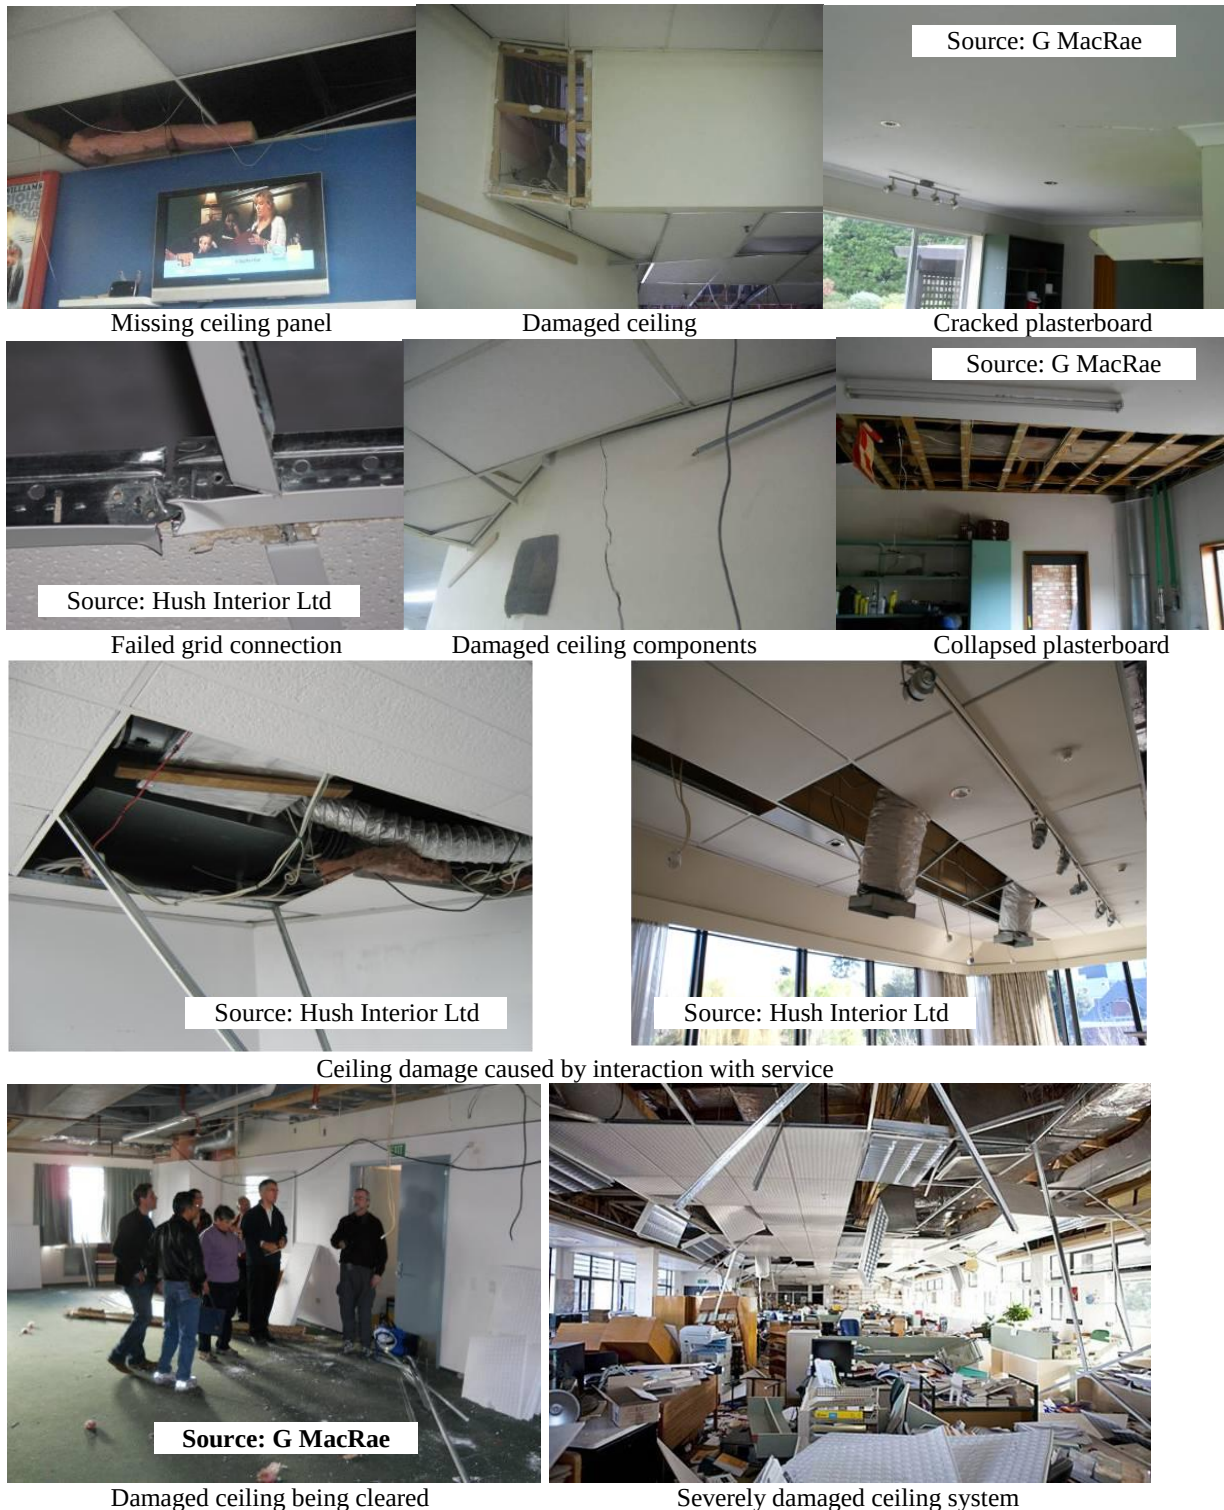
**Figure 4: Different types of damage to ceiling systems in residential and commercial buildings.**

designed seismic braces were not used in the ceilings in the inspected buildings. Hence, it was not surprising that the ceilings were damaged in several buildings in this earthquake. In a crude approximation, 10%-15% of commercial/industrial buildings incurred ceiling damage to different extents.

The proportion of residential houses with ceiling damage was significantly less than in commercial/industrial buildings. In residential houses, the common form of ceiling damage was cracks (of varying length and width) on the plasterboard, crushed plasterboard particles falling on the floor and plasterboards being detached from the frame (due to punching through the nail or tearing off at the glue). On the other hand, in commercial buildings, the observed ceiling damage included dislodging of the panels, breaking of the panels, failure of the ceiling grid members and connections, failure of perimeter angles and damage of ceiling panels due to interaction with the services. Some photographs of typical ceiling damage are presented in Figure 4.

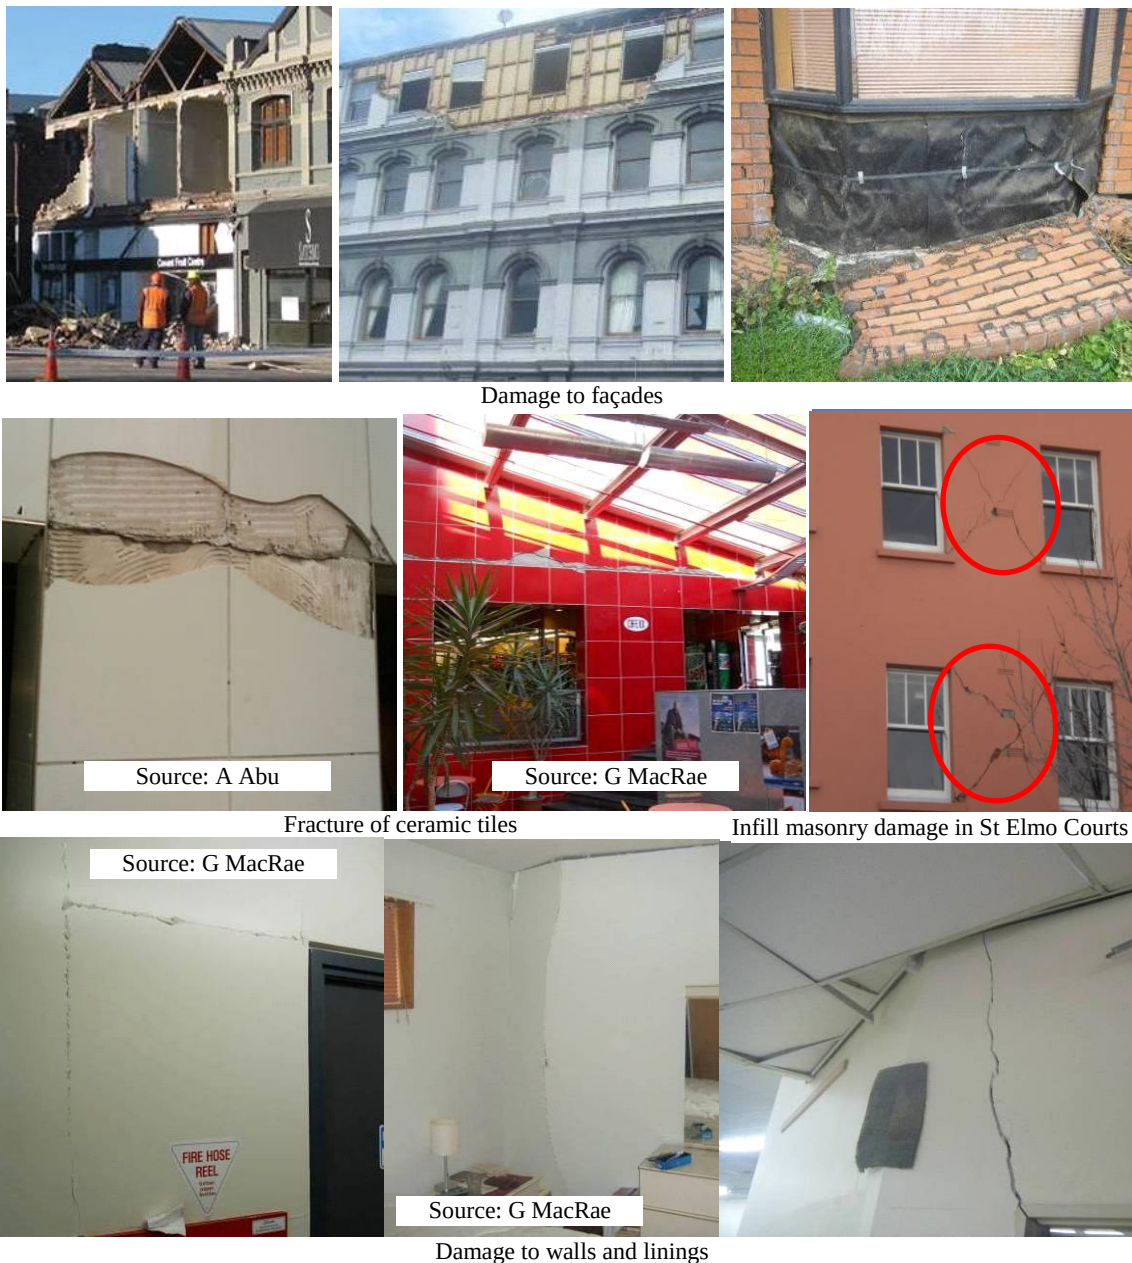
**Figure 5: Damage to non structural vertical elements.**

the next section under “windows damage”, which could also have been categorized as facades. Many residential houses exhibited warping of their joinery without any cracks visible in the glass. The other type of facade damage consisted predominantly of brick facades falling out due to poor connection with the structure. In the partition walls and internal linings, it was very common to see cracks initiating from door and window corners (see Figure 5). Some cases of observed façade, wall, lining, tile damage are shown in the photos in Figure 5. As shown in the photos, ceramic tiles on the walls (and floor in some cases) also suffered damage.

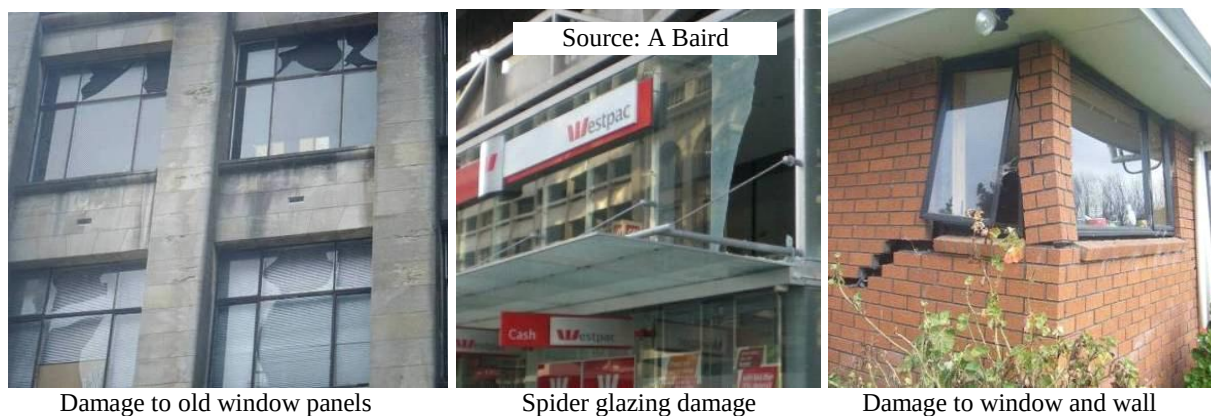
**Figure 6: Typical damage to windows.**

Broken glass panels in windows were observed in several buildings. The worst of the glass panel damage was focussed in the central city, where the majority of Christchurch’s taller and historic buildings are located. Window panels cracked in the main shock were reported to have broken in the aftershocks in some buildings. As the window framing system used in the old buildings was rigid and did not allow relative glass displacement, most broken glass panes were observed in this type of window frames. On the other hand, modern aluminium frame windows have deformable rubber sealing which allow the glass panels to displace to some extent. Hence, very few broken glass panels were observed in this type of window. Although spider glazing is a modern system, damage to this type of glazing was observed; for example in the Westpac building in the city centre (see Fig 6). In all cases, the window glass damage posed a falling hazard for pedestrians. Some typical window damages are shown in Fig 6.

- Windows with tight frames and without any deformable sealing (as in old windows) are very vulnerable to glass breaking in earthquakes. The modern windows with aluminium frames and rubber sealing performed very well.

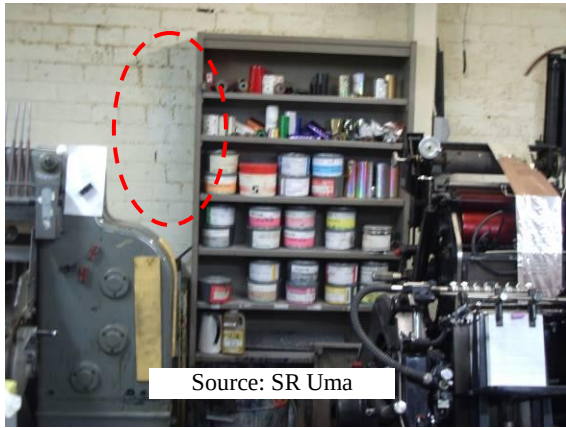
non-structural elements and suffered no interruption to their business services. One notable exception was damage to storage rack systems and the subsequent loss of stock. The damage to the rack systems varied. Complete collapse occurred to heavily loaded, relatively light gauge racks. It was reported by storeowners that more things fell from racks that were secured to the floor but not to the walls than the racks that were not secured to the floor. This might have been due to lower forces in the unsecured racks as a result of rocking and sliding. In some cases, it has also been found that inadequate provision of bolts in one segment of racking system resulted in twisting of the whole rack (see Figure 7). In some cases, cracks were found in the infill wall panel where the racks were anchored (see Figure 7). A sampling of the observed racking damage is shown in Figure 7.

Crack developed in the wall behind the rack at the anchor

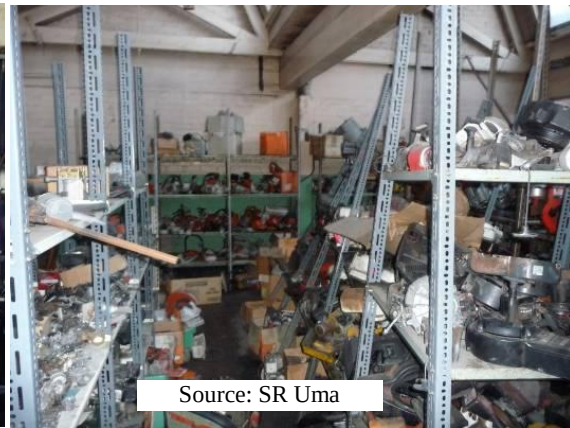
Twisted racks due to insufficient bolt in a segment

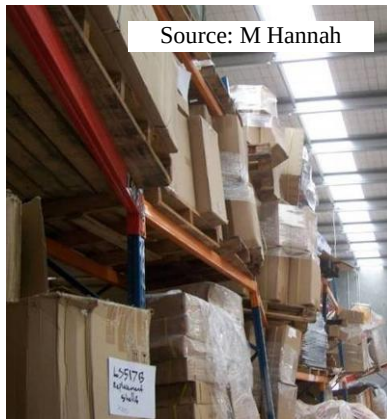
Damaged racks at a storage facility

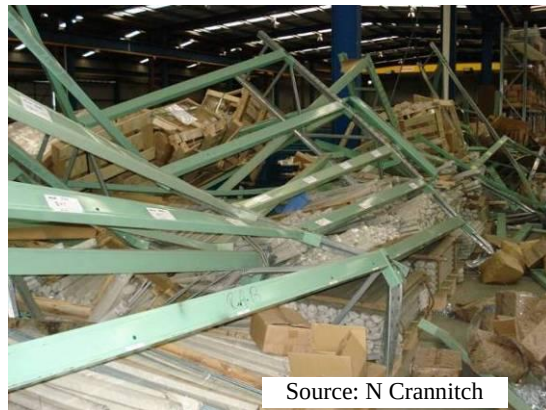
Collapsed racks at a metal fabricator warehouse

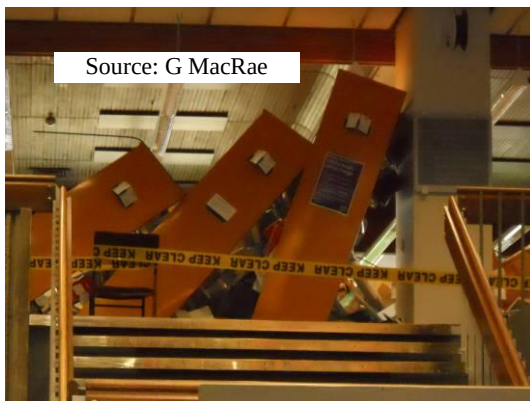
In offices, unsecured book shelves fell to the floor. In libraries, even the shelves that were tied together collapsed (see Figure 7). It was found that the ties in this case were not strong enough and failed to resist the tilting tendency of the shelves. Shelves tied to the wall and tied with each other using strong ties were intact.

Damage to book shelves in university library

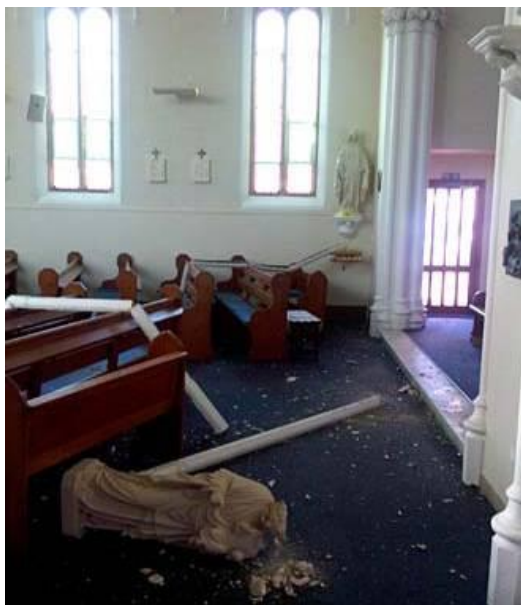
Furniture and artifacts damage in a church.

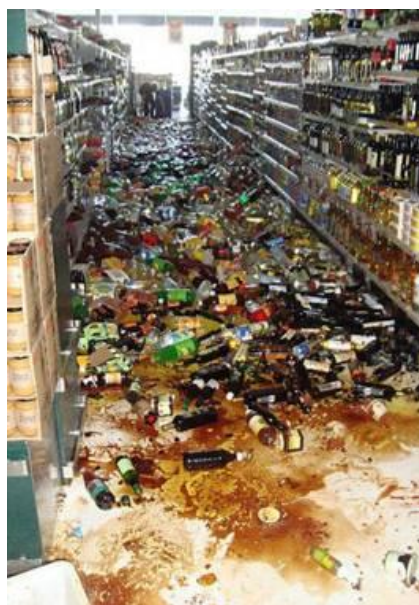
Liquor damage in a store.

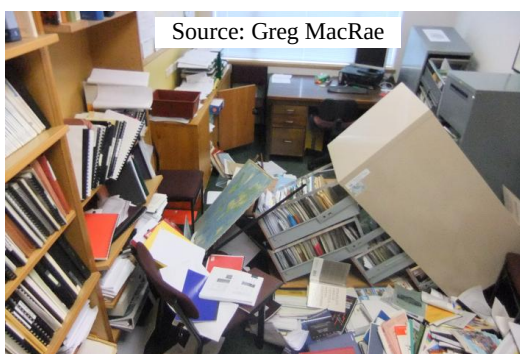
Cabinet and book damage in an office.

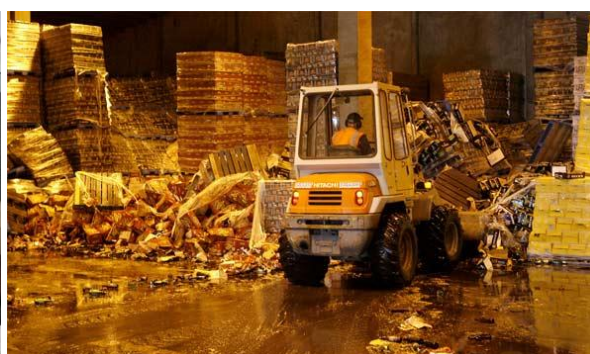
Damaged contents in a warehouse.

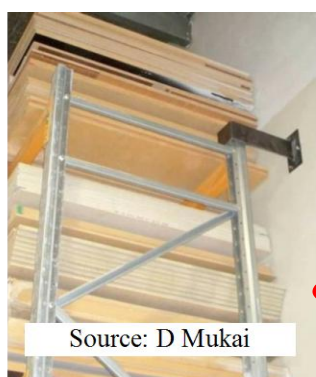
Wall-anchored rack with no damage

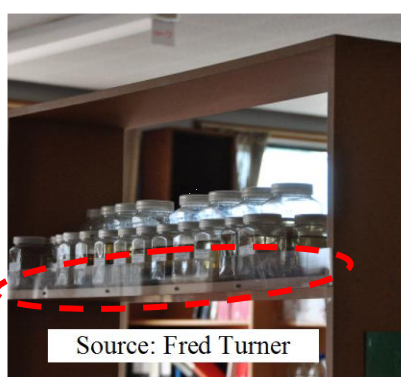
Lips and bars at the edges of racks protecting the contents from falling down
