# GEOTECHNICAL ASPECTS OF THE 2007 NIIGATAKEN CHUETSU-OKI, JAPAN EARTHQUAKE

**Rolando P. Orense<sup>1</sup>, Masayuki Hyodo<sup>2</sup>, Hiroaki Kanda<sup>3</sup> and Junya Ohashi<sup>3</sup>**

## SUMMARY

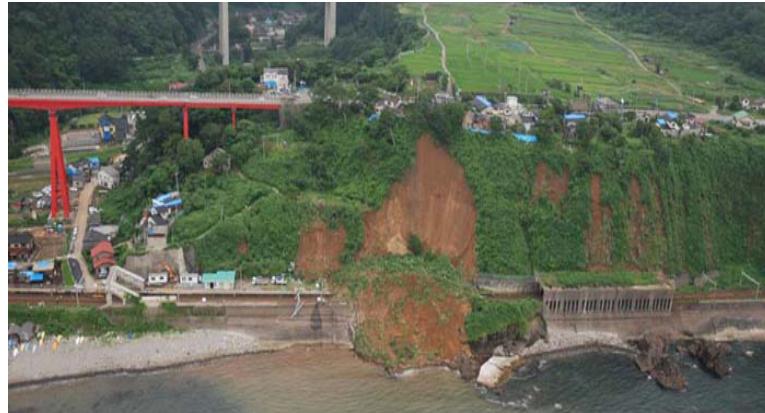
Figure 3: Slope failure near JR Omigawa station (photo by Kokusai Kogyo Co. Ltd).

Near the station, large cracks were observed on the asphalt roads, indicating the occurrence of lateral spreading in the downslope direction.

One major landslide occurred in the vicinity of JR Shin-etsu Mainline's Omigawa station (see Figure 3) where the debris covered part of the railway line. Fortunately, no one was injured due to the landslide. The slope was fairly steep and the slide involved a volume of soil about 100 m high, 50 m wide and 10 m deep. The resulting scar had an almost vertical face. Because of the steep hills in the vicinity of the station, other landslides were observed in the area as well. Note from the figure the presence of railway tunnel protection structure immediately to the right of the landslide, indicating slope instability problems in the area.

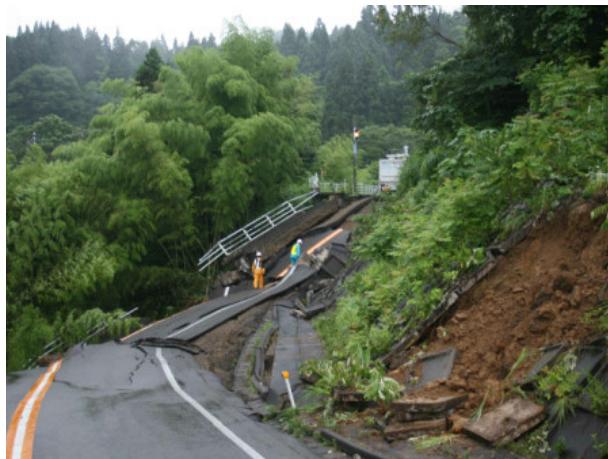
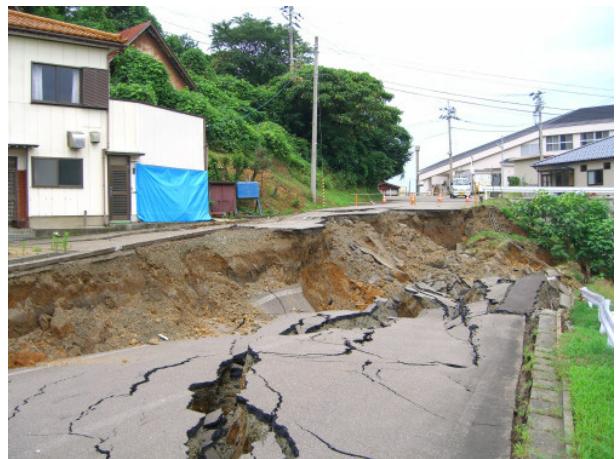
**Figure 4:** Top photo shows the slope failure along National Route No. 8 in Senbon, Nagaoka City (photo by Prof. Inoue). Bottom photo shows the reconstruction works during the site visit.

Another large-scale landslide occurred along National Route No. 8, which connects Kashiwazaki to Nagaoka. The landslide, which occurred in the foothills of Senbon (east of Kashiwazaki), started at about 60 m above the road pavement (see Figure 4). The slide pushed the highway into the Kurokawa River which runs parallel to the road (on the left lower portion of the photo). The debris covered about 80 m section of the road, causing the suspension of traffic operation along this major road.

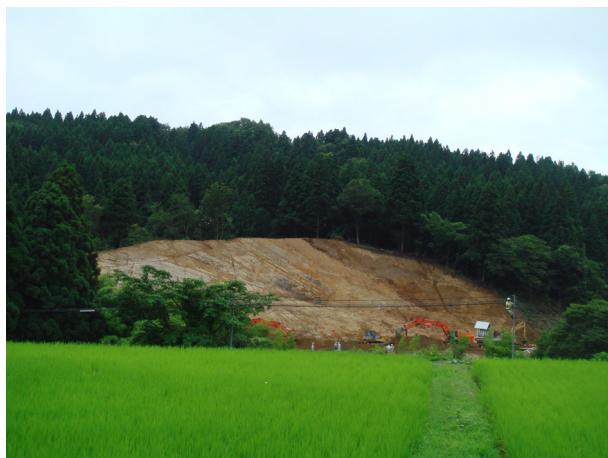
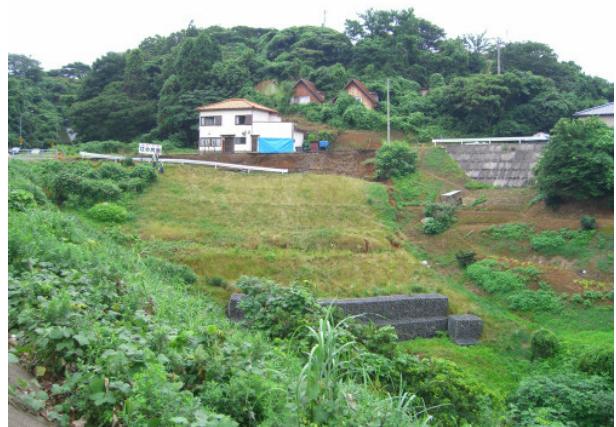
**Figure 5:** Top photo illustrates the collapse of man-made embankment in Kasashima. Bottom photo shows the slope stabilization measures applied at the site.

Several embankment failures were observed in road fills along the coast. In Kasashima off Route No. 8, a 60 m portion of an embankment underwent more than 1 m of vertical displacement, resulting in road closure (see Figure 5). In the vicinity of this area, sand boils and ground fissures were observed, indicating the possibility of liquefaction-induced slope failure. The slope appeared to have undergone previous stabilization using slope grading and gabion baskets to support the toe, as shown by the lower photo in the figure.

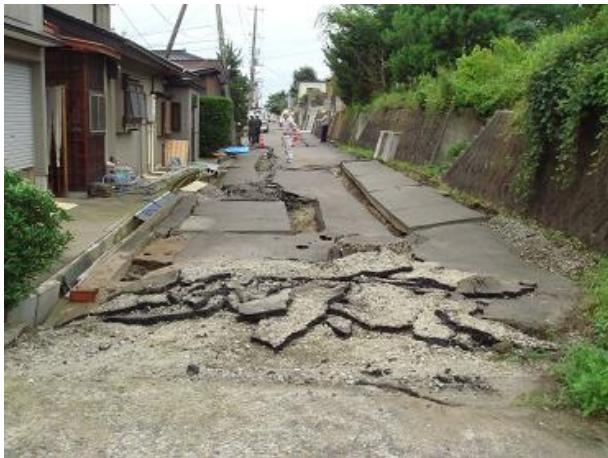
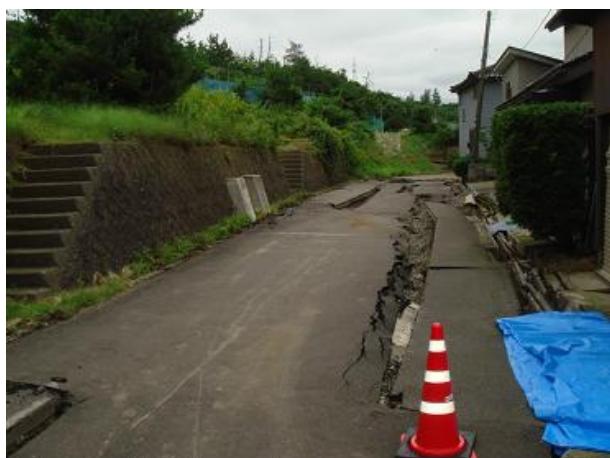
Figure 7: Liquefaction-induced ground deformations in Yamamoto Danchi, Yamamoto town.

Another area of considerable damage was observed in Yamamoto Danchi, Yamamoto Town adjacent to the incinerator plant (Figure 7). Cracked pavements, uplifted manholes, lateral spreading and uneven settlements were observed in many parts of the area. Although these observed ground deformations were localized in nature, they resulted in extensive damage to residential houses, road facilities and water supply networks.

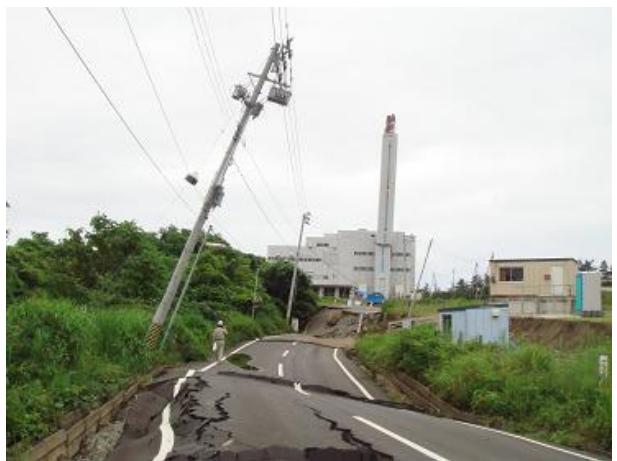
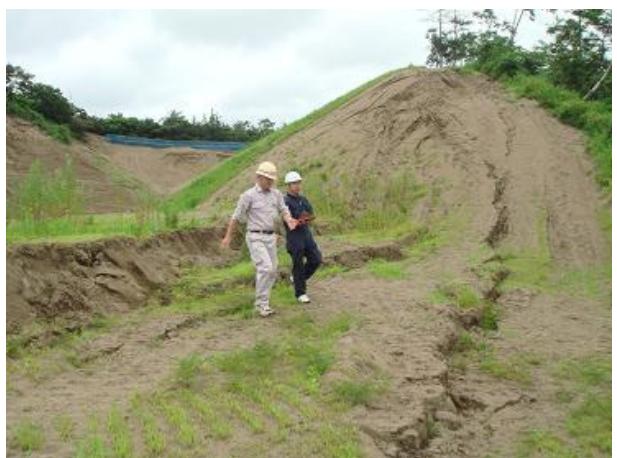
The road parallel to the Sabaishi River which leads to the Kashiwazaki City's Garbage Incinerator Plant underwent extensive liquefaction. The road spread laterally towards the river, resulting in massive embankment failure (See Figure 6). The vertical displacement of the head scarp was about 3 m (maximum), with the lateral spread movement occurring from the sand quarry area towards the river. Sand boils were also observed near the river. Based on the locations of sand boils and ground cracks, it was inferred that this site may have been a former river channel of the Sabaishi River which was buried when the road was constructed.

Figure 6: Top photo: liquefaction-induced collapse of the road leading to Kashiwazaki Incinerator Plant; Bottom photo: quarry site immediately to the right of the road.

Also seen in the background of the top photo is the damaged exhaust chimney of the plant. The reinforced concrete chimney, measuring 60 m high by 4.5 m wide, was broken at the lapped splice of the longitudinal reinforcements slightly below the centre of the chimney.

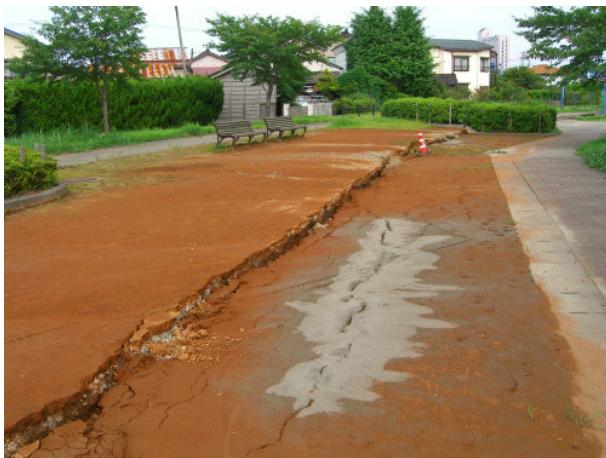
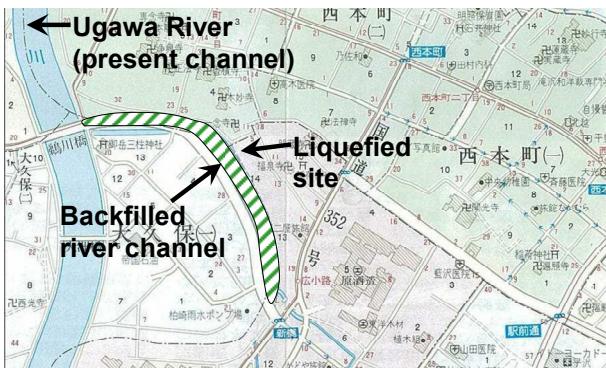
**Figure 8: Top photo: Ground crack and sand boils induced by soil liquefaction at Suidobashi Park; Bottom map: location of backfilled river channel and liquefaction site.**

Extensive liquefaction was also observed at the Suidobashi Park in Nishimoto, Kashiwazaki City. A very long ground crack was observed traversing through the entire length of the park (Figure 8). Relative settlements ranging from a few centimetres to as much as 200 mm accompanied the ground crack. Sand boils and ground fissures were also seen adjacent to this crack. Further investigation showed that the region which settled was a former river channel backfilled with soil at the time the Ugawa River system was straightened in 1997. During this time, flood mitigation efforts were implemented and the area was transformed into a park.

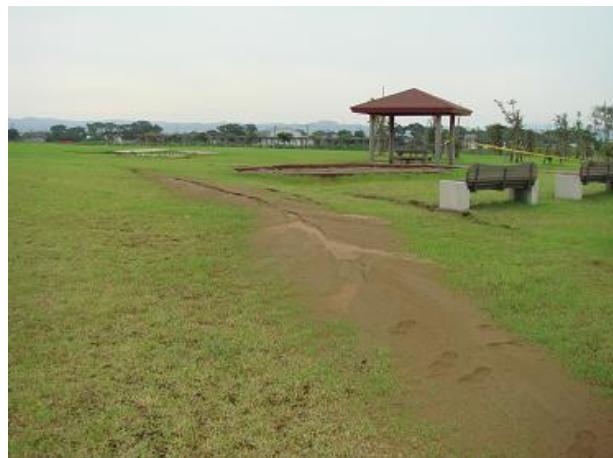
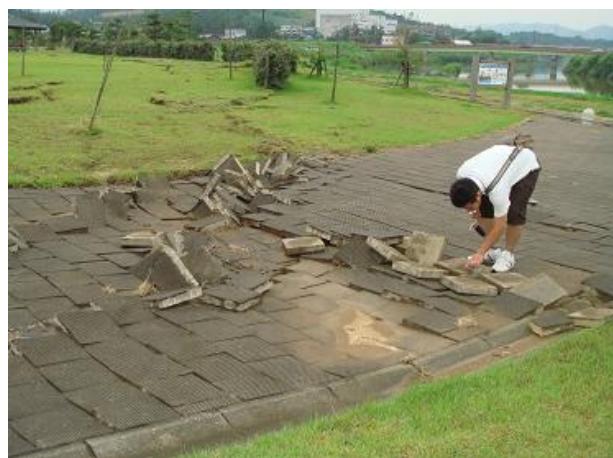
Sand boils, cracks and large ground fissures were also observed at various locations in Sabaishigawa Memorial Park in Makihara, Kashiwazaki City (Figure 9). The park was constructed on a sandbar formed by two branches of the Sabaishi River. As part of the river improvement schemes implemented in the 1990s, the river was straightened by backfilling the northern branch. Apparently, the old river channel and portions of the sand bar liquefied during this earthquake, causing lateral spreading towards the existing river channel.

**Figure 9: Sand boils and ground fissure observed in Sabaishigawa Memorial Park.**

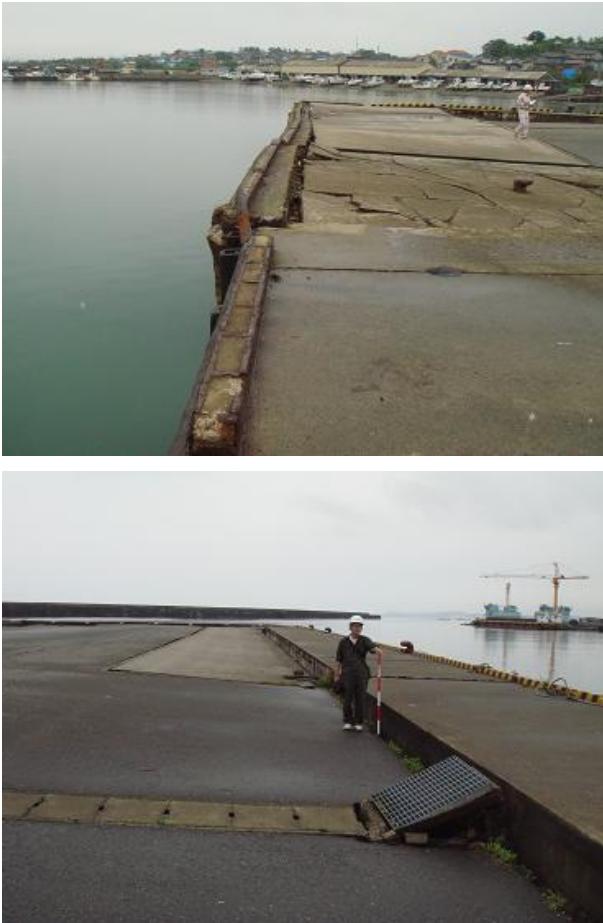
The earthquake affected several coastal structures in Niigata Prefecture. Among these, the Kashiwazaki Port, the largest facility in the affected region with approximately 1.25 km of waterfront berths, suffered extensive damage due to liquefaction-induced ground deformations. At the West Wharf, settlement and displacement of the quay walls opened joints in the aprons and deformed the ground in the yard area (see top photo in Figure 10). At the Fishing Port, the apron settled by as much as 200 mm due to the lateral displacement of the quay wall toward the sea (see bottom photo in Figure 10). Similar types of damage were observed at the Central Wharf, where cracked pavements, deformed quay walls and uneven surfaces were noted. In addition, the boiled sands and fissures caused by liquefaction were observed in many places around the harbour.

**Figure 10: Damage to Kashiwazaki Port.** Top photo shows lateral spreading of the quay wall towards the sea while bottom photo shows settlement of the apron.

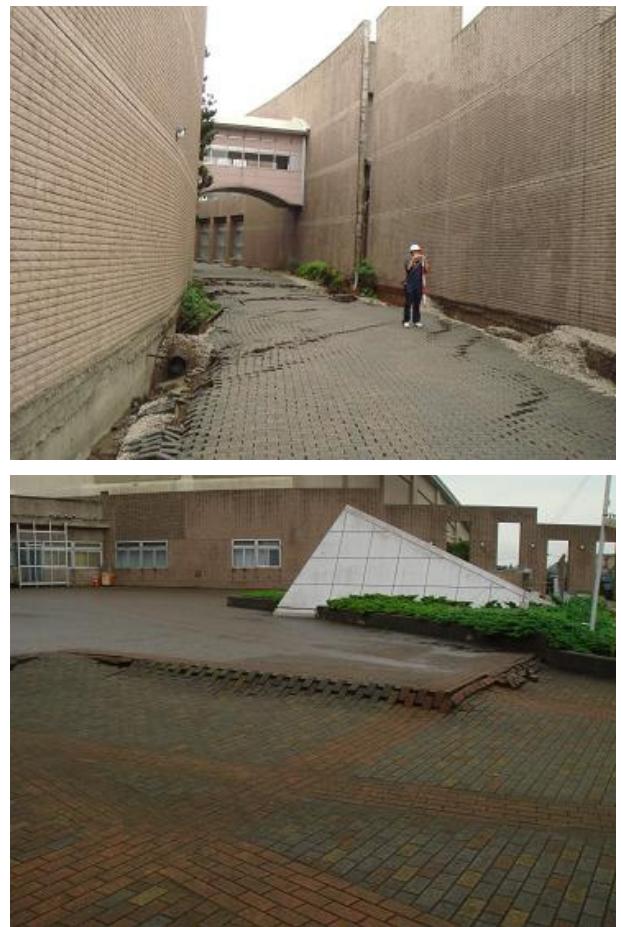
The Kashiwazaki Aquapark building, located near the port, suffered damage as a result of ground shaking and liquefaction of the foundation soil. The majority of the perimeter of the main building settled and lateral separation between an external wall and the main building occurred (see Figure 11). Although details of the type of building foundation was not available at the time of the visit, it was inferred that the main

structure was supported by pile foundations, and the liquefaction of the foundation ground caused uneven ground settlement with no major effect on the main structure.

**Figure 11: Damage to Kashiwazaki Aquapark.** Top photo shows uneven settlements in the perimeter of the building and lateral separation of the walls; bottom photo shows the settlement of the pavement in front of the building.

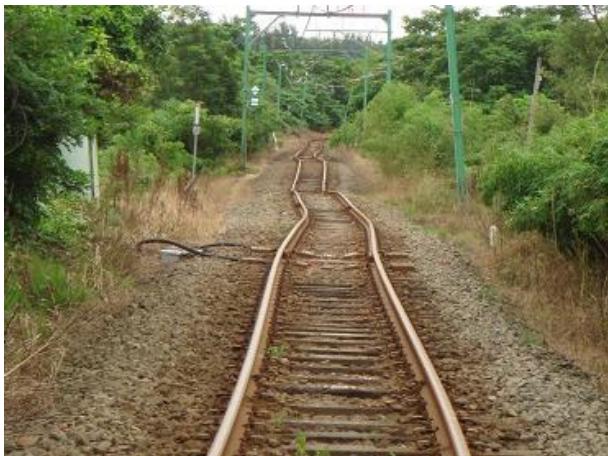
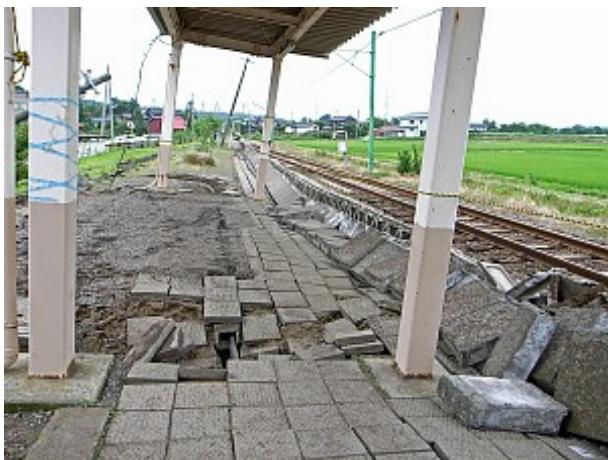
Damage to railway lines were also evident in the region, although highly localized. Between Arahama Station and Nishiyama Station on the JR Echigo Line, the rail track buckled at locations where the railway embankment moved laterally during the earthquake (top photo of Figure 12). Moreover, the Arahama Station platform was completely damaged, together with the powerlines and signalling equipment, as a result of liquefaction-induced settlement and lateral spreading (bottom photo of Figure 12).

**Figure 12: Damage to railway facilities: top photo shows the buckled railway track while the bottom photo shows the damaged platform of Arahama train station.**
