## NZ SOCIETY FOR EARTHQUAKE ENGINEERING RECONNAISSANCE TEAM TO SEATTLE, USA: THE FEBRUARY 28, 2001 NISQUALLY EARTHQUAKE

#### Report of the NZSEE and MCDEM Reconnaissance Team

# Dick Beetham<sup>1</sup>, Graeme Beattie<sup>2</sup>, Barry Earl<sup>3</sup> and Denzil Duncan<sup>3</sup> ABSTRACT

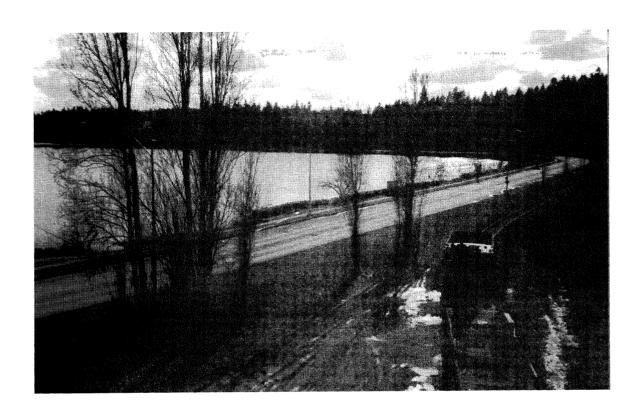
Spectacular and damaging examples of cracking, lateral spreading and ground slumping occurred in Olympia along the margins of Capitol Lake and at Sunset Lake, Tumwater. Displacements of up to several metres affected nearby roads, footpaths, railway lines and utilities and resulted in road closures that will require expensive repairs (Figures 9 & 10).

Figure 9: Sand boils indicating liquefaction by the rail wagons. This road along the margin of Capitol Lake, Olympia, was closed due to extensive lateral spreading damage about the middle part of this view. Similar lateral spreading causing extensive damage occurred nearby at Tumwater.

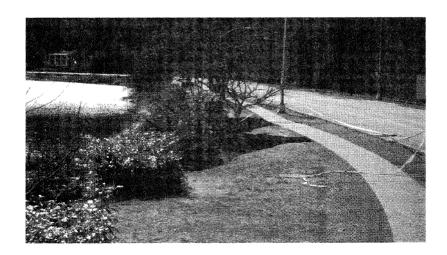
Figure 10: Slumping/lateral spreading at the margin of Capitol Lake, Olympia. Sand boils, indicating liquefaction, were present to the right of the road. The road was closed due to extensive lateral spreading damage to it beyond this view.

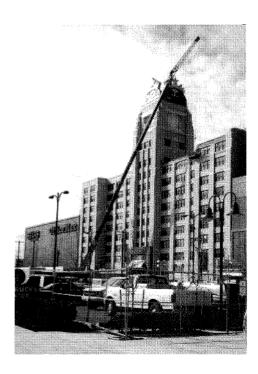
The Starbucks (famous for coffee) headquarters is located in a reinforced concrete slab-column structure with extensive brick cladding (Figure 20). A retail building had been built adjacent to the south end of the original building and a parking structure had been built adjacent to the north end. The concrete slab-column structure appeared to experience greater ground accelerations in the east-west direction (from front to back) and there were substantial cross cracks in the brick cladding (Figure 21).

Figure 20: Starbucks Headquarters.

It appeared that the retrofitting had served to provide excellent life safety for the occupants but building damage was not prevented. Large sections of the exterior cladding required removal before the building could be reoccupied. There was apparently also significant non-structural damage inside the building, particularly to suspended ceilings.
