DAMAGE TO STATE HIGHWAY 73 FROM THE 29 MAY 1995, ARTHUR'S PASS EARTHQUAKE

B.R. Paterson¹ and J.B. Berrill²

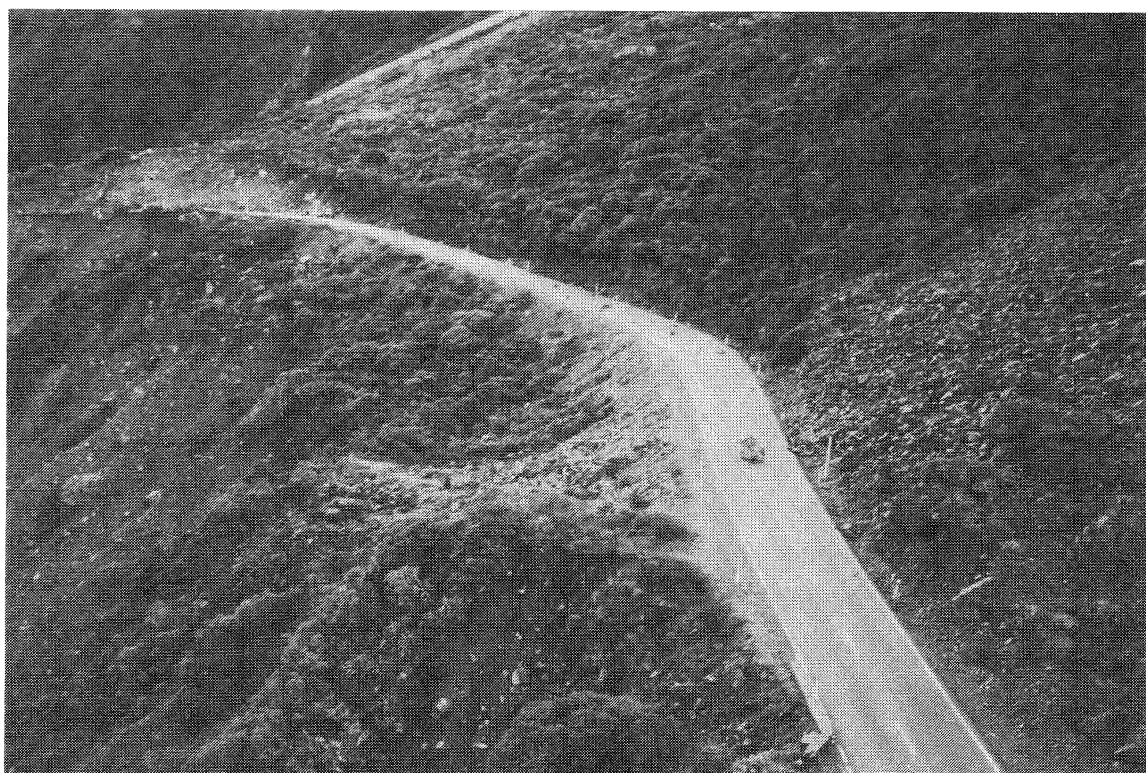
Blocks of greywacke sandstone fell onto the highway at the top of the Zig Zag and at several hairpin bends where the highway

FIGURE 2 Blocks of rock on the highway at the top of the Zig Zag.

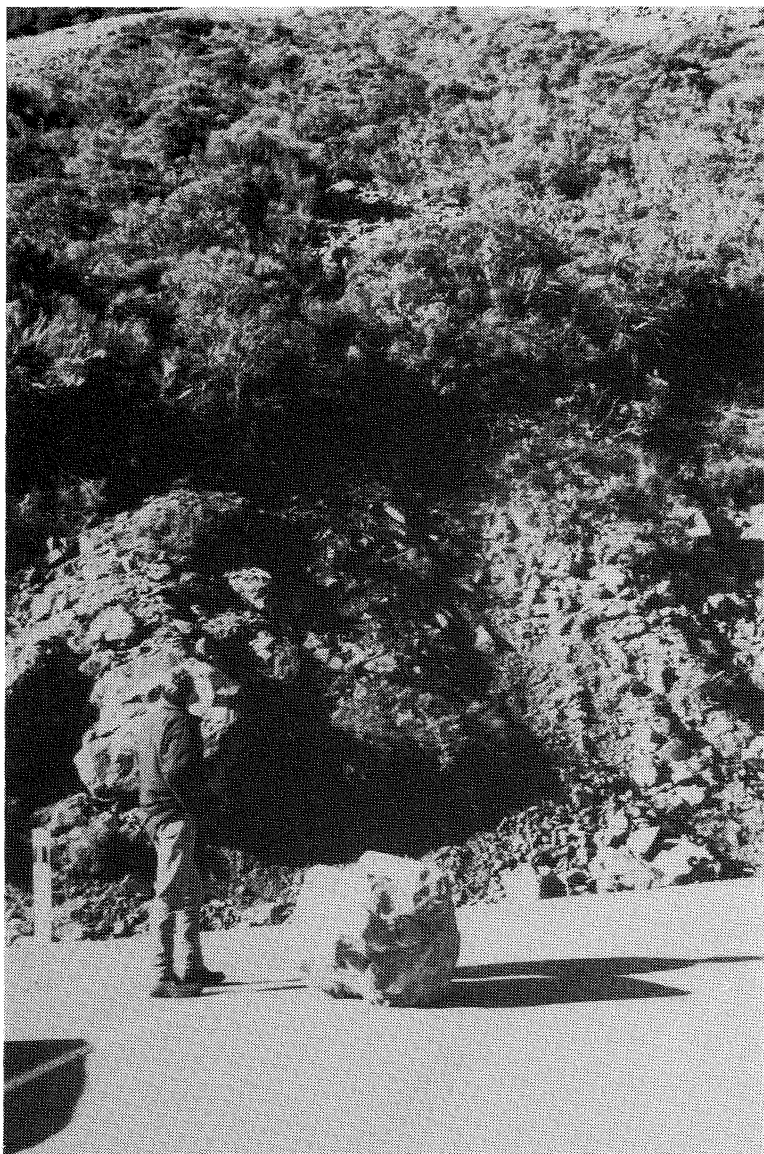
FIGURE 3 A block of rock on the highway at the Zig Zag.

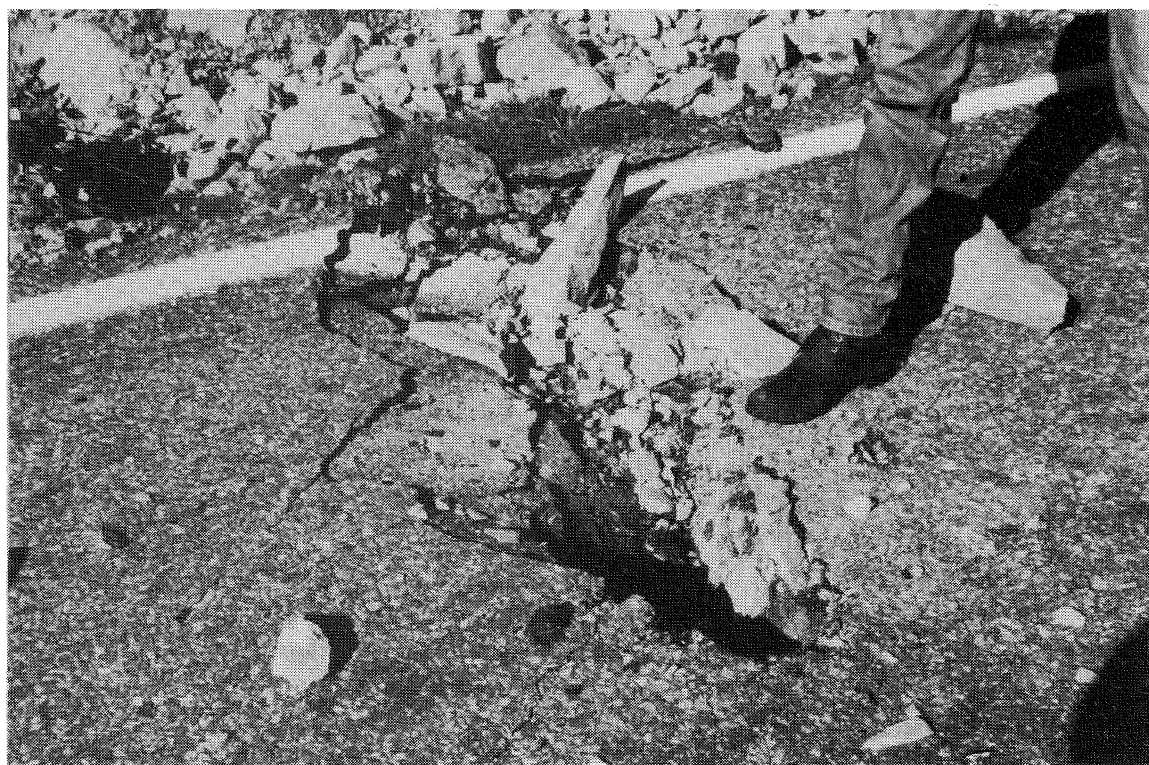
descends into Otira Gorge. These sections of the highway side across the toe of extensive scree deposits which extend almost 400 m upslope to the base of rock bluffs, the headscarp of the Otira rock avalanche [Patterson et al, 1992]. Most blocks rolled onto the highway from batters and adjacent scree deposits, causing no significant damage. Several blocks 1.5 m diameter, created impact craters on the highway indicating that they had originated from a considerable height above the highway (Figures 3 & 4). During the helicopter survey, the tracks of individual blocks were traced through bush above the highway onto the upper scree slopes where tongues of rock debris, deposited by rockfall during the earthquake, were identified by their "fresh" appearance (Figure 5). Sources of rockfall on the headscarp above the scree deposits were also identified by scars (Figure 6). The main rockfall source occurs at the head of the northern most, scree fan (Figure 5), with several minor sources being located along the headscarp to the south.

FIGURE 5 Fresh rockfall debris on the northern scree deposit (highlighted) and main rockfall source (arrowed) above the Zig Zag.

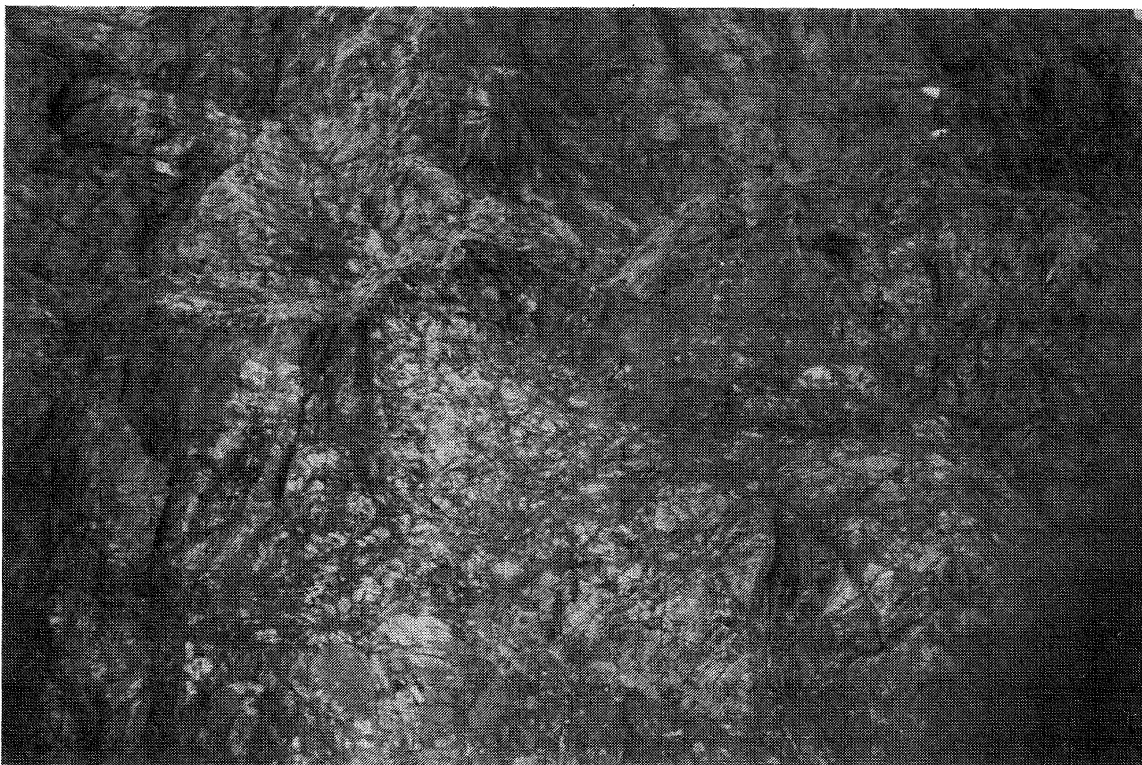
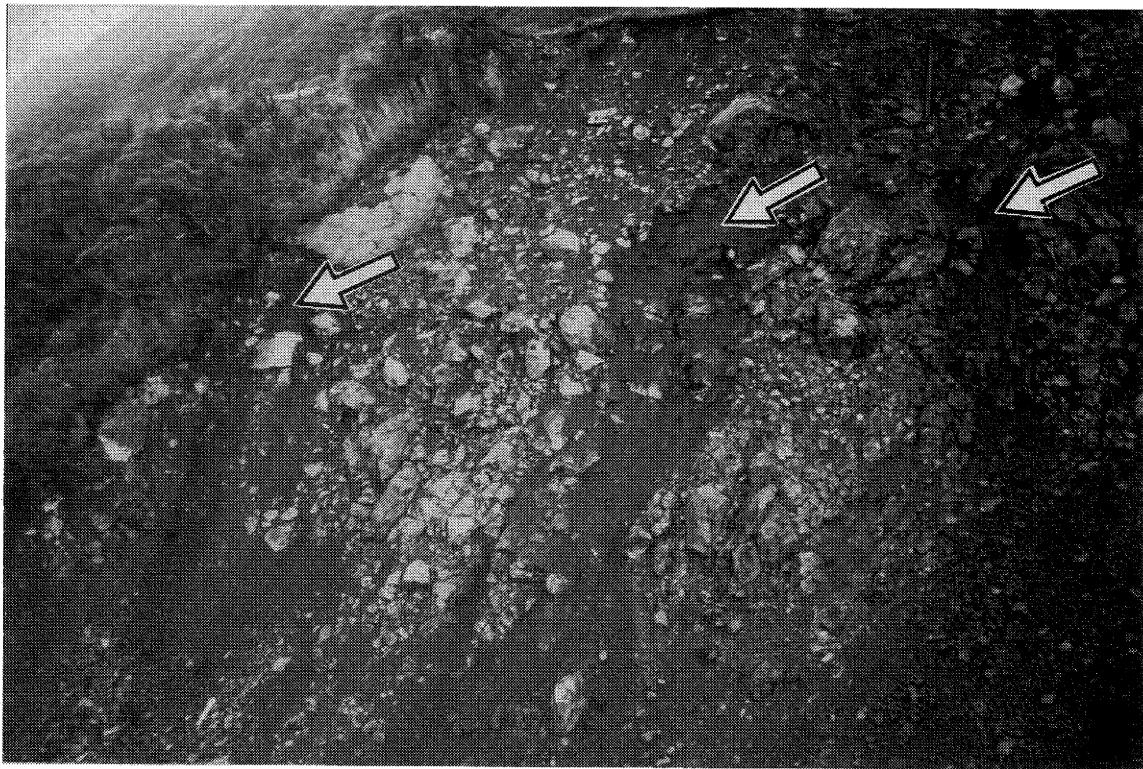
Rockfall also originated from steep slopes of rock avalanche debris below the highway, judging by fresh scars observed where blocks were released from over steepened slopes immediately below the highway (Figure 7), and by accumulation of blocks on the drilling access track at the foot of the slope (Figure 8). Blocks up to 4 m diameter fell onto the track, and

FIGURE 7 Sources of rockfall (arrowed) from rock avalanche debris below the highway at a Zig Zag hairpin bend. Note highway barrier top left.

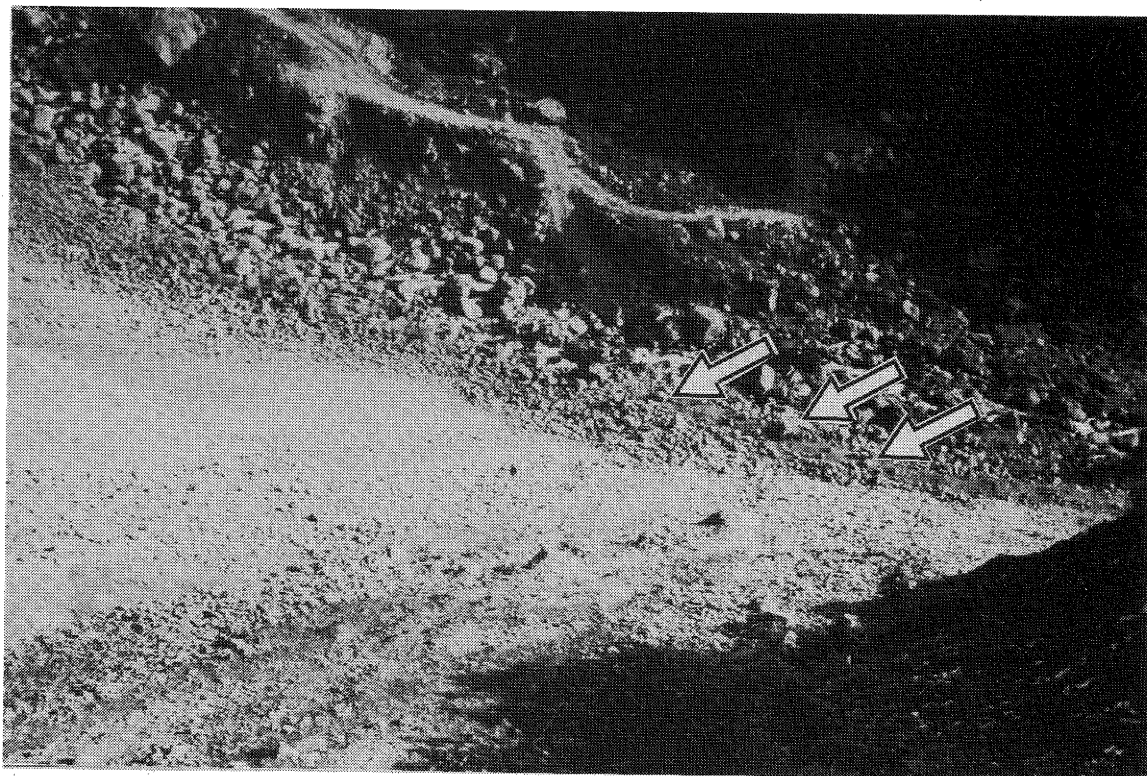
FIGURE 8 Large rockfall blocks (arrowed) on the access track below the Zig Zag. Otira River flows left to right.

impact craters on the track indicated that several blocks continued into the river below. This demonstrates the need to mitigate the hazard of further rockfall during future investigation and construction work for the viaduct, and the necessity for protection of the viaduct during its operational life, aspects addressed in the design of the viaduct.

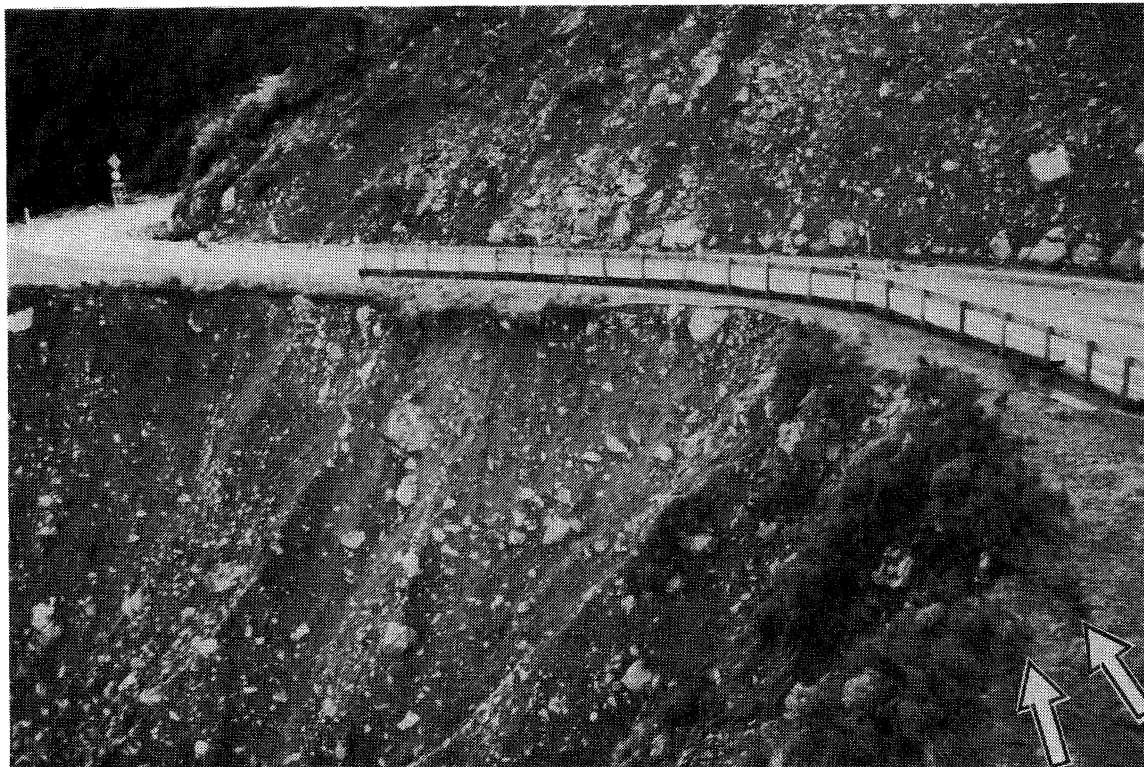
Slumping occurred along the edge of the highway at several locations, including at the top of the Zig Zag (Figure 9), and at the second hairpin to the north. Linear, parallel slump cracking occurred along the edge of the pavement several metres back from the edge of the highway bench. The ground fracturing appeared to be relatively superficial, although there was concern that surface fracturing along the highway, and rockfall from the slopes beneath the highway, may indicate initiation of deep seated circular failure. At both locations, slopes beneath the highway have been over steepened by gradual degradation of in situ, rock avalanche debris, with the result that if circular failure occurred, part, or the entire width of the highway bench could collapse, closing the route for a considerable period.

FIGURE 9 Tension cracks (bottom right) along the edge of oversteepened slope at the top of the Zig Zag.

On the basis of existing data it was concluded that the ground disturbance from earthquake shaking was relatively superficial. However, because of the lack of definitive data and as a precautionary measure, the width of the carriageway was reduced, an inspection programme to detect further ground fracturing was implemented, and investigation of temporary by-passes at both sites was initiated.

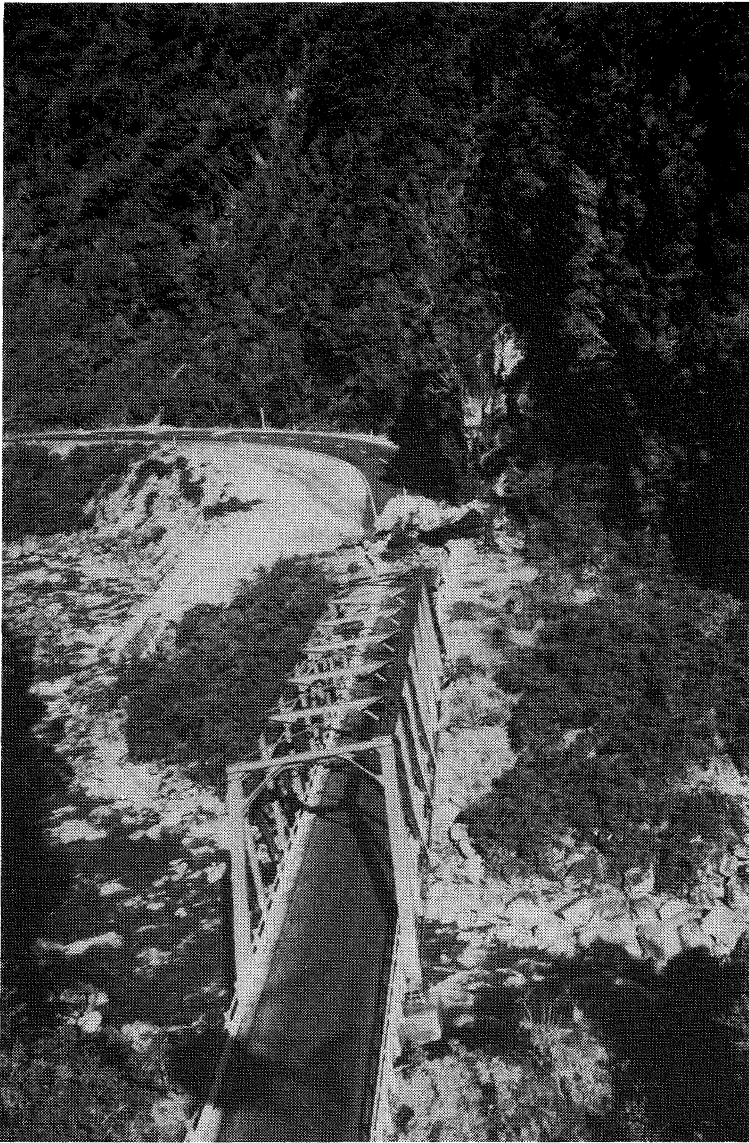
At Yorkys Bridge, several large blocks of greywacke sandstone which formed a prominent spur of bedrock overhanging the southern end of the old wooden truss bridge, were displaced by the earthquake, ending up on the highway, blocking the southern approach to the existing bridge (Figure 10). A relatively small block was dislodged from the end of the spur during the 1994 earthquake, and at that time it was recognised that further material could be mobilised by strong earthquake shaking. Failure of the spur probably resulted from the combined effects of an unfavourably oriented basal joint, isolation of the rock spur from the adjacent rock mass, and rock mass disturbance created by the 1994 earthquake.

FIGURE 10 Rockslide at the southern end of Yorkys Bridge, Otira Gorge.

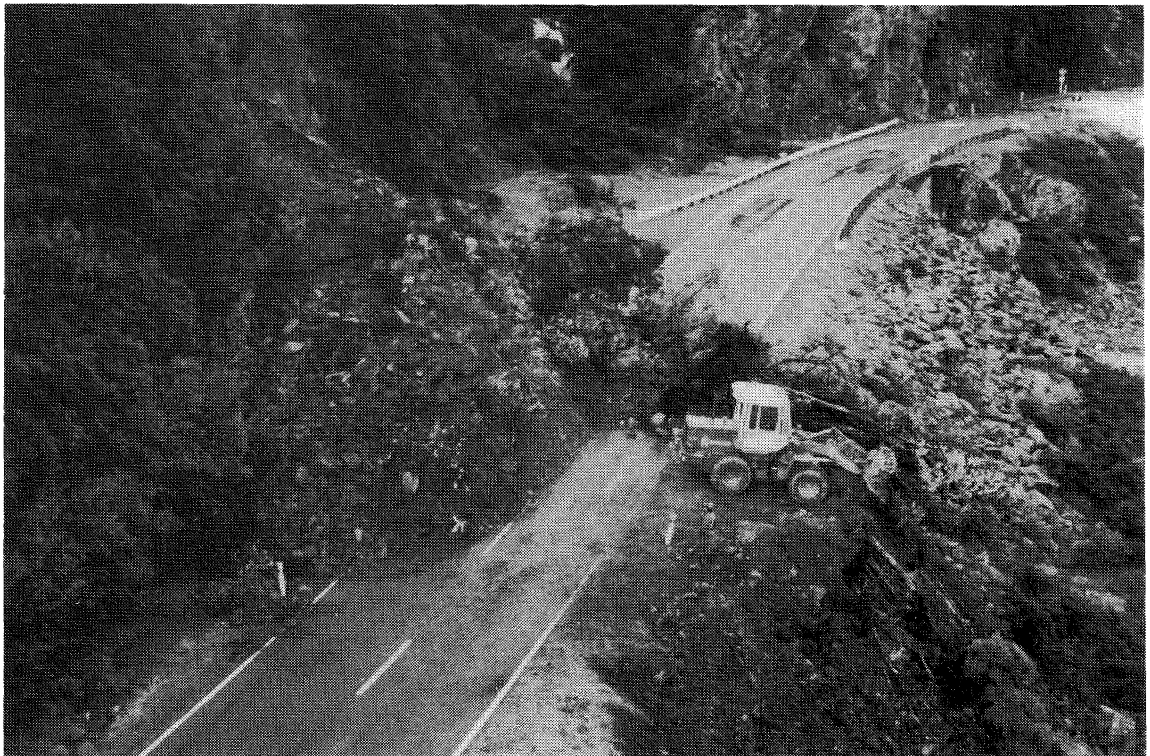
Near Wesley Creek, a 2000-3000 m³ slope failure of highly weathered, dilated greywacke was initiated by the 1995 earthquake at a location adjacent to two previous slope failures caused by the 1994 earthquake (Figure 11).

FIGURE 11 Rockslide near Wesley Creek, Otira Gorge.
