# RESTORATION OF ROAD AND RAIL TRANSPORTATION FOLLOWING THE GREAT HANSHIN EARTHQUAKE<sup>1</sup> OF 17 JANUARY 1995

I.J. Billings<sup>2</sup>

## ABSTRACT

This paper describes the restoration of the rail and road routes which were seriously damaged in the Great Hanshin Earthquake of 17 January 1995. It is based on observations and data provided during a visit to Kobe, Japan in July 1995, 6 months after the earthquake.

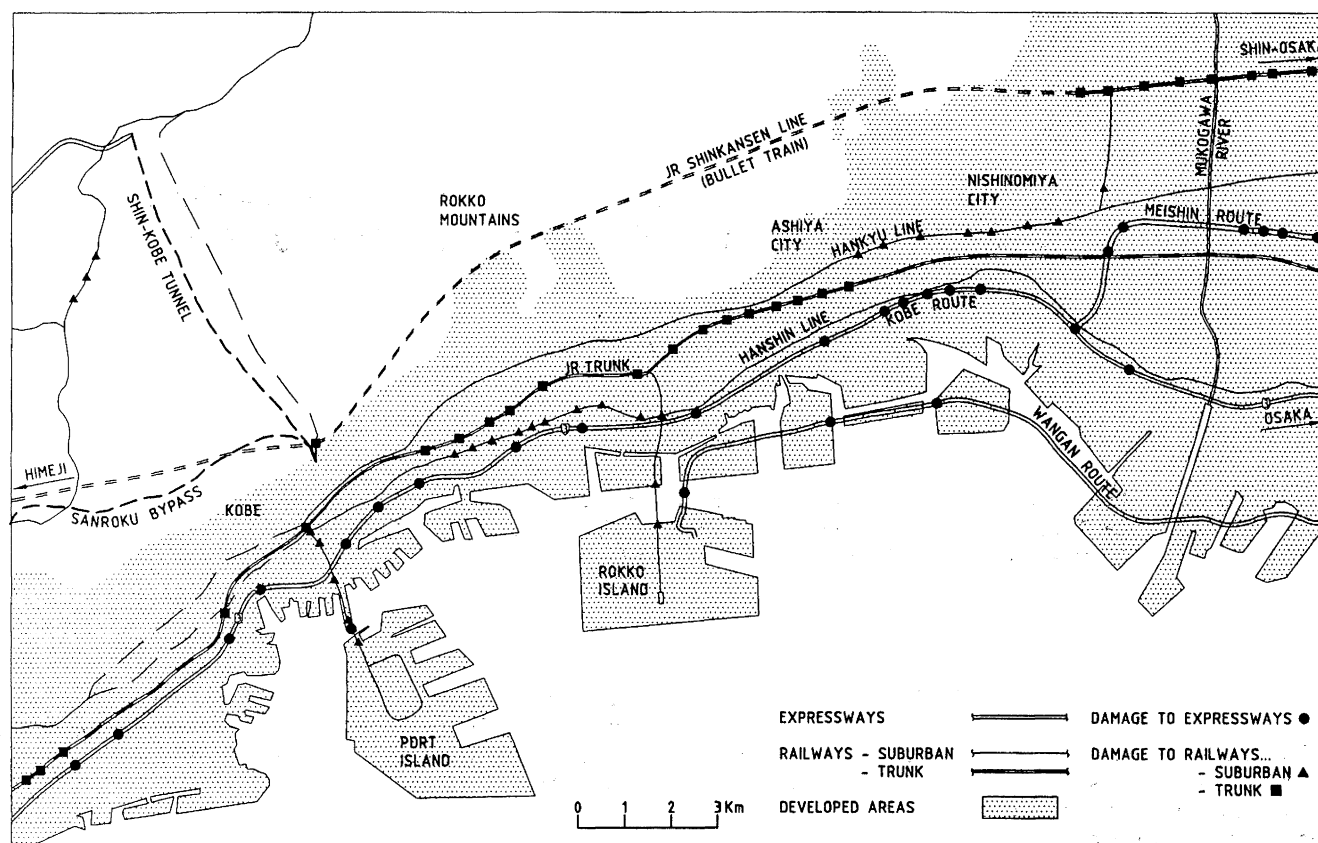
FIGURE 3.1 Damage to Primary Transportation Routes in Kobe/Nishinomiya Area

All the primary transportation links between Nishinomiya City and Kobe City were cut, causing the remaining on-grade roads to become chaotically overloaded. Bridge collapses on the Shinkansen (bullet train) Line cut the system, isolating the northern and southern lines.

The locations where damage cut the transportation links are indicated in Figure 3.1. Further details of this damage are given in the previous NZNSEE reconnaissance report [Park et al, 1995].

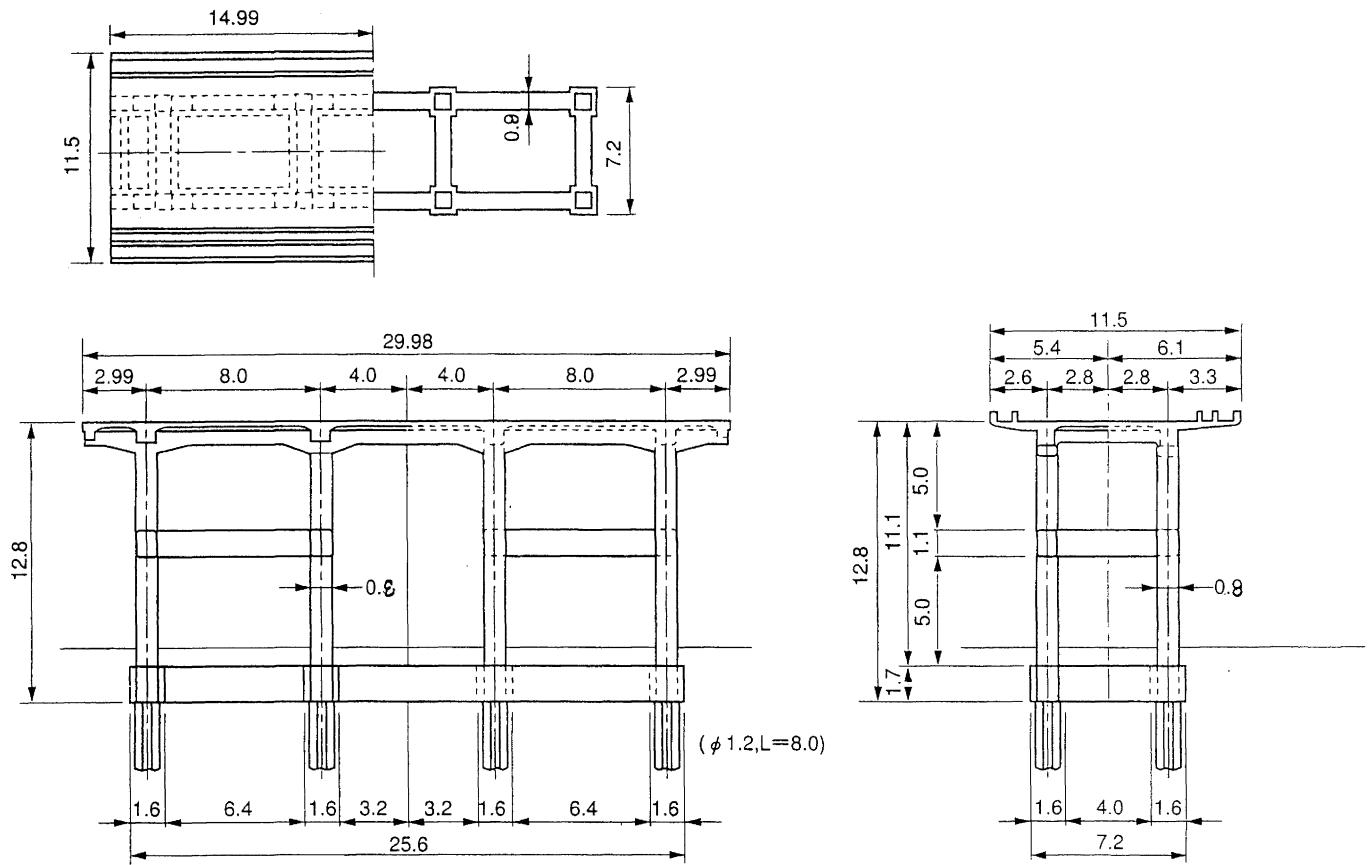
FIGURE 6.1 Typical Section of Shinkansen Viaduct

A typical three span section viaduct section is shown in Figure 6.1. In general the superstructure was not seriously damaged and because of the urgent need to reopen the line, most of the superstructure was reused. The substructure was found to be undamaged. Restoration therefore proceeded as follows. Collapsed sections (of up to 500t weight) were wherever possible jacked back into position and the supporting columns reconstructed (Figures 6.2 to 6.4). In a few cases reconstruction was required. The 800mm x 800mm columns were reconstructed by breaking back the damaged concrete to the existing bars, welding new D32 longitudinal reinforcement to the existing bars, installing column ties (D13 at 100mm centres) and reconcreting the columns. Columns not requiring reconstruction were repaired by epoxy injection. 6mm steel plate encasement was then welded in place full height around all reconstructed or repaired columns and a shrinkage compensating grout used to fill the gap between the plates and concrete. (Figure 6.5). The sections of superstructure lifted back into position were epoxy injected if appropriate and then the longitudinal beams were steel plate encased, anchors being epoxy resin anchored into the existing beams to provide extra restraint (Figure 6.6).

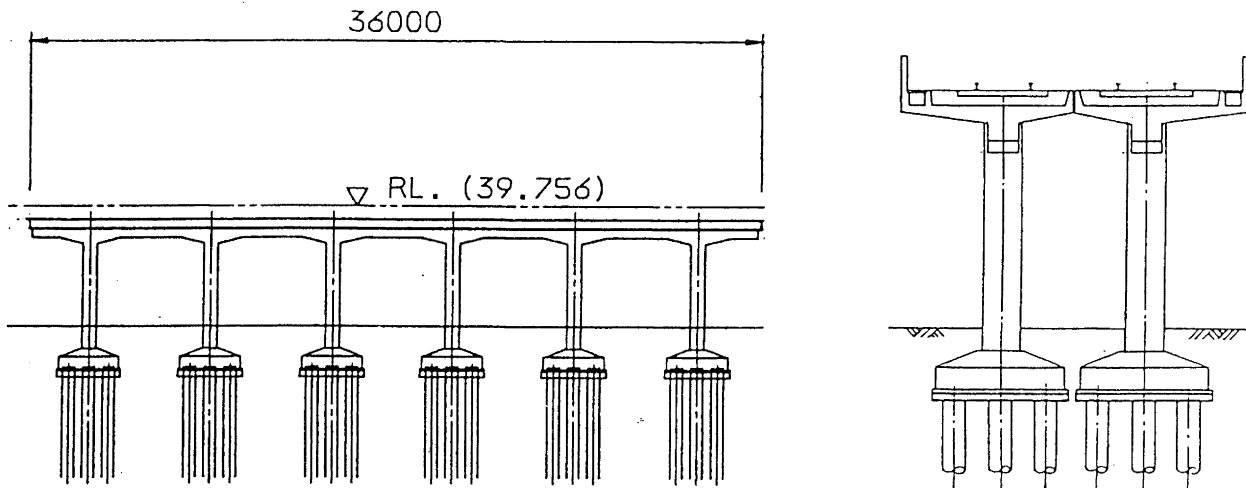
FIGURE 6.12(a) Hankyu Railway - Original Viaduct

The most critical section of the Hankyu line both in terms of programme and restoration cost was the 1.6km length located 0.5 km west of Nishinomiya which was seriously damaged with severe column shear failures and collapses of several viaduct sections occurring. The original structure comprised a reinforced concrete viaduct constructed in 36m sections with 6m span lengths, refer Figure 6.12(a). This structure was demolished and replaced with the structure shown in Figure 6.12(b).

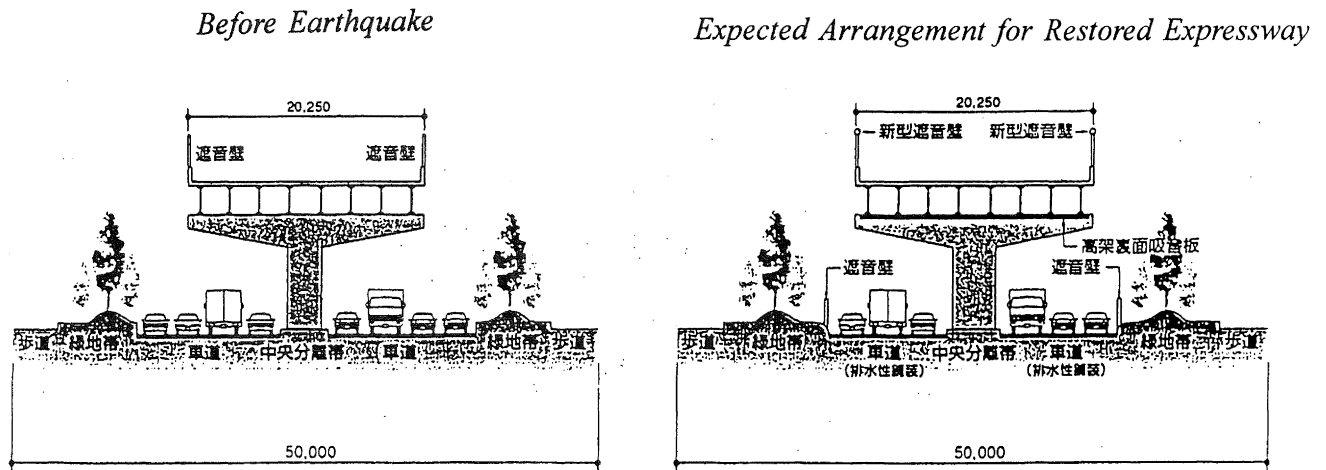
FIGURE 7.2 Kobe Route Expressway

the expressway required temporary securing to allow initially emergency traffic and later normal traffic to access the Kobe/Nishinomiya route. This was especially critical for the Kobe Route which runs above the on grade Highway 43 (refer Figure 7.2).

An item of particular importance in the restoration of this expressway is the environmental standard to be used for the reconstruction. There is considerable pressure to apply much higher standards to the restored expressway and the national highway (Route 43) beneath it than applied before the earthquake. Measures which are being considered include additional noise barriers and the use of porous pavement to mitigate noise. In addition there is a possibility Route 43 may lose two lanes. These matters are illustrated in Figure 7.2.

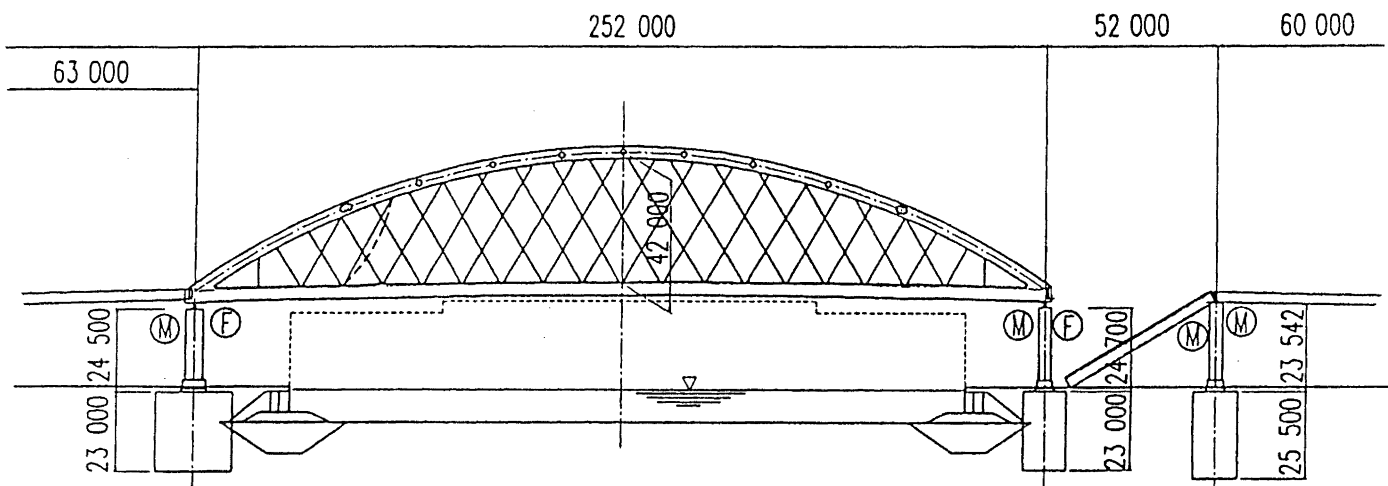
FIGURE 7.6 Nishinomiya-ko Bridge

The Nishinomiya-ko Bridge is illustrated in Figure 7.6. The massive caisson foundations are founded on a gravel layer. The upper half of the caisson is surrounded by reclaimed material while the lower half penetrates very soft marine mud. The reclamation is a sandy material (a highly weathered granite) which showed evidence of liquefaction and lateral spreading at the margins in the earthquake. Both the reclaimed material and marine mud have low standard penetration test blow counts. After the earthquake measurement showed the top of the caisson had moved 90 mm westward (toward the sea) and the top of the steel framed pier had moved 170 mm westward. On 24 February the collapsed span was removed in three pieces using a floating crane in the adjacent seaway. Repairs to the bridge to receive a new span were carried out including installation of new bearings and a seat extension to the pier. The replacement span comprised 3 steel boxes similar to the original but the total construction weight was lighter because a steel deck was used instead of a concrete deck. The 800t span which had been barged to site was lifted into place on 18 March 1995 using a 4100 t floating crane.

To reduce the risk of caisson movements in future earthquakes, the reclaimed ground around the eastern pier of the Nishinomiya-ko Bridge is being improved using sand compaction rigs.

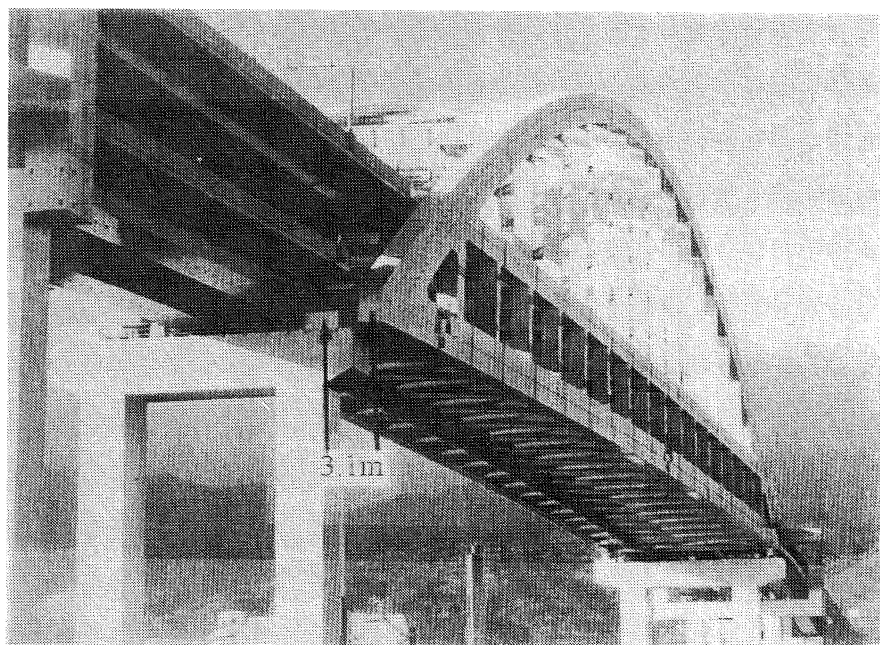
FIGURE 7.7 Damage to Rokko Island Bridge 3.1 m Superstructure Shift

The Rokko Island Bridge is illustrated in Figure 7.7. The double decked bridge moved 3.1 m transversely at pier P214 during the earthquake falling about a metre at the same time. The bridge was seriously damaged and required major repairs. The 217m span was lifted back into position using two floating cranes of 4100 t and 3500 t capacity respectively. Refer Figure 7.8. The bridge is expected to reopen on October 31 1995.

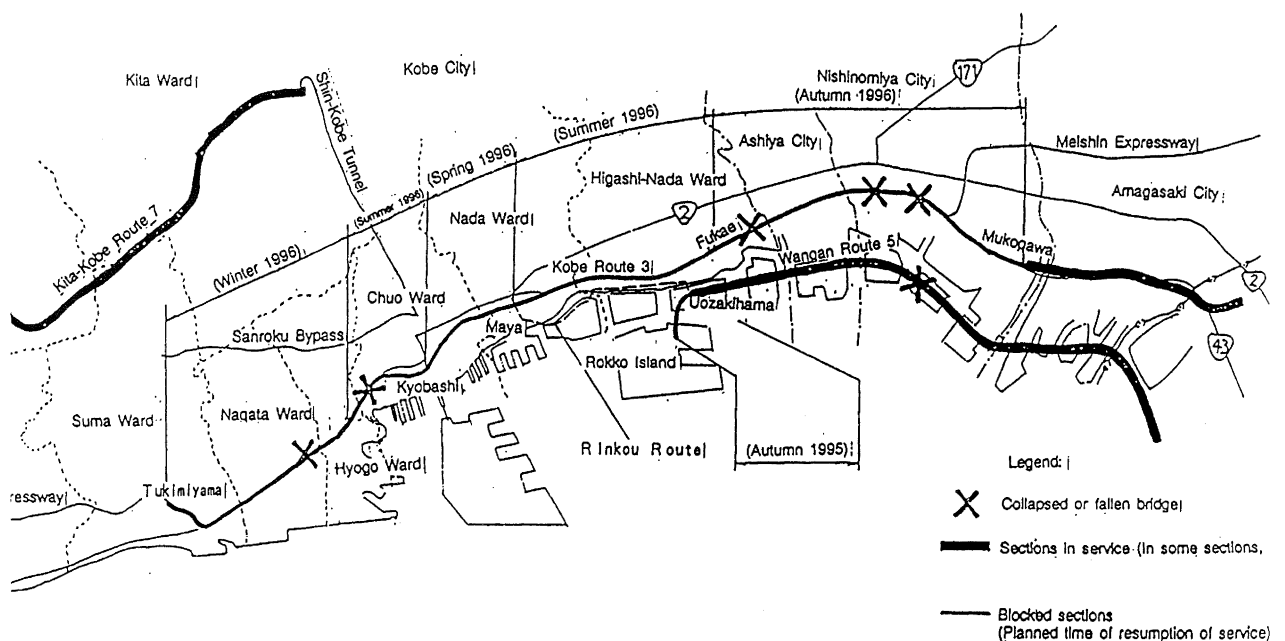
FIGURE 7.9 Restoration Plan for Kobe Route and Wangan Route Expressways (As at July 1995)

This elevated expressway suffered extensive damage in the earthquake as noted above and described in section 7.2.1 of Park et al [1995]. A spectacular collapse occurred to a 600m section near Ashiya (Figure 7.2 of Park et al [1995]). Many piers were seriously damaged - refer to 7.3 below. The expressway is not expected to be fully operational again until the end of 1996. The route is being restored in stages as set out in Figure 7.9. The first stage, Maya to Kyobashi is scheduled to open in spring (March) 1996. This will allow traffic better access the Kobe business and port areas by using (a) the restored Kobe Route between Kyobashi and Maya, (b) the on grade Rinkou Route to Ouzaki-hama and (c) the Wangan route on the Osaka and beyond. Figure 7.9, also shows the other stages leading to completion at the end of 1996.

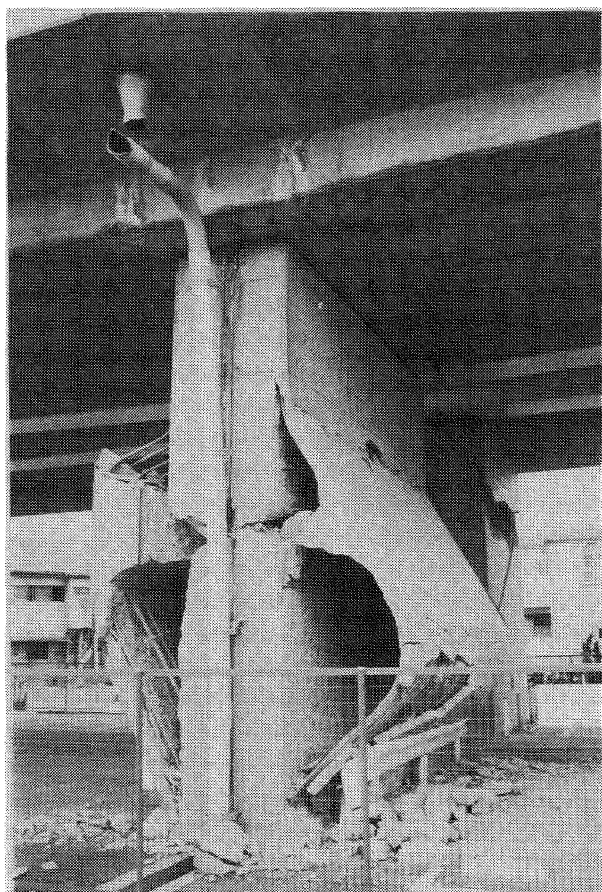
FIGURE 7.10 Meishin Expressway Pier Damage

The 4 lane expressway has two separate viaduct structures each supporting two lanes. The superstructure is a reinforced concrete hollow slab continuous over 5 spans, and supported on reinforced concrete wall type piers (Figure 7.10).

Damage to the expressway included one span collapse and damage to 457 of the 1,588 bridge piers on the damaged section of the expressway. 99 of the piers suffered spalling or severe damage to the concrete and in the worst cases shear failures and partial collapses of the continuous superstructure (refer to Figure 7.7 of Park et al [1995]). 1,594 of the 3,439 bearings were damaged.
