# RECONNISSANCE REPORT ON GEOTECHNICAL AND GEOLOGICAL ASPECTS OF THE 14-16 APRIL 2016 KUMAMOTO EARTHQUAKES, JAPAN

**Gabriele Chiaro<sup>1</sup>, Gavin Alexander<sup>2</sup>, Pathmanathan Brabhaaran<sup>3</sup>, Christopher Massey<sup>4</sup>, Junichi Koseki<sup>5</sup>, Suguru Yamada<sup>6</sup> and Yudai Aoyagi<sup>7</sup>**

## ABSTRACT

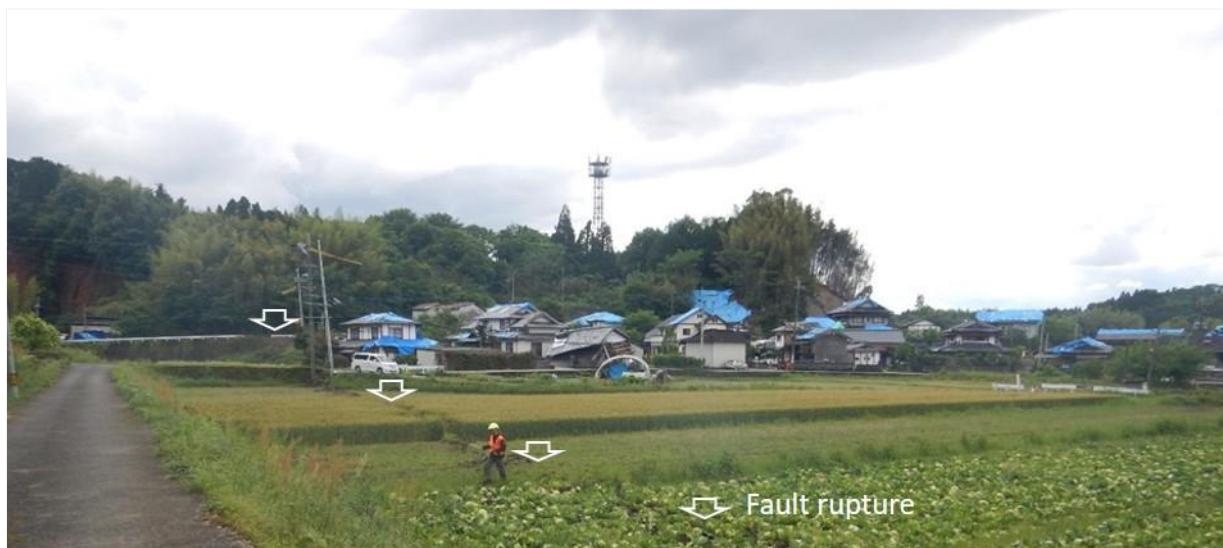
The most common form of damage was to the tiled roofs of residential houses and buildings. Such damage extended further out from the immediate epicentral area. In many locations, blue plastic sheets had been used to cover damaged roofs, and were a common sight across the area, see Photo 1.

*Photo 1: Typical blue sheets covering damaged roofs in close proximity to the surface fault rupture (Location 22 in Figure 2: N 32.80487; E 131.8593).*

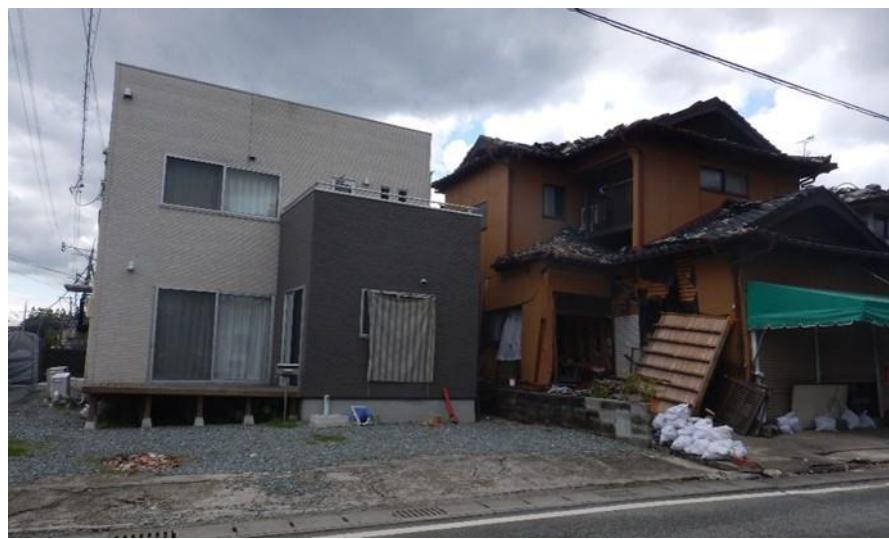
Most of the buildings appeared to have collapsed due to the strong ground shaking caused by the action of the inertia forces on the heavy roofs (Photo 2). Collapsed buildings were mostly old wooden one- and two-storey houses. The roofs of these houses were typically formed from “*kawara*” tiles, which were intentionally made to be heavy, in order to prevent them from “flying away” during typhoons. The Kumamoto district is one of worst typhoon disaster areas in Japan. It is also possible that deterioration of the structural members could have occurred as a result of insect damage.

**Photo 2:** Low damage to a new residential house (without tiled roof) and severe damage to two-storey timber house (with heavy tiled roof) observed in Mashiki Town (N 32.7876; E 130.8185).

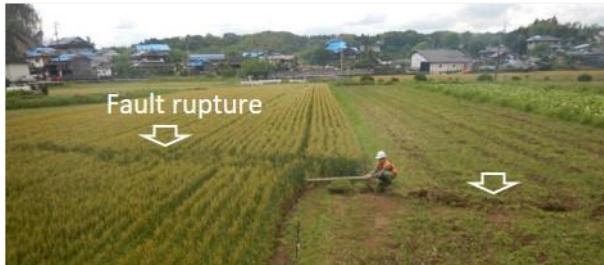
**Photo 3:** Fault rupture of 1.8 m lateral displacements observed in rice fields in Mashiki Town (location 22 in Figure 2: N 32.80487; E 130.8593).

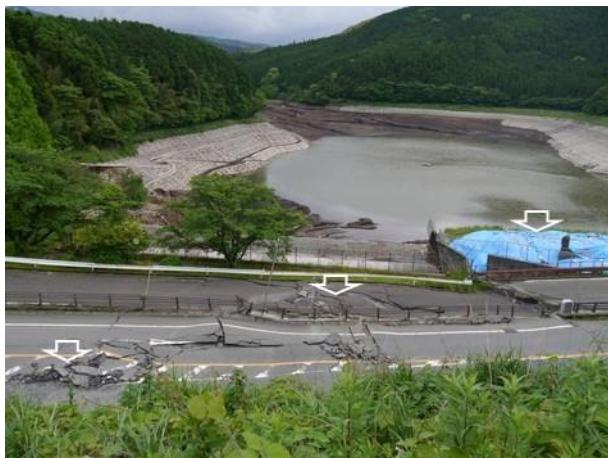
In Nishihara Village severe damage to the left hand side wall of the spillway of the OOKIRIHATA earth dam and adjacent highway over dam crest were observed (Photo 4). No other damage was apparent to the team on the earth dam, but the dam has been drawn down following the earthquake. The GEER team [15] investigated this dam in detail and identified additional fault related damage.

**Photo 4:** Surface fault rupture at the OOKIRIHATA earth dam in Nishihara Village (Location 23 in Figure 2: N 32.8415; E 130.9321).

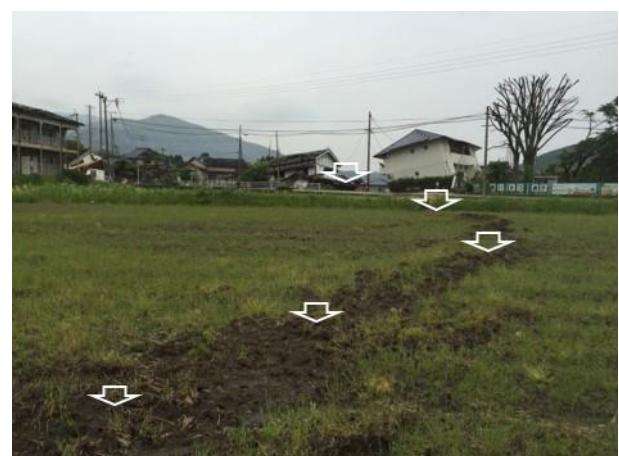
In Minami Aso severe damage and collapse of houses adjacent to the fault trace was observed (Photo 5). Fault displacement of less than 0.5 m was noticed in the rice fields adjacent to housing area.

**Photo 5:** Collapsed apartment block located on the fault rupture in Kurokawa, Minami Aso Village (Location 17 in Figure 2: N 32.8852; E 130.9943).

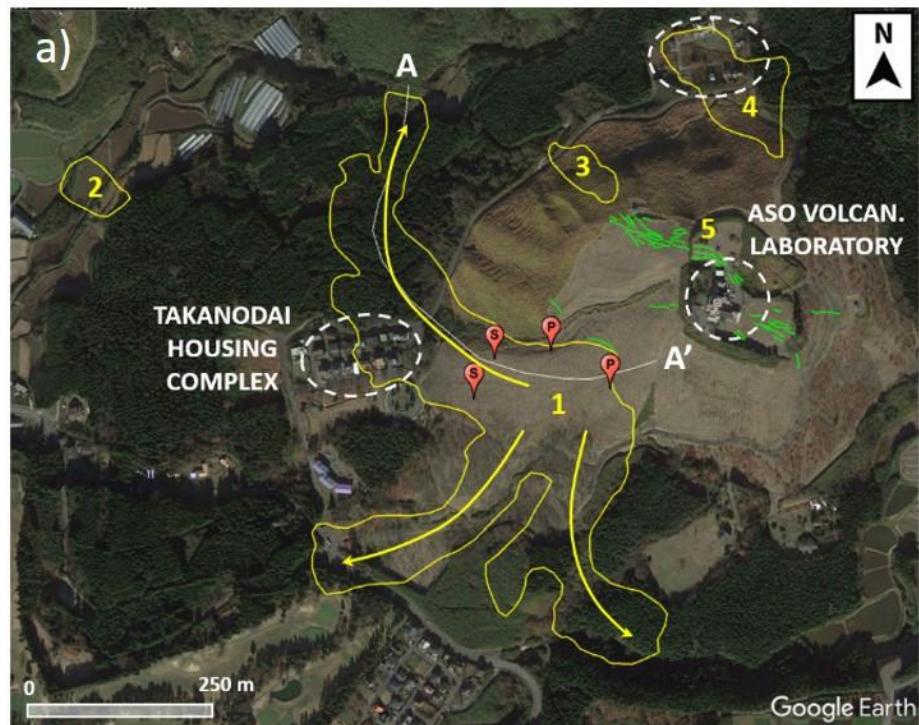
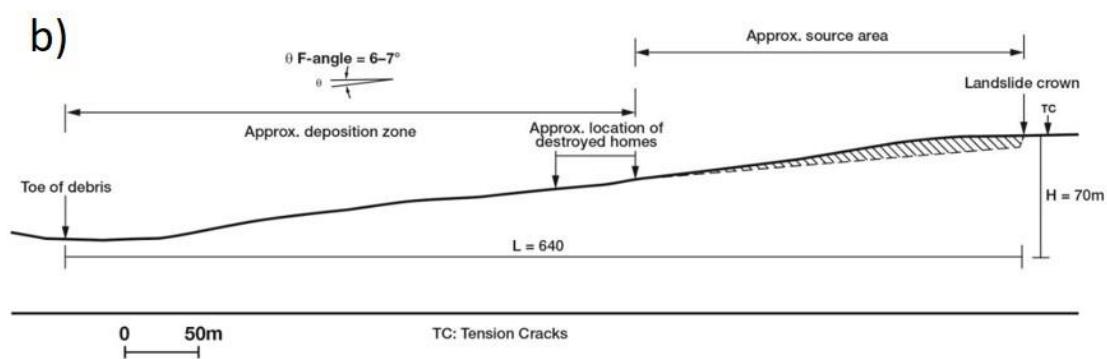
Figure 8: Location 9 in Figure 2 (No.1: main landslide; No.2-4 minor earth slides; No. 5 cracks; A-A' cross-section; s: soil sampling; p: trial pits); and b) cross-section through the Takanodai earth flow/slides.

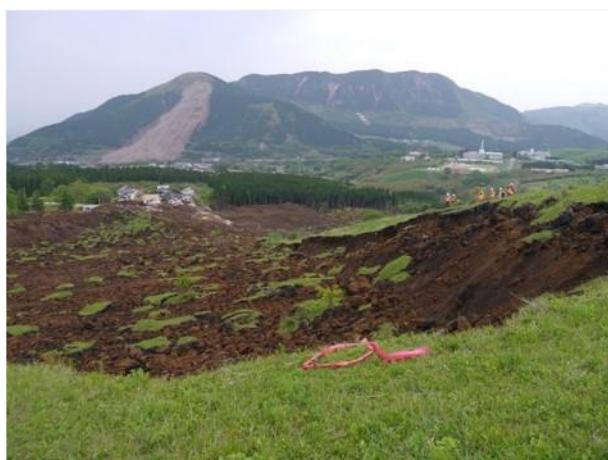
Photo 6: Source of earth flow/slides in Minami Aso Village (looking downhill), with damaged houses and the large debris avalanche at Aso Ohashi Bridge visible in the distance (Location 9 in Figure 2: N 32.8851; E 131.0049).

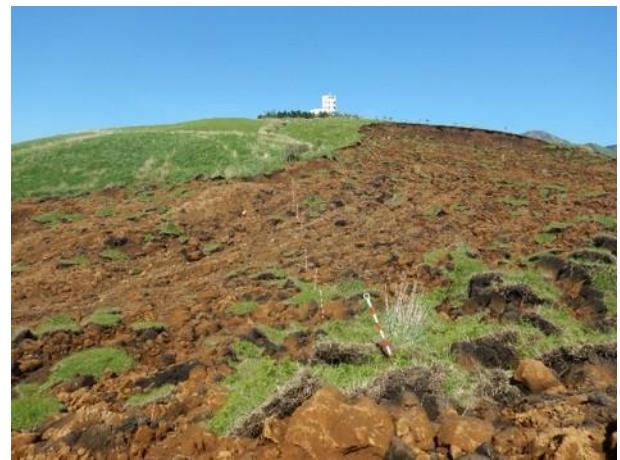
Photo 7: View of the main landslide (looking uphill), with the Aso Volcanological Laboratory visible in the distance (Location 9 in Figure 2: N 32.8951; E 131.0135).

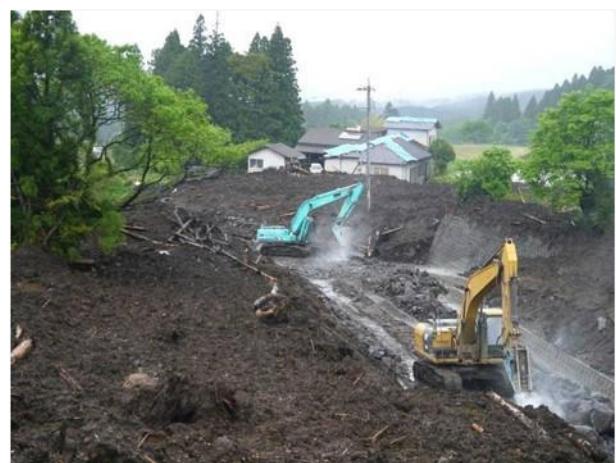
*Photo 9: Debris-flow deposits being cleared up (Location 13 in Figure 2: N 32.8643; E 131.0216).*

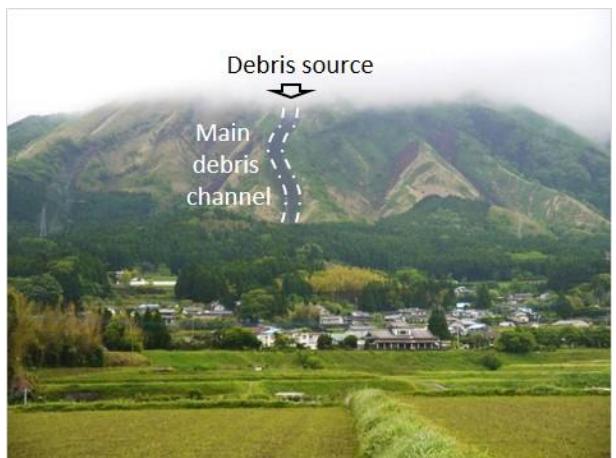
*Photo 10: Debris flows sourced from the steep volcanic slopes above Kawayo, Minami Aso Village.*

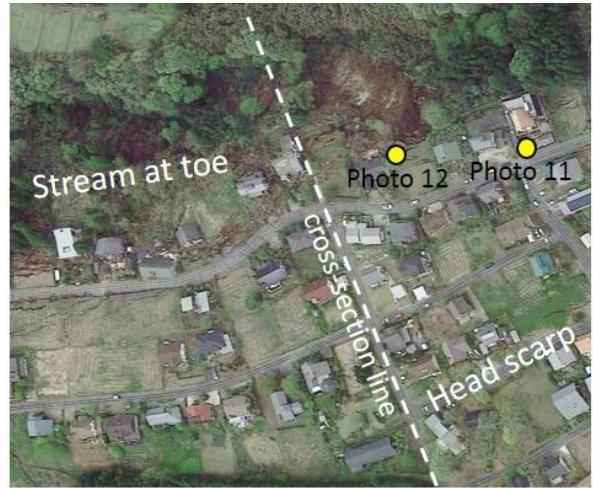
Figure 11: Google Earth image of the earth slide/slump at Tokyu Country Town (Location 12 in Figure 2). This landslide damaged about 40 homes.

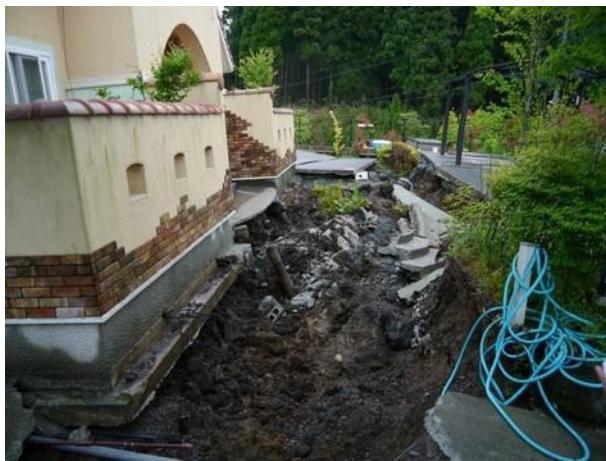
**Photo 11:** Translational slide / slump at Tokyu Country Town, Aso. About 40 houses were affected by landslide movement (N 32.8796; E 131.0030).

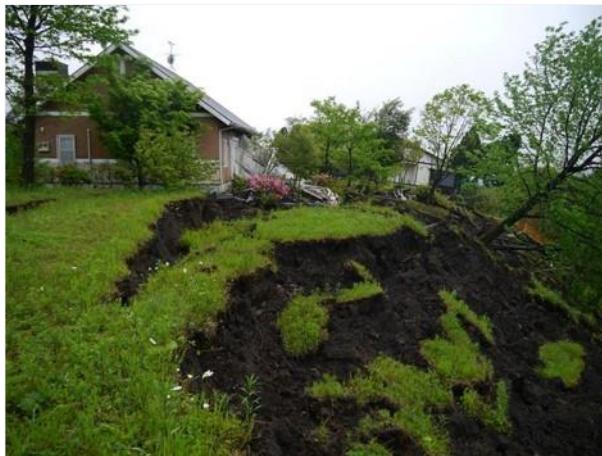
**Photo 12:** Toe area of the translational slide/slump at Tokyu Country Town showing the transition from sliding to slumping towards stream (N 32.8805; E 131.0025).

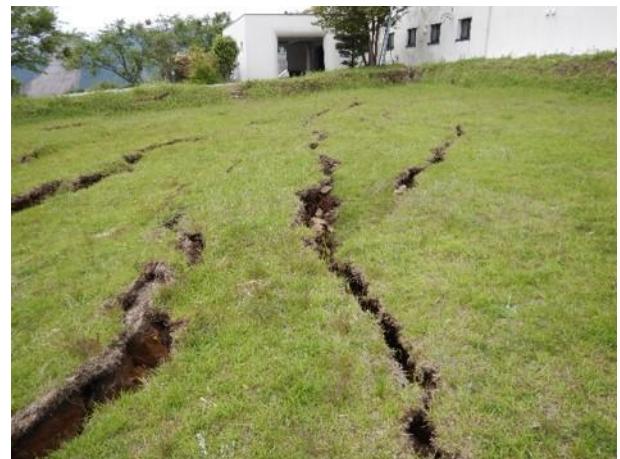
**Photo 13:** Extensive cracking located upslope near the Aso Volcanological Laboratory (N 32.8857; E 131.0069).

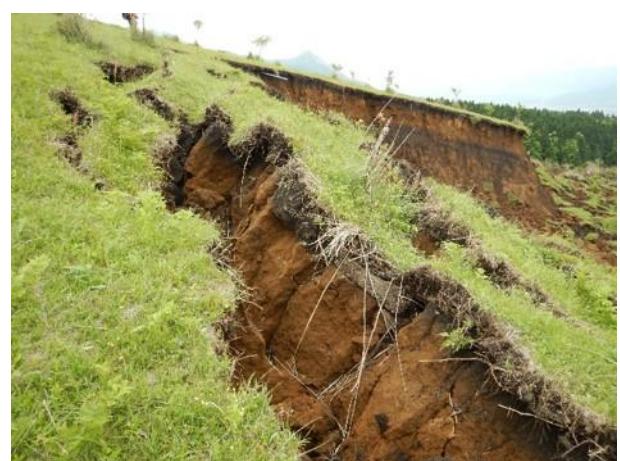
**Photo 14:** A typical cracking located near the scarp of the translational slide/slump below the Aso Volcanological Laboratory (N 32.8851; E 131.0050)

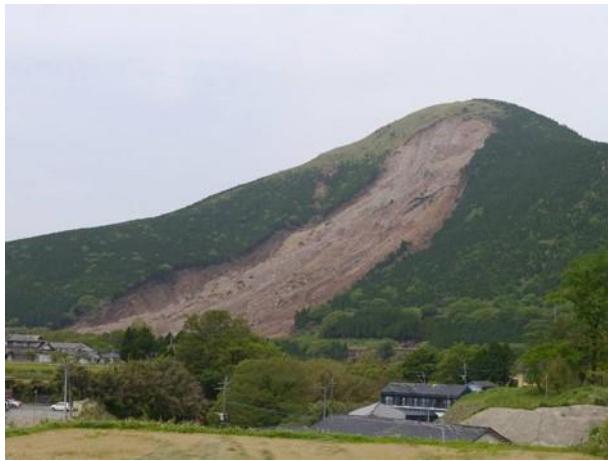
**Photo 15: Debris avalanche at Aso Ohashi Bridge (Location 10 in Figure 2: N 32.8834; E 130.9896).**

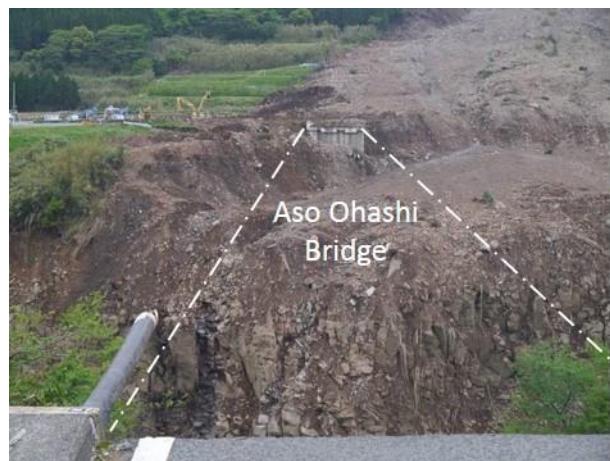
**Photo 16: Toe of the debris avalanche at Aso Ohashi Bridge.**  
Note the bridge has been destroyed by the landslide  
(Location 10 in Figure 2: N 32.8834; E 130.9896).

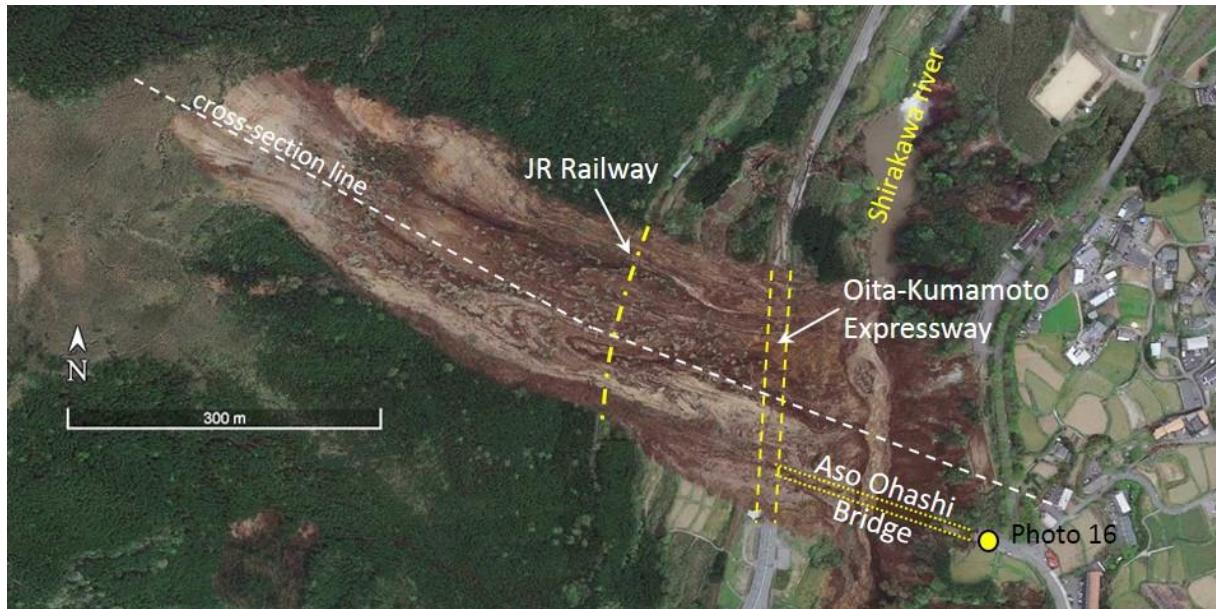
**Figure 14: Google Earth image of the debris avalanche that destroyed the main road bridge across the Shirakawa River (Location 10 in Figure 2).**

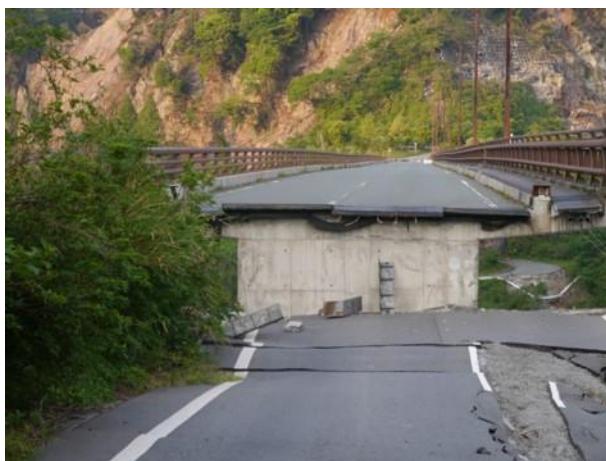
**Photo 18:** Displacement of the road bridge abutment. The displacement resulted from loosening and toppling of the jointed rock mass supporting the abutment foundation (N 32.8764; E 131.9827).

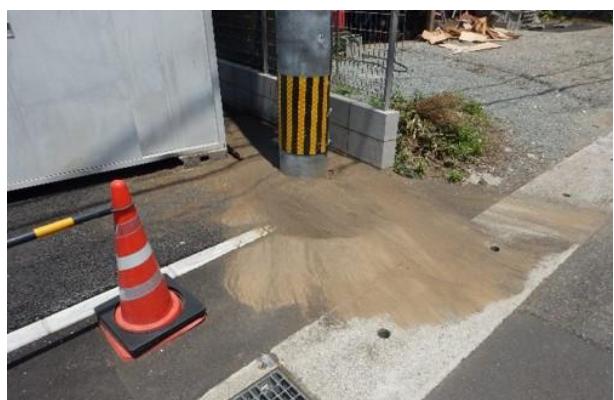
**Photo 21:** Traces of sand ejection adjacent to power pole in Kumamoto City (N 32.7583; E 130.6823).

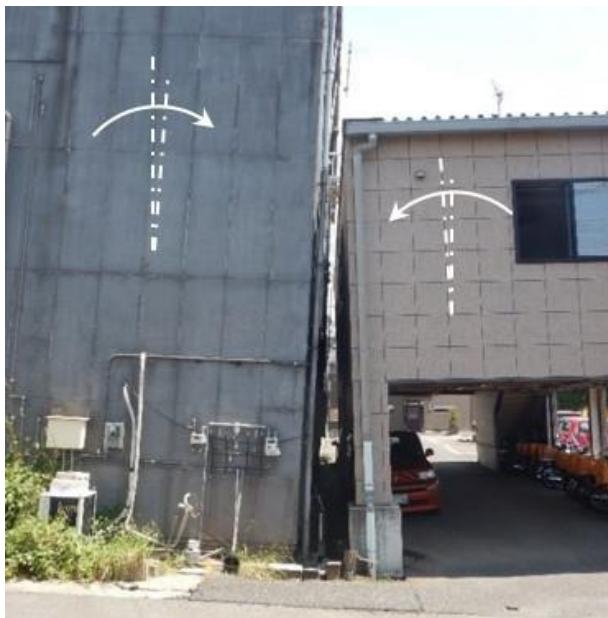
*Photo 22: Liquefaction-induced tilting of two residential buildings in Kumamoto City (N 32.7600; E 130.6829).*

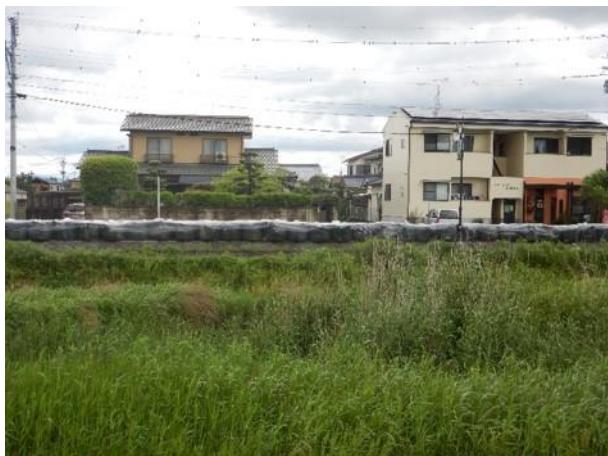
*Photo 23: Temporary flood protection measure to mitigate the impact of liquefaction-induced subsidence of river bank in Mashiki Town (N 32.7832; E 130.8084).*

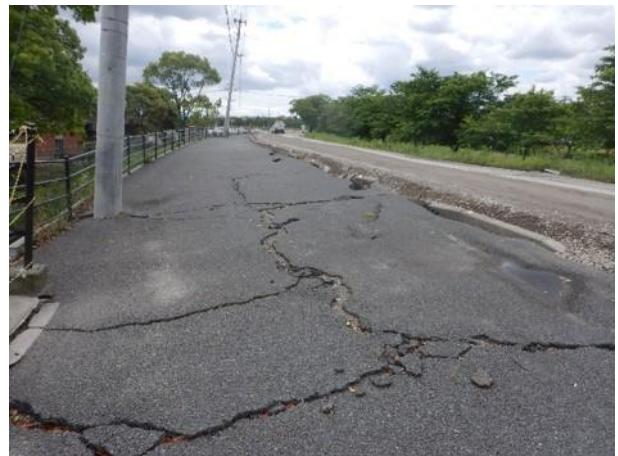
*Photo 24: Cracking, lateral displacement and tilting of power lines induced by lateral spreading in Mashiki Town (N 32.7860; E 130.8177).*

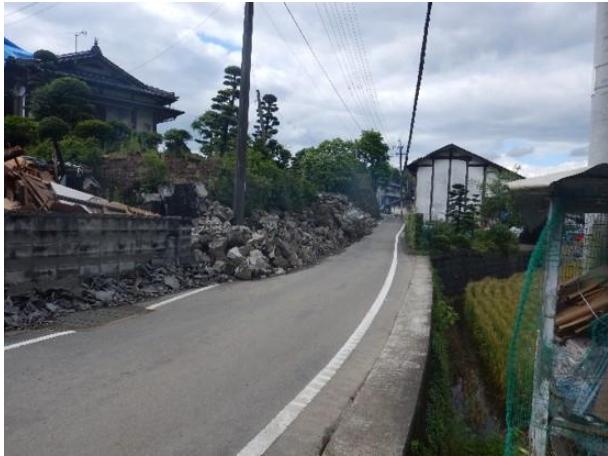
*Photo 25: Collapse of a typical unreinforced wall in Nishihara Village (N 32.8056; E 130.8583).*

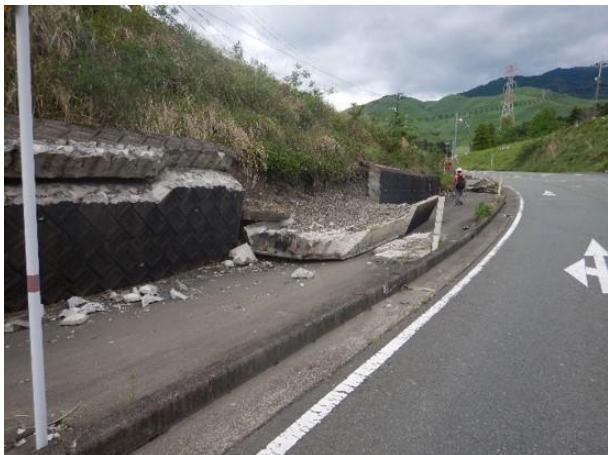
*Photo 26: Fault rupture-induced collapse of a concrete facing unreinforced wall near the Ookirihata earth dam in Nishihara Village (N 32.8413; E 130.9317).*

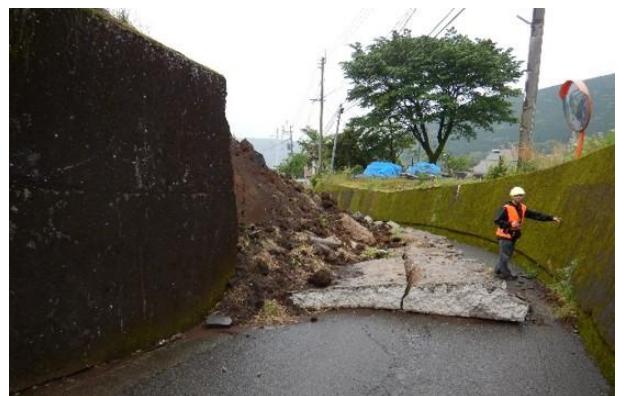
*Photo 27: Complete collapse of a typical unreinforced concrete wall in Minami Aso Village (N 32.8844; E 130.9918).*

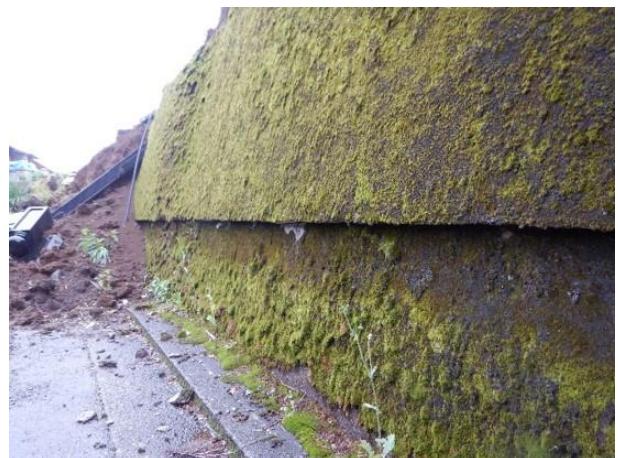
*Photo 28: Displacement of the upper part of a wall along construction joint (N 32.8843; E 130.9916).*

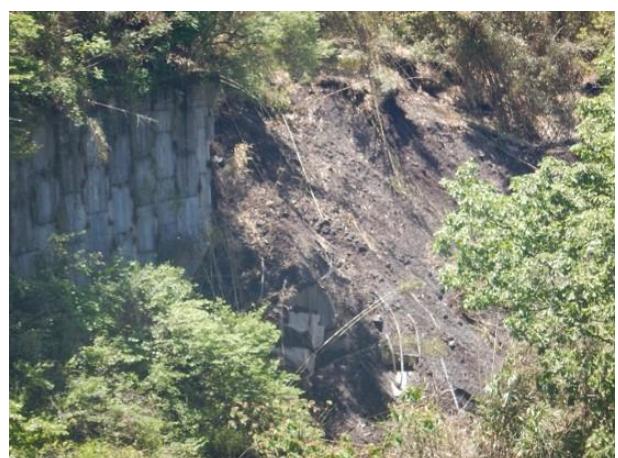
*Photo 29: Total collapse of a reinforced earth wall near Tokyu Country Town (N 32.8805; E 131.0039).*

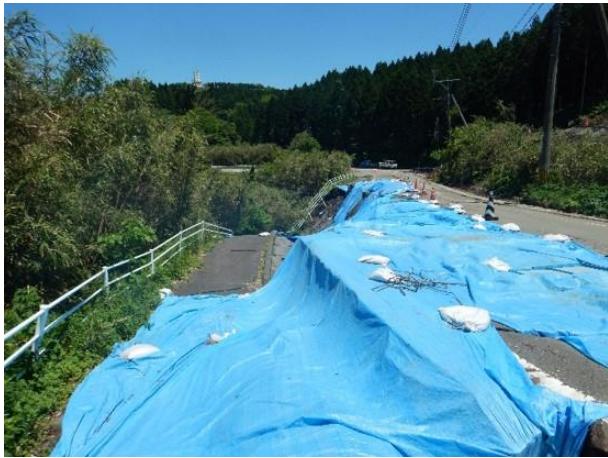
**Photo 30:** Effects of the collapse of the reinforced earth wall (shown in Figure 29) on the supported road (N 32.8804; E 131.0040).

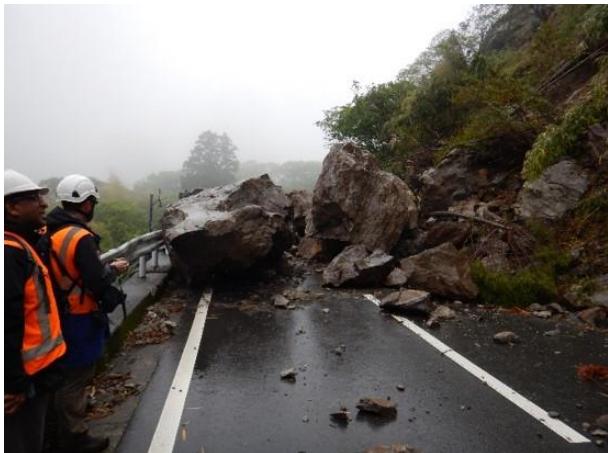
**Photo 32:** Road above the tied-back retaining wall (shown in Photo 31) closed by rock fall (N 32.8714; E 130.9924).

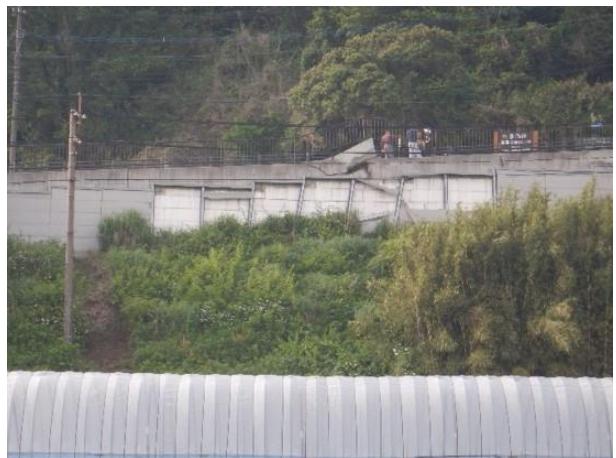
**Photo 33:** Good performance of a retaining wall with EPS block backfill (N 32.8792; E 130.9833).

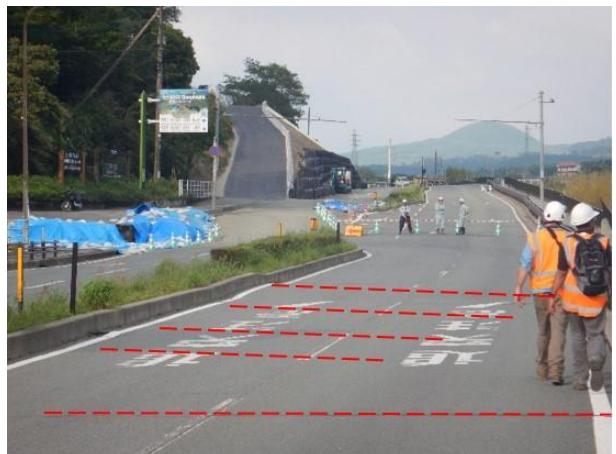
**Photo 34:** Some cracking appeared on the road supported by the walls shown in Photo 33 (N 32.8792; E 130.9833).

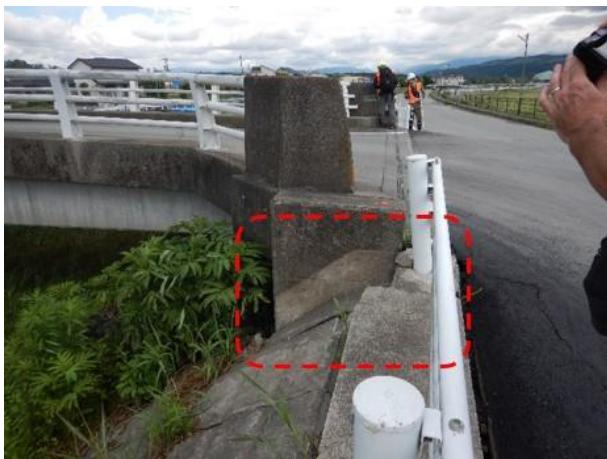
*Photo 35: Typical settlement of short span concrete bridge approaches observed in Mashiki Town (N 32.7830; E 130.8085).*

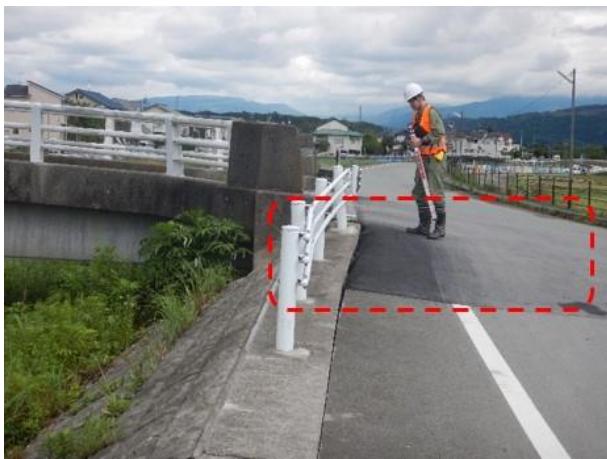
*Photo 36: Temporary ramp being formed to provide access due to settlement of short span concrete bridge approaches (N 32.7830; E 130.8085).*

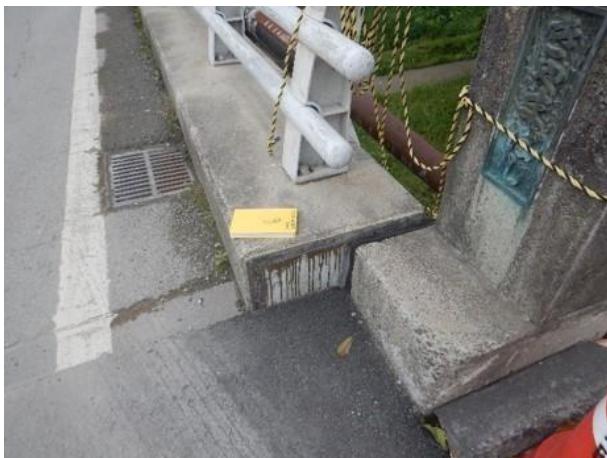
*Photo 37: A two span bridge jumped 300 mm laterally off its bearings (view from the road) (N 32.7864; E 130.8186).*

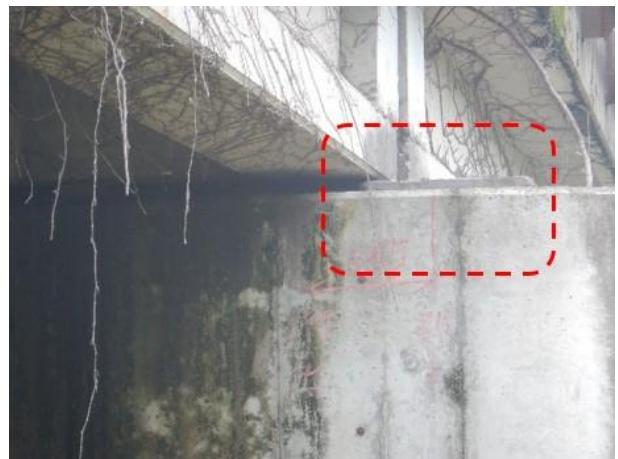
*Photo 38: A two span bridge jumped 300 mm laterally off its bearings (view of the bearing) (N 32.7864; E 130.8186).*

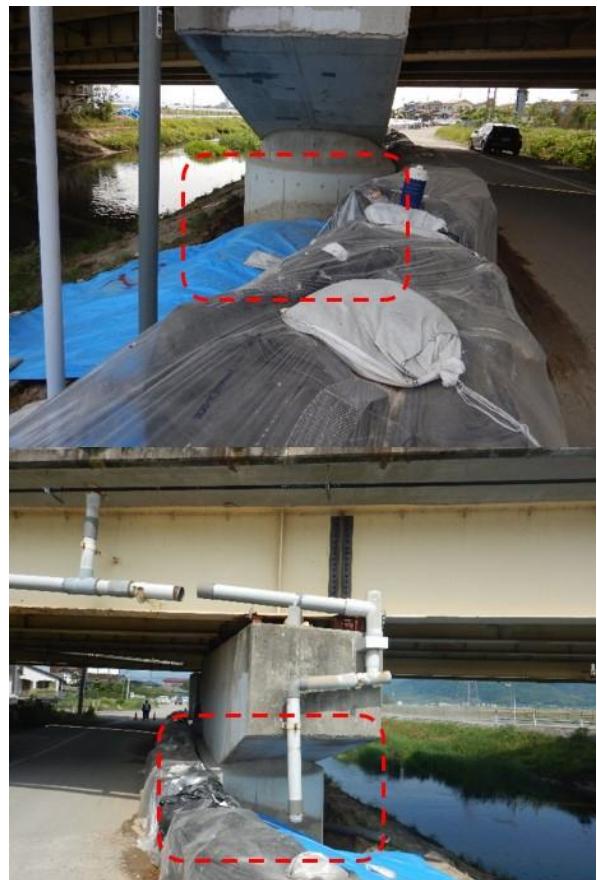
*Photo 39: Ground settlement around piers of a long span steel girder bridge observed in Mashiki town (N 32.7787; E 130.79.39).*

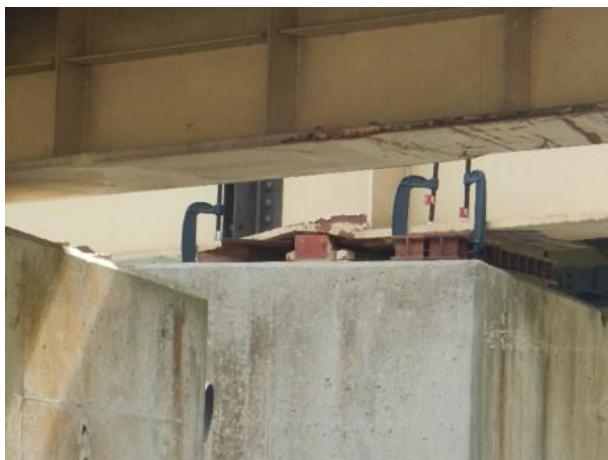
**Photo 40:** Local buckling of girder bottom. The girders were re-levelled temporarily with steel plates either side of original bearings (N 32.7790; E 130.7939).

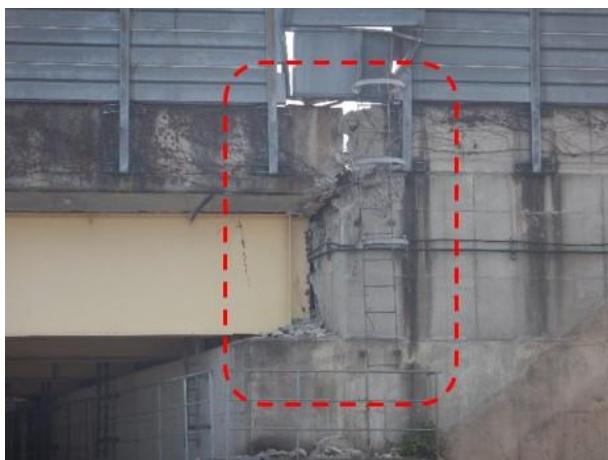
**Photo 41:** Punching of I-shape girder ends into the abutment wall caused shearing of back wall (N 32.7789; E 130.7943).

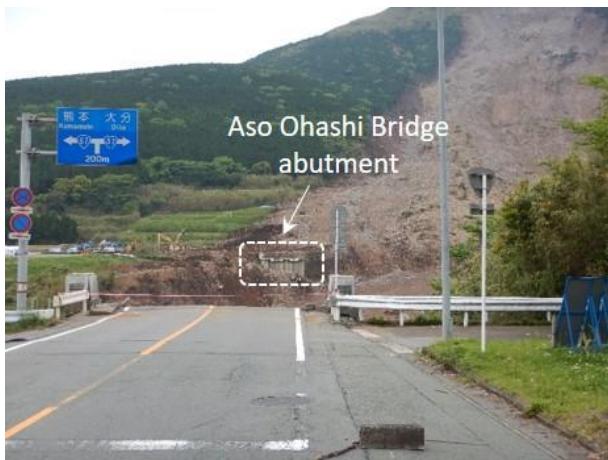
**Photo 42:** Landslides caused the collapse of a number of bridges in the mountainous areas of Mt. Aso volcanic caldera (N 32.8834; E 130.9896).

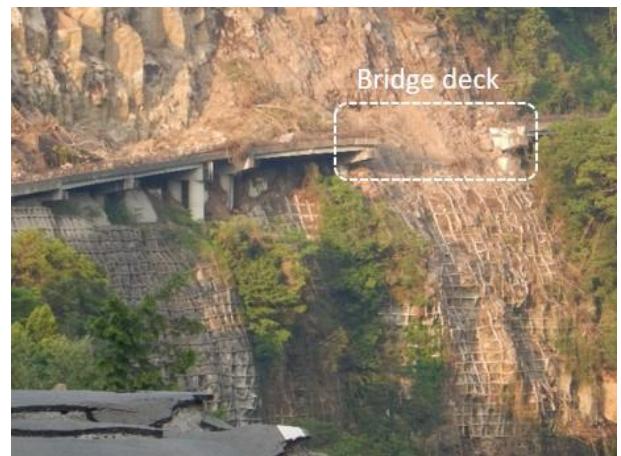
**Photo 43:** Landslides caused also the collapse of bridge decks in the mountainous areas of Mt. Aso volcanic caldera (N 32.8752; E 131.9886). See also Photo 17.

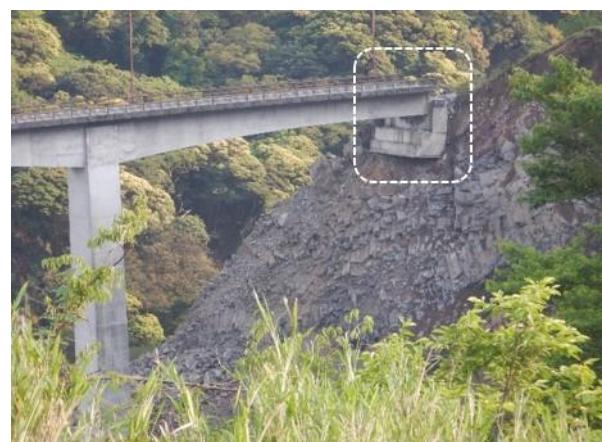
**Photo 44:** Abutment foundation failure due to the collapse of underlain columnar jointed bedrock (N 32.8770; E 130.9840). See also Photo 18.

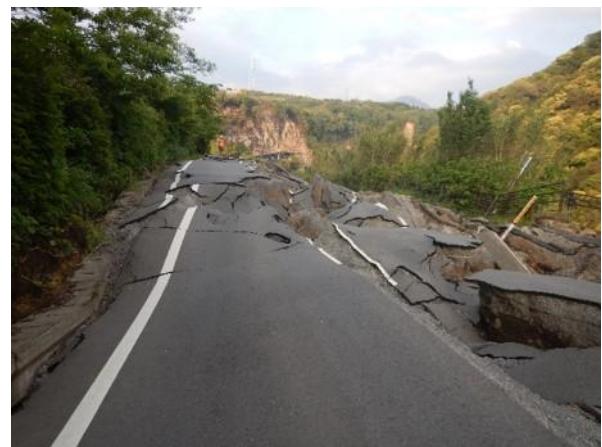
**Photo 45:** Severe disruption to approach embankment due to the collapse of underlain columnar jointed bedrock (N 32.8744; E 130.9827). See also Photo 18.

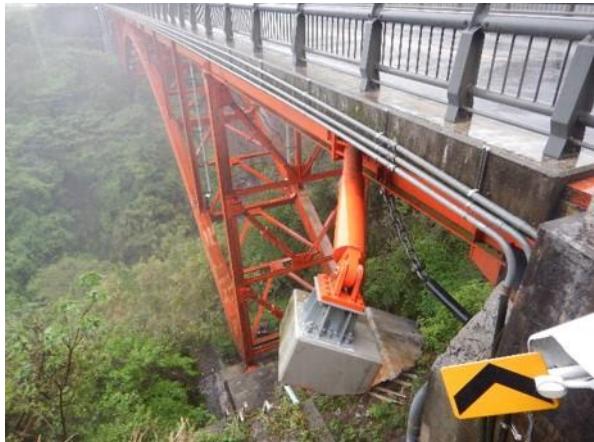
*Photo 46: Connection of a retrofitted damper of steel arch bridge failed at one abutment (N 32.8779; E 130.9094).*

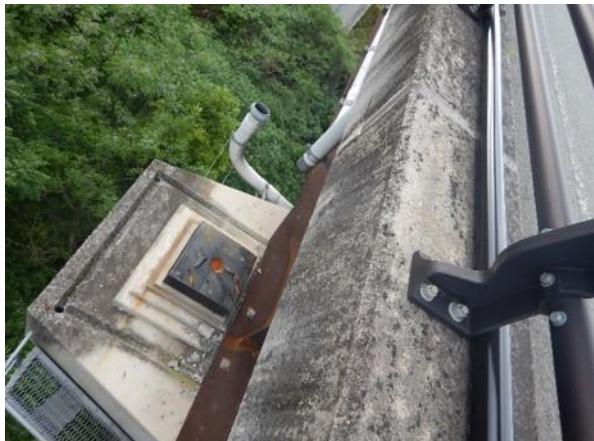
*Photo 47: A curved steel arch bridge jumped laterally off bearings (N 32.8426; E 130.9272).*

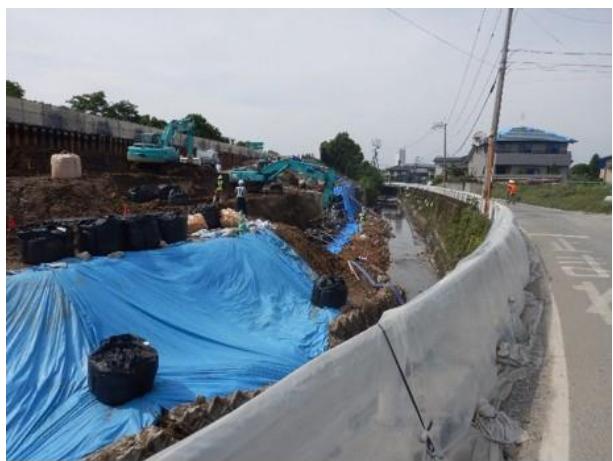
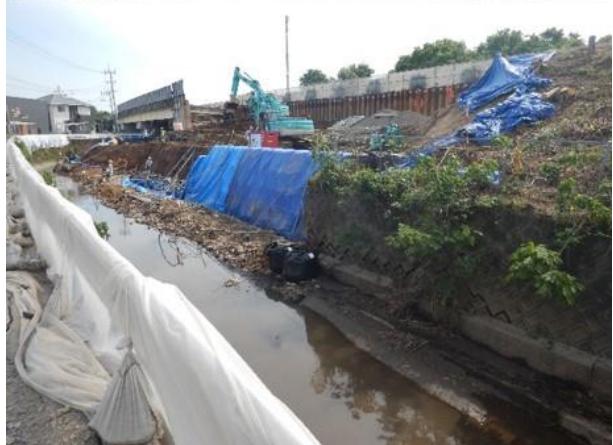
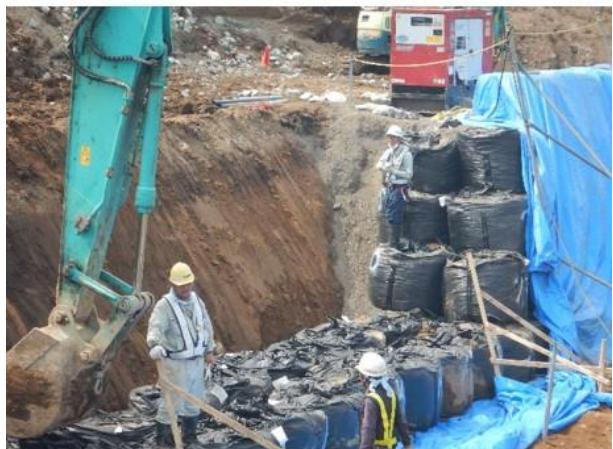
*Photo 48: Collapse of a retaining wall supporting an expressway embankment. Gravel filled polyester bags were used to quickly rebuild the wall and reopen the expressway (N 32.7792; E 130.7943).*

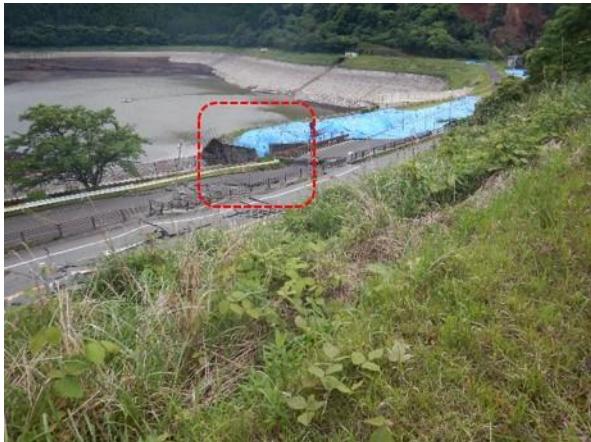
*Photo 50: Fault rupture damaged the spillway of the Ookirihata earth dam (N 32.8414; E 130.9317). See also Photo 4.*

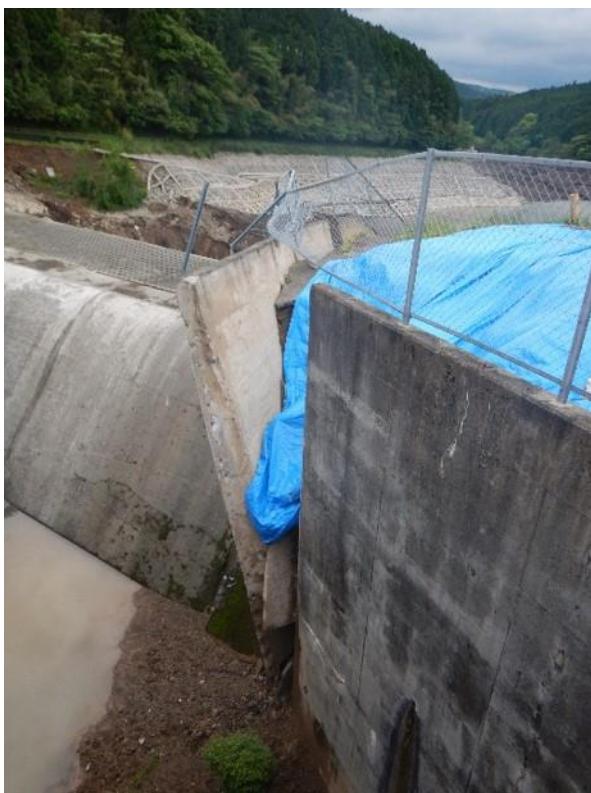
*Photo 51: Close up of the damaged spillway of the Ookirihata earth dam (N 32.8414; E 130.9317).*

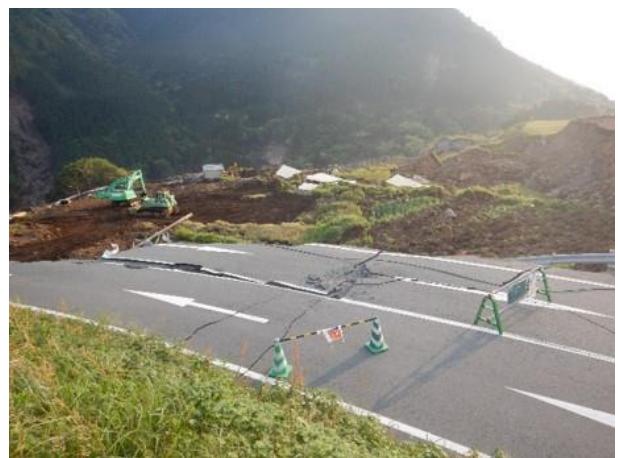
*Photo 52: New dam construction site destroyed by fault rupture (N 32.8776; E 130.9764). See also Figure 20.*
