THE HOKKAIDO-NANSEI-OKI EARTHQUAKE

Preliminary Report of the NZNSEE Reconnaissance Team

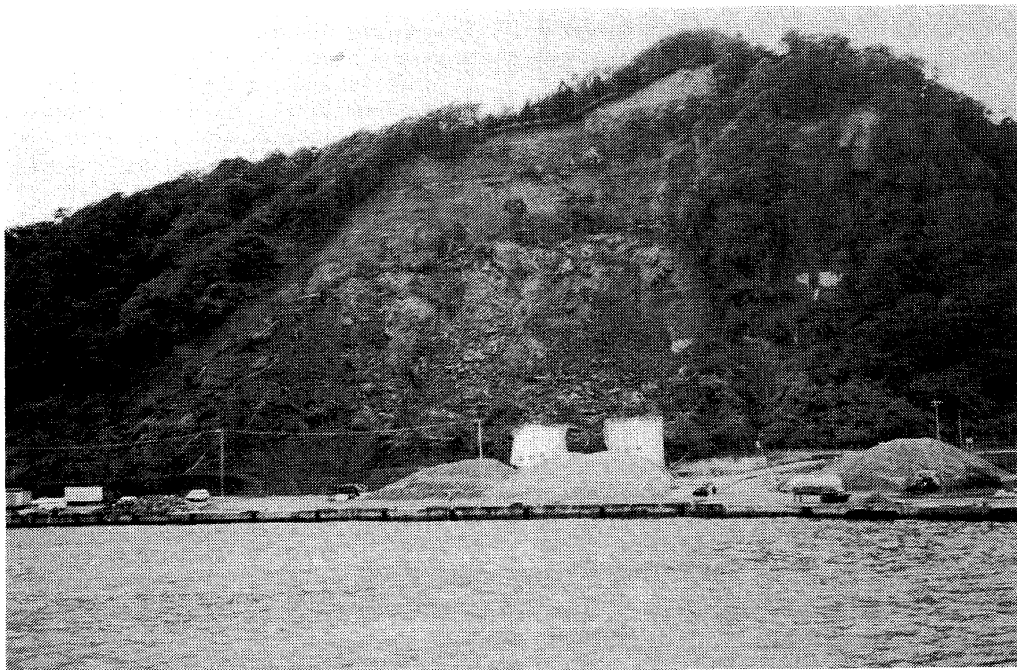
A large sidling embankment failure occurred on a new section of road at Horonai on the west coast of Okushiri Island. The weathered granite soils were also involved in a bridge abutment failure and several large shallow based landslips also occurred in the nearby natural slopes. The surface of the disturbed soils had been quickly eroded indicating a sensitive soil type.

Figure 3 Okushiri Ferry Port - landslide which buried the hotel causing 19 deaths

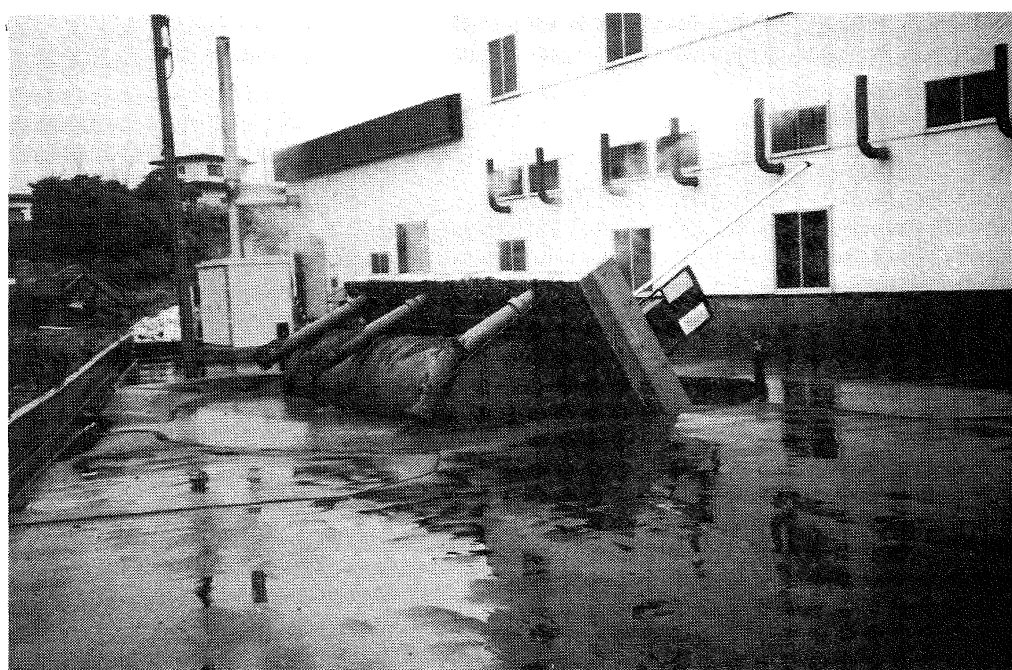
- Shiribetsu River Valley, 2.5 km damaged stopbank, minor structural damage
- Shiribeshi-Toshibetsu River Valley, 8.5 km of damaged stopbanks, lateral displacement of roading and ground rupture, minor structural damage
- Esashi - Stopbank damage, bridge bearing damage, flotation of storage tanks (Figure 4)
- Osyamanbe - Ground rupture and slumping, lateral displacement causing damage to building foundations, roading embankments and pavements
- Hakodate Port - Major liquefaction induced consolidation overturning of sea walls, tilting of cement silo, damage to wharf structures and pavements (Figure 5).

Figure 4 Liquefaction and uplifting of 20 m³ storage tank (one third full)

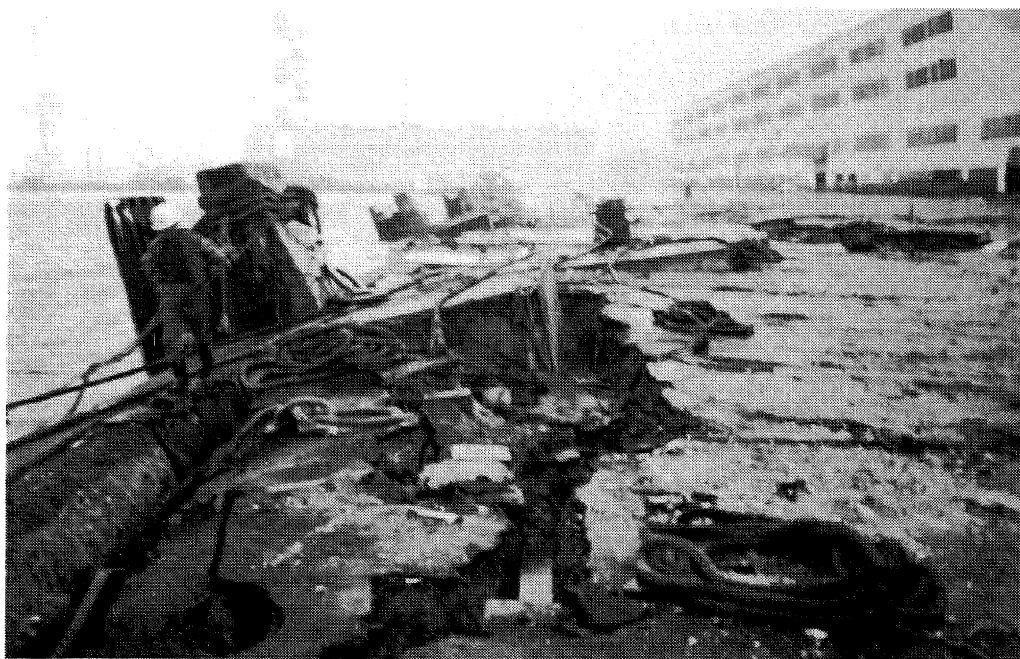
At Hakodate Port, where the soft alluvial deposits are up to 100 m deep, the amplification due to site response characteristics resulted in settlement of reclamation fill of up to 1.5 m at the dry dock areas.

While damage to structures is limited, the facilities are effectively inoperable with major reconstruction works required. This may need to include densification of the reclamation soils to reduce the potential for repeat damage.

Figure 5 Hakodate Port - Liquefaction damage

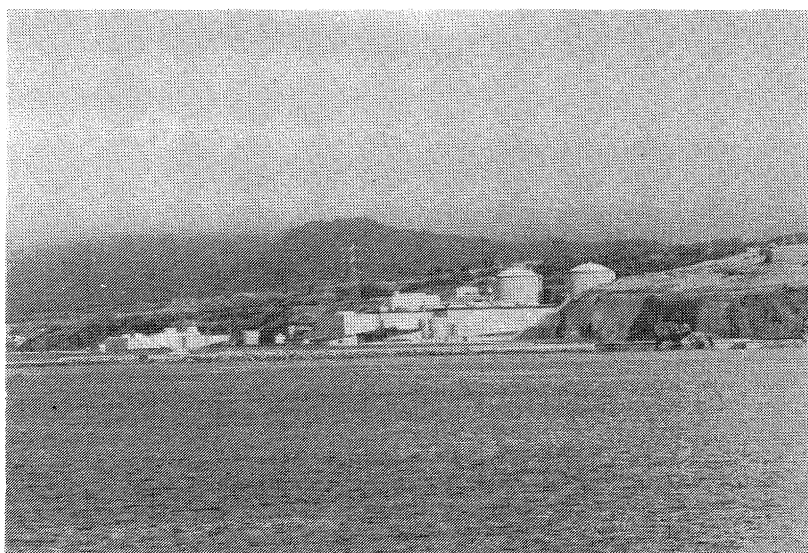
The nuclear power station at Tomari on the west coast of Hokkaido and about 70 km from the epicentre, was reported to be undamaged (Figure 6). On Tuesday 13 July, the Ministry of International Trade and Industry reported that all the nuclear power stations in Hokkaido and northern Honshu were functioning normally.

Figure 6 Nuclear power station at Tomari 70 km from epicentre, apparently undamaged.

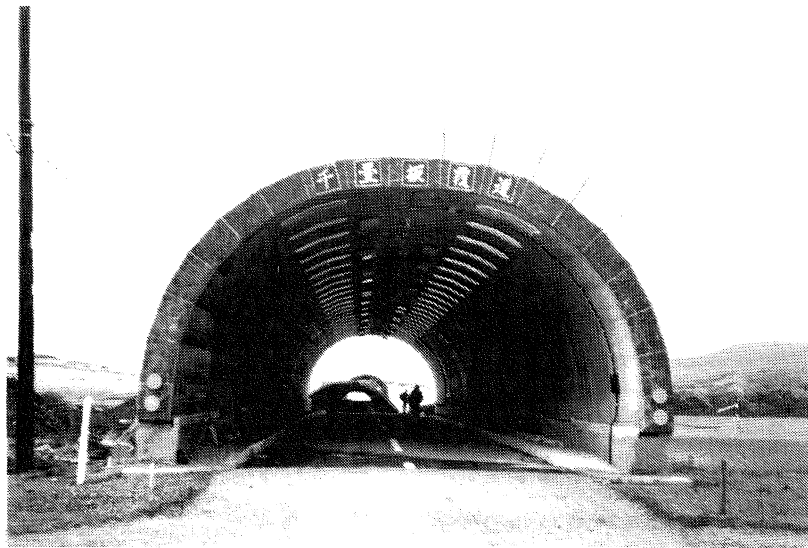
The snow tunnel arch footings and retaining walls were not tied and relied on piles to provide stability. Part of the tunnel collapsed (Figure 7) and the footings of the remainder spread. There is some evidence to indicate that the piles were either not provided or were not connected to the footings. The Team was unable to carry out a detailed inspection of the steel framing to the batching plant to determine why the main columns had buckled at the bracing nodes. It would appear however, that the outstand to thickness ratios of the angle forming the column was excessive.

Figure 7 Part collapse of snow tunnel near Aonae on Okushiri Island. Structure was a precast concrete three pin arch.

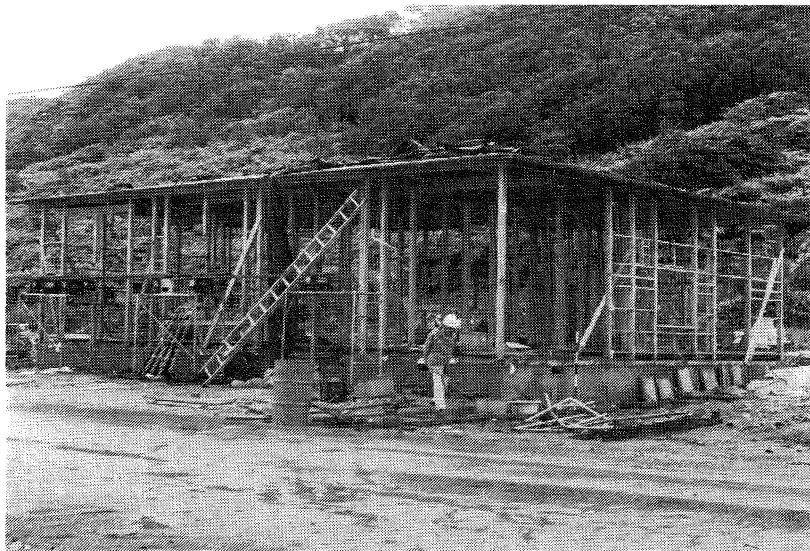
Well built timber framed houses (Figure 8) similar to those constructed in New Zealand, performed well, even when exposed to the tsunamis (Figure 9). Much of the damage to houses which resulted from ground shaking was due to rotting of framing caused by poor weather protection, failure of rigid external cladding and poor construction practices. Features of the framing, not practised in New Zealand, was the use of mortice and tenon joints between studs and plates and the use of studs and plates 100 mm by 100 mm in cross section.

Figure 8 Well built timber framed house under construction near Inaho at northern end of Okushiri Island.

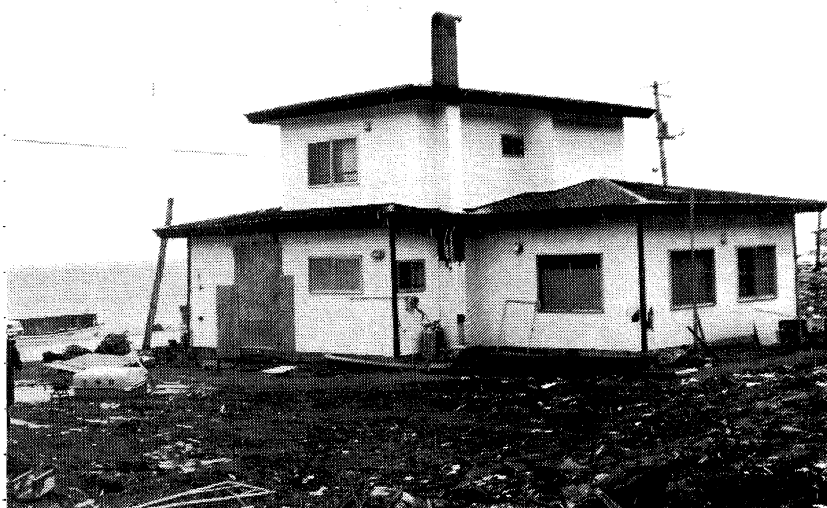
Figure 9 Timber framed house near Inaho which survived the tsunami which appeared to be about 3-4 m high. Note the puncture damage to the external sheathing due to debris.
