THE SEISMIC RESPONSE OF NONSTRUCTURAL ELEMENTS IN BUILDINGS

C. Arnold¹

This paper was presented as a keynote address at the Pacific Conference on Earthquake Engineering, Auckland, November 1991.

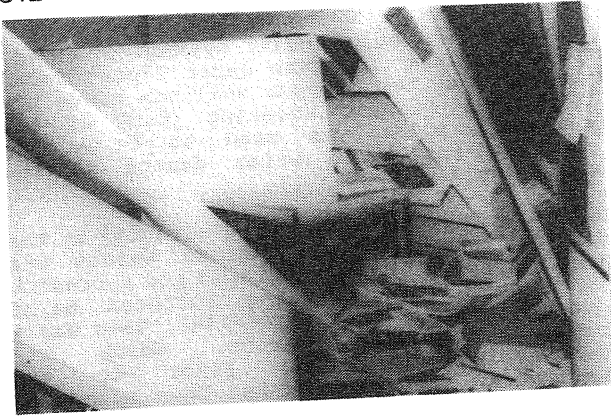
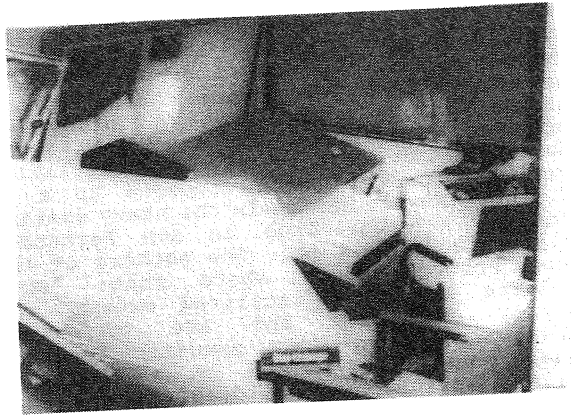
The Morgan Hill (1984) and Mt. Lewis (1986) earthquakes resulted in considerable contents damage in the 13-story steel moment frame Santa Clara County Services Building, though no other structural or nonstructural damage occurred (Figure 2). Heavy shelves that were braced following the first earthquake performed very well in the second quake [10].

FIGURE 2 TYPICAL WORKSTATION UPSETS, SANTA CLARA OFFICE BUILDING, 1984 (PH. W. VANOSDOL)

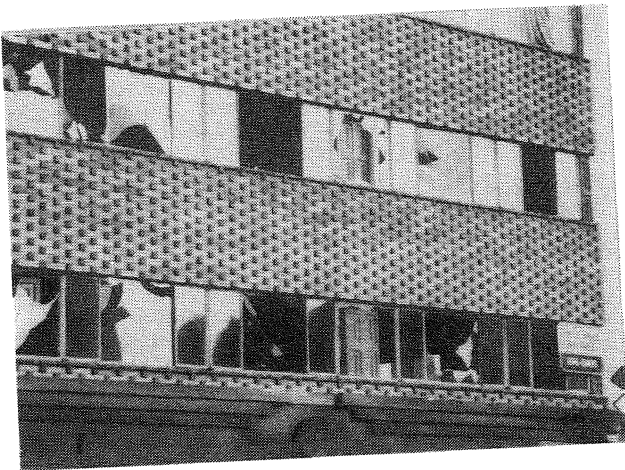
As an example of the difficulties of assigning nonstructural damage, consider the building shown in Figure 3. This office building in Oakland displays considerable glass damage, and the brick facing has detached from the concrete backing (Figure 4). Is the glass damage due to incorrect detailing, or has the structure deflected to an extent that no detailing could tolerate? Or, in looking at Figure 5, which clearly shows significant pounding from an adjoining building, has the glass been broken by the sudden impact, and the brick veneer dislodged by repeated sharp, out of plane accelerations? Is this a structural, nonstructural, or pounding failure, and what mitigation measures could have prevented this from happening?

FIGURE 3 GLASS DAMAGE

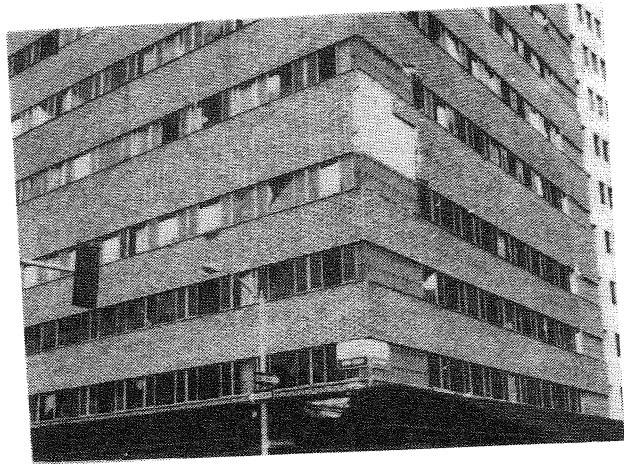
FIGURE 4 BRICK VENEER FAILURE

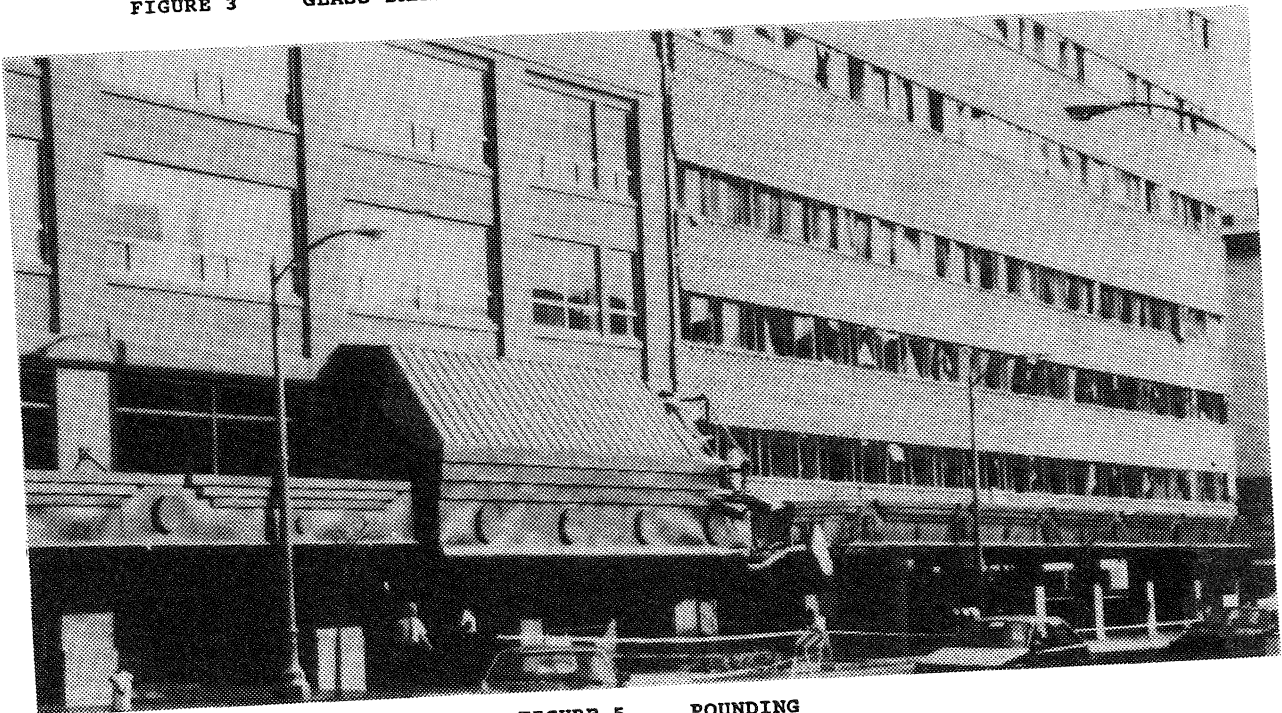
FIGURE 5 POUNDING

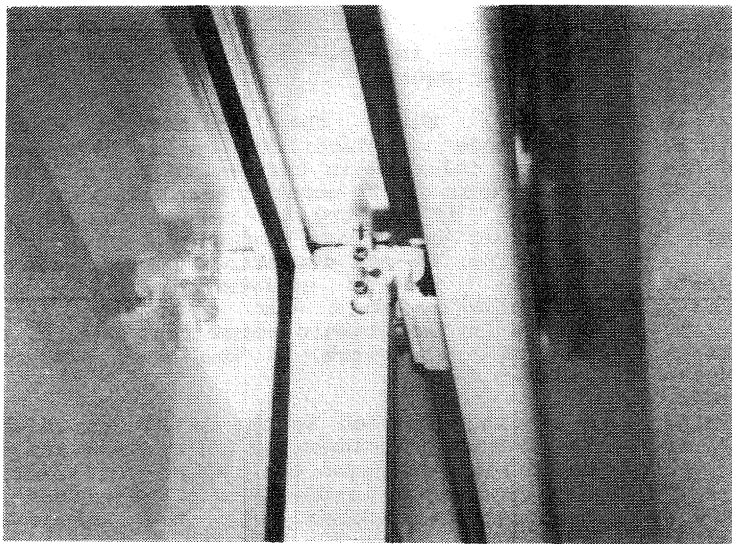
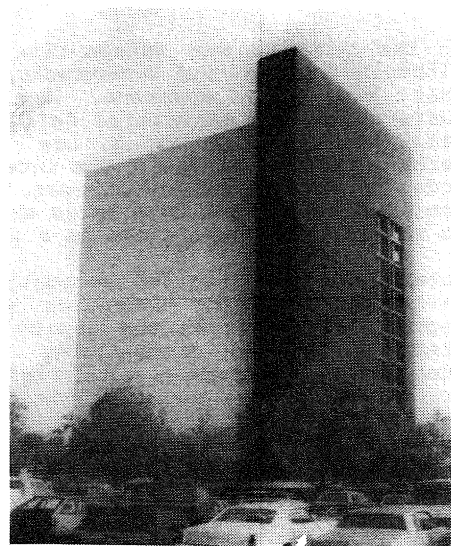
FIGURE 6 DETAIL OF CURTAIN WALL SUPPORT, SANTA CLARA OFFICE BUILDING (PH. S. RIHAL)

However, our methods of installing cladding and glass seem to be quite effective, at least for the moderate shake. To return to the Santa Clara building (which is of particular interest because of the available records) the integrity of its all-glass curtain wall over three earthquakes has been a source of comment. Recent investigation shows that this wall appears to have been attached by use of an unusual and sophisticated detail which effectively isolates it from the steel supporting structure and permits differential movement (Figure 6).
