# EARTHQUAKE DAMAGE AT EDGE CUMBE AND KAWARAU ELECTRICORP SUBSTATIONS IN THE BAY OF PLENTY EARTHQUAKE ON 2 MARCH 1987

A. L. Rutledge\*

This paper describes the major damage to Edgcumbe and Kawarau substations in the Bay of Plenty earthquake on 2 March 1987. Questions such as why the equipment failed and what actions should be taken to strengthen the equipment are addressed.

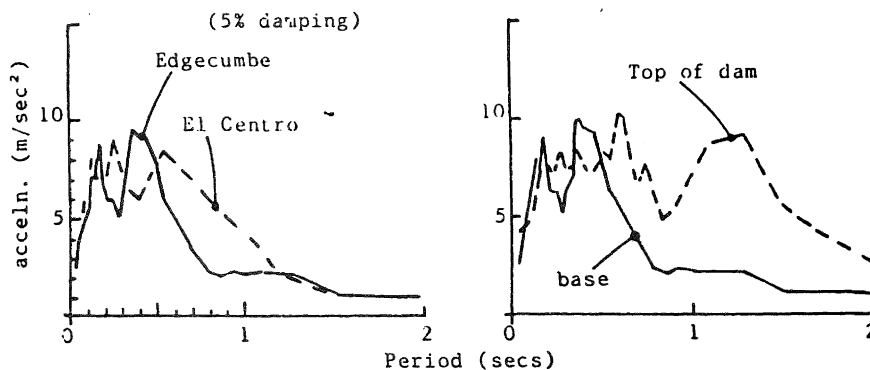
Strong motion accelerographs recorded peak ground accelerations of up to 0.33g at the base of the Mdatahina dam, 15km from the epicentre. Processing of the strong motion data by the DSIR Physics and Engineering Laboratory has produced a response spectrum surprisingly like the 1940 El Centro N-S spectrum. Response spectra are given in Figure 1.

The earthquake was therefore quite representative of the Electricorp design earthquake for which the El Centro 1940 N-S is one of the 8 component spectrum.

FIGURE 1 RESPONSE SPECTRA AT THE MATAHINA DAM FOR THE EDGECUMBE EARTHQUAKE

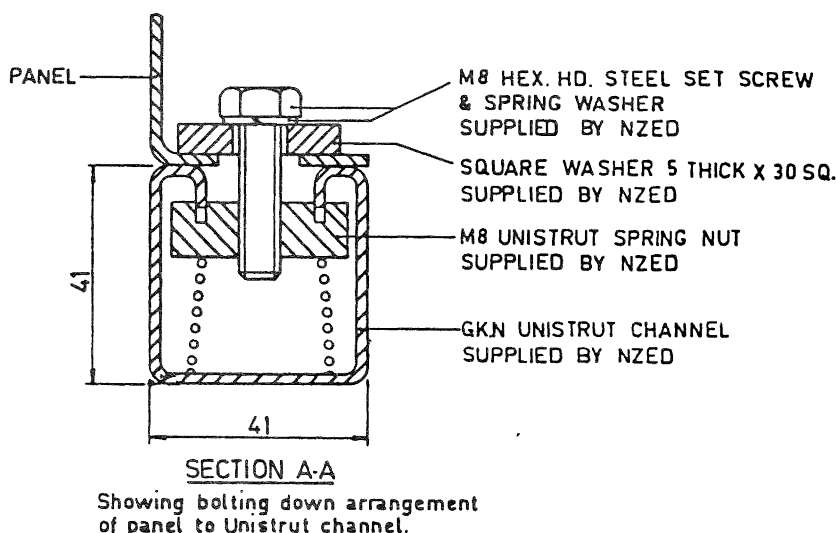
Coach screws offer little resistance to overturning and this method of securing panels is no longer standard Electricorp practice. The current practice is to bolt panels to a Unistrut support system as in Figure 2. Some older existing panels on wooden plinths at other Electricorp substations have been strengthened by tying

FIGURE 2 UNISTRUT SUPPORT SYSTEM FOR PANELS

together at the top and bracing securely to a structural wall.

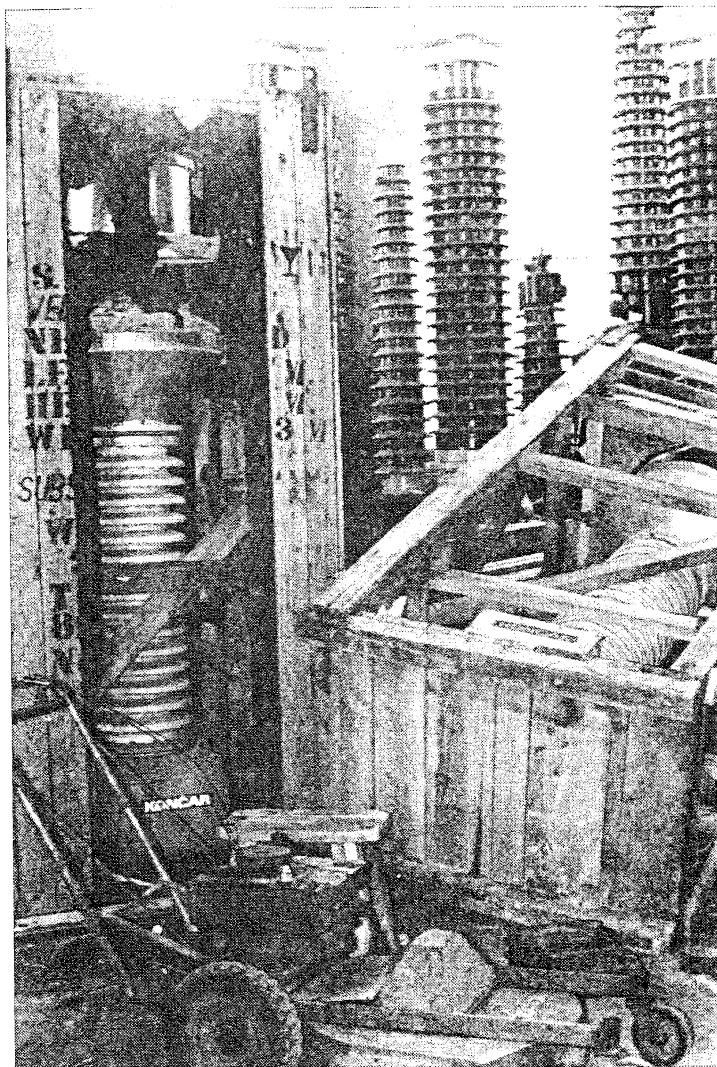
In the 80 ton Edgecumbe workshop three out of six unsecured spare 110kV CTs still in their shipping crates fell over (Figure 3). Crates of tools, nuts, bolts and other miscellaneous items were also spread around the workshop floor by the earthquake. The importance of securing spares adequately and good housekeeping practice in general is self evident.

FIGURE 3 SPARE CTS TOPPLED OVER IN THEIR CRATES

Spares likely to topple in an earthquake should be secured to the floor or tied back to a wall.

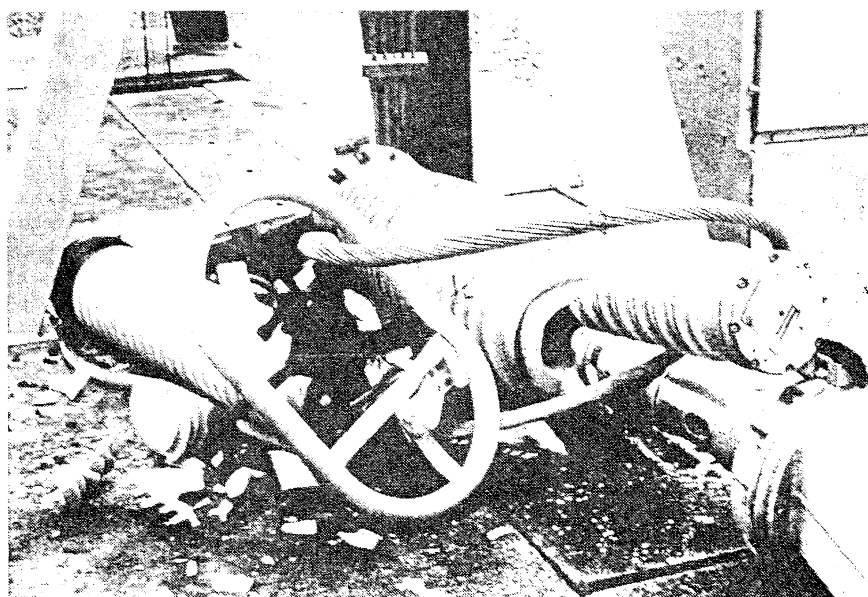
FIGURE 4 220KV CIRCUIT BREAKER AT KAWARAU DESTROYED

In the Kawerau 220kV switchyard the blue phase of CB622, a Merlin Gerin 220kV FA2 CB was totally destroyed (Figure 4). Failure occurred at the base of the top support insulator. The falling interrupter head then broke the support insulator of the adjacent isolator 624.

The Merlin Gerin CBs were installed in 1979 and the design met Electricorp current earthquake design specifications. It is likely that the "tight looking" flexible connection to the isolator caused extra shock loading on the circuit breaker [4].

Flexible connections that were installed with insufficient free length is the likely cause of failure of the Merlin Gerin 220kV FA2 CB at Edgumbe and the ASEA 110kV CB at Kawarau. Connections should be installed with a generous amount of slack even if it detracts from the overall tidy appearance of the installation.

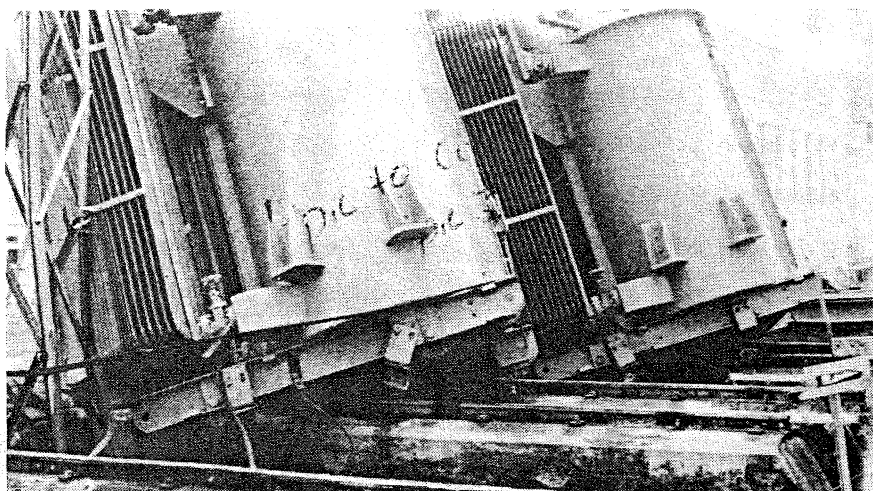
An example of the first mode of failure is shown in figure 5 where all the Metropolitan-Vickers 110kV spare transformers at Edgcombe sheared the 16mm bolts securing the holding down brackets to the undercarriage and the rail. As a result the transformers came completely off the rails.

The original holding down brackets are several times taller than the horizontal spacing of the 16mm bolts. Therefore horizontal earthquake load in the direction of the rails subjected the 16mm bolts to very high shear forces. The brackets were also only originally designed for 0.25g.

FIGURE 5 110KV TRANSFORMERS AT EDGE CUMBE OFF THEIR RAILS

If the transformer fastenings had been upgraded to current Electricorp standards for earthquake design most of the damage would have been avoided.

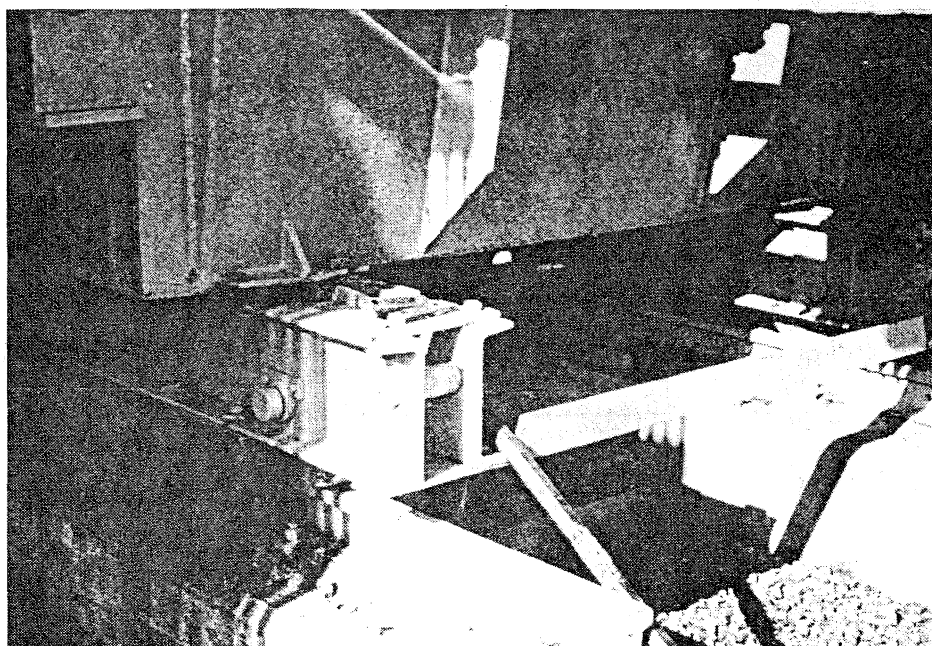
An example of the second mode of failure is the Kaweruu T2A and T2B Feranti 110kV banks where the M16 bolts securing the transformers to their undercarriages failed in shear as in Figure 6.

FIGURE 6 110KV TRANSFORMER AT KAWARAU SHEARED UNDERCARRIAGE/TRANSFORMER BOLTS

The shear failure of the fixings for the T5 AEI and T2A/T2B Ferranti transformers to their undercarriages demonstrates that an earthquake will expose the weakest part of the overall installation. The manufacturer's method of fixing the transformer tank to the undercarriage should always be checked when holding down arrangements are designed.

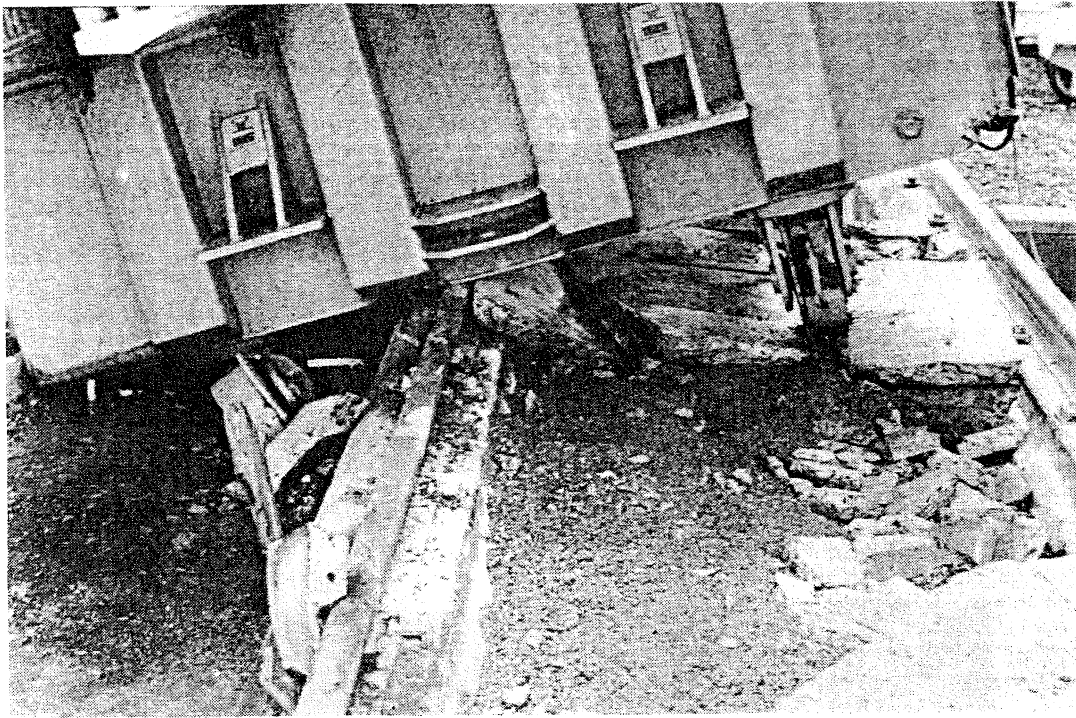
Some transformers suffered both modes of failure. For example, all Savigliano 210kV T8 transformers at Edgecumbe including the spare came off the rails when the holding down arrangements failed completely. Most of the 20mm studs securing the holding down brackets to the wheels failed in shear as in Figure 7. The studs were subjected to extremely high shear loads because of the

lever action of the relatively long brackets on the narrowly spaced studs as in Figure 8. Even if the transformer wheels had been adequately fastened to the rails the transformers would not have survived because of the weak attachment of the undercarriage to the transformer tank. Several of the wheels were ripped off either when the transformers left the rails or when they hit the concrete. The holding down arrangements for the Savigliano transformers were designed to 0.25g. When the transformers are reinstalled they will be bolted directly to the foundation pad.

FIGURE 7 220KV TRANSFORMER AT EDGE CUMBE OFF THE RAILS

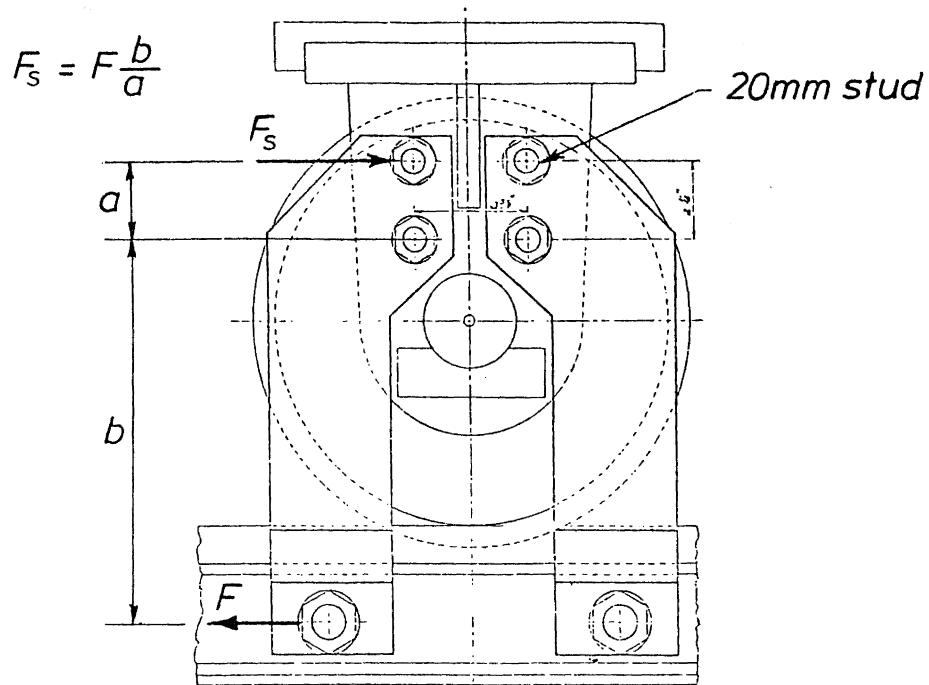
FIGURE 8 EDGE CUMBE T8 TRANSFORMERS - SHEAR FORCE ON 200MM STUDS

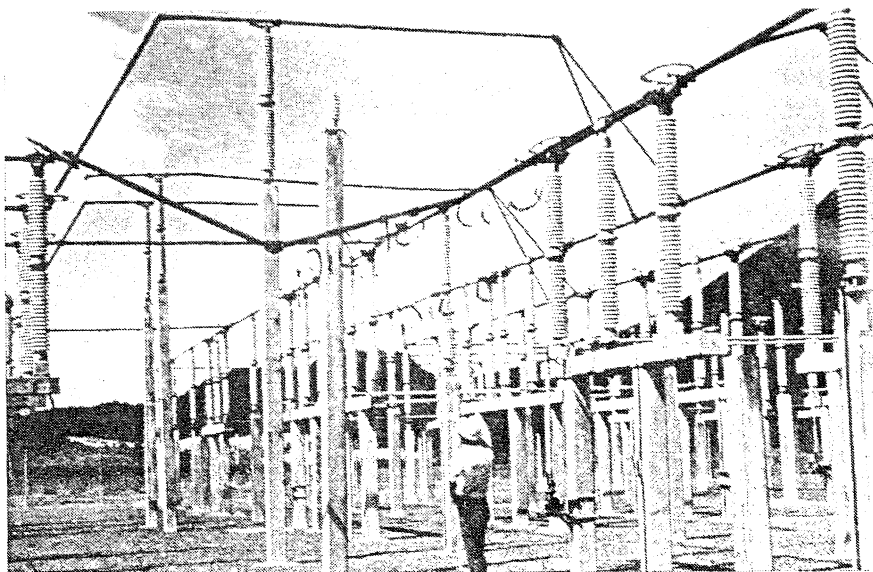
The 220kV buswork at Kawarau was extensively damaged as in Figure 9. Numerous concrete posts which support the insulators and buswork cracked at the base [5]. Several long cross-over conductors pulled out of the interconnecting clamps and fell to the ground. One insulator on top of a tall concrete post was completely destroyed.

In general the damage to the 220kV buswork was easily repaired. The concrete posts were originally designed to yield at the base without failing completely.

FIGURE 9 220KV BUSBAR DAMAGE AT KAWARAU
