## EDGE CUMBE EARTHQUAKE — SOME NOTES ON ITS SOURCE, GROUND MOTIONS, AND DAMAGE IN RELATION TO SAFETY

by David J. Dowrick

This paper first describes the basic features of the earthquake, its size, causal mechanism, and fault rupture characteristics, and distribution of felt intensities. The ground motions measured in various places are described in terms of accelerations, response spectra and attenuation. Finally safety aspects are discussed in relation to damage levels, strength of shaking and current code loading requirements.

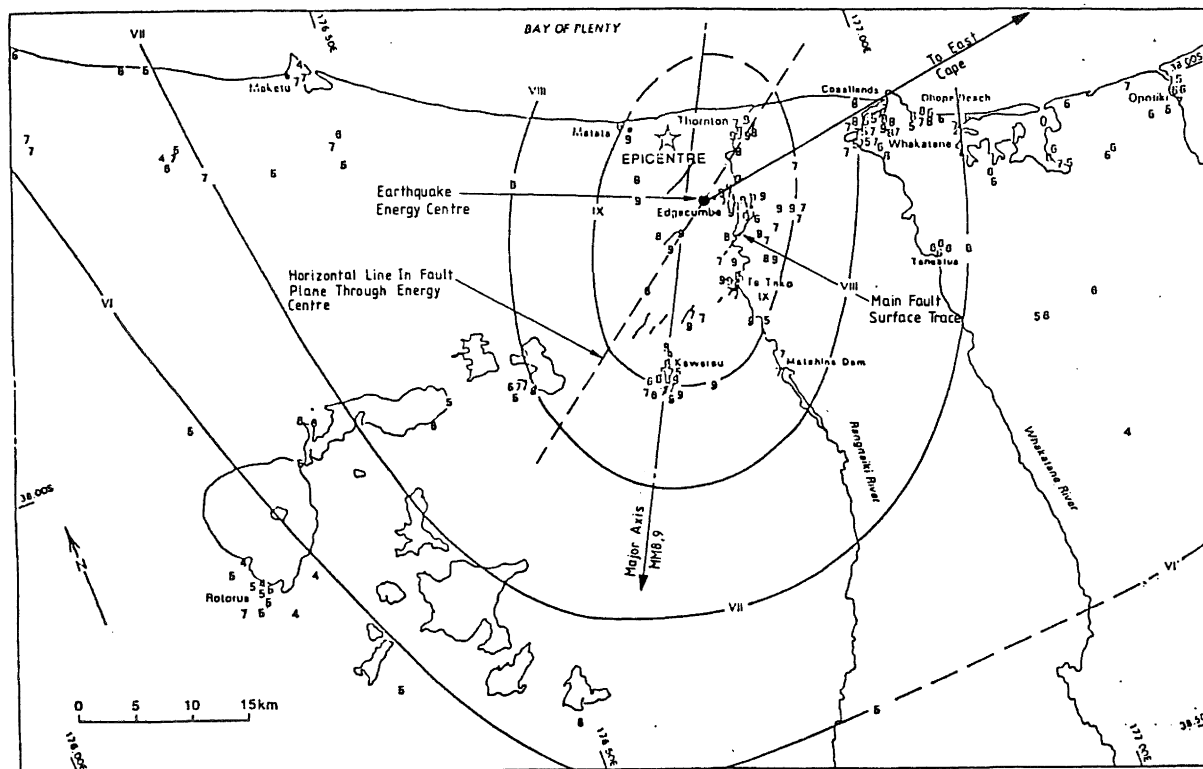
As shown in Figure 1, surface deformation included multiple surface breaks with the main surface rupture being 7 km long with a maximum vertical displacement of 2 m. The latter displacement was essentially downthrow, with no transcurrent displacement. Establishing the size and shape of the fault rupture surface is difficult to do with certainty, but studies by Darby [2] show that the rupture surface would have an area of about 100-120 km<sup>2</sup> and that the main fault plane would dip at an angle of about 39° to the horizontal. A focal depth of 8 km implies that the bottom of the rupture surface was 8 km below the Rangitaiki Plains.

Figure 1, adapted from Lowry et al [3], is a map of isoseismals showing intensity on the Modified Mercalli (MM) scale. The inner isoseismal pattern is fairly symmetrical, with the strongest isoseismal being MM9. As would be expected from a non-vertical fault plane, neither the surface trace of the main fault nor the epicentre lie on the major axis of the inner isoseismals.

FIGURE 1. STRONG MOTION AREA SHOWING EPICENTRE, FAULT RUPTURES, INTENSITIES, ISOSEISMALS, ENERGY CENTRE, FAULTING (ADAPTED FROM LOWRY ET AL, REF 3).

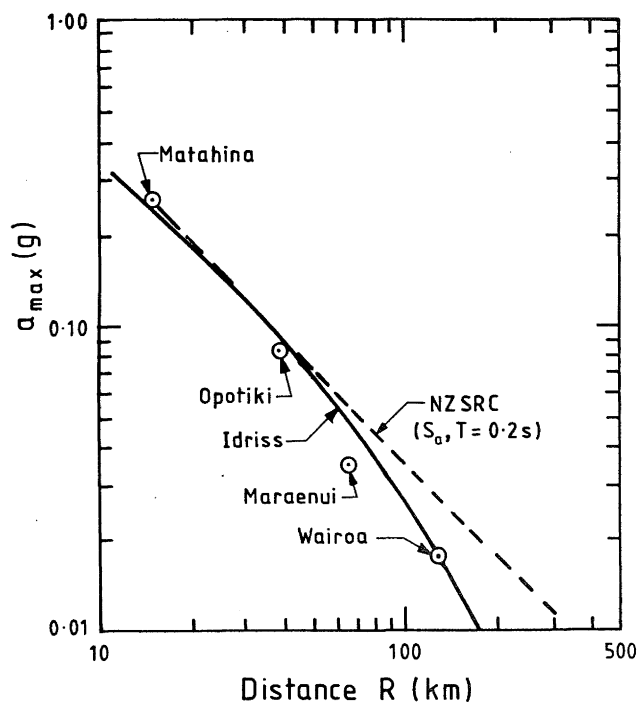
peak ground accelerations from the 1968 Inangahua earthquake [6]. The level of this line on Figure 2 has been arbitrarily set to start from the field data point for Matahina dam.

Both the Idriss and NZSRC curves fit the data points quite well, particularly the former. The standard deviation of the  $\log_e$  values for the four data points in relation to Idriss's curve is 0.08, which is less than half the residual standard deviation of 0.165 found by Idriss for his data set. No comparable significance test of the fit of the NZSRC curve can be carried out, as only its slope is known.

FIGURE 2. ATTENUATION OF PEAK GROUND ACCELERATION FOR EDGECUMBE EARTHQUAKE, COMPARED WITH NEW ZEALAND AND WESTERN USA MODELS.

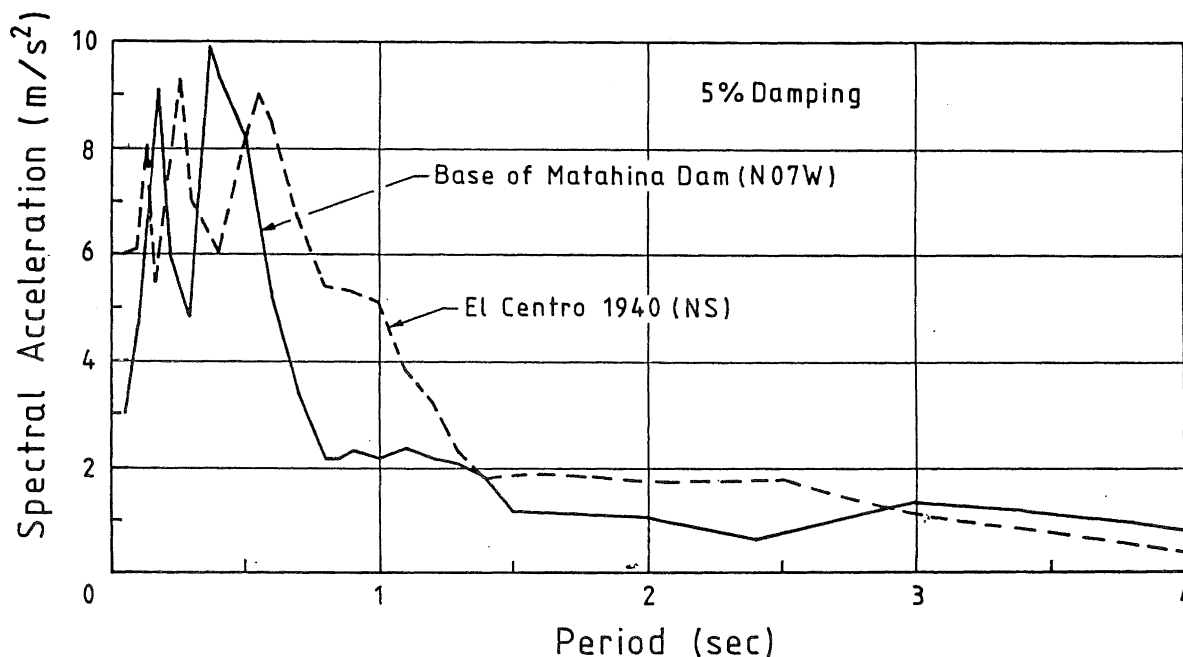
The ground shaking at the base of the Matahina Dam was the strongest acceleration history so far recorded in New Zealand, and was similar in strength to the El Centro 1940 earthquake record which has long been used as a basis for design loadings in this country. This is evident from a comparison of response spectra from these two records as plotted on Figure 3. It follows from Figure 1 that much of the area inside the (undrawn) MM8.5 isoseismal experienced shaking equal to or greater than the code design level for Seismic Zone A, our

FIGURE 3. ACCELERATION RESPONSE SPECTRUM FROM GROUND MOTIONS AT THE BASE OF MATAHINA DAM COMPARED WITH EL CENTRO 1940 (AFTER DOWRICK, REF.8)

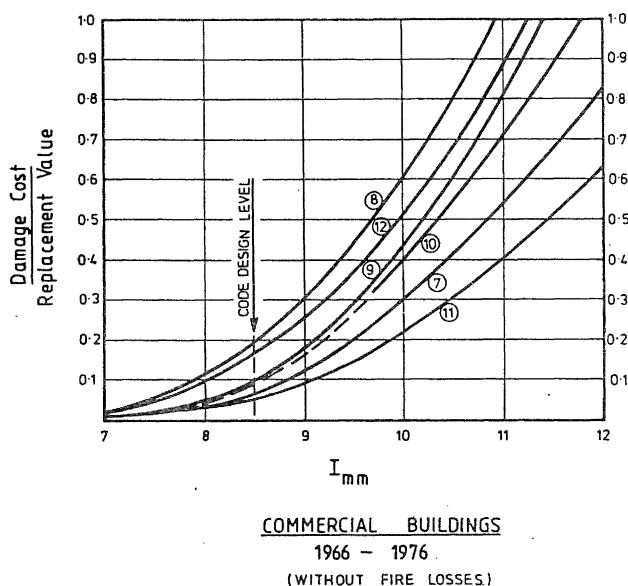
The degree of damage that we should expect near the centre of earthquakes such as Edgcombe is indicated by the damage ratios plotted as functions of  $I_{mm}$  in Figures 4 and 5, where damage ratio<sup>mm</sup> is the cost of the damage divided by the total value of the building (or other item) concerned. It can be seen that damage ratios between about 4% and 60% would be the norm for  $8 \leq I_{mm} \leq 10$ , depending on the type and age of structure, but as the curves are of mean values, damage ratios up to 100% (ie total write-offs) would not be exceptional (for

The damage ratios in Figures 4 and 5 are not directly comparable because they define the total values of the buildings differently. It should also be noted that the curves on Figures 4 and 5 are highly uncertain because of the scarcity of data, both world-wide and especially for New Zealand construction. This is especially true for the curve for post-1977 reinforced concrete construction on Figure 5, for which of course there was no New Zealand damage data available at the time of that study. Hence this curve was inferred entirely from overseas experience. The relationship between the Birss 1836-1877 and post 1977 curves is unsatisfactory; the two curves should be much nearer the same for about  $I_{mm} < VIII$ , ie at response levels less or not much greater than the elastic limit, as the main difference in the damageability of structures of these two eras is in their post-yield performance.

FIGURE 4. DAMAGE RATIOS FOR NEW ZEALAND COMMERCIAL BUILDINGS (AFTER DOWRICK, REF 10).

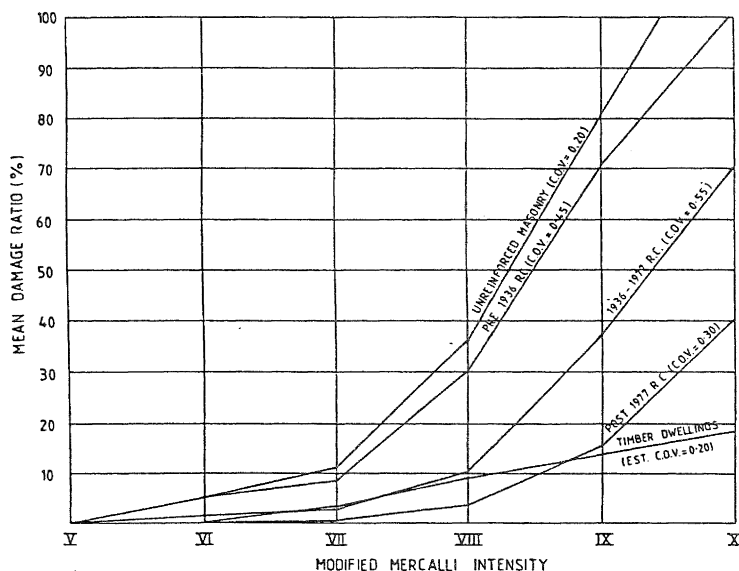
FIGURE 5. DAMAGE RATIOS FOR NEW ZEALAND BUILDINGS (AFTER BIRSS, REF 11).
