THE BEHAVIOUR, OVERVIEW OF DAMAGE AND RETROFIT OF STEEL BUILDINGS AFTER THE EARTHQUAKES OF SEPTEMBER 1985

Enrique Martinez-Romero⁽¹⁾

Presented at the Pacific Structural Steel Conference, Auckland, August 1986

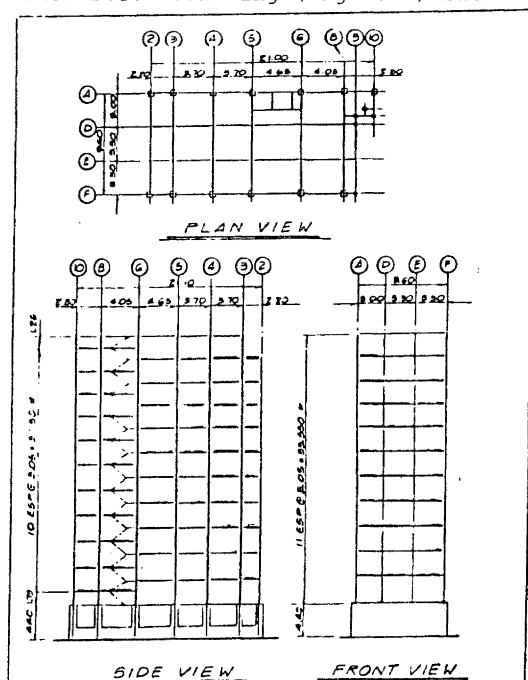
FIG. 6 - AMSTERDAM BUILDING

This 12-story single-span rigid-framed steel building (Figure 6) showed

large lateral displacements hitting adjacent construction. The main damage pattern was cracking of the filler-masonry sidewalls, the breaking of some poor weldments joining the cover plates to the channels in box columns at the rigid joints, and minor local damage at the areas of collision. The main built-up plate girders working compositely with the concrete slab exhibited no distress.

Excessive lateral deflections, rather than insufficient strength, produced the main damage on non-structural elements. The building was partially occupied after the earthquake to allow for repairs.

The office building on Amsterdam Ave, for example, required only minor reinforcing elements according to the author, which opposed to previous opinions recommending both a reduction of four floors in height and the reinforcing of the buildings columns. By the addition of some elastomeric dampers in the short direction of the building, at four of the six frames, and two eccentric braced bays, one at each long side, the building significantly improved its dynamic response by increasing its damping to about 20 percent of the critical, resulting in a diminished spectral acceleration which considerably reduced the horizontal inertial forces. (Figure 9). The dampers were installed on the lower vertex of an additional narrow "V" brace, at the connection with the main floor girders, as shown in Figure 10.

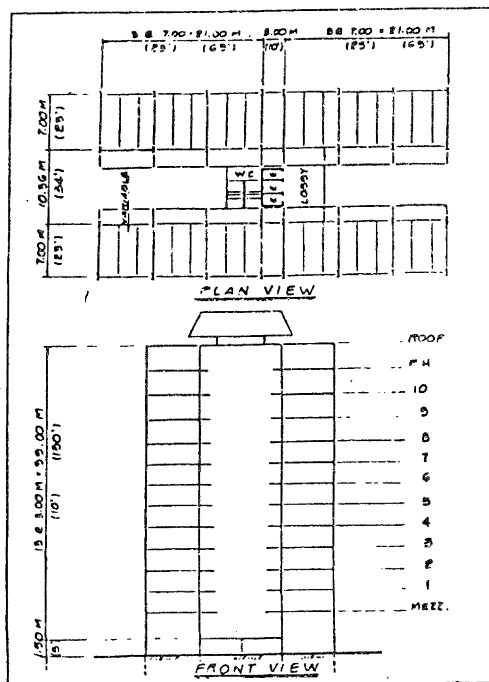
FIG. 7 - AZUCAR BUILDING

The Azucar building is "H" shaped in plan (Figure 7). It is a 12-story building used as a government office and was overloaded with files and paper work. The columns are built-up W sections and girders are open-web joists of two-angle chords and box-angles as diagonals in composite construction with the slab. The two legs are joined at the central area by a concrete shear wall elevator core.

The typical damage pattern was local buckling and/or fracture in tension on the main joist girder's web members located normally at the central third of the span and was apparently caused by excessive floor shears transferred from the slab and column rotation at the joints. Some anchor bolts of corner columns were fractured by tension magnifying lateral displacements.
