PRELIMINARY FIELD OBSERVATIONS OF THE CHILEAN EARTHQUAKE OF 3 MARCH 1985

David J. Dowrick

This paper is an initial appraisal of the effects of the $M = 7.8$ earthquake centred near San Antonio, Chile, which occurred on 3 March 1985. The author arrived in Chile six days after the main shock and spent a week investigating as many aspects as possible. The earthquake caused heavy damage to a large area including the major cities of San Antonio, Valparaiso and Santiago, and resulted in 700,000 people being made homeless.

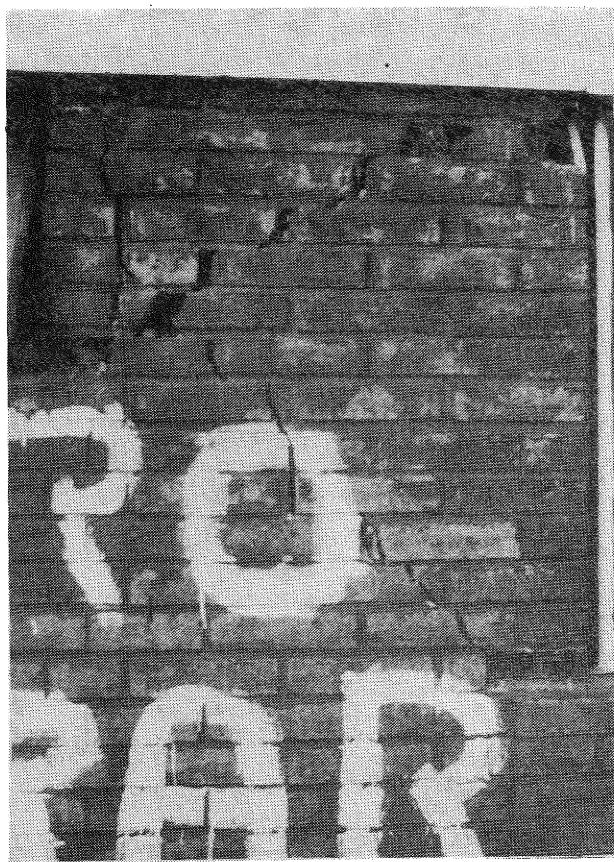
The Villa Santa Carolina in Santiago comprised three-storey blocks of 1984 construction all of which were heavily damaged (Figure 1). While the materials and workmanship appeared to be generally of good quality, the bricks had perhaps excessive vertical holes and the amount of vertical reinforcement was considerably less than would be required by the New Zealand code.

Figure 1. Shear cracks in reinforced brick walls, Villa Santa Carolina, Santiago.

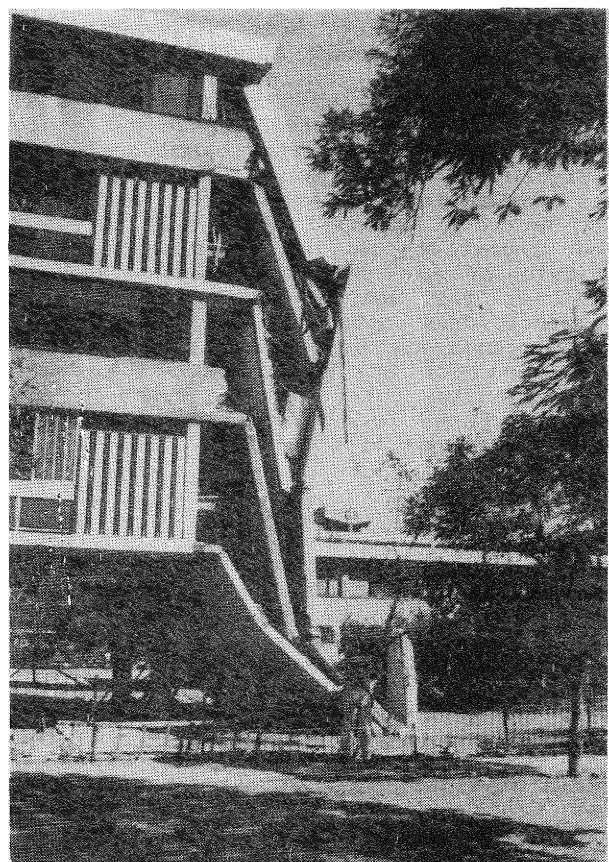
One example of this factor was at the Villa Olímpica in Santiago with the collapse (Figure 2) of the end bay of one of a series of similar buildings which otherwise performed moderately well. Two aspects of structural form seemed likely to have contributed to this local collapse. Firstly high asymmetry existed in plan layout because this building was rigidly connected to an adjacent building at the other end from the collapse, and secondly there was a soft storey effect at the collapsed end as can be seen from Figure 2.

Figure 2. Collapsed end bay of reinforced concrete apartment block, Villa Olympia, Santiago.

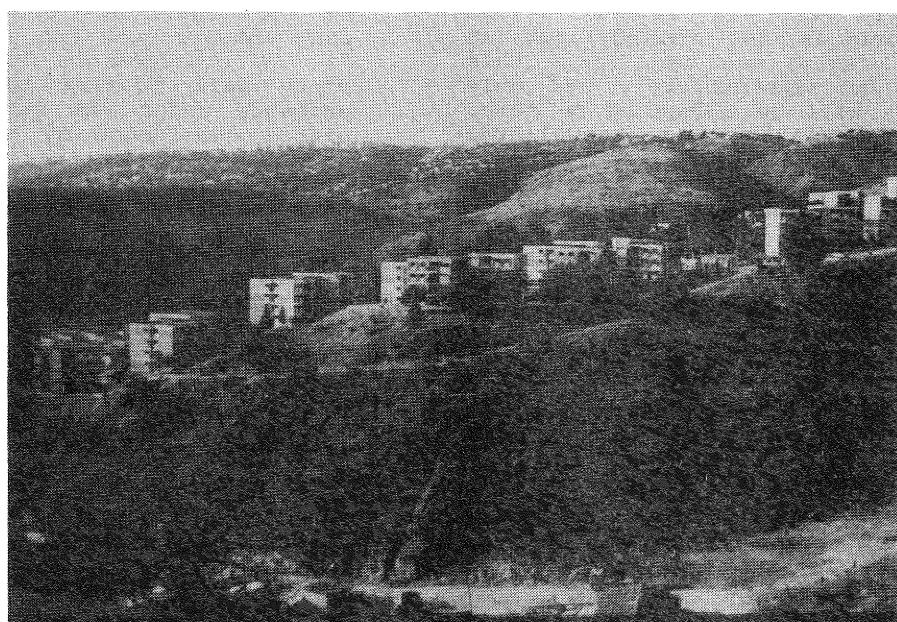
The earthquake apparently provided a spectacular example of topographical focusing of ground shaking at the Canal Beagle housing estate at Viña del Mar. A number of discrete groups of similar blocks of apartments have been built in the same neighbourhood but on topographically very different sites. The buildings on the tops of steep hills (Figure 3) were heavily damaged (Figure 4) while those on flat or valley sites

Figure 3. Topographical focusing appeared to have worsened the shaking for the buildings on this ridge, Villa Canal Beagle, Vina del Mar.

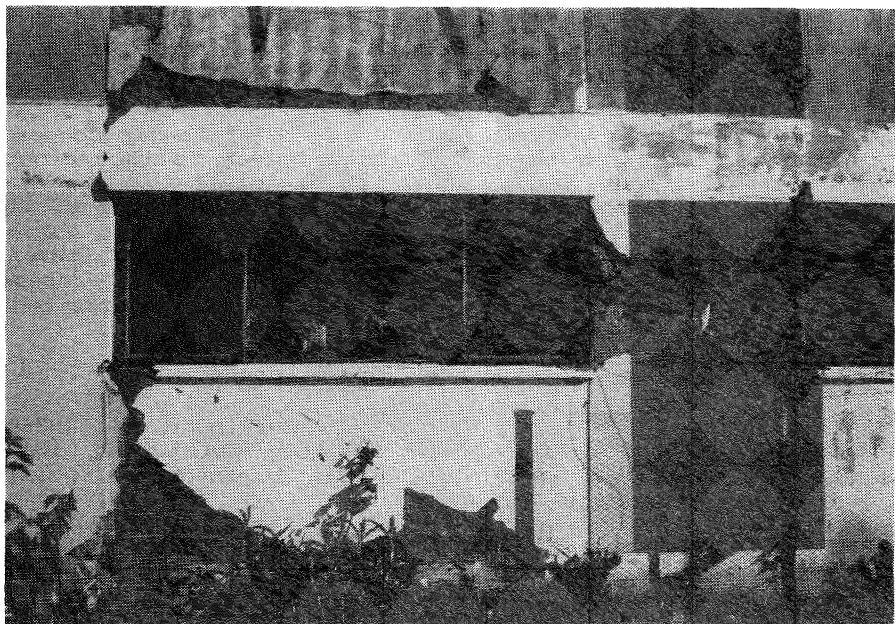
Of the 16 concrete buildings discussed above, it is of interest to consider those having both modest (that is, repairable) structural damage and non-structural elements. There were three such buildings and all had suffered heavy damage to infill walls, spandrels and glazing (Figure 4), none of which was separated from the structure. This, of course, would be expected in the moment-resisting frame building, but the other two buildings had shear wall structures. Some investigation of the deformations in these latter two buildings might therefore provide further data on the degree of protection to non-structure provided by shear wall stiffness above.

Figure 4. Shear failure of reinforced concrete column and reinforced brick infill despite good performance of some of the concrete shear walls as on the left of the picture, Villa Canal Beagle.

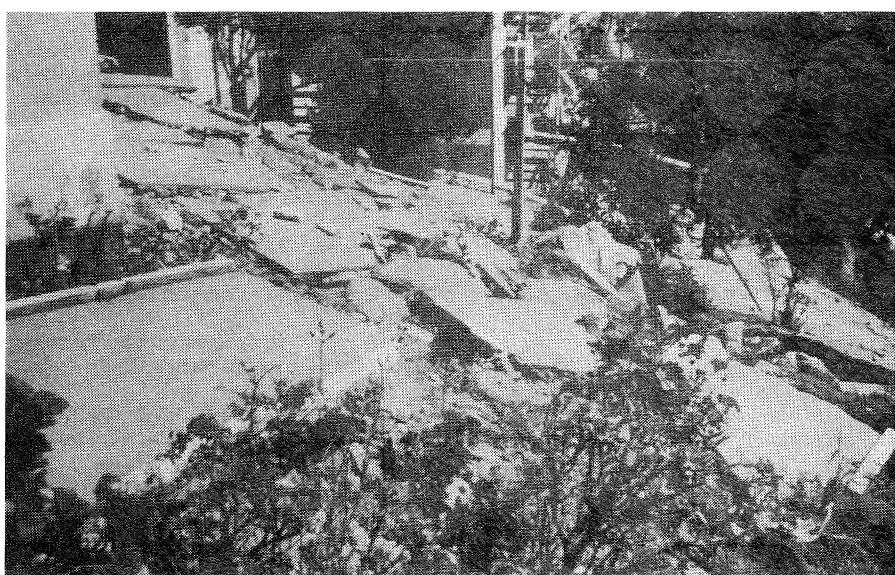
Figure 5. External infill brick walling which fell from a building at Villa Canal Beagle.

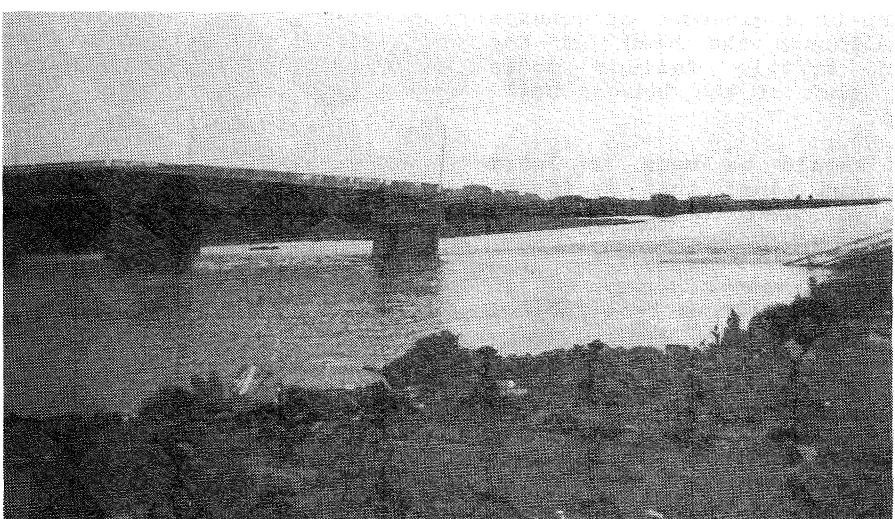
Initially it was reported that about ten bridges had failed, but as the affected region was very large this proved hard to substantiate, and only three bridges will be commented on here. Just south of San Antonio the Lo Gallardo Bridge (Figure 6) forms a major modern crossing of the Maipo River. A number of spans of this bridge collapsed, no doubt initiated by the failure of the piled piers in the permanent watercourse, the loss of this part of the deck then permitting larger longitudinal pier movements and the unseating of further deck spans. While foundation failure was the apparent cause of the loss of the piers, a detailed explanation will hopefully come from subsequent studies by Chilean engineers and the EERI team members.

Figure 6. Lo Gallardo Bridge, Maipo River, one pier subsided, another pier and one deck span completely submerged, northernmost span just visible on the right of picture.

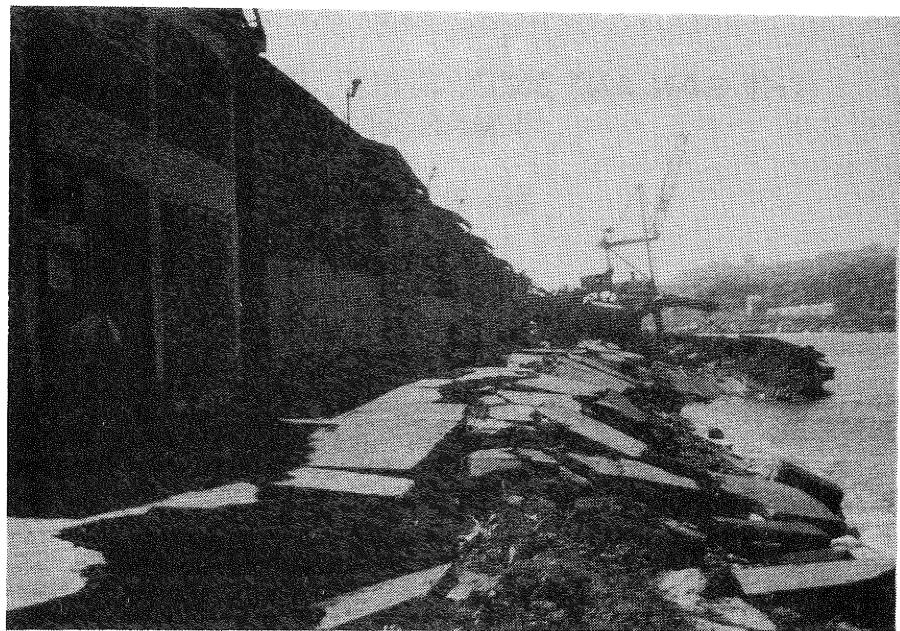
Large ground displacements often provide the most spectacular examples of earthquake damage, and the failure of the inner face of the breakwater at San Antonio was no exception (Figure 7). A considerable length of the concrete wall forming the quay had disappeared under the water and the associated subsidence of the adjacent paved area was enormous, causing massive damage to the quayside buildings and overturning ship-loading cranes. A few sand-boils were found in crevices in part of the subsided zone, but an initial appraisal did not find large scale liquefaction to be likely. However, the evident increase in pore water pressure in the embankment fill and the underlying sands may well have contributed to the quay wall failure and to the subsidence that seemed to have occurred in parts of the embankment not affected by the quay wall failure.

Figure 7. Quay side of breakwater at San Antonio harbour, showing collapsed quay wall and cracks.

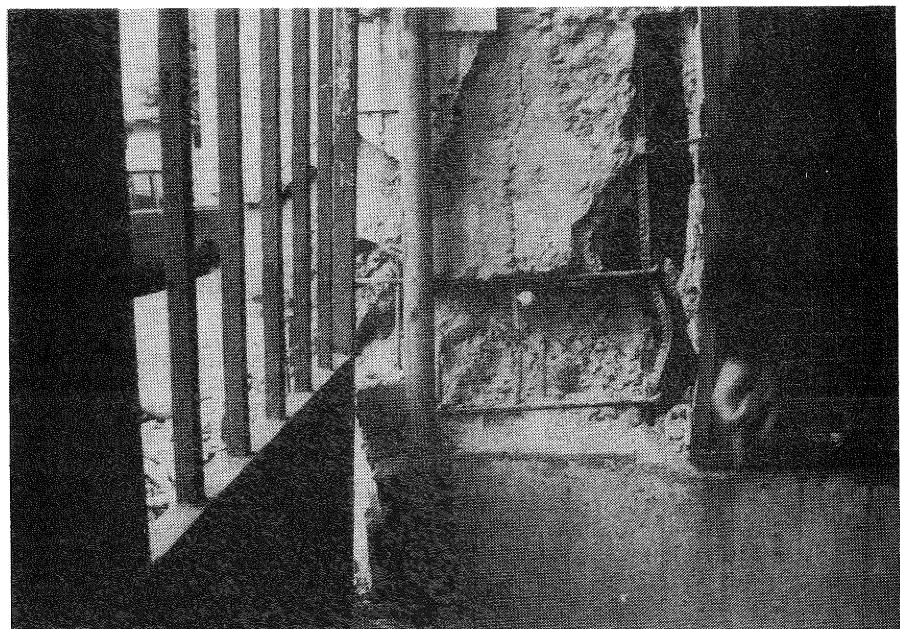
Including hospitals in the definition of lifelines, it should be noted that at least two modern hospitals had to be evacuated due to heavy damage, namely the Claudio Vincuña Hospital in San Antonio and the Sermena Regional Hospital of Valparaiso (Figure 8).

Figure 8. Compression failure of corner column of Sermena Regional Hospital in Valparaiso which had to be evacuated.
