THE SAN ANTONIO, CHILE, EARTHQUAKE OF 3 MARCH 1985

Ian N. Connor*

ABSTRACT

This paper consists of the author's observations on the damage caused by the earthquake of 3 March 1985, centred near San Antonio, Chile. The damage was inspected approximately four weeks after the earthquake. At that time the overall cost of the damage caused by the earthquake was estimated at NZ\$1,750 million.

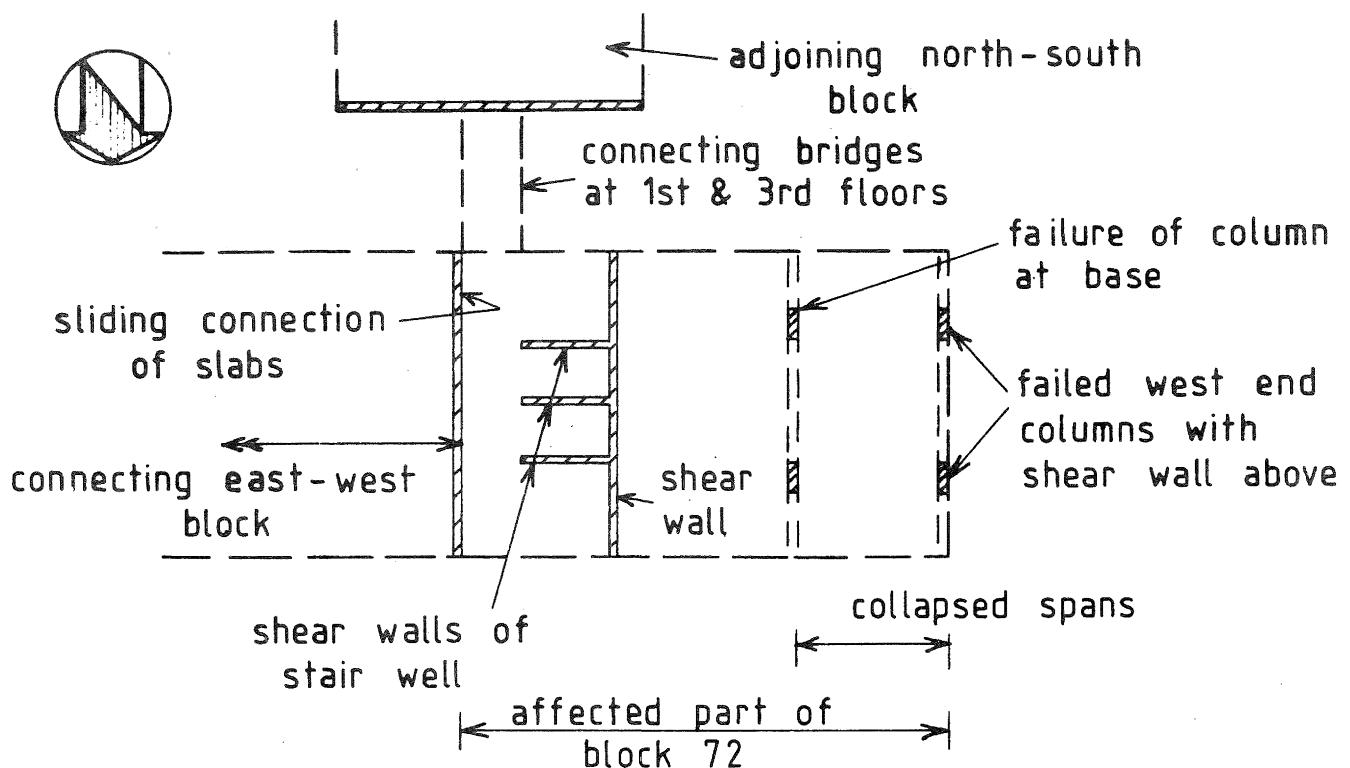
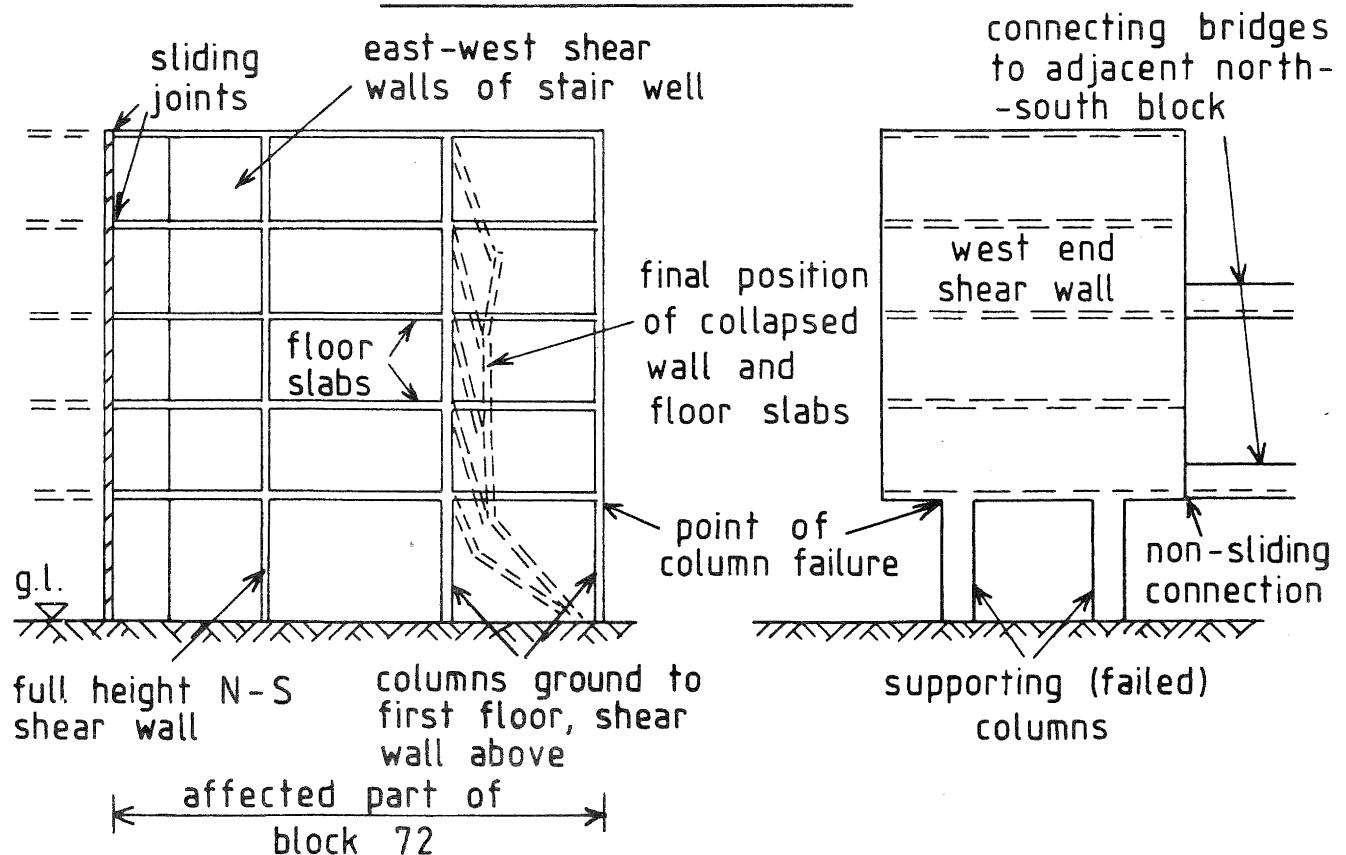
Figure 2. Villa Olimpica — Block 72 Layout.

From the overall orientation of the building (see sketch) the presence of cracks at the connection of the bridges to the adjacent block (see photograph 3) and the apparent east-west direction of the general ground motion, it seems that torsionally induced shear loading of the end wall initiated the failure. The relatively stiff stairwell structure at the east end of the block and the eccentric effect of the bridge restraints would have accentuated the torsional effect of basic eccentricity of the structure.

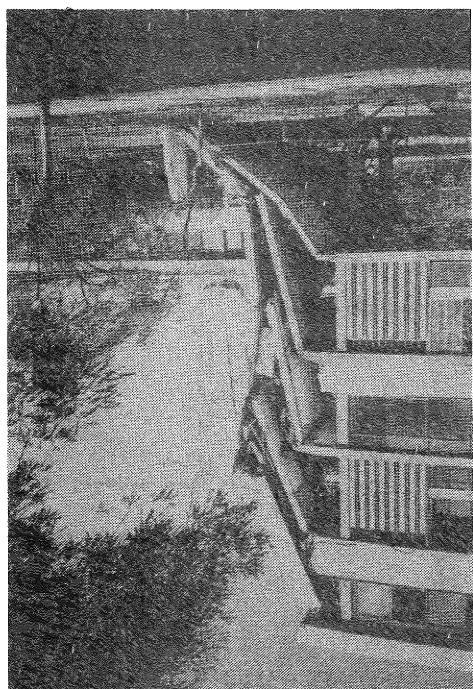
The connection of the bridges to the adjacent north-south block would have been expected to have a sliding joint at the end of their connection but this had not been constructed as such, and spalling on the bridge support beam (see photograph 3) confirms this. The internal columns of the adjacent north-south block were partially constructed of masonry and suffered severe damage, indicating significant deformation of this block, also five storeys.

Photo 2. West end of block — adjoining north-south block in background at right.

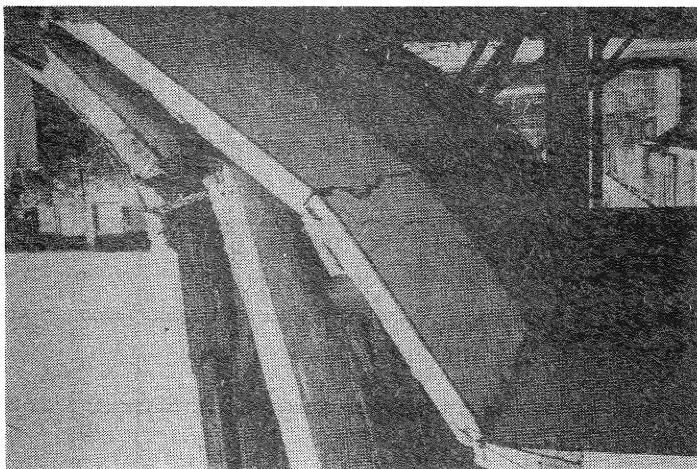
Photo 3. South side of block showing sliding joints at slab connections to adjacent block at the east-bridge connections to adjacent north-south block (note spalling at ends of support beams to connecting bridges).

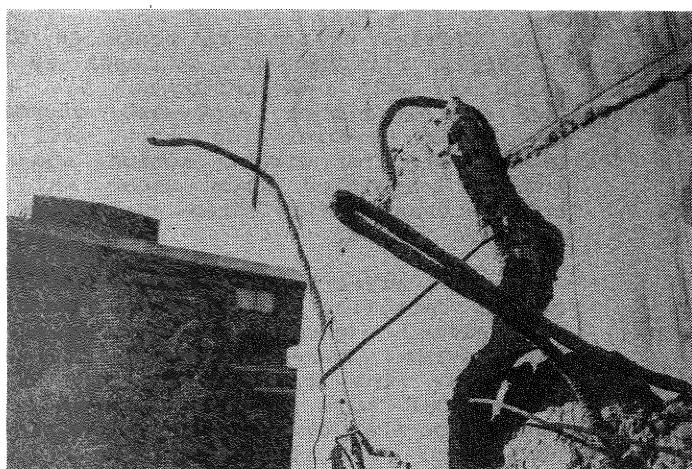
Photo 5. Close-up view of shattered top of failed column.

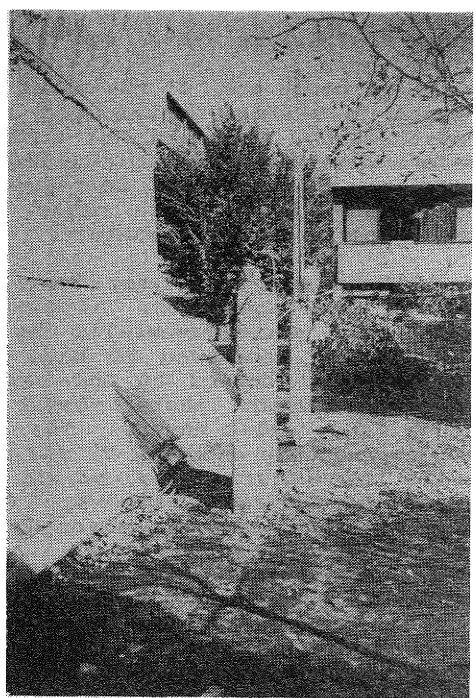
Failure appears to have been due to lack of capacity at the column/shear wall connection on the west end wall of the block. Column ties at this highly stressed joint are too widely spaced, too small and inadequately anchored into the core to provide either sufficient shear capacity or confinement to the main column bars and the columns appear to have suffered a shear-compression failure.

Both the failed columns showed extensive fine cracking in both main faces. Although a general pattern was hard to see, it did appear that the cracks were inclined and were shear cracks. There did not appear to be any disturbance of the ground at the base of the columns indicating that the columns failed in shear and compression long before flexural capacity was reached.

Photo 6. Failed west end column.

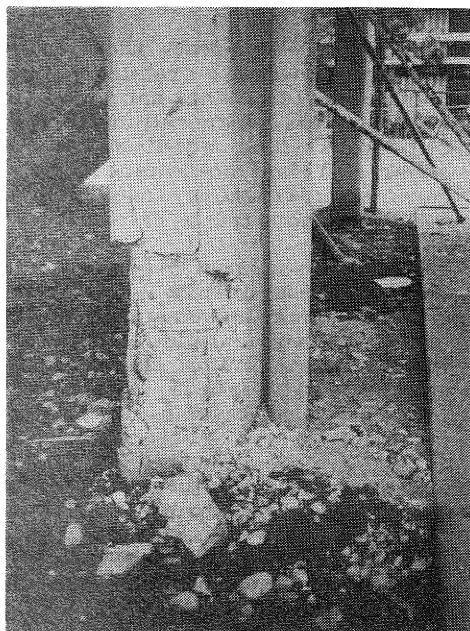
Similar lack of adequate column ties is evident in the photo showing damage to the base of the south column in the second row from the west face. The failure of this column appeared to have been in compression, not in shear-compression, and possibly occurred at the moment when the west end columns failed and the end wall and upper floors collapsed, momentarily transferring excessive axial load on to these columns. No clearly identifiable shear cracks

Photo 7.
Failure at base of south column —
second row from west.

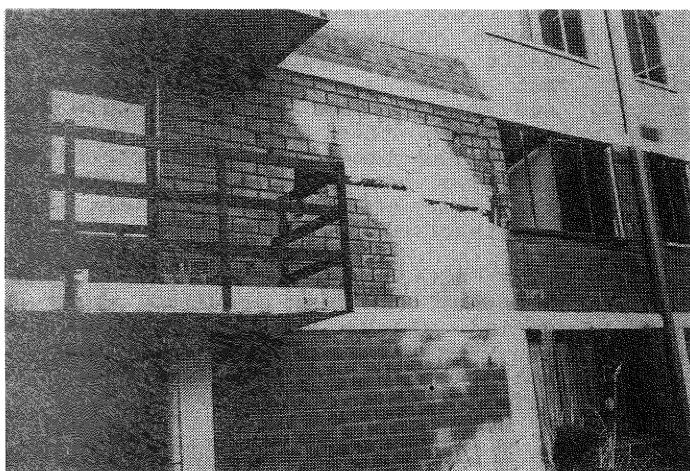
Photo 9. Shear cracks in unconfined first floor wall panel.

The damaged brick panels show predictable diagonal shear cracks in both directions from lateral load reversals. The cracking has occurred at the first floor rather than the ground floor where the concrete frames have provided confinement to the brick walls. The first floor walls are completely unconfined by either column or reinforcement. The walls do have some reinforcement but this is nominal and totally inadequate to prevent the cracks opening.

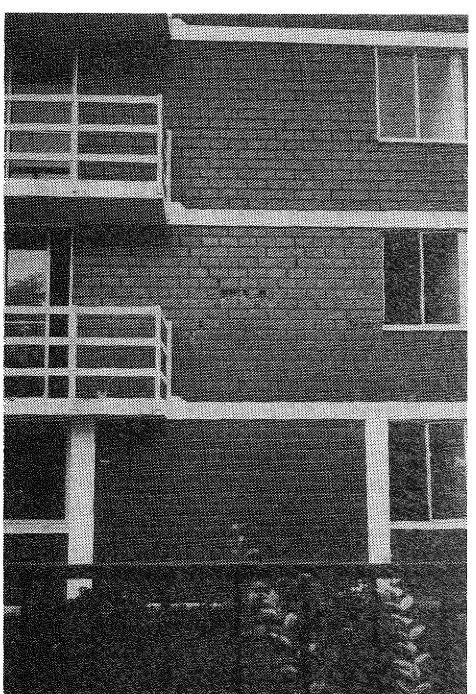
Photo 8. Shear cracks in unconfined first floor wall panel.

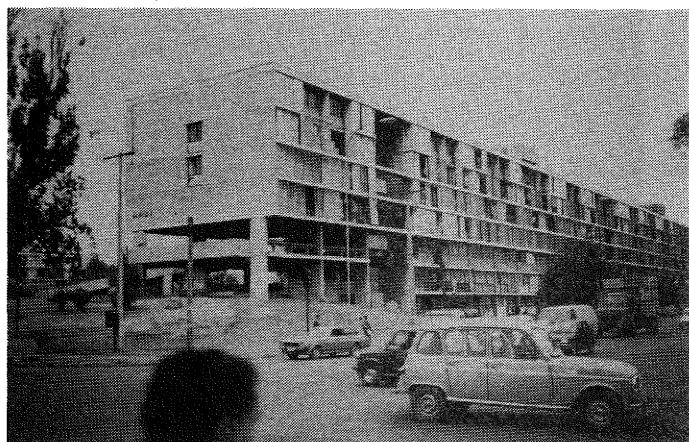
Similar effects to those in block 72 Villa Olimpica can be seen on the north end wall (see photograph 9). With the characteristic east-west direction of ground acceleration this wall was effectively in direct action and the sudden transition from shear wall to columns created high stress concentrations at these joints.

Photo 10. North end wall showing shear wall transition to columns.

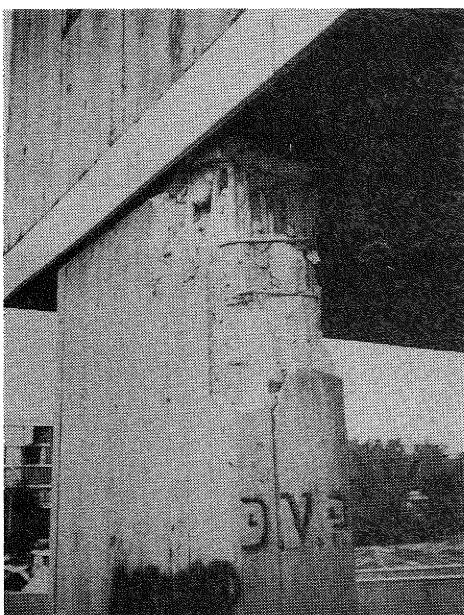
The effects of floor main steel cutoff detailing and inadequate column tie sizing, spacing and anchorage in high stress zones are evident. Main bars have laps, cutoffs and hooks within a critical zone and have created such congestion that bars have had insufficient anchorage. Tie steel, as well as being spaced widely, has not been anchored into the column core, possibly because main bar congestion has prevented this.

Photo 11. Left-hand (east) column/wall joint.

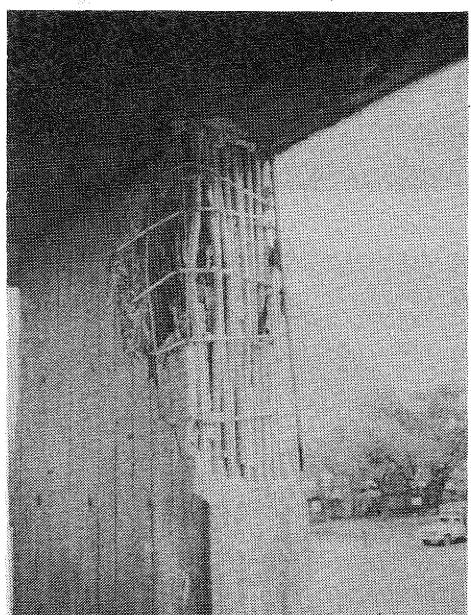
Photo 12. Right-hand (west) column/wall joint.

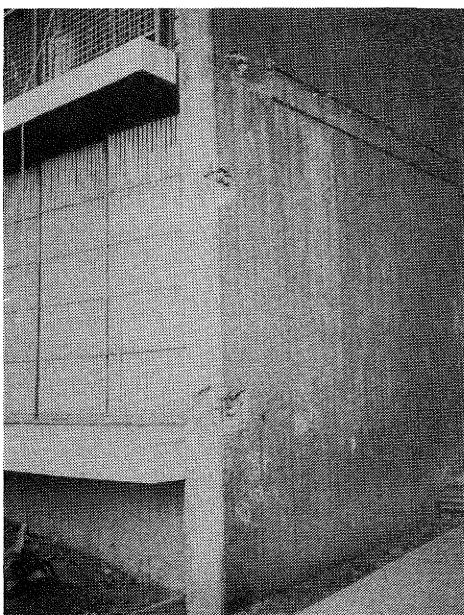
Further photographs show similar inadequate confinement reinforcing at interior shear walls. At bar hook locations spalling has occurred (see photograph 12) and at the critical end zone of one shear wall no confinement is provided over approximately one metre of bar length (see photograph 13).

Photo 13. Spalling at slab connection to shear wall and at main bar hooks at edge of east-west shear wall.

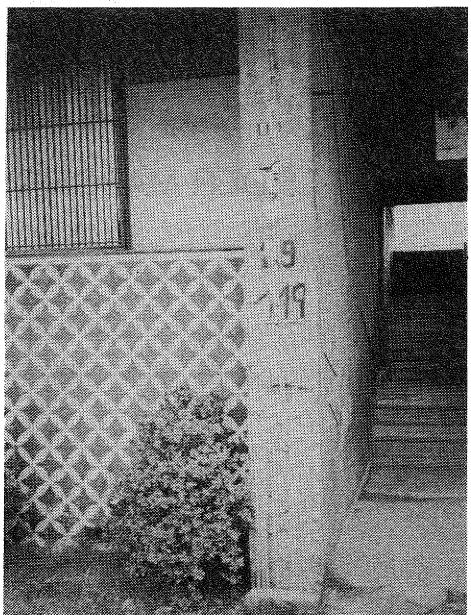
Photo 14. Spalling at unconfined main bars at base of east-west shear wall.

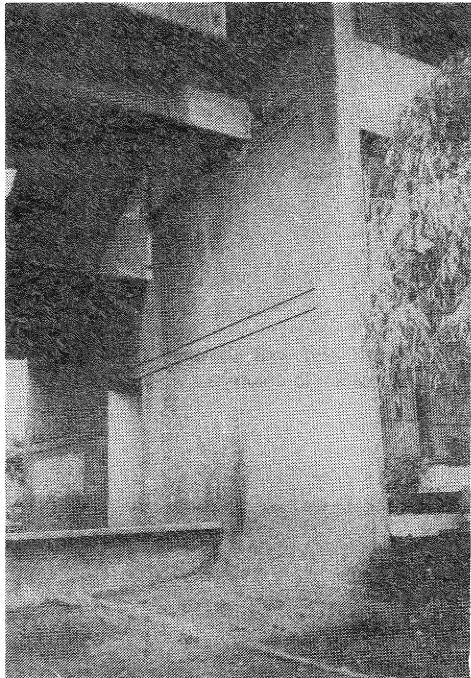
Another photograph (14) shows problems from incompatible deformations where stair flights and supporting beams connect with the shear walls. The photograph shows propagation of shear cracking from the punching damage resulting at the rigid beam connections to the shear wall.

Photo 15.
Punched holes and connecting
cracks in shear wall at stair
connection to east-west shear wall.

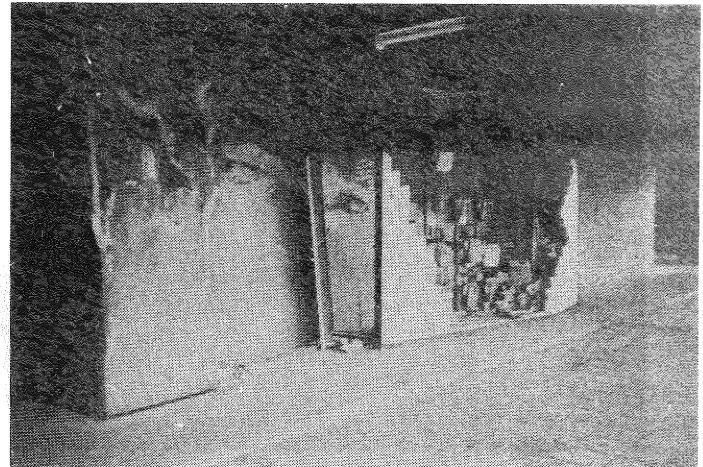
Many internal non-structural walls in the blocks were of thin, lightly reinforced concrete and, because of the lack of structural separation from the floors above, were very badly damaged (see photograph 15).

Photo 16. Typical damage to non-structural internal partition.

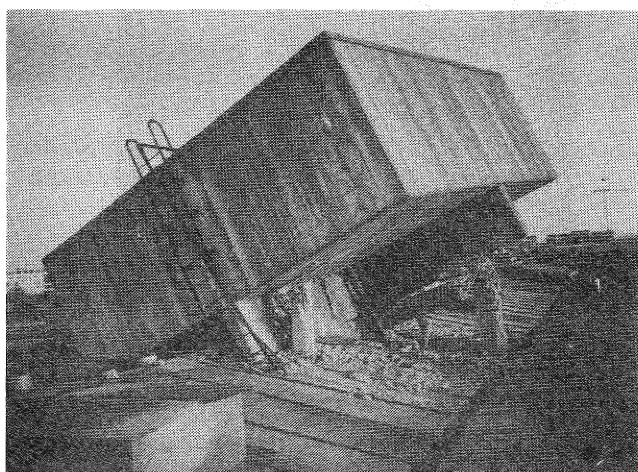
On almost all the apartment blocks in Villa Portales, roof mounted water tanks suffered severe damage. Lack of allowance for torsional effects on full tanks in support design appeared to be the main problem. Tanks were supported on either crossed shear walls, or cross braced columns. The supporting shear walls were integral with support beams but formed a step at their connection and shear forces appear to have concentrated at this step to induce failure. The cross braced column supports appear to have been totally inadequate under torsional effects and complete collapse has resulted.

Photo 17. Toppled water tank supported on cross-braced columns.

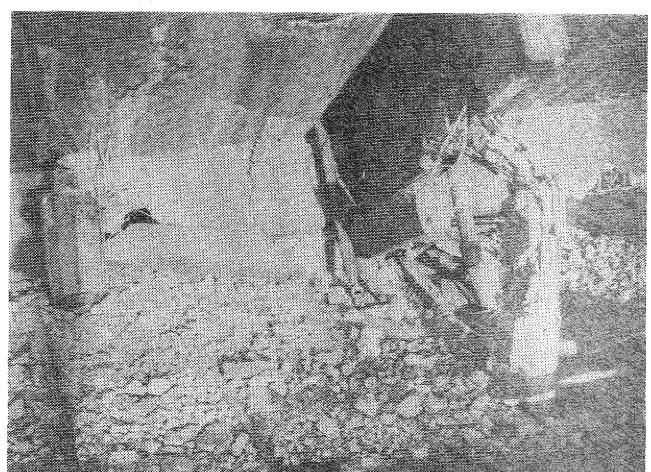
Photo 18. Close-up view of failed supports.

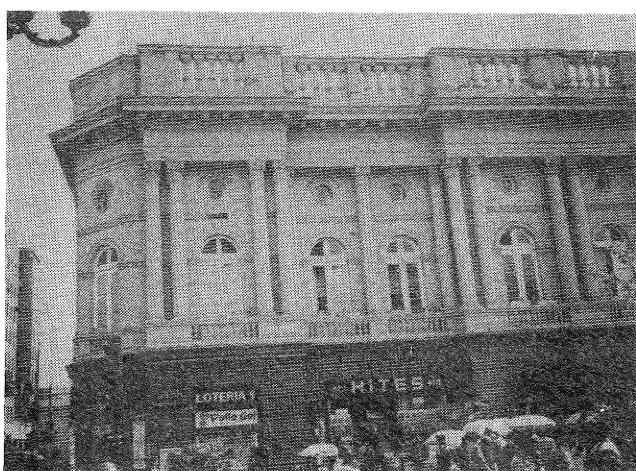
Photo 19. Badly damaged parapet, cracking near corner of building and around window arches.

Damage at the corner of an old masonry building and cracking at openings is evident in the photograph of a high stud commercial building located in the same square as the City Council headquarters. Imminent collapse of the heavy, untied parapet is also visible in this photograph.

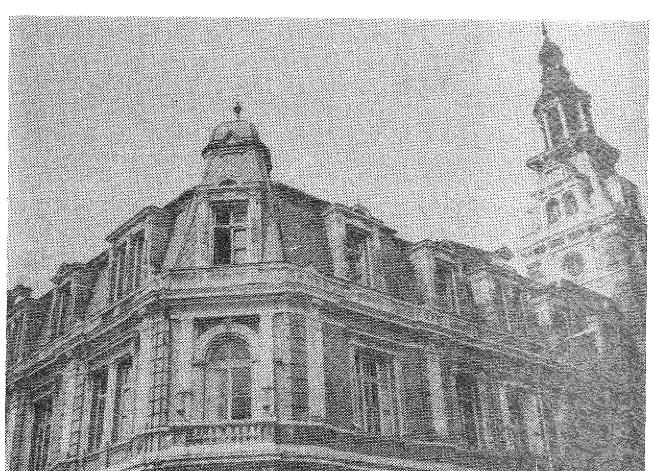
Photo 20. Inadequately tied dormer windows, temporary repairs with wire ties, cracking down corner of second storey.

Dislocation of inadequately tied, heavy dormer windows and similar cracking at the corners of the building are evident in the photograph of an old commercial building on the same block as the City Council headquarters.

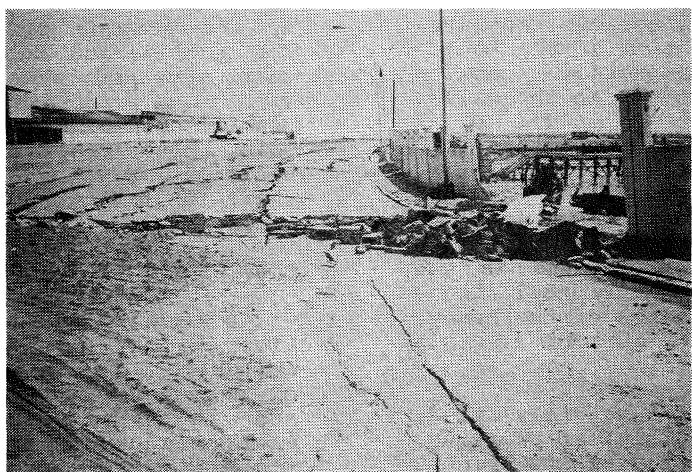
At San Antonio, the second largest port in Chile, extensive subsidence of a large-scale port reclamation dating from about 1971 destroyed a solid wharf facility, and caused the complete collapse of 30 metres of an open piled wharf. In addition, major damage occurred to remaining structures at the port.

Photo 21. Subsidence in port reclamation. Collapse of end of pier-type wharf and subsidence of foundations.

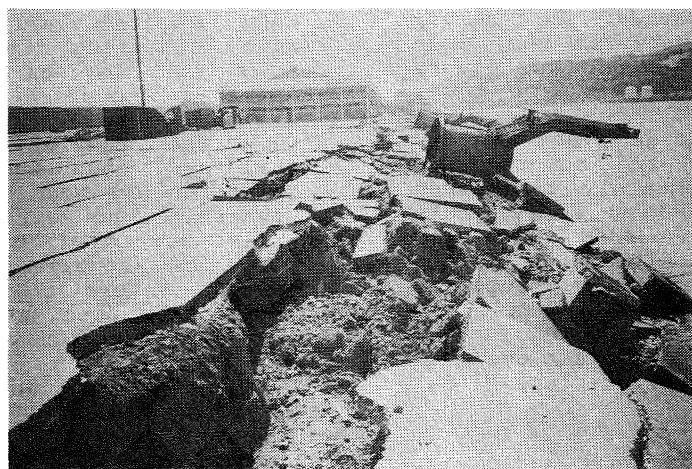
had been done when the author visited it. Liquefaction appeared to be the major cause of the failure, as indicated by the pumping of the tank foundation. The reclamation behind the failed solid wharf appeared to be variable in character with clay, concrete rubble and even some general building rubbish being evident. This, plus water being present in the backfill, may have contributed to the wharf failure.

Photo 22. Subsidence of reclamation and complete collapse of retaining wall wharf leading to crane toppling.

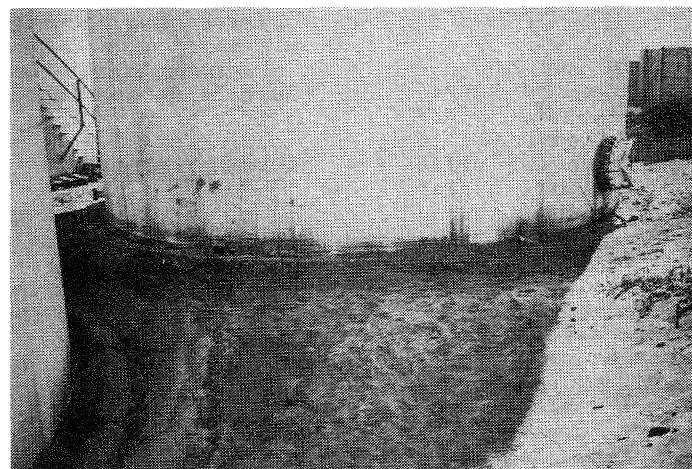
A small tank farm for storage of byproducts from a fish processing plant, situated on the same reclamation, showed pumping of the tank foundations. The steel tanks themselves and concrete foundations remained basically undamaged, although connecting pipework was ruptured. The tanks, approximately 7 metres in diameter and 7 metres high, had been deformed out-of-vertical by up to 300 mm. Although no base restraint was provided to any of the tanks, translation was less than 10 mm in the worst case.

Photo 23. Evidence of pumping of tank foundations on reclamation.
