2. ANGLICAN PARISH OF BLENHEIM:
STRENGTHENING TO THE CHURCH OF
THE NATIVITY

C.C. Davidson*

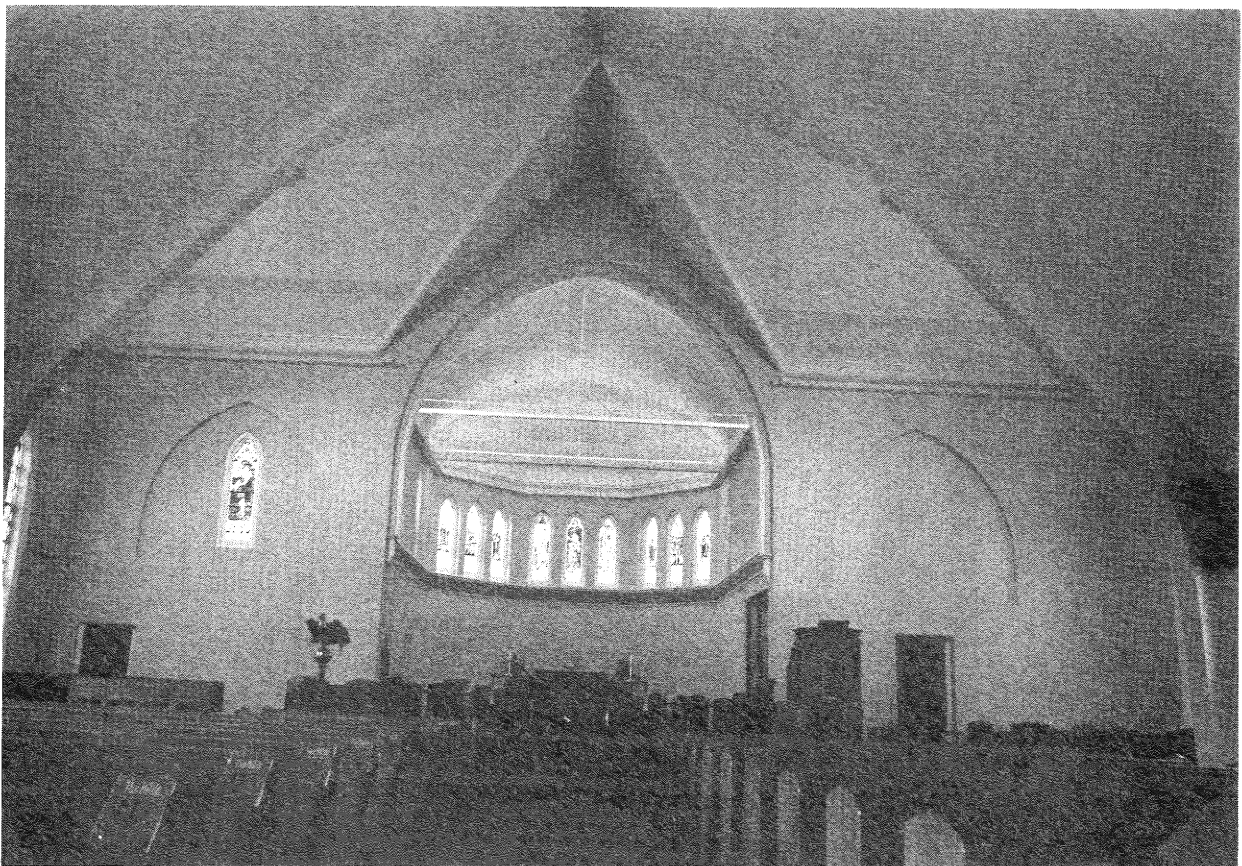
Interior as completed.
