# LIFELINES PERFORMANCE AND MANAGEMENT FOLLOWING THE 22 FEBRUARY 2011 CHRISTCHURCH EARTHQUAKE, NEW ZEALAND: HIGHLIGHTS OF RESILIENCE

# SUMMARY

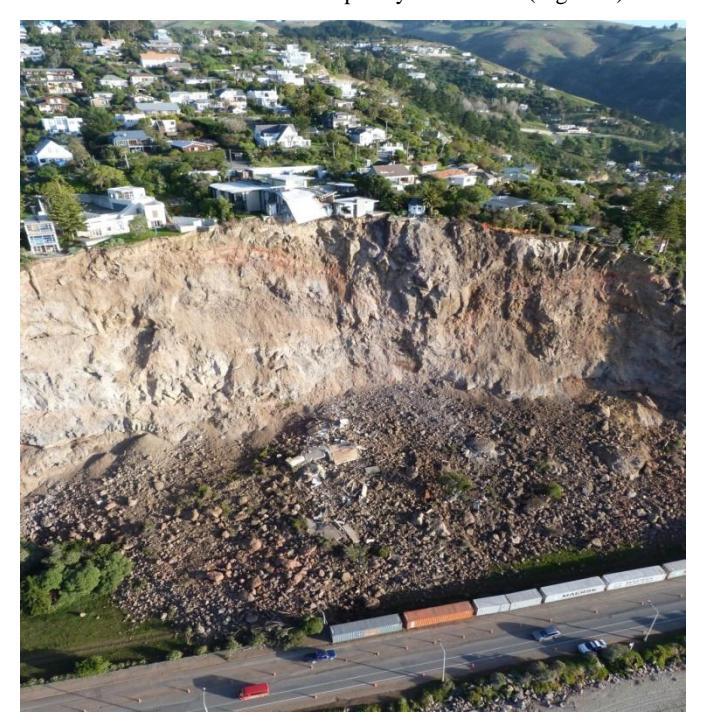
The extremely high ground-shaking during the 22 February and 13 June earthquakes in the northern Port Hills lead to extensive rockfalls and rock slope failures. Rockfalls mostly occurred from the jointed lava flows, leading to tens of houses being impacted by falling rock in Redcliffs, Heathcote Valley, Lyttelton, Rapaki and Sumner. The time of day (mid-day) meant few were occupied which reduced the number of potential casualties. The mitigation measures in place (fences, benches and trees) were overwhelmed by the large number and volume of rocks, which came down off the hills (Bell, 2011). During the 22 February and 13 June earthquakes, largescale cliff collapses occurred in Redcliffs and Sumner (southeast Christchurch suburbs). Up to 15 m of cliff failed along sub-vertical cooling fractures and through intact rock during each shaking event due to very high vertical and horizontal accelerations (>1.0g). This lead to hundreds of houses being severely damaged, requiring evacuation, and ~100 houses unlikely to be reoccupied both at the cliff top and base (Bell, 2011). Power, water and sewage services were also severely damaged in the hill suburbs. Clifton Hill collapses threatened the seaward road linking Red Cliffs and Sumner to Christchurch city, requiring the use of ballasted shipping containers to be used as a temporary catch fence (Figure 3).

Figure 3: Cliff collapse at Clifton Hill following the 22 February and 13 June 2011 earthquakes - flown 14 June 2011. Note the partially collapsed house and use of ballasted shipping containers as temporary catch fences (Photo credit: Marlène Villenueve/David Bell).

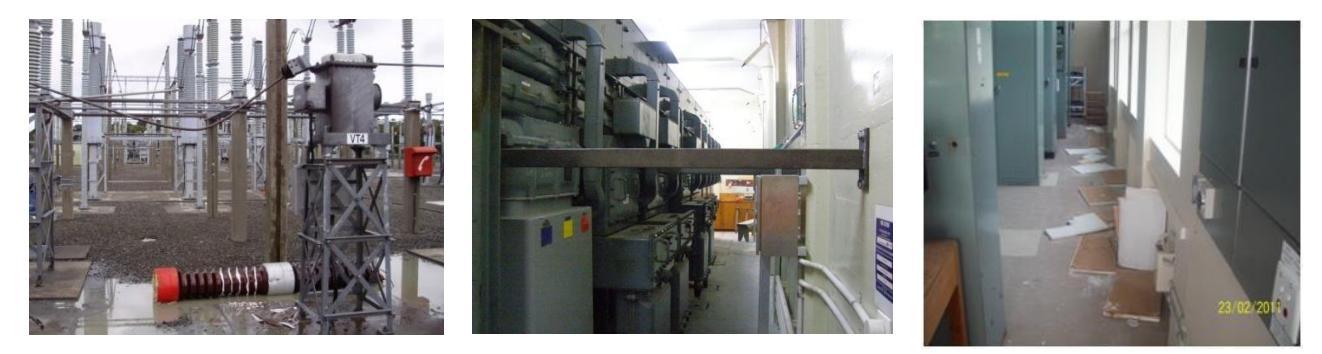
Damage at the Bromley substation occurred in the 66 kV switchyards and 220 kV switchyards, where severe liquefaction occurred (Figure 5a), and within the adjacent control building from where the switchyard equipment is controlled and operated via switchboards (Figure 5c). Damage to the 220 kV switchyard included a broken 220 kV capacitor voltage transformer (CVT; Figure 5a). Damage to the 66 kV switchyards included two broken 66 kV transformer bushings (replaced by using bushings from a spare transformer available on site) and failure of a 66 kV cable circuit.

Figure 5: Bromley Substation: a) 220 kV failed current voltage transformer; b) Bromley bracing installed at the front and rear of the switchgear panels; c) dislodged ceiling tiles in the control and relay building, (Photo credit: Transpower).

The implementation of the lessons learned following the 1987 Edgecumbe earthquake, on the need to seismically restrain heavy equipment installed in the substations (e.g. transformer banks) and the subsequent seismic restraint retrofit programme, was demonstrably worthwhile and contributed to minimising seismic damage and disruption to the transmission grid following the 22<sup>nd</sup> February earthquake. Transpower will continue to reduce the seismic vulnerability of their assets by removing or strengthening existing buildings, items of plant not complying with Transpower's current Seismic Policy (TP.GG 61.02). As part of the lessons learnt following the 22<sup>nd</sup> February earthquake, all instruments with insulators held by "finger clamps" will be replaced as this type of clamping is known and has shown (Figure 5a) to perform poorly during earthquakes (McGhie and Tudo-Bornarel, 2011).

Within the Bromley substation control building, short-term remedial work was undertaken soon after the earthquake to temporarily repair and enable the 11 kV switchboard equipment to return to service (Figure 5b). Action has been already taken to rebuild the Bromley substation and to install new 11 kV switchgear and switchboard. The new switchboard will be immediately available from an on-going substation construction project in Timaru.

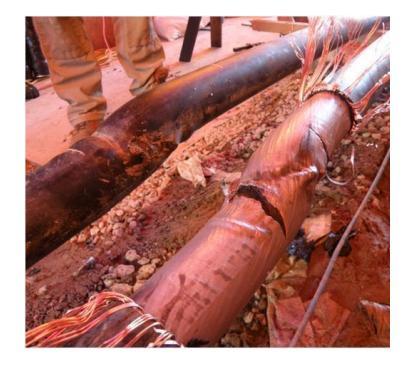
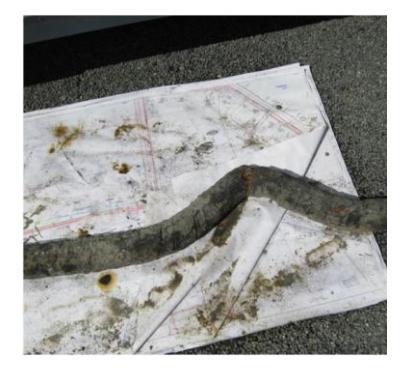
Of the 66 kV underground cable network, 50% of cables were damaged, 30 km out of a total of 60 km. All major 66 kV cables, supplying Dallington & Brighton zone substations (north-east area of Christchurch, Figure 6) were damaged beyond repair and had to be abandoned. These cables were pairs of radial 66 kV 3-core aluminium (300 mm<sup>2</sup>Al), oil filled, aluminium sheathed with an outer cover of semiconducting plastic sheath over the aluminium. The two cables were laid in a common weak mix concrete trench (750 mm depth) spaced 300 mm apart and capped by a 50 mm layer of stronger concrete (Orion AMP 2009).

Regarding the 11 kV underground cable network, 14% cables were damaged, 330 km out of a total of 2,300 km (Figure 8b). A total of more than 1000 faults were identified and repaired at 31<sup>st</sup> August (Orion Media release 31<sup>st</sup> August 2011). The affected 11 kV cables were either aluminium, or copper core cables of different length, diameters and types, including: paper lead; paper-insulated lead-covered, armoured, PILCA; PILCA HDPE cables, PILCA with a high density polyethylene HDPE outer jacket; cross-linked polyethylene, XLPE cables with PVC and HDPE protective outer jackets.

# Figure 8: a) 66 kV XLPE cable fault; b) Typical 11 kV internal cable damage (Photo credit: Orion).

More than 600 quake-related underground cable faults to both 11 kV and 66 kV cables were repaired within three months – more faults than Orion is used to experiencing in a decade. The approach followed to restore the functionality of the 66 kV underground cable traversing and serving the Christchurch CBD and the faulted 11 kV underground networks has been to locate the cable faults by cutting out of the damaged section and inserting a new piece of cable with two repair joints, whose resistance to further movement induced by potential aftershocks can not be, unfortunately, guaranteed. Each of the cable faults took more than 12 hours to find and repair. Cable crews were assembled from around New Zealand and Australia under a mutual aid support agreement. Following a massive work programme fault detection and repair was completed by the end of April 2011.

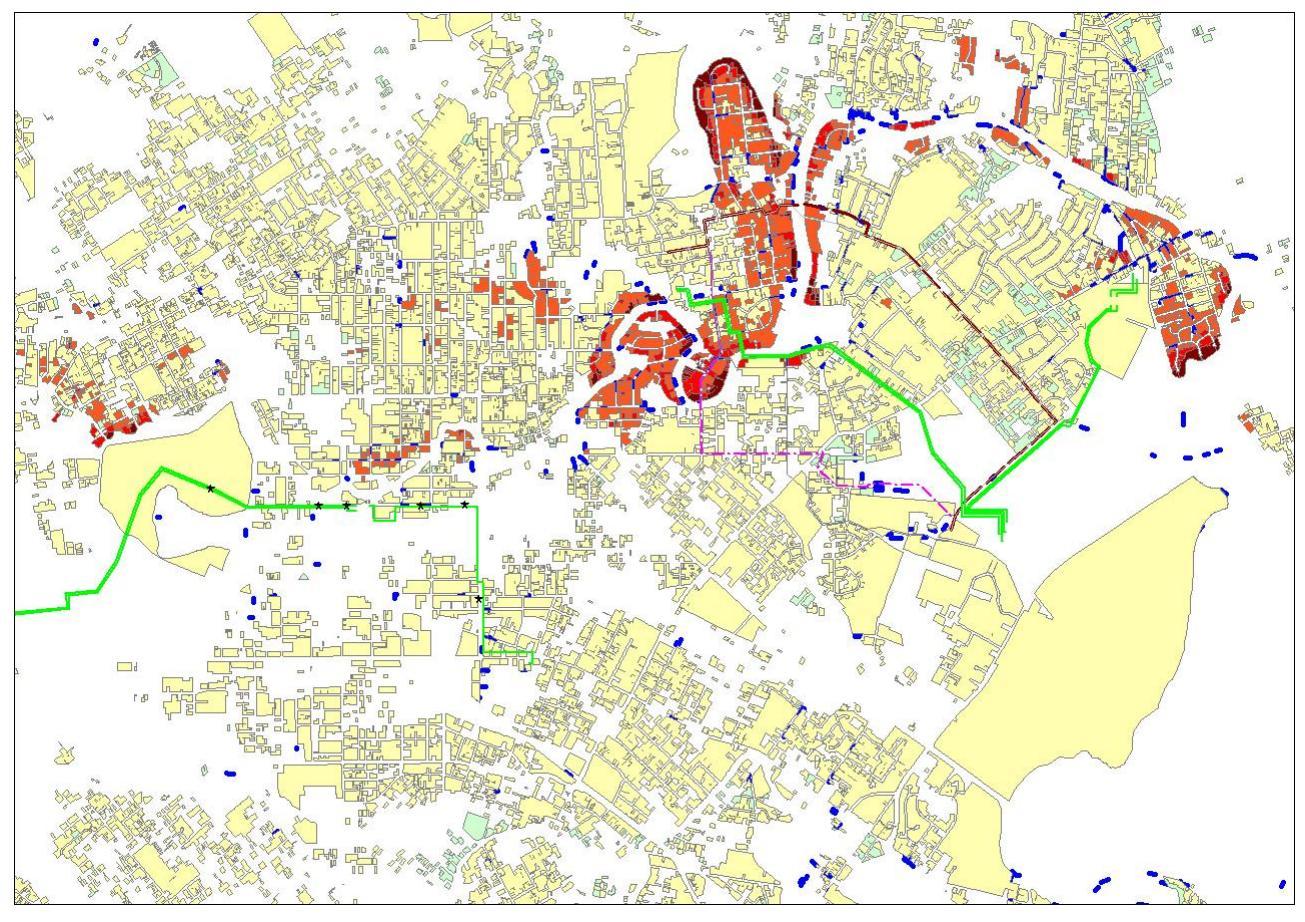
Figure 9: Orion 66 kV faulted cables following 22nd February Earthquake.

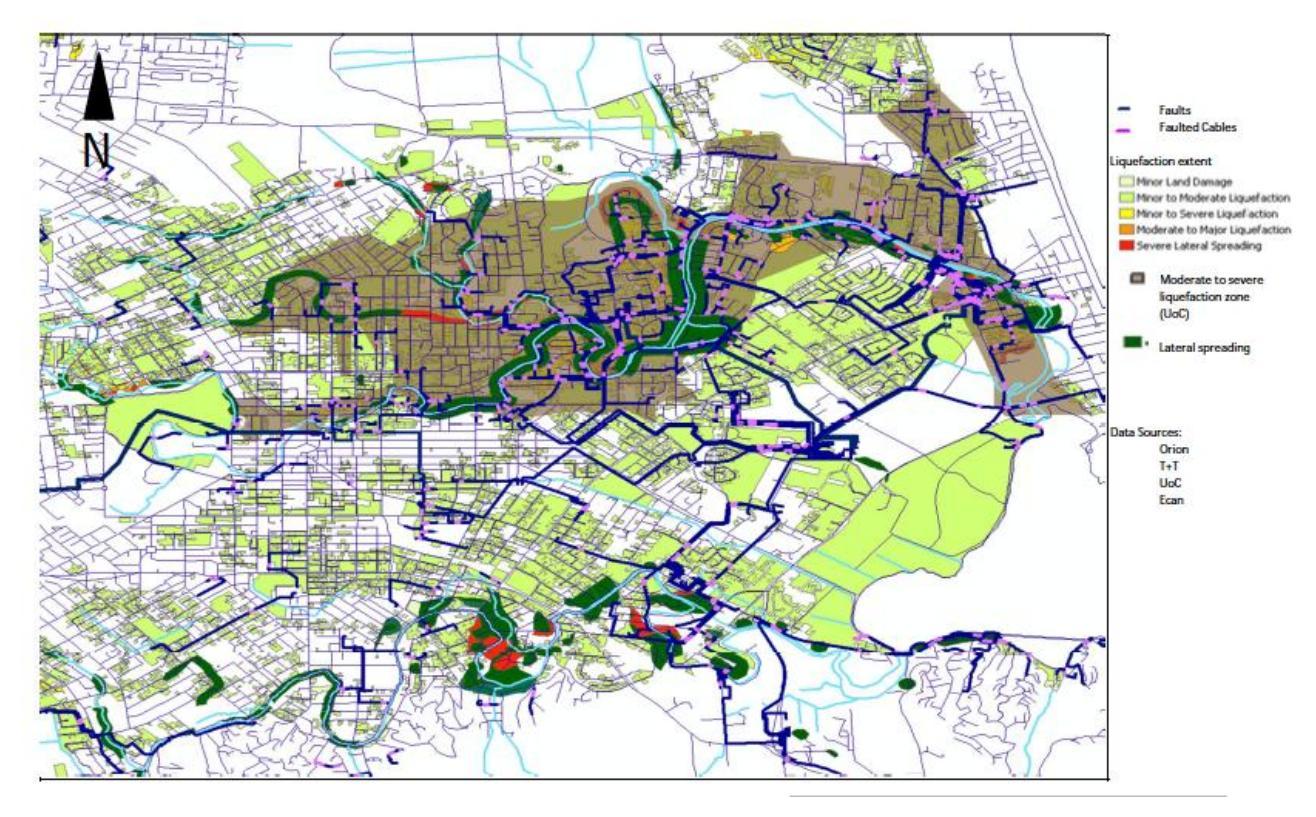
Figure 10 presents Orion 11 kV faulted cables following 22nd February earthquake overlaid with Tonkin and Taylor liquefaction map (Tonkin and Taylor 2011) and the "Drive-Through" Reconnaissance map (Cubrinovski and Taylor, 2011). It is worth noting that the two land damage maps show a general agreement with each other. Table 2 summaries the

Figure 10: Orion 11 kV faulted cables following 22nd February Earthquake liquefaction maps from Tonkin and Taylor (2011) and Cubrinovski and Taylor (2011).

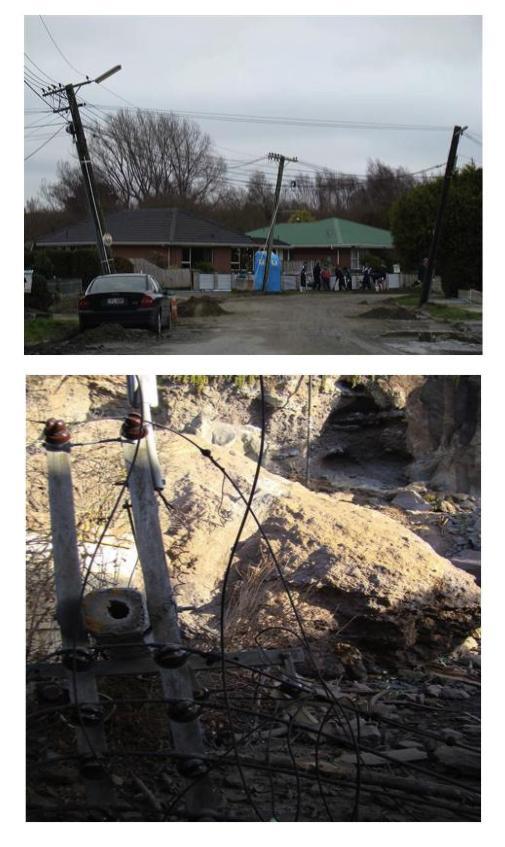
The 33 kV, 11 kV and 400 V overhead lines experienced some relatively minor damage including cracked insulators and poles affected by liquefaction (Figure 11).

Figure 11: Damage to the distribution over-head lines: a). (Top) Leaning poles due to a combination of shaking and liquefaction in Kingsley street; b). Poles and insulators along the Sumner road affected by rockfall and landslides. (Photo credit: Andrew Massie CPIT).

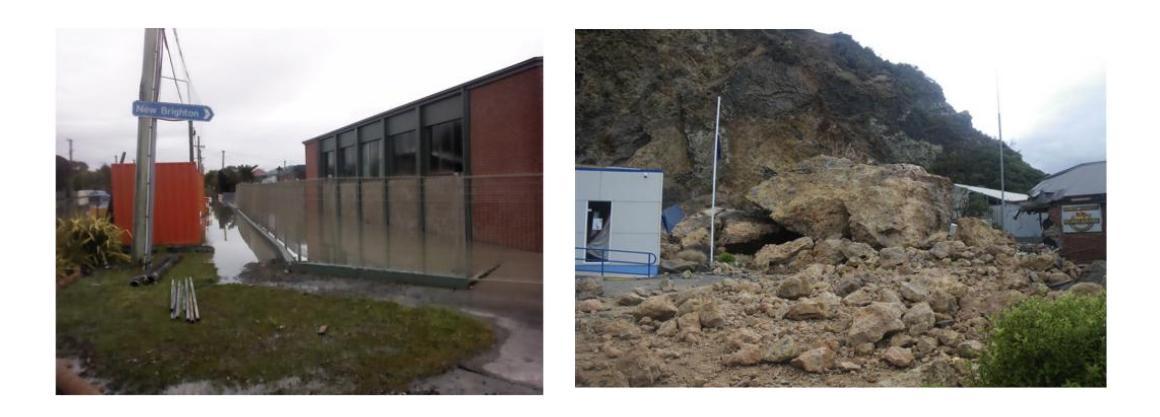
Of approximately 300 distribution building substations located in Christchurch urban area only 4 experienced significant damage. The Sumner substation was hit by a rockfall (Figure 12b).

Figure 12: Damage to Orion substation: a) (Left) New Brighton substation . (Photo credit: Orion.; b) Sumner substation hit by a boulder falling form the Sumner Cliffs (Photo credit: Andrew Massie CPIT).

The construction of a new substation in the Rawhiti Domain was commissioned, as well, as part of the immediate recovery plan to replace the severely damaged New Brighton substation.

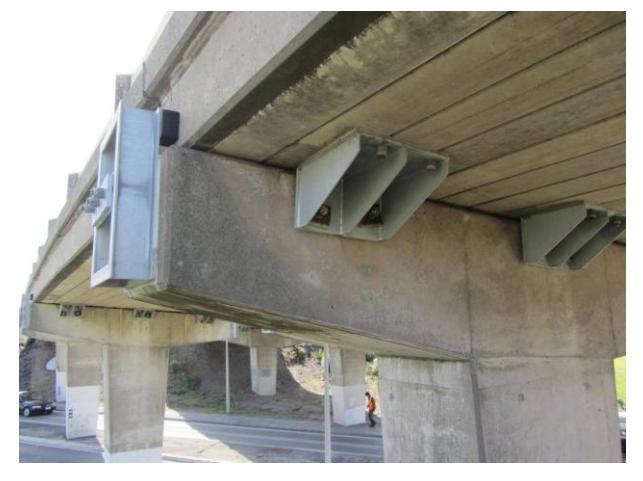
Pre-earthquake seismic improvements to bridges on Highways 73 and 74 proved successful in resisting substantial loads and keep the highways in operation post-earthquake (Figure 16).

Figure 16: Pre-earthquake seismic improvements to bridges on Highways 73. (Photo credit: Craig Davis).

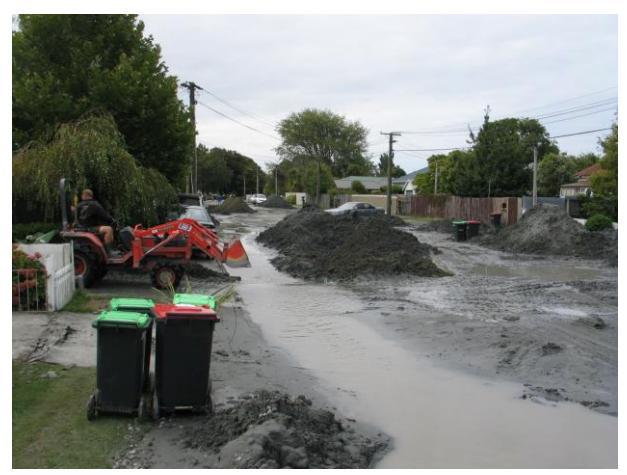
The 22nd February 2011 earthquake induced widespread liquefaction phenomena across the Christchurch urban area that resulted in widespread ejection of silt and fine sand (Figure 18). This created unique impacts to many lifelines. Road networks with significant liquefaction ejecta deposits were difficult to transit or impassable for two-wheel drive traffic and contributed to traffic congestion. Liquefaction ejecta, continually erodeding over time, had the potential to infiltrate and contaminate the damaged storm water system and the urban waterways. Due to the extensive damage to the sewage disposal networks, there was the risk that much of the liquefaction ejecta had been contaminated with raw sewage creating a long-term health risk to the population (P. McDonald & J. Rutherford pers. comm., 2011; Weerasekara, 2011). During hot and windy conditions the dry, finer portions of silt was mobilised by the wind creating a respiratory health hazard.

Figure 18: Piles of liquefaction ejecta cleaned from residential properties and roads, ready for removal by heavy earth moving machinery at Bracken Street in the suburb of Avonside. (Photo credit: Jarg Pettinga).
