SEISMIC ASSESSMENT AND IMPROVEMENT OF UNREINFORCED STONE MASONRY BUILDINGS: LITERATURE REVIEW AND APPLICATION TO NEW ZEALAND

**Marta Giaretton¹, Dmytro Dizhur², Francesca da Porto³ and
Jason M. Ingham⁴**

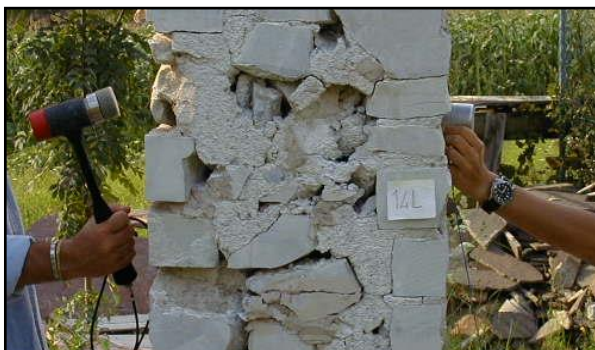
Figure 2: Example of direct sonic pulse velocity test [Source: University of Padova].

NDT tests such as sonic pulse velocity, radar tests and infrared thermography allow hidden characteristics of the masonry to be found, including voids, construction flaws, the presence of different materials, the number and depth of each leaf in the wall cross-section, and the effectiveness of grout injections. With *sonic pulse velocity*, a signal is generated by percussion with an instrumented hammer and is received by means of an accelerometer, see Figure 2. The data processing consists of measuring the transit time between the transmitter and the receiver. Recommendation references and examples are available in [18], [19], [20].

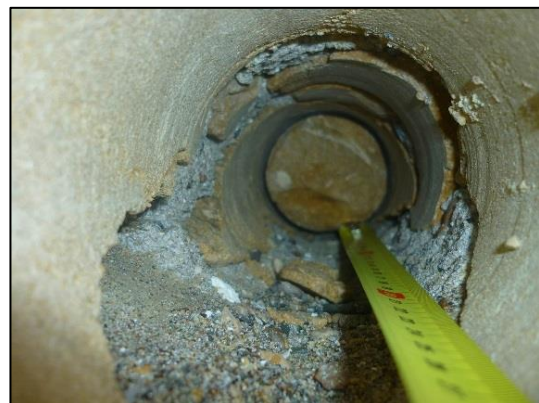
Figure 3: Execution of boroscopy test [www.expin.it].

MDT tests include direct inspection, boroscopy, drill-energy (penetration test), pull-out and flat-jack tests that are used to provide qualitative information on materials and structures. *Direct inspection* consists of removing a plaster area of approximately 1 x 1 m, and where possible also removing a few stones, in order to survey the wall in detail. A small camera is inserted into a borehole (diameter 20-30 mm) during boroscopy *inspection*, allowing a detailed analysis of the wall cross-section, see Figure 3.

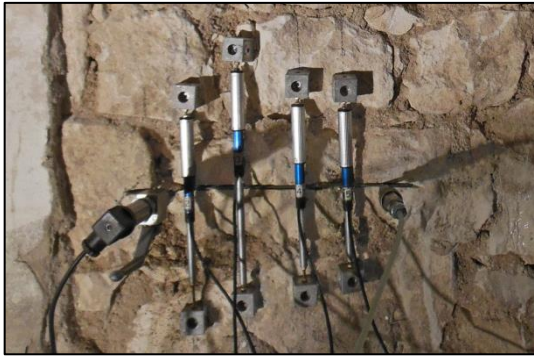
Figure 4: Execution of single flat-jack test [www.expin.it]

A *Flat-jack test* is performed using a steel pad which is inflated (into the mortar layer) with oil until the slot is tightly filled, i.e. the original vertical load condition is restored and the relative strength can be reconstructed. The reliable determination of the equilibrium pressure is the fundamental requirement for the test. A single flat-jack (Figure 4) allows determination of the state of stress, the compressive strength

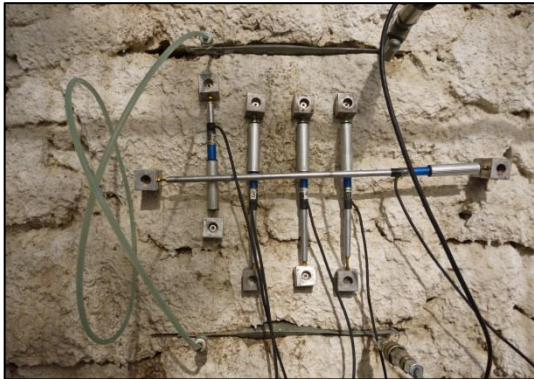
Figure 5: Execution of double flat-jack test [www.expin.it].

and the elastic modulus of the masonry, while the double flat-jack test (Figure 5) permits the deformability and stress-strain behaviour, the stiffness degradation, and the effectiveness of grout injection to be identified. Recommended references are [28], [29].

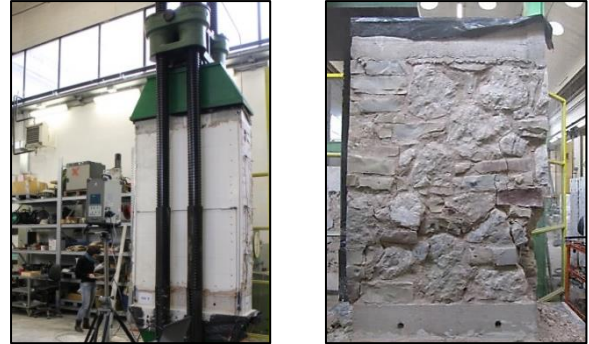
Figure 6: Compression test and failure mode [30]

The *compression test* consists of apply a vertical (axial) stress state to a masonry panel [20], [34]. The stress can be monotonic or cyclic, where in the first case the load is applied up to collapse while in the second case the test involves several loading and unloading cycles before failure. The specimen deformations are recorded by displacement transducers. The compressive test allows the compressive strength, elastic modulus and Poisson's ratio, stiffness degradation, tensile stress and deformation capability in compression to be determined. The laboratory experiments are carried out using a test frame and a hydraulic jack acting in either displacement or load control mode, see Figure 6. During in-situ testing a panel is isolated from the whole structure and a distribution beam is installed to diffuse the load applied using actuators.

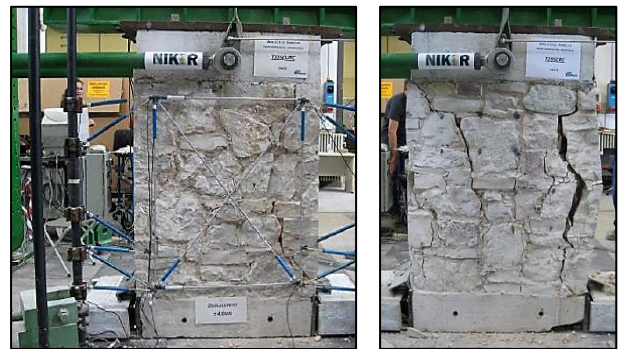
Figure 7: Shear-compression test and failure mode [30].

monotonic or cyclic lateral displacement is applied with step-wise increasing displacement amplitudes, see Figure 7. The aim of the test is to determine the shear and tensile strength, shear modulus, ultimate tensile stress and the evaluation of ductility, energy absorption capacity, stiffness degradation and effectiveness of grout injection. The test can be performed either in the laboratory on extracted samples or on-site, depending upon the portability of testing apparatus.

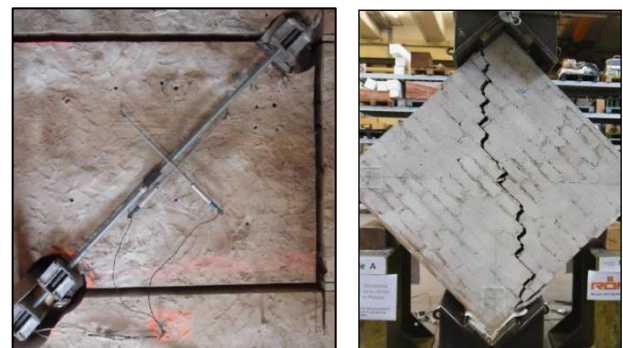
Figure 8: In-situ and laboratory diagonal compressive test undertaken using two different set-up configurations [Source: University of Padova].

When the *diagonal compression test* [35] is undertaken on-site the specimen is isolated from the remaining structure and is compressed along its diagonal, see Figure 8. When the test is executed in a laboratory, the extracted or replicated specimen can either be rotated by 45 degrees or kept horizontal. The diagonal compression test allows the shear strength and shear modulus, the tensile strength, stiffness degradation, and the effectiveness of a retrofit solution such as grout injection to be evaluated.

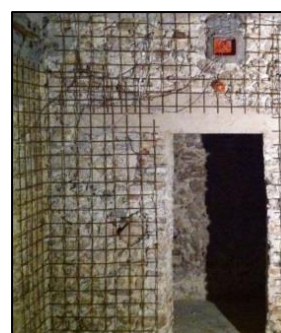
a) Application

Figure 12: Jacketing using RC plaster [68].

Application of *fibre-reinforced polymers* (FRP) involves the use of different fibres such as carbon, glass, steel, or hemp that are impregnated in a polymeric matrix [60], [61], [62]. Recently several studies have also focused on the use of an inorganic matrix known as Textile-Reinforced Mortar (TRM), that includes Steel-Reinforced Grout (SRG) and Basalt Textile-Reinforced Mortar (BTRM) [63], see Figure 11. For both FRP and TRM applications, the fibres (grids, strips or cords) are immersed into the matrix and bonded directly to the masonry surface. Useful standards, recommendations and examples on the application of FRP are [64], [65], [66]. This intervention can be considered an extension of *jacketing*, typically using hand applied RC plaster. RC jacketing consists of the use of a reinforcing steel net placed on both faces of a wall, connected with frequently spaced steel connectors and covered with cement mortar based rendering [47], [67]. This technique is particularly invasive and considerably increases the mass and stiffness of the wall. In addition, the presence of the RC jacketing often produces an increase in moisture within the wall, generating a barrier that hinders evaporation. Recently it was observed that RC jacketing has insufficient transverse ties to provide confining action and low durability due to insufficient steel mesh cover, resulting in steel corrosion and separation of the jacket [68], [69], see Figure 12.

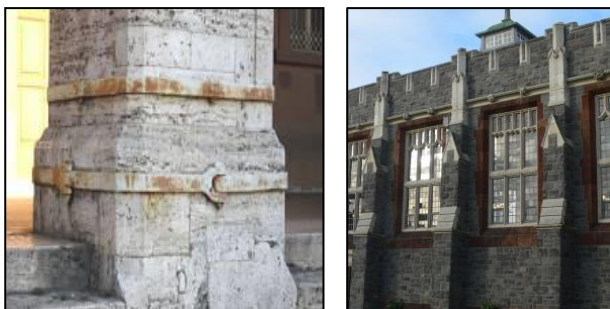
a) Addition of column confinement
b) Presence of buttresses

Figure 14: Stability improvements.

Confinement of columns and pillars that suffer from cracks caused by compression is made using metal elements, see Figure 14a, or FRP strips. Polyester bands are also used in the case of emergency interventions. The confinement allows an increase in the compression strength capacity and stability of structural elements and improvement of the global behaviour of the structure.

Buttresses resist lateral forces and lateral deformations, essentially due to their self-weight. Large elements or flying buttresses are added laterally to the structure to improve out-of-plane stability, see Figure 14b.

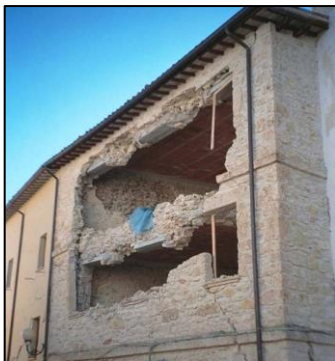
Figure 17: Eccentricity and redistribution of load in existing masonry walls due to RC beam positioning [75].

Over the last few decades seismic interventions applied to diaphragms mainly consisted of the *replacing of timber structures with RC or mixed clay/RC floors*. This intervention entailed the insertion of RC tie beams in the masonry wall cross-section after partial demolition of the masonry portion. Such intervention led to eccentricity and redistribution of the load in the existing masonry walls, causing out-of-plane

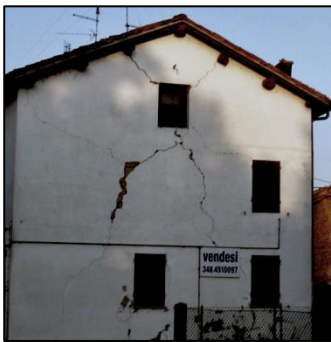
Bomporto, Emilia Romagna (Italy) – C3

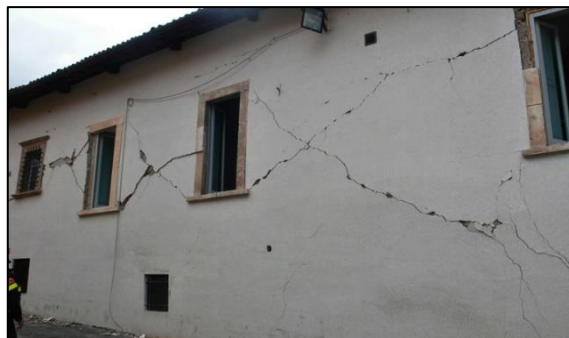
San Pietro di Coppito, L'Aquila (Italy) – C6

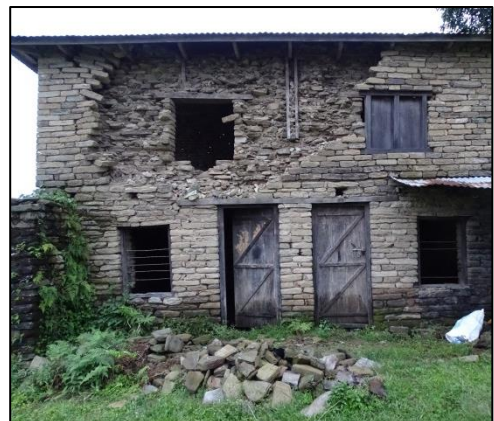
Kathmandu (Nepal) – C1
 Example of delamination of leaves

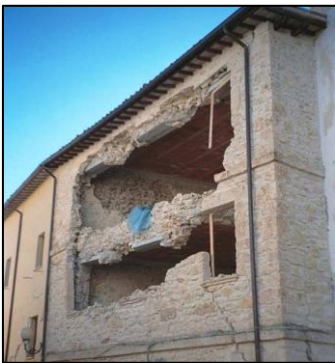
L'Aquila (Italy) – P2

P3. Vertical bending (plan view):

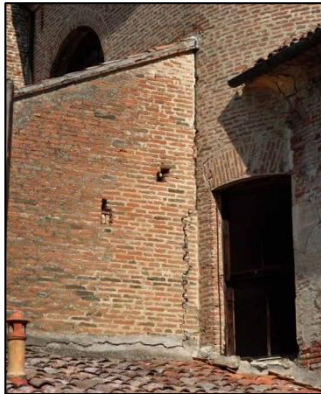
Emilia Romagna (Italy) – P20

Warnings: (i) Cracks or hammering failure at interaction points (corners or edges); (ii) Rotation of the highest block; (iii) Cracks or local collapse due to the changing of material.

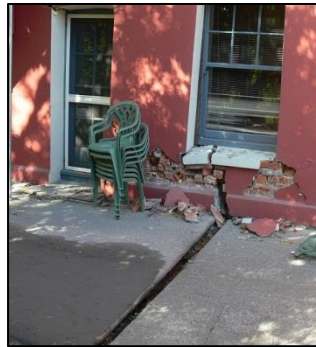
Christchurch (New Zealand) – P22

Warnings: (i) Vertical cracks; (ii) Local shear failures with changing in level between two parts of the building; (iii) Local or global leaning or collapse; (iv) cracks in the surrounding floor.

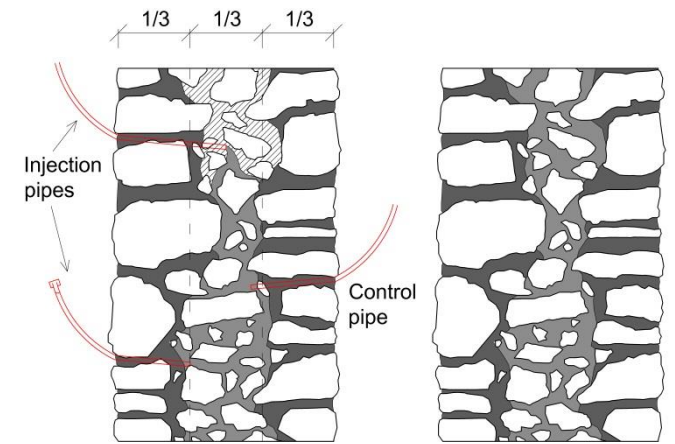
Considerations	Advantages	Concerns	Schematic
<p>Grout injection of the inner core</p> <p>Grout injection of cracks</p> <p>References: Grout [31][46][47][48][49][45][54] Test standards [45][50][51][52] Recommendations [53]</p>	<p>Suitability of the wall cross-section (percentage of internal voids higher than 10% of the entire wall cross-section)</p> <p>Selection of the grout considering chemical, physical and mechanical compatibility with original mortar and unit, durability, injectability, fluidity and stability, low hydration heat, hygroscopic properties, adhesion, salt resistance</p> <p>Preparation of the wall (choice of the injection point, hole drilling, repointing of joints and cracks, cleaning the core with water or air) considering 2 to 3 injection points per m²</p> <p>The injection tubes (Ø10-15 mm) must penetrate to $\geq 1/3$ of the cross-section, and some of them at $1/2$</p> <p>Use of low injection pressure (0.7 to 1.5 atm)</p>	<p>Restore the homogeneity of the cross-section filling voids and cracks</p> <p>Improve the mechanical properties of the masonry</p> <p>Improve the bond between cross-section leaves</p> <p>Low-tech equipment and workmanship (although experienced)</p> <p>Possible use of premixed grouts</p>	<p>Not-reversible intervention</p> <p>Not suitable for walls with percentage of voids less than 4% of the entire wall cross-section</p> <p>Avoid the use of grout that causes segregation or shrinkage</p> <p>Sensitivity to sulphates and other salts (gypsum mortars, impurities in bricks and stones, cement binder)</p>

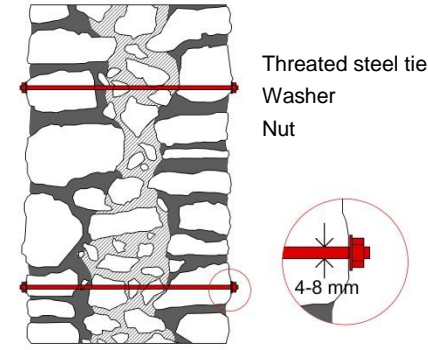
<p>Insertion of tie-rods</p> <p>References: [32][54]</p>	<p>Use of steel bars fixed by bending or injection</p> <p>If threaded bars with a bolted head are used, place the bar in tension by warm and tighten the nut</p> <p>Compatibility between the type and material of the ties and the masonry</p> <p>May necessitate anchorage</p>	<p>Limit out-of-plane deformation of the wall</p> <p>Ensure stability, integrity of the wall</p> <p>Simple, fast and low cost execution</p> <p>Removable intervention with minor alteration of the wall</p>	<p>May lead to corrosion problems if ties are not suitable</p> <p>May be obtrusive</p>

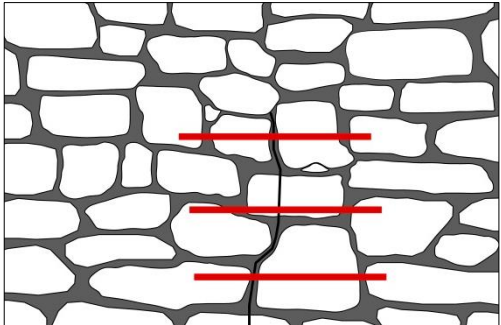
Considerations	Advantages	Concerns	Schematic
Crack stitching and anchoring References: [68]	Selection of chemical, physical and mechanical compatible materials Location and type of anchoring	Improve the connections of adjacent walls or portion of wall Can increase strength and stability of structure or element Add extra strength and ductility to the wall Can control the crack propagation	Might be irreversible by harming the original fabric Can be obtrusive and invasive depending on the type and shape of material used May need intense intervention for the placement of bars

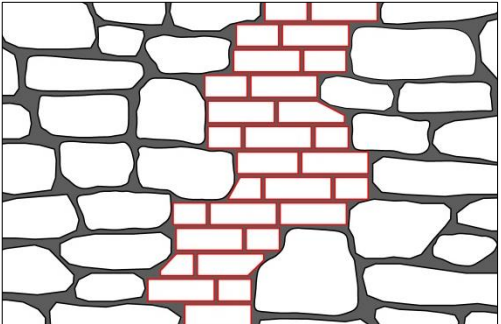
Local dismantling and rebuilding (unstitch-stitch) References: [54]	Selection of mortar and units considering chemical, physical and mechanical compatibility with the original materials Scraping the joints and removing the units without causing percussion or vibration Ensure penetration and connection between the original and new masonry	Can be used to repair a single crack or a more extensive area Reconstitute the structural continuity of the masonry	Ineffective when there is insufficient or absent connection between existing and new masonry

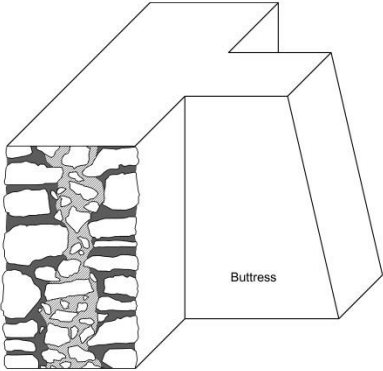
Addition of buttress	Location of application Adequate connection or interlocking must be provided between existing and new leaves Must resist lateral forces and deformations using the buttress self-weight Typically thickness of the buttress changes with wall height	Increase the stiffness and integrity of the structure Improve the global behaviour Horizontal confinement of the structure Relieve stresses in certain places	Alteration in appearance Might not be reversible depending on size and form of the buttress Lack of connection can lead to separation and collapse

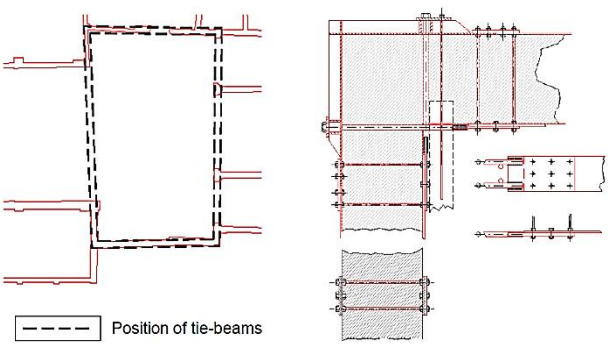
Considerations	Advantages	Concerns	Schematic
<p>Building confinement using tie-beam or steel cables</p> <p>References: [60]</p>	<p>Selection of chemical, physical and mechanical compatible confining materials (metal or FRP strips)</p> <p>Determination of locations for confining rings/bars/tis</p> <p>Emergency confinement could be done using polyester bands</p> <p>On large structures the confinement actions could be obtained using bed joint structural repointing</p>	<p>Improve the stability, strength and stiffness of whole element or structure</p> <p>Prevent separation of external leaves or other parts</p> <p>Can be reversible, depending on the material used and on the tension load</p>	<p>Can be obtrusive depending on the material used</p> <p>May lead to deterioration problems if not protected against environmental effects or if unsuitable material is selected</p> <p>Requires special care for stress distribution when adopted for square or irregular columns</p>

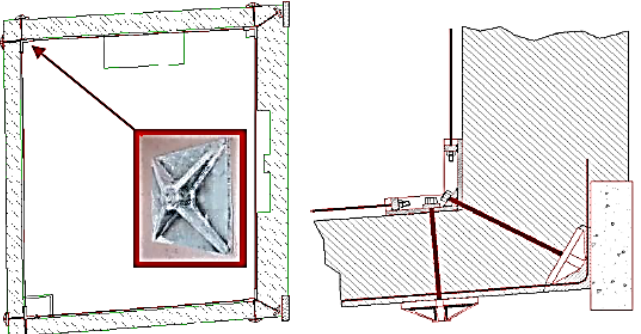
<p>Addition of cross-ties</p> <p>References: [54][60]</p>	<p>Positioned at the roof or diaphragm level</p> <p>Dimension of the anchor is related to the tie tension and masonry quality</p> <p>Corners require special care due to the stress distribution</p>	<p>Improve integrity of the structure</p> <p>Low cost, easy installation, easy maintenance</p>	<p>Excessively high tension in the ties could damage the masonry</p>

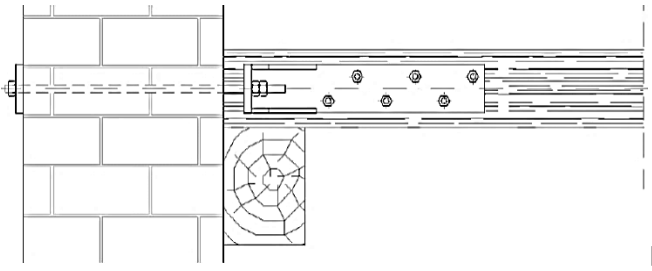
<p>[60]</p>
<p>Metal or wooden anchors</p> <p>Timber tie-beam</p> <p>References: [67]</p>	<p>Wooden beams are slightly tensioned</p>	<p>Prevent the beam slipping and hammering</p> <p>Distribute shear action</p> <p>Restrain the walls preventing possible overturning</p> <p>Reversible and not invasive</p>	<p>May lead to deterioration problems if not protected against environmental effects or if unsuitable materials are selected</p> <p>May be obtrusive</p>
