EARTHQUAKE DAMAGE AT SENDAI JUNE 1978

On 12 June, 1978 an earthquake of magnitude 7.5 occurred about 100 km off the east coast of Honshu, the main island of Japan. The earthquake caused widespread damage in Sendai, a city of some 600,000 inhabitants, which is located about 350 km north of Tokyo and 250 km south of Hachinohe (where extensive damage occurred in the 1968 Tokachi-oki earthquake). According to press reports, only 20 people lost their lives in Sendai. These photographs and sketches of building damage in Sendai are by Doukou Hayashi of Yokoyama Consulting Engineers, Tokyo, and are reproduced here courtesy of Mr. W. P. Edwards of Wellington.

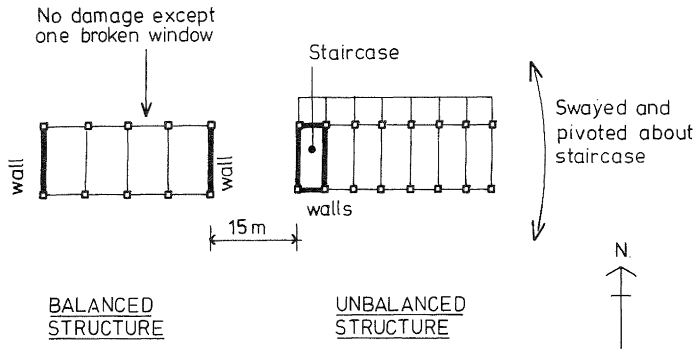
PLAN OF TWO BUILDINGS SHOWN IN PHOTOGRAPH BELOW

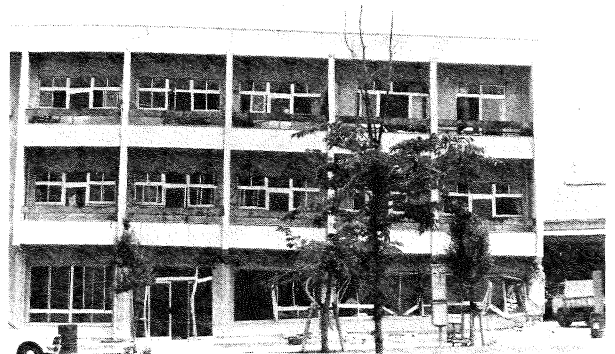
VIEW OF SOUTH WALL

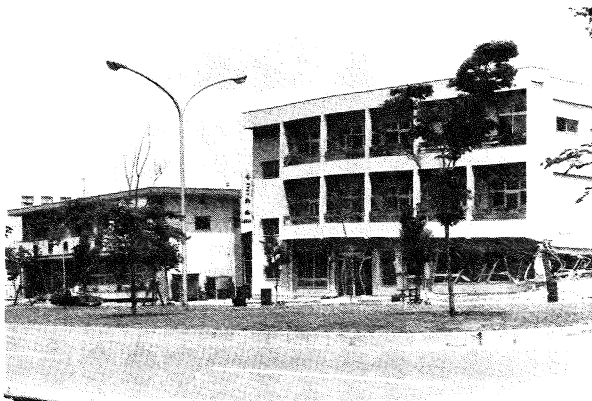
THE LEFT BUILDING IS PRACTICALLY UNDATED

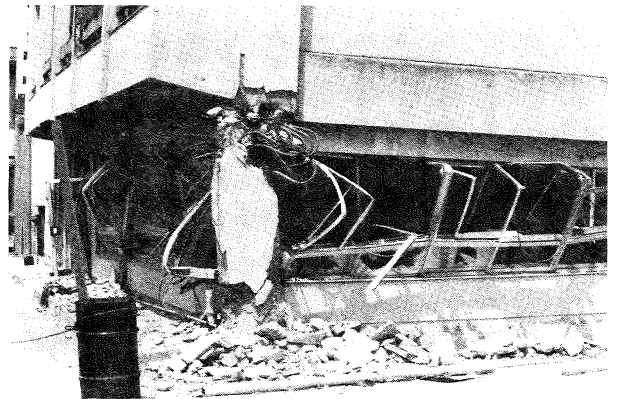
DAMAGE TO CORNER COLUMN

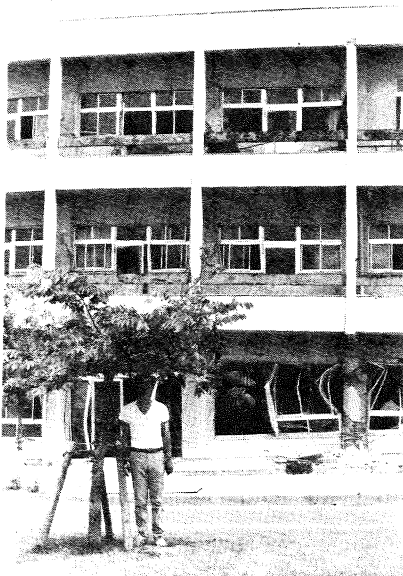
PHOTOGRAPHER IN FRONT OF SOUTH WALL

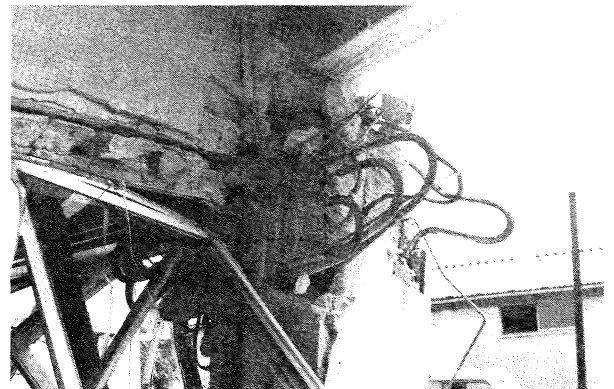
DETAIL OF CORNER COLUMN

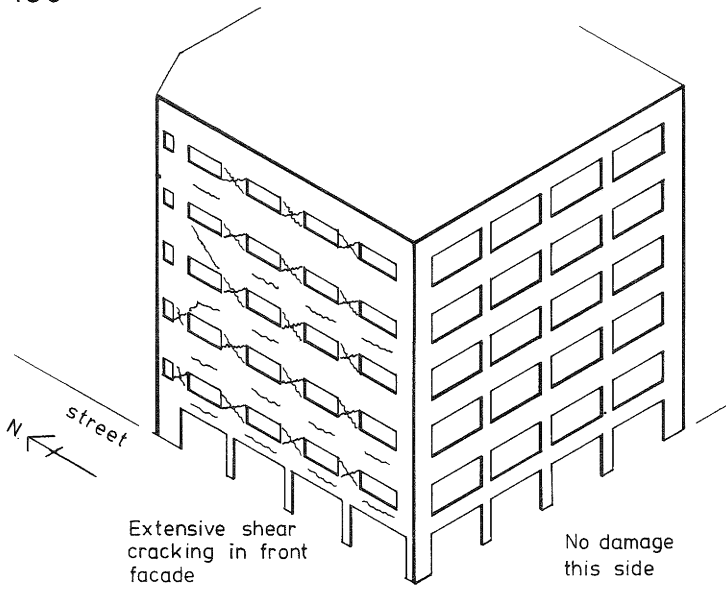
SKETCH OF BUILDING SHOWING LOCATION OF DAMAGE

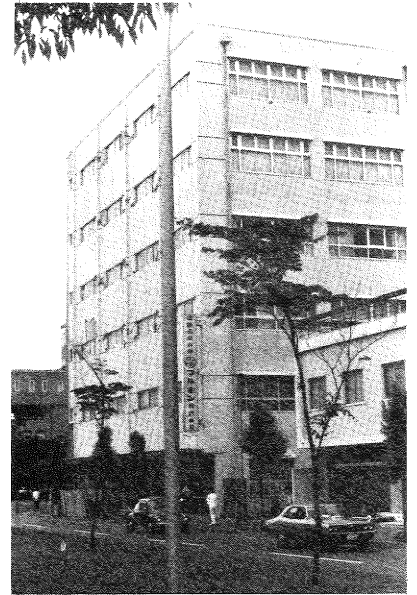
FRONT AND SOUTH SIDE

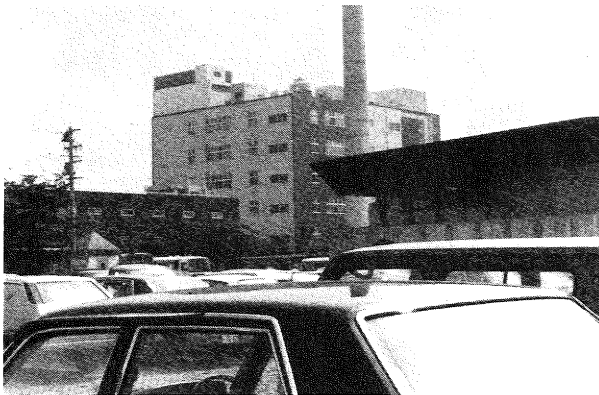
BACK (EAST) SIDE

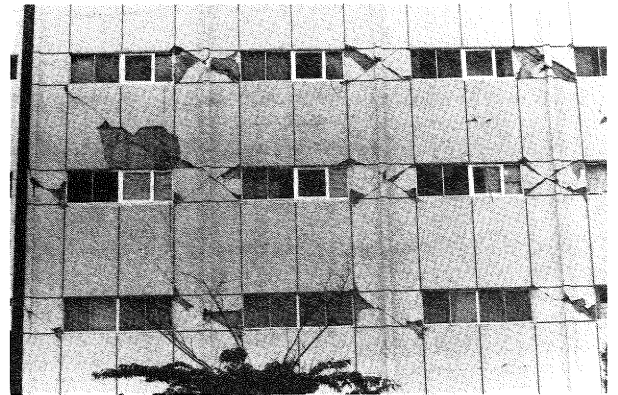
SHEAR CRACKING FRONT WALL

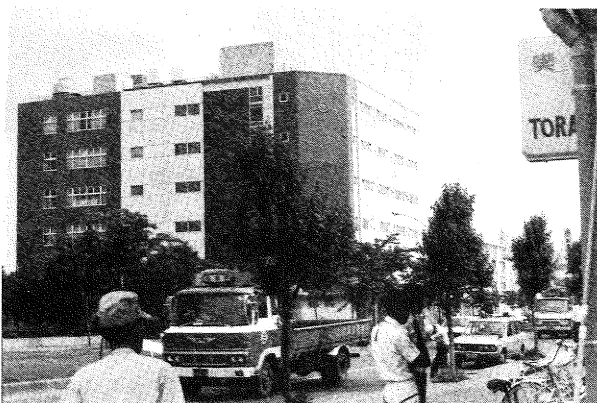
NORTH SIDE

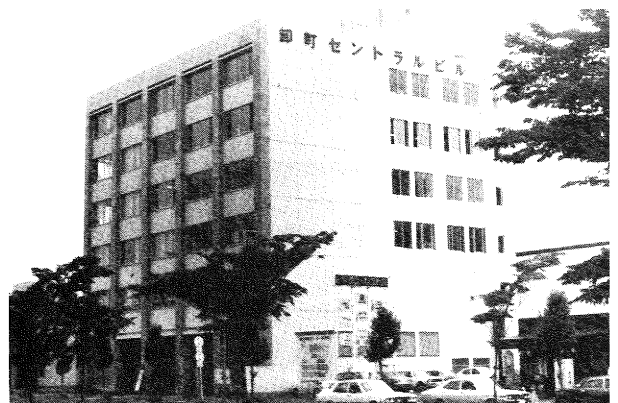
NO DAMAGE TO BUILDING OPPOSITE
