SEISMIC FRAGILITY OF SUSPENDED CEILING SYSTEMS USED IN NZ BASED ON COMPONENT TESTS

**Rajesh P. Dhakal¹, Gregory A. MacRae², Atefeh Pourali³ and
Giacomo Paganotti⁴**

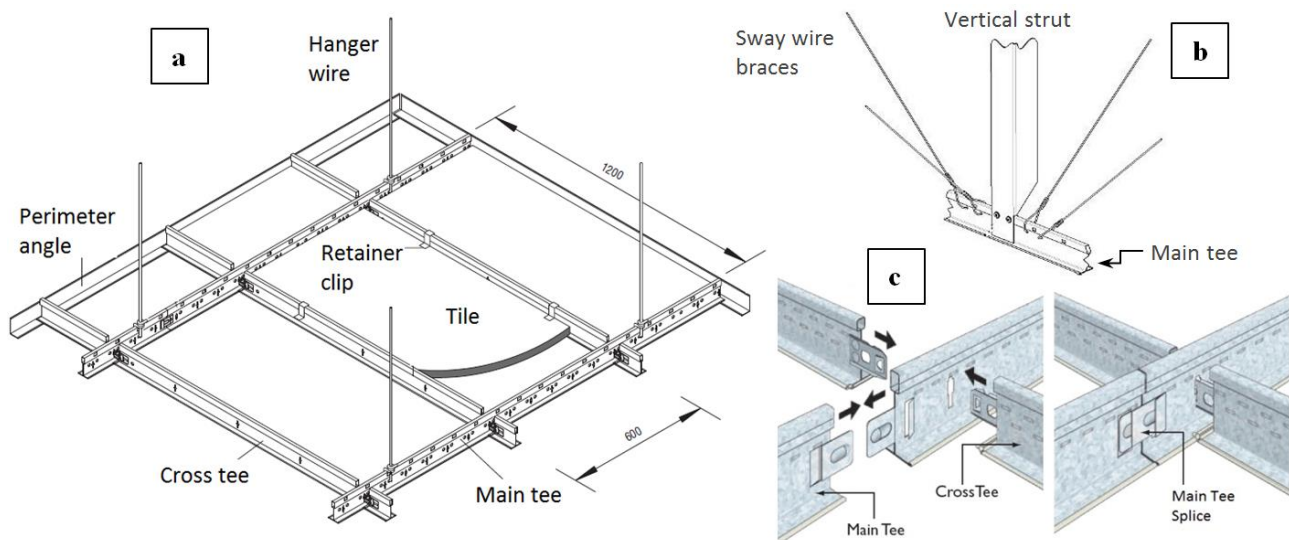
Figure 2: (a) Typical suspended ceiling components [13]; (b) Typical back bracing options [10] & (c) tee joint details [14].

A typical suspended ceiling consists of a grid system of inverted T-shaped beams assembled perpendicular to each other forming square or rectangular grids for the lay-in tiles to sit on (Figure 2a). The grid system consists of 3600 mm long main tees and 600 mm or 1200 mm long cross tees. Main tees are generally placed perpendicular to the upper floor joists or in shorter direction. For cases where the length of the main tee direction exceeds 3600 mm, they may be extended via splices. Cross tees pass through special slots in the main tee webs and are connected to the next cross tee via click-fit clips (Figure 2c). No additional mechanical fasteners are used in the assembly of the grid system itself. On the fixed ends, the grid system is connected to the perimeter angle fastened to the surrounding walls using mechanical fixtures such as rivets, screws or proprietary clips. The lay-in tiles are not fastened to the grids but rather sit freely on the inverted tee flanges. AS/NZS 2785:2000 [12] recommends the use of retainer clips to control the upward movement of the tiles. However, these clips are not commonly used due to installation difficulties.

The grid system is hung from the structure above via hanger wires connected to main tees at 1200 mm intervals. The hanger wires are a minimum of 12-gauge galvanized, soft annealed mild steel wire [15]. The wire must be wrapped around itself a minimum of 3 full turns within 75 mm. These vertical wires don't have any lateral resistance but their application, particularly on perimeters, has proven advantageous in limiting the spreading of grid ends and consequent damage during earthquakes. For this purpose all terminal ends of grid members should be supported via vertical hanger wires at a maximum 200 mm from each wall or ceiling discontinuity. Ceilings designed for seismic design categories D, E and F should have a minimum perimeter support ledge of 50 mm and grid ends are required to have a clearance of 18 mm from the perimeter member [11]. The bracing can consist of four diagonal wires and a vertical strut performing as a compression post (Figure 2b). Diagonal channel or strut members can also be used instead of the wires.

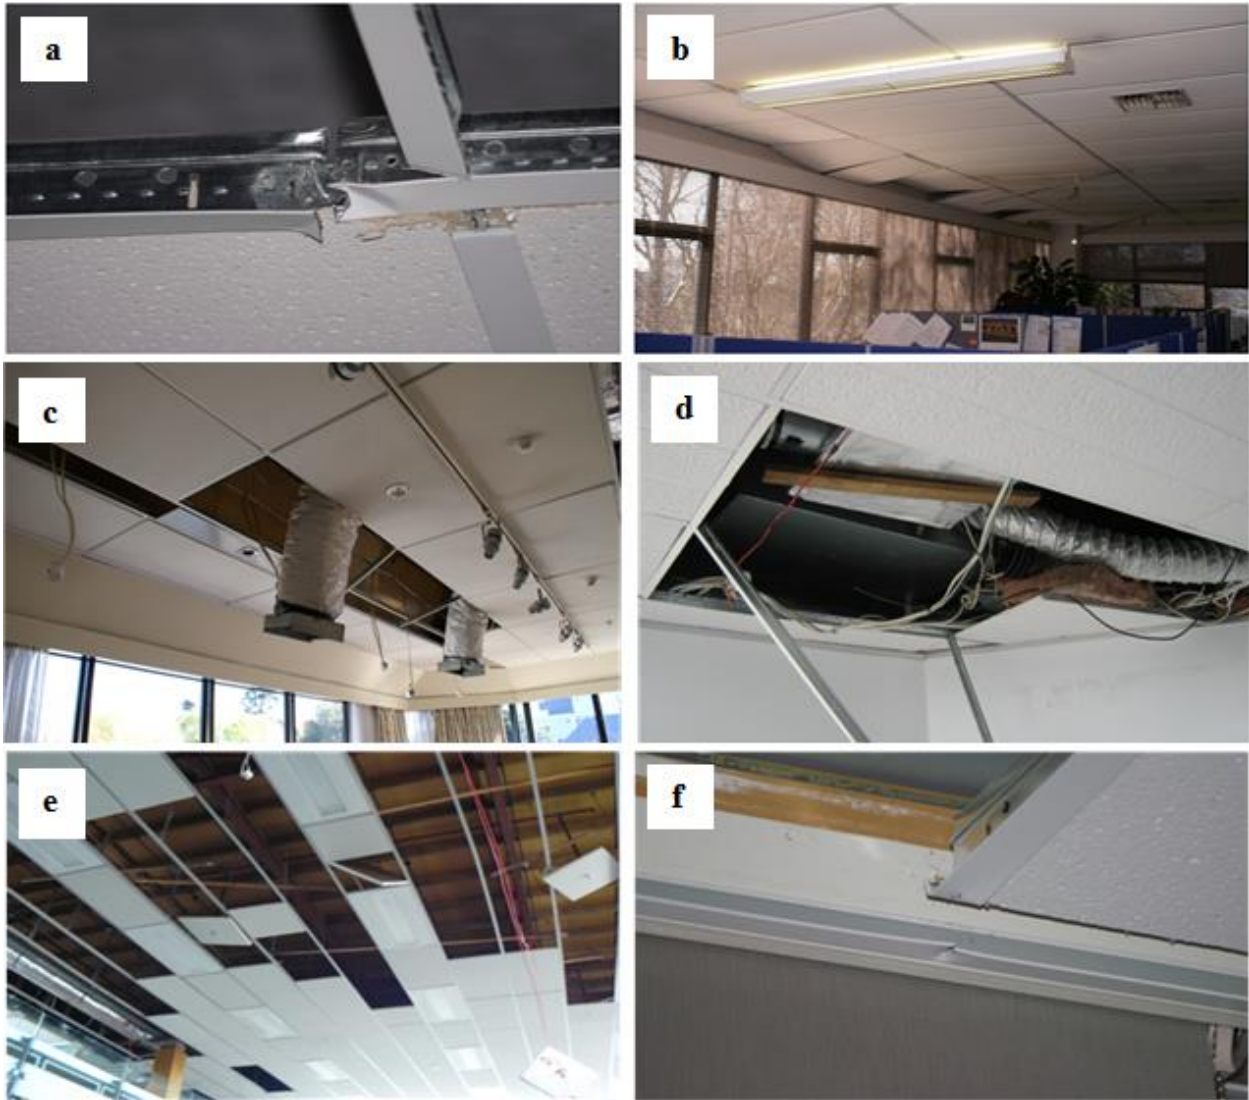
Figure 4: Failure due to (a) main tee splices; (b) perimeter fixings; (c & d) services support; (e) grid spreading; and (f) perimeter fixing damage [3].

The other type of grid damage occurred in one-way suspended ceilings where tiles are supported by main tees spanning one way and hung from the structure above. There are typically no transverse tees. As soon as the first tile fails the system loses integrity and grid members are free to spread resulting in failure of adjacent tiles (Figure 4e).

A large portion of grid damage observed was concentrated around perimeters which results from the main tee or cross tee either being compressed into the rigid surrounding structure or losing support on the perimeter angle around the ceiling. Loss of support can be due to the absence of proper perimeter hanger wires, absence of rivets to connect the grid member to the angle or failure of the rivet itself (Figures 4b & 4f). Perimeter fixings are especially prone to damage as they transfer the largest inertial force from the suspension system to the rigid supporting structure. As acceleration is applied to the ceiling, the inertial force induced by the seismic mass increases throughout the length of the grid carrying ceiling tiles.

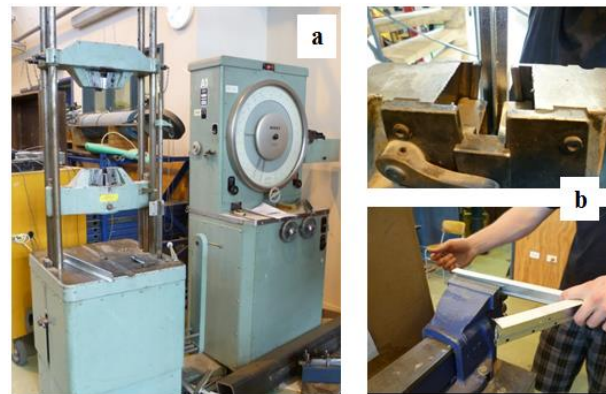
Figure 6: (a) Test apparatus and (b) preparation of specimens.

kN divisions and the second machine applies load at a range of 5 kN by 0.01 kN divisions. For tension and compression tests on members, the Avery Universal testing machine was used. The Instron Universal testing machine was used to conduct all other tests on connections. The choice of machine depended on maximum load searched as well as the length of the specimens tested. The loading rate for connection tests was lower than the member tests as connections were expected to fail at an earlier stage.

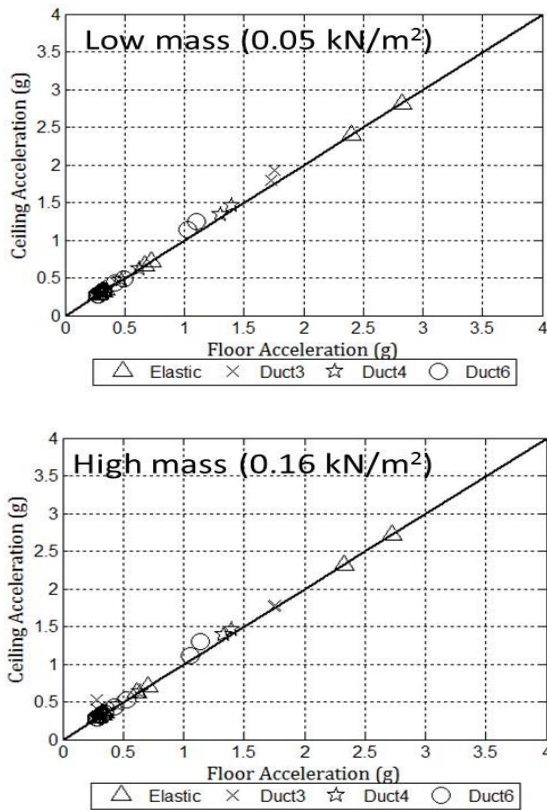
Figure 10: Perimeter-fixed ceiling acceleration vs. floor acceleration for light and heavy ceilings [41].

Analytical investigations by Singh *et al.* [41] showed that the negligible addition of mass from suspended ceilings compared to the total structure mass does not alter the dynamic properties of the floor and the building noticeably. It was also concluded that the typical connection between ceilings and perimeter structure is rigid enough to assume the input acceleration to the ceiling was equal to the floor acceleration (Figure 10).

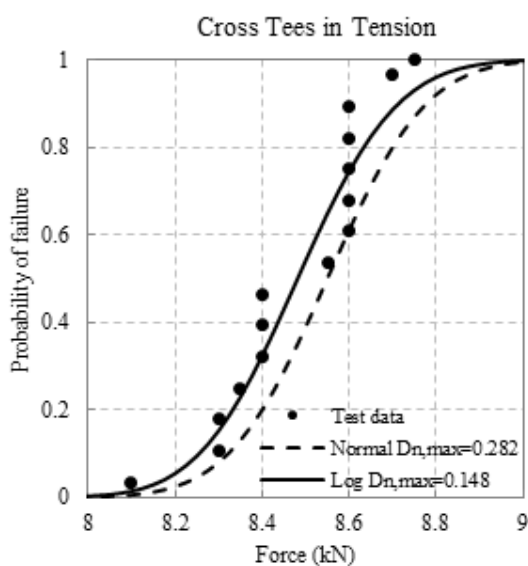
Figure 17: Fitted data vs. normal and lognormal distributions.

Following the completion of tests, values of median and standard deviation for each component (Table 2) were used to derive a cumulative distribution of failure loads. Both normal and lognormal distributions were derived for each component. To compare the appropriateness of the theoretical distribution functions, Kolmogorov-Smirnov (K-S) goodness-of-fit (GOF) tests were carried out. The K-S statistic ($D_{n,max}$) for the normal and lognormal distribution functions are reported in Figure 17 for comparison. In most cases, both distributions fit the data with similar error. In a few cases which showed some difference, lognormal distribution was found to be a better fit. Therefore, for consistency lognormal distribution was used for all component fragility curves.

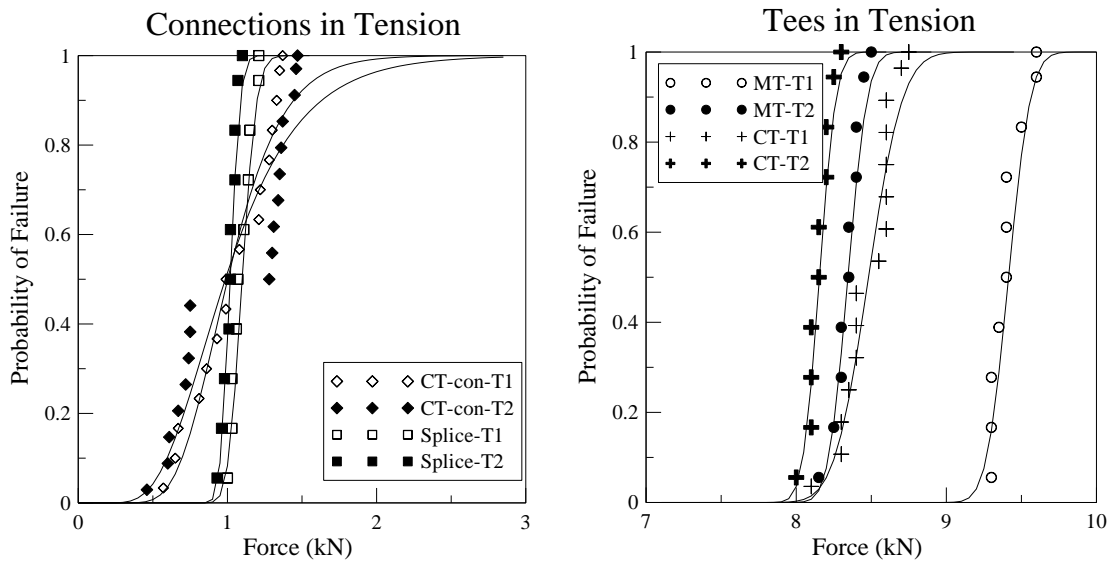
Figure 18: Fragility curves for tension tests.

Figure 18 shows the fragility curves for all components tested under tension. Based on this figure, cross tee connections (shown as CT-con) were the weakest elements when under tension.

The general trend in all tests as per Figures 18 and 19 showed that, both under compression and tension, connections failed before the members, making connections the weakest link in the overall capacity chain. In the case of cross tee connections and main tee splices, failure occurred due to the breakage of little fasteners in the joint and in few cases the rivets connecting the joint clip to the member. This means although the tee section performance was satisfactory according to code requirements, the overall system was exposed to failure at demands much lower than the members' capacity due to the weak performance of the connections.

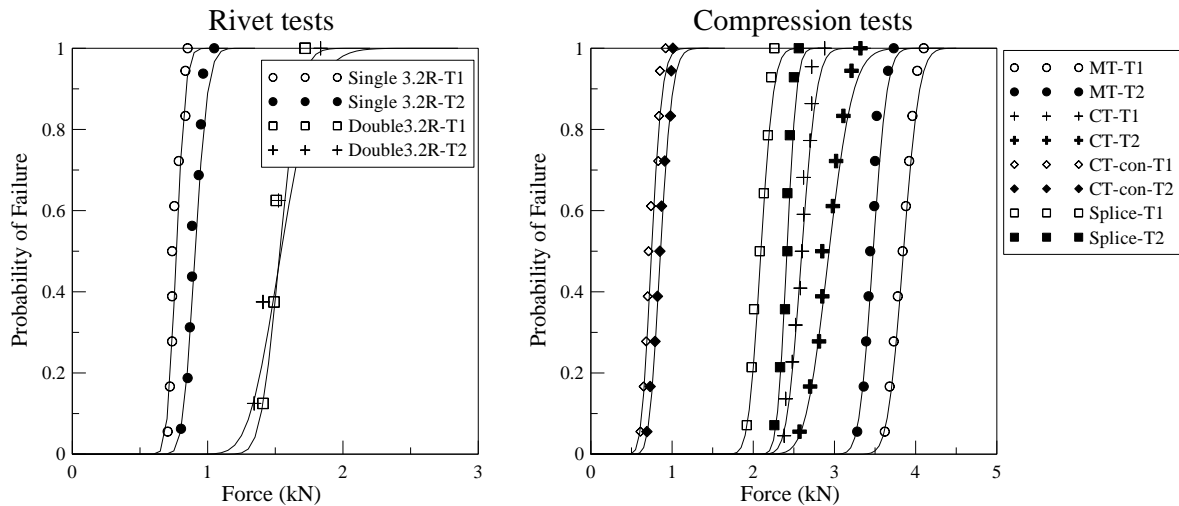
Figure 19: Fragility curves for rivet and compression tests.

Comparing fragility curves of components tested under compression showed that i) cross tee connections were the weakest components under compression and ii) capacity of components in general was lower under compression than tension except for main tee splices which were discussed in previous section. Fragility curves for components tested under compression can be found in Figure 19.

Perimeter fixed suspended ceilings are connected to the surrounding walls on two adjacent sides via pop rivets. This type of rivet due to its financial and application advantages is most commonly used for fixing the ceiling grid to the perimeter angles. The capacity of various configurations of single and double 3.2 mm aluminium rivet connections under tensile loads (which causes shear in the rivet) were evaluated. As expected, using double rivets instead of one improved the capacity of the fixing. Figure 19 shows the fragility curves for 3.2 mm single and double rivets. The single rivets in this figure were in the centre position.

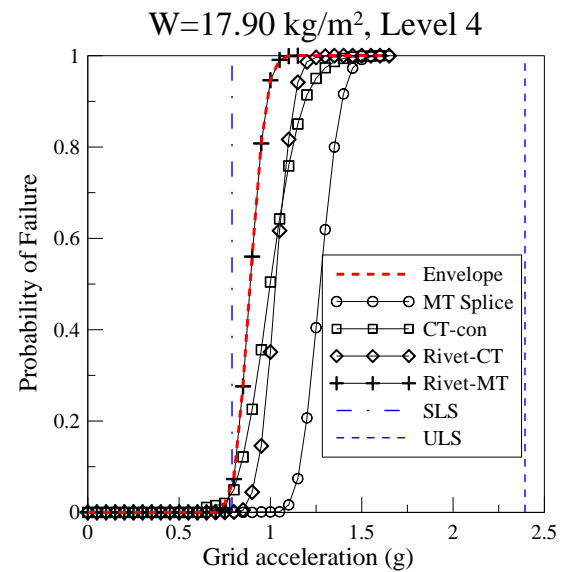
Figure 20: Fragility curves for the designed ceiling on Level four.

The total seismic mass of the ceiling for the design was therefore assumed as 17.9 kg/m^2 . This mass was used to design ceilings based on the recommendations of ceiling manufacturers [10, 28]. One example of the designed ceilings on the fourth level was $4.1 \text{ m} \times 7.1 \text{ m}$ with main tees in the shorter direction and single 3.2 mm Aluminium rivets connecting the tees to wall angles on two adjacent sides. Fragility curves were derived based on the three most vulnerable components: single rivets, cross tee connections in compression and main tee splices in tension. For any given grid acceleration, the seismic force on the longer dimension of the ceiling is calculated using the assumed seismic mass and Equation 1. The probability of failure of the weakest component in that direction –e.g. cross tee in compression- is derived for the associated seismic force from the fragility curve in Figure 19. This probability of failure will be assigned to the grid acceleration considered. After considering all weak components, an envelope curve is drawn on the furthest left end of the group of fragility curves. This envelope represents the system capacity of the perimeter-fixed ceiling being considered (Figure 20).

The horizontal design coefficient on level four was determined for both SLS with a 25 year return period and an ULS event with a 500 year return period (structural design level). The probability of failure of the designed ceiling was evaluated for both limit states (Figure 20). As it can be observed in the fragility curves, the designed system on level 4 performs satisfactorily when subject to a serviceability level acceleration (probability of failure ~5%). However when compared with the ultimate level excitation demand, the probability of failure is 100%, i.e. failure is inevitable.

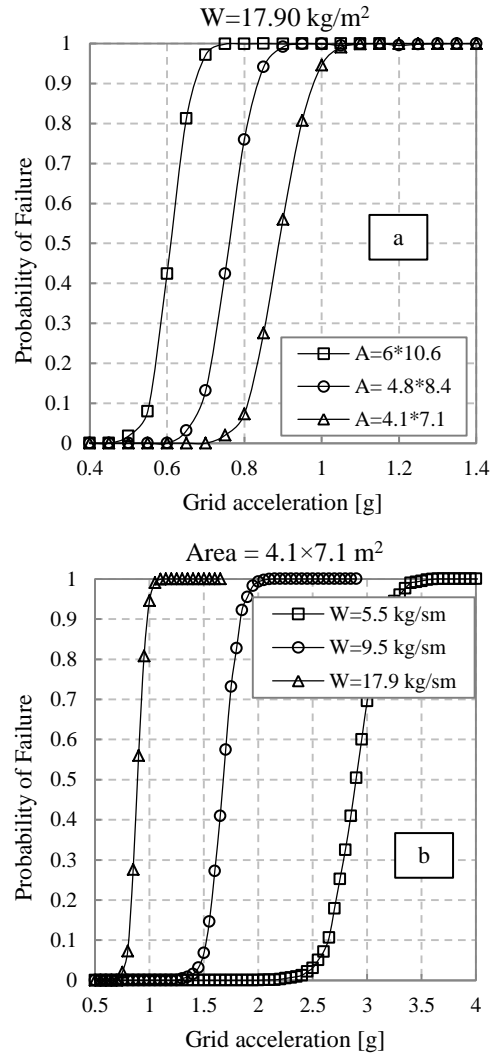
Figure 22: Fragility curves for ceilings with different (a) areas and (b) weights.

In order to investigate the effect of ceiling weight, ceilings were then designed assuming three different seismic mass values; Light: 5.5 kg/m²; Average: 9.5 kg/m² compared with the previously mentioned; Heavy: 17.9 kg/m² example. These ceilings are all assumed to have the same area of 7.1 m × 4.1 m and are located in similar conditions. Figure 22b shows the fragility curves associated with these ceilings.

As it can be observed in Figure 22, the demand on a ceiling is proportional to its size and weight. Using lighter tiles can increase the failure acceleration demand as much as 3 times. Ceilings of a relatively small size (29.1 m²) but supporting heavy tiles (17.9 kg/m²) show 50% chance of failure at a horizontal grid acceleration of about 0.9g. The same ceiling with light tiles (5.5 kg/m²) instead has a median failure probability at 2.9g.

A larger area has similar effect on the overall demand on the perimeter-fixed ceiling. Figure 22a shows the probability of failure in ceilings with heavy tiles and different areas. All three ceilings undergo 100% failure when subject to an ultimate limit state level event. With $6 \times 10.6 \text{ m}^2$ area on the first or second floors, the ceiling has less than 10% probability of failure at a serviceability level event. The probability of failure is almost similar for ceilings with areas $4.8 \times 8.4 \text{ m}^2$ and $4.1 \times 7.1 \text{ m}^2$ designed to be located on the 3rd and 4th floors, respectively.

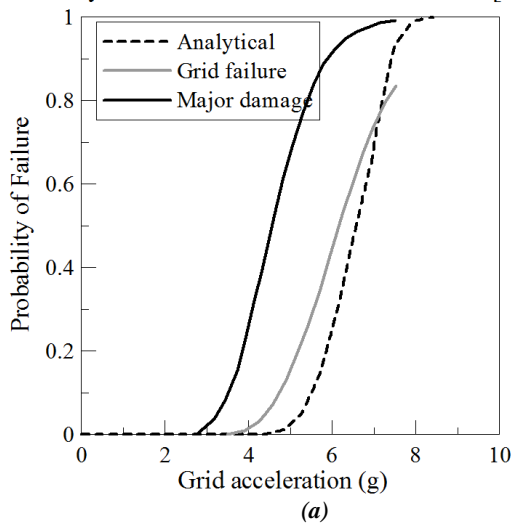
Figure 26: Comparison between experimental [33, 37] and proposed analytical fragility curves.

Figure 26a shows the experimental fragility curves obtained from Badillo-Almaraz *et al.* [33] tests plotted after converting the peak floor acceleration (PFA) to ceiling grid acceleration (PCGA). The experimental fragility curves corresponding to two different damage states monitored in the tests are compared with an analytical fragility curve derived for a perimeter-fixed ceiling of the same size and weight. As can be noticed in the figure, the analytical fragility curve is in better agreement with the experimental grid failure fragility. This is expected as the analytical procedure considers the failure of any grid member (and connections) as the damage state.

Figure 26b shows the proposed analytical fragility curves associated with three test specimens in Ryu *et al.* [37] along with grid accelerations at the onset of repair or collapse. In all three specimens, the experimentally obtained ceiling grid acceleration capacity lies within the range covered by the analytical fragility curves. In assembly #11, which is the largest of the three, the peak grid acceleration at the onset of collapse is associated with 50% probability of failure in the proposed fragility curve. In assembly #13 the onset of collapse happens at the PCGA corresponding to 10% failure probability in the analytical fragility curve. In assembly #15
