MEASURED RESPONSE OF INSTRUMENTED BUILDINGS DURING THE 2013 COOK STRAIT EARTHQUAKE SEQUENCE

Gye Simkin¹, Sherif Beskhyroun², Quincy Ma³,
Liam Wotherspoon⁴ and Jason Ingham⁵

ABSTRACT

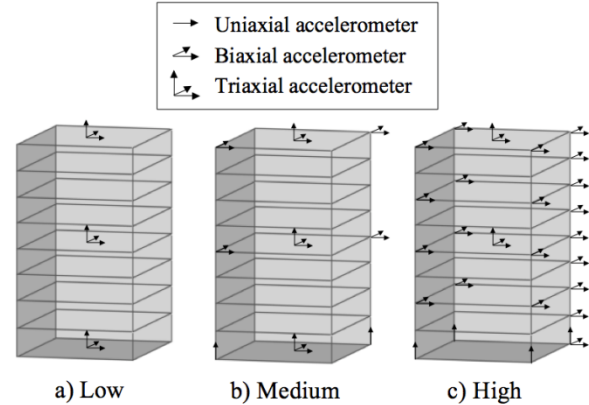
Figure 3: Example of the minimum recommended number and placement of sensors for the three densities of instrumentation options for an 8 storey building.

advanced results, such as drifts and torsional effects. In addition to the tri-axial accelerometer installed at basement or ground level, a minimum of two tri-axial accelerometers are recommended for a low density system, with these sensors installed at mid-height and roof level, as shown in Figure 3a. The number of sensors required for low density instrumentation is independent of the height of the structure.

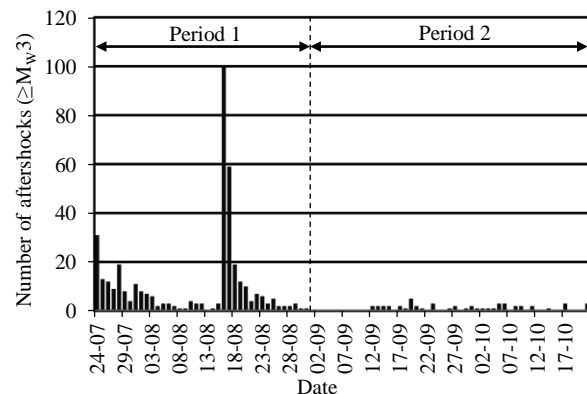
Figure 10: Number of aftershocks greater than M_L 3.0 recorded during the two monitoring periods.

In total, the accelerometers recorded approximately 540 separate aftershocks having a magnitude greater than M_L 3.0 during monitoring periods 1 and 2, as shown in Figure 10. The accelerometers proved to be very sensitive and recorded high quality building response data sets with good signal to noise ratios.

The number and magnitude of aftershocks during the second monitoring period were significantly less than during the first monitoring period, as shown in Figure 10. During the monitoring period for Building G, the largest recorded excitation at ground level was 0.0057 g during a M_w 4.67 event on 2 October 2013. These small intensity events recorded data with adequate signal to noise ratio to allow a detailed analysis to be conducted.

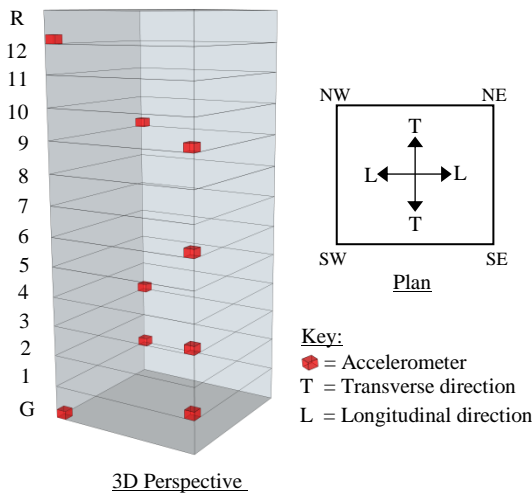
Figure 11: Layout and distribution of accelerometers in Building A.

Buildings A and B both have regular geometry and a low density of sensors was installed. Because these buildings were instrumented during the same monitoring periods and the results obtained were similar, only Building A will be discussed in this section. A summary of the details of Building A are provided in Table 3. The nine accelerometers installed in Building A were mounted at the extreme perimeter of the structure and spaced across different floor heights, as shown in Figure 11.

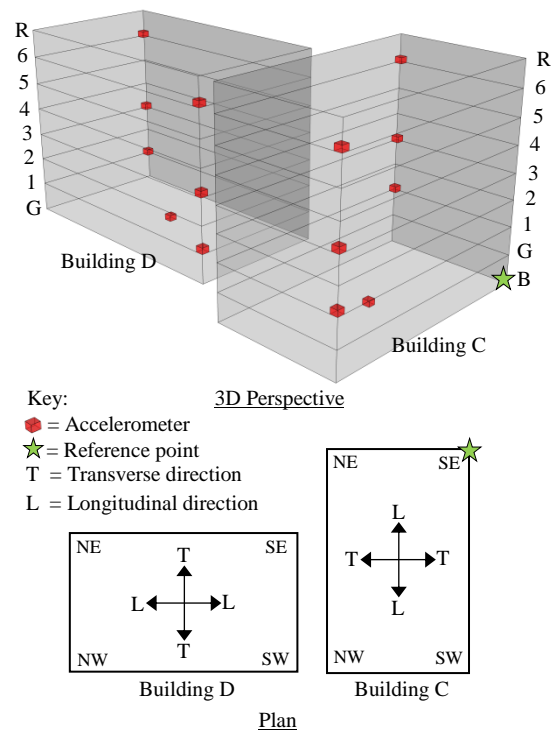
Figure 13: Layout and distribution of accelerometers in Buildings C and D.

Buildings C and D were both concrete multi-storey structures, eight and seven floors high, respectively. The buildings are adjacent to one another, with a clear seismic gap of approximately 100 mm. Seven accelerometers were installed into each building: one at ground/basement level and two sensors at each of the extreme corners on floors 1, 3 and 6. Refer to Figure 13 for more details on Buildings C and D.

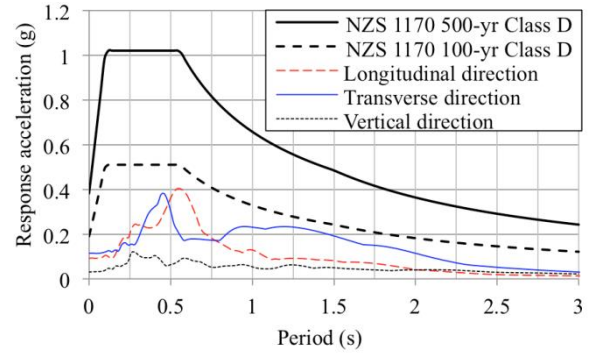
Figure 14: 5% elastic response spectra for Building C during the M_W 6.6 event.

The accelerometers at ground/basement level in Buildings C and D recorded PGA values in excess of 0.127g during the M_w 6.6 Lake Grassmere earthquake. Elastic response spectra were produced for both buildings during the M_w 6.6 event to help determine the characteristics of the earthquake and to estimate the demand on the two structures. The response spectra recorded at ground level for Building C in the transverse, longitudinal and vertical directions are shown in Figure 14.

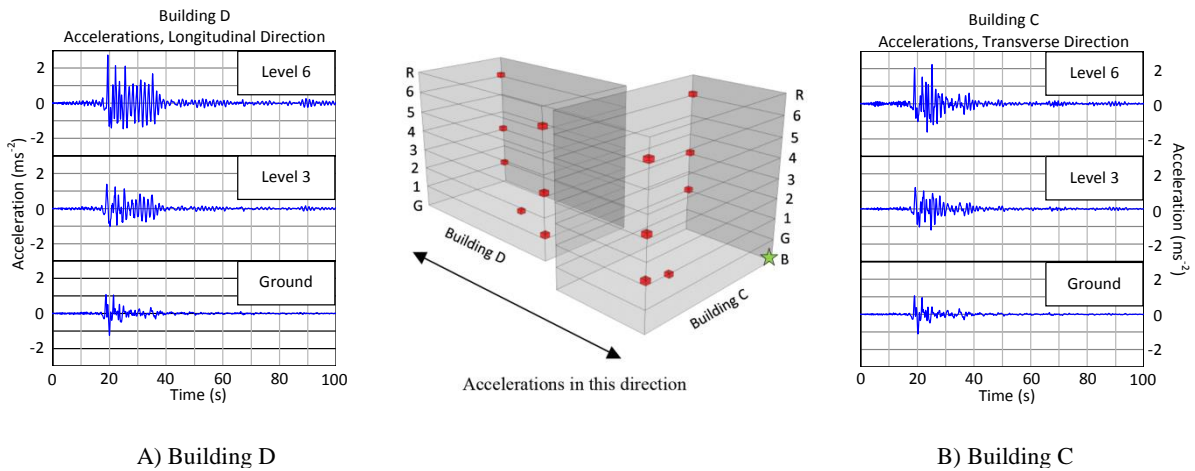
Figure 15: Acceleration response of Buildings C & D in the pounding direction during the M_W 6.6 event. The accelerations at ground, Level 3 and Level 6 are shown for both buildings.

The presence of pounding between Buildings C and D was investigated using the recorded acceleration data. The acceleration time-history responses in the transverse direction of Building C and longitudinal direction of Building D during the M_W 6.6 event are shown in Figures 15a and 15b. The estimated displacement time-history responses at level 6,

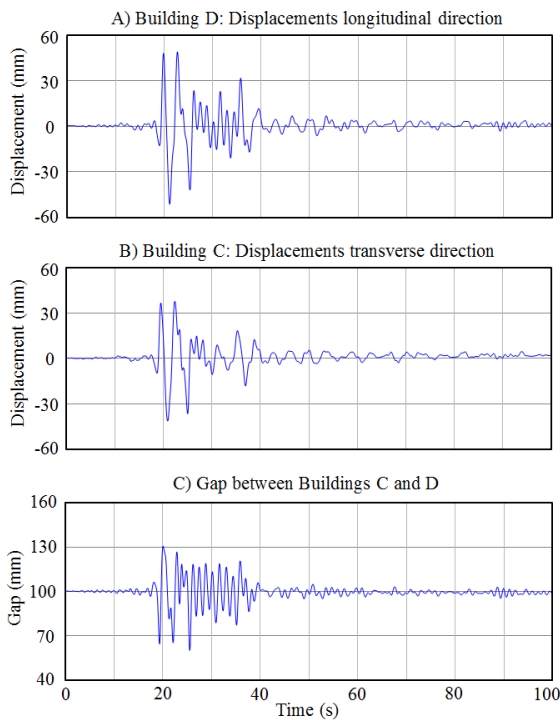
Figure 16: Estimated time history responses of the displacements at level 6 of Buildings C & D during the M_W 6.6 event, along with the relative gap between the two buildings.

where maximum displacements were assumed, for Building C in the transverse direction and Building D in the longitudinal direction are shown in Figures 16a and 16b, respectively. The real-time opening and closing of the gap between the two buildings at level 6 is shown in Figure 16c. The gap was initially 100 mm and during the M_w 6.6 event closed to 60mm. Since the estimated gap did not reduce to zero no pounding between the two buildings occurred, this corresponded with observations.

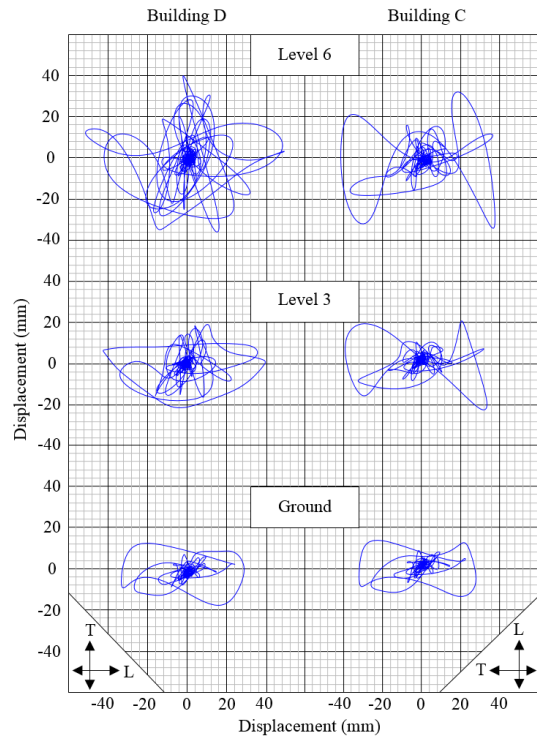
Figure 17: Estimated in-plan displacement trajectories for Buildings C & D during the M_W 6.6 event.

Displacement data was estimated through the double integration of accelerations method to produce the displacement trajectories shown in Figure 17. The estimated displacement trajectories at ground level for both buildings was found to be near identical, as expected for two adjacent buildings. The displacement trajectories shown in the top region of Figure 17 reveal that the maximum displacements estimated at level 6 for Buildings C and D were 41 mm in the transverse direction and 51 mm in the longitudinal direction, respectively.

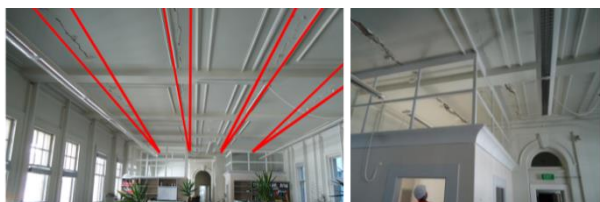
Figure 22: Underside of flooring system with location of cracking indicated by bold lines.

The Old Public Trust Building was erected in 1908 and is listed as a Category 1 heritage structure. The building is stone masonry construction and has an internal steel skeleton that supports the floors and facades. The building was strengthened in the 1920s and again in the 1980s. A view of the building from Stout Street is shown in Figure 21. A site investigation and installation of 33 accelerometers was undertaken on 9 September 2013. During the Cook Strait earthquakes, the Old Public Trust building experienced low/medium levels of structural damage. Large cracks appeared in the underside of the floor diaphragms, as shown in Figure 22.

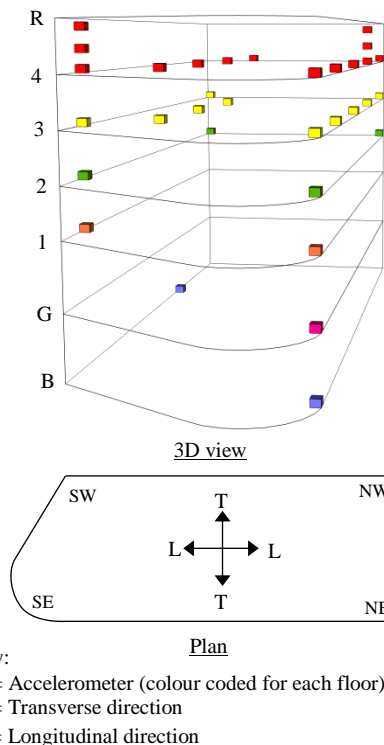
Figure 23: Layout and distribution of accelerometers in the Old Public Trust building (Building G).

Levels 3 and 4 received a greater number of accelerometers than the floors beneath, with 10 accelerometers installed on each floor. The layout of accelerometers and details of Building G are found in Table 5 and Figure 23.
