THE PERUVIAN EARTHQUAKE DISASTER

The following is a condensation of a report in the "Peruvian Times", June 5th, 1970 which was sent to New Zealand by Miss J. Williman who was climbing in the area at the time. Fig. 1 is a map of the disaster area.

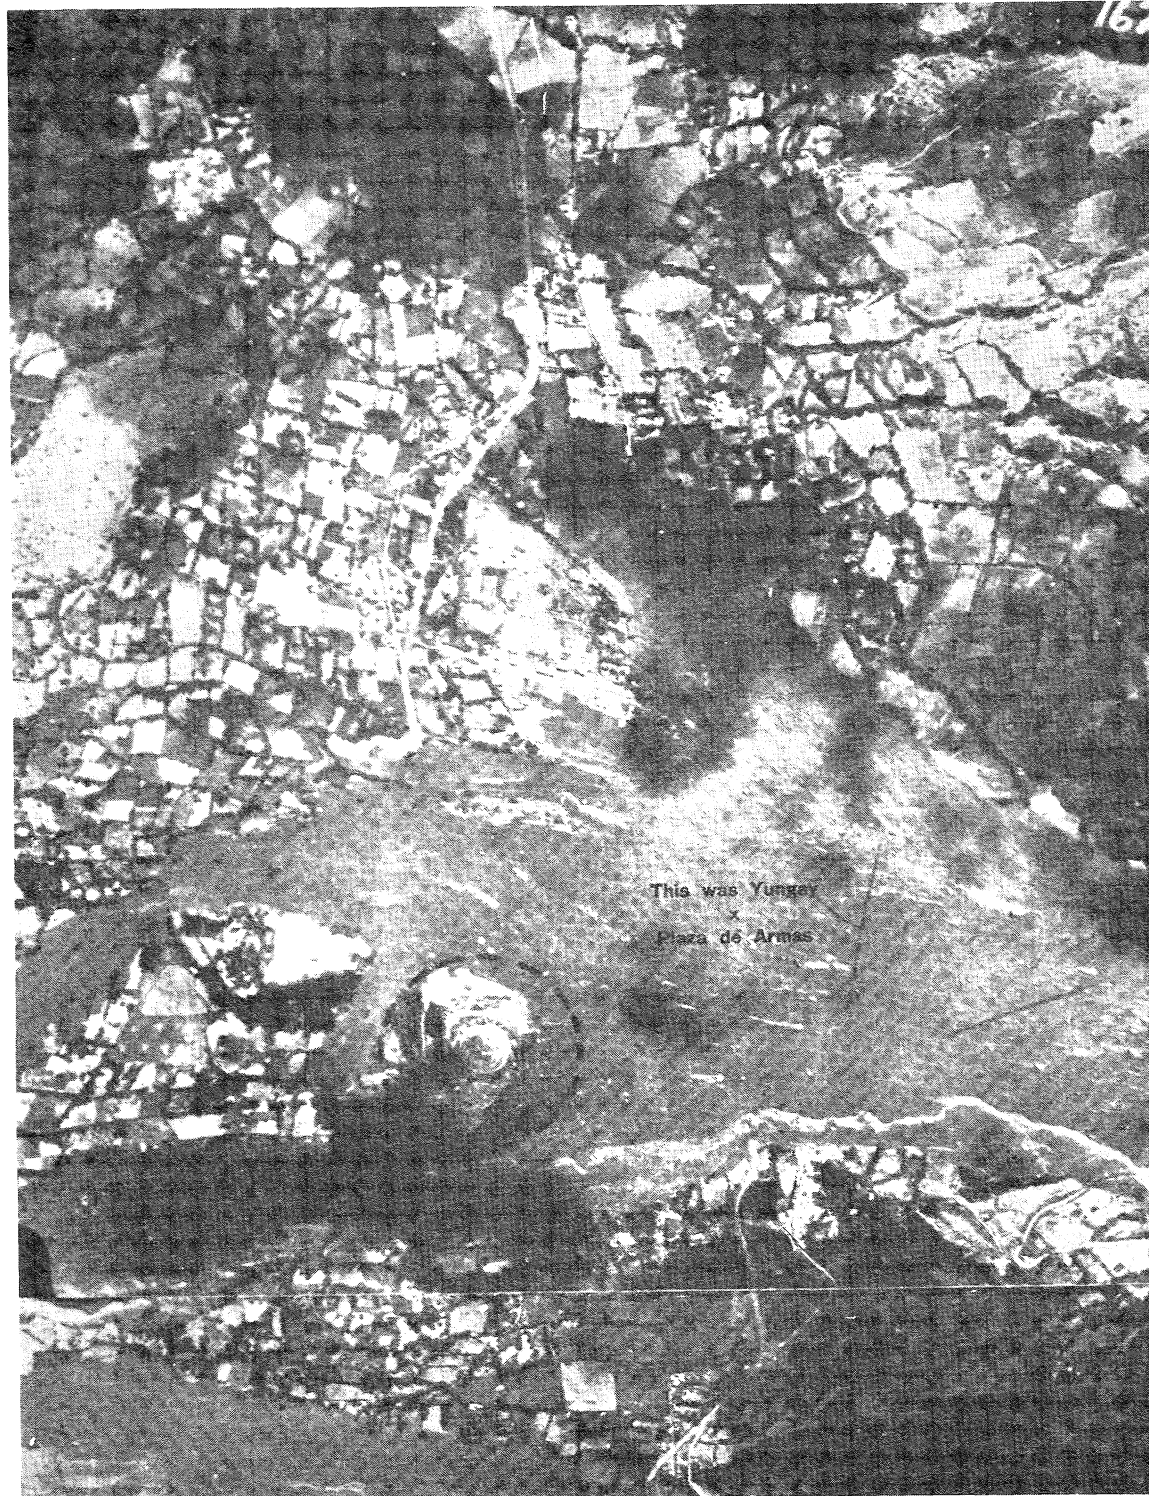
One of the towns, Yungay, was completely wiped out. A huge avalanche of mud, rock, water and possibly ice swept down the side valley in which Yungay lay and, as Fig. 2 indicates, buried the whole town, except the cemetery hill.

In fig. 2, taken 48 hours after the earthquake hit, the little town is circled by a dotted line. What may have happened is that when the earthquake hit many of those who were not buried under the rubble of houses or seriously injured, fled for surrounding high ground, concentrating on the cemetery hill. When the avalanche swept through and around they were, though immediately safe, unable to escape in any direction.

Taken 48 hours after Sunday's earthquake, this airforce photograph shows the path of the avalanche that wiped out Yungay; at the bottom of the photo, too, can be seen the new Ranrahirca avalanche. The dotted circle encloses the Yungay cementary hill, where helicopter pilots estimated that 2,500 people took refuge before the avalanche, travelling probably at 60 m.p.h., swept through, an unknown time after the earthquake shocks. The hill is completely surrounded by mud, rock and ice. The orientation of the photograph is roughly North at the top.

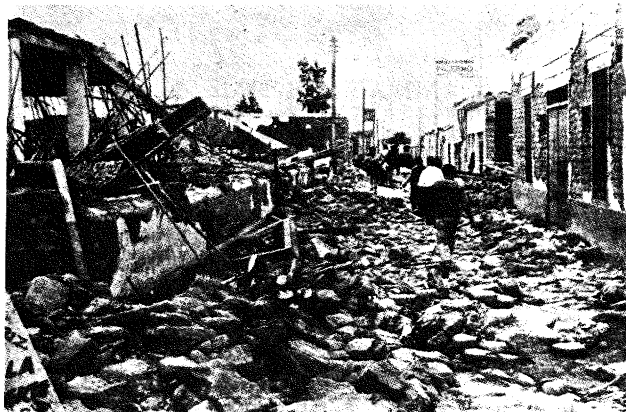
THE shock came in fast waves. A side-street of a coastal town

Most of the houses of two or three storeys, though badly, perhaps irretrievably, damaged remain standing. One single-storey cement house, had been lifted up about four feet, and seemed at first glance intact, though at an angle. However, both the roof and the back wall had caved in. (See figures 4 and 5.)

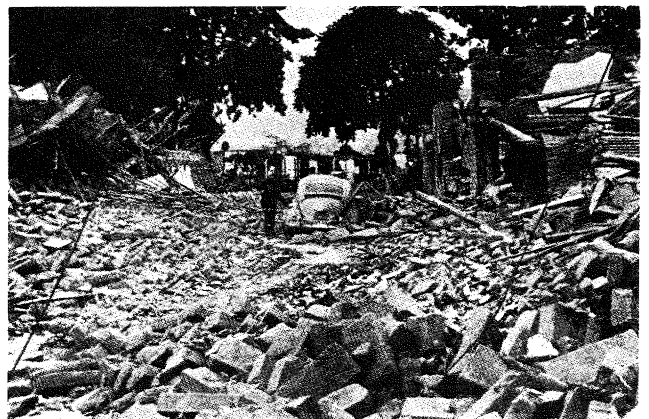
CASMA, a town on the coast was almost entirely destroyed
