Field experience section

SIMULATED EARTHQUAKE TEST OF A TIMBER HOUSE

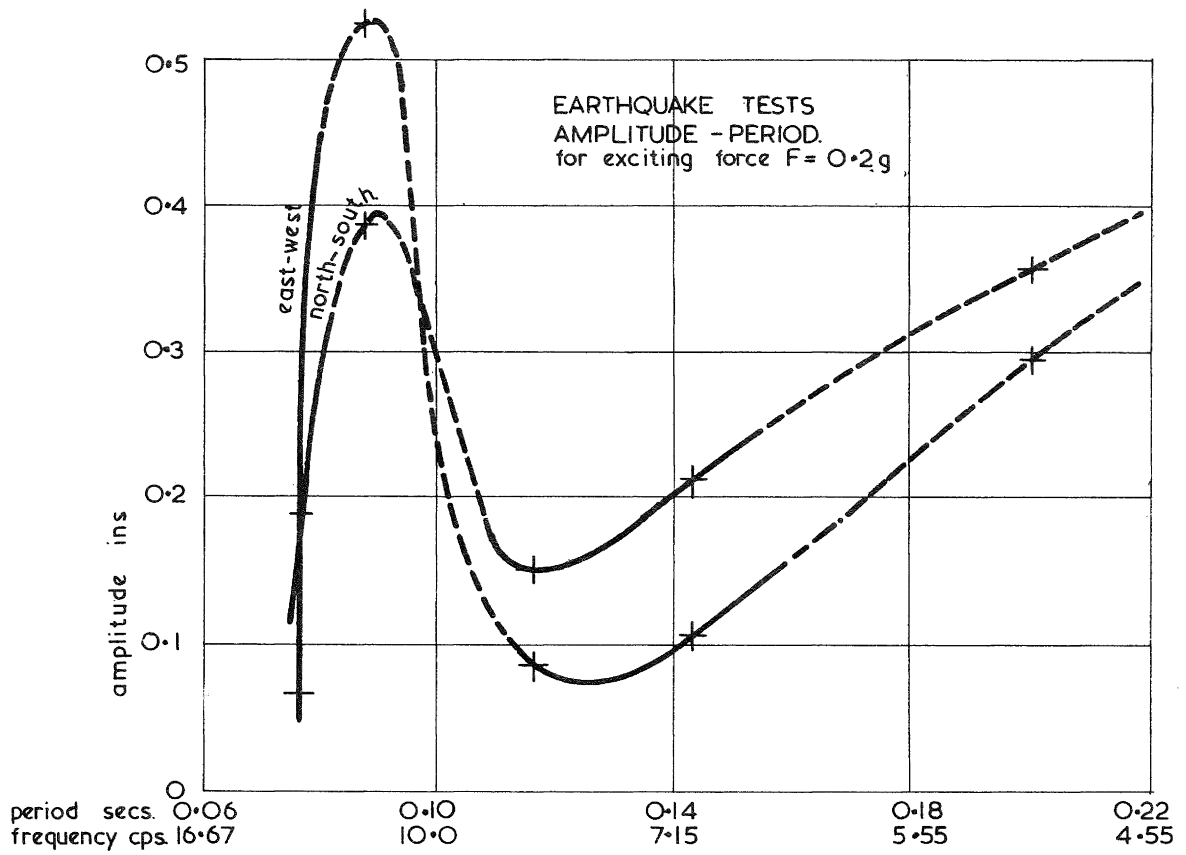
Fig. 2. Variation of amplitude with period of excitation

The frequency/amplitude curve (Fig. 2) was plotted for an exciting force equal to 20% of the total weight of the building tested, including the floor. From this graph, the effects of the second degree of freedom appeared to be more significant at the higher frequencies, i.e. as the speed of the rotating arm was increased, the concrete blocks started to rock at ground level.

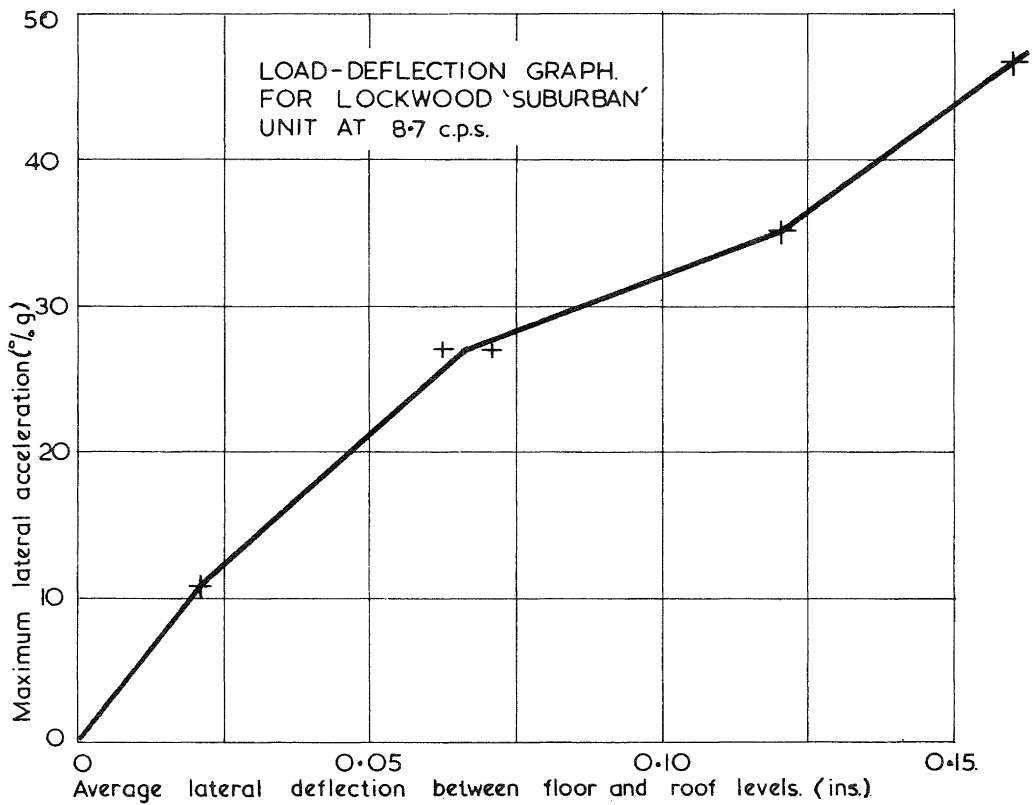
Fig. 3. Relation of load and deflection, at 8.7 cycles/second

A series of tests was made, the first six at 8.7 cycles/sec. (Fig. 3), with progressive increments in the out-of-balance force. The internal ties were loosened off for the last two tests in the first series and no noticeable increase in the movement of the house was observed. These were followed by a second set of five tests which vibrated the building (without the internal tie rods) at different frequencies.

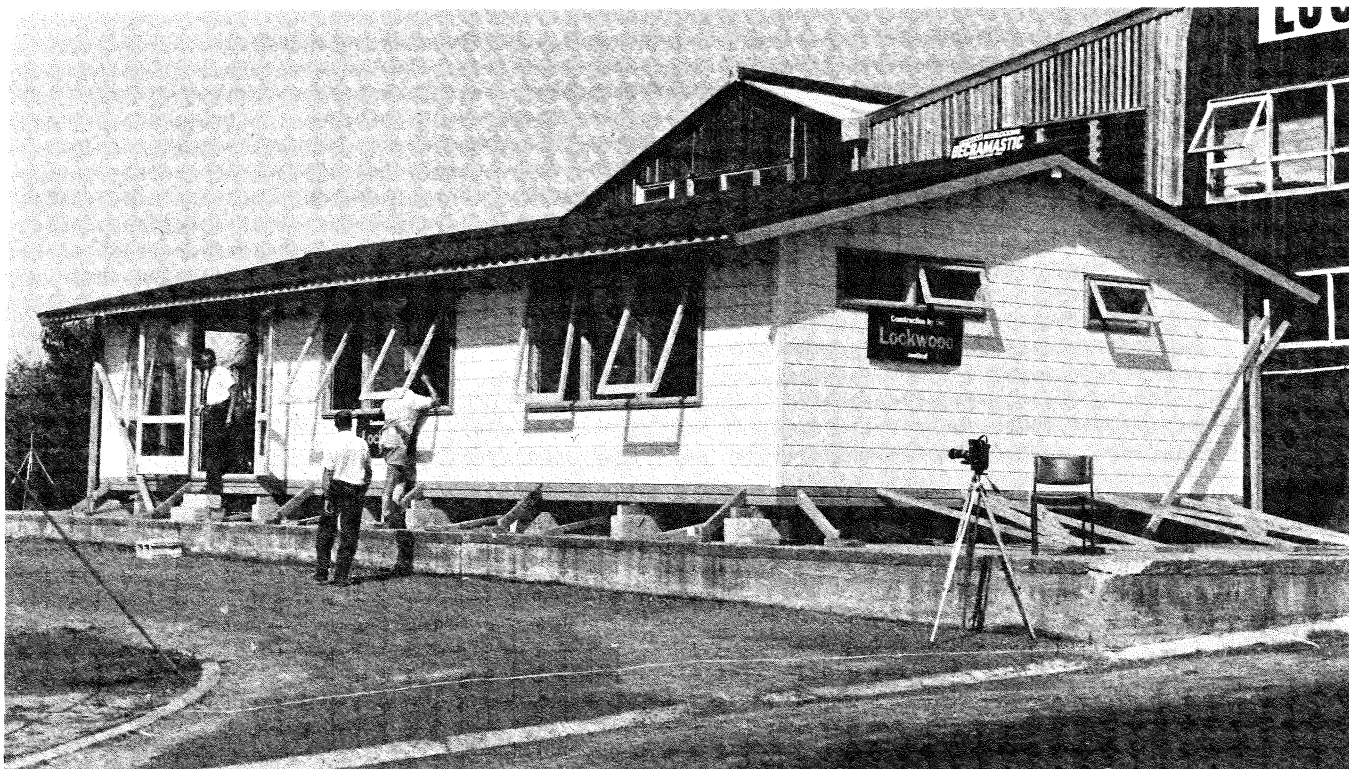
Fig. 4. View of house supported by concrete blocks upon a concrete slab.
