# DAMAGE, OPERATION AND REINSTATEMENT OF POST OFFICE COMMUNICATIONS SERVICES

D. C. A. Eddy\* B. B. Hands\* D. S. G. Preston\*

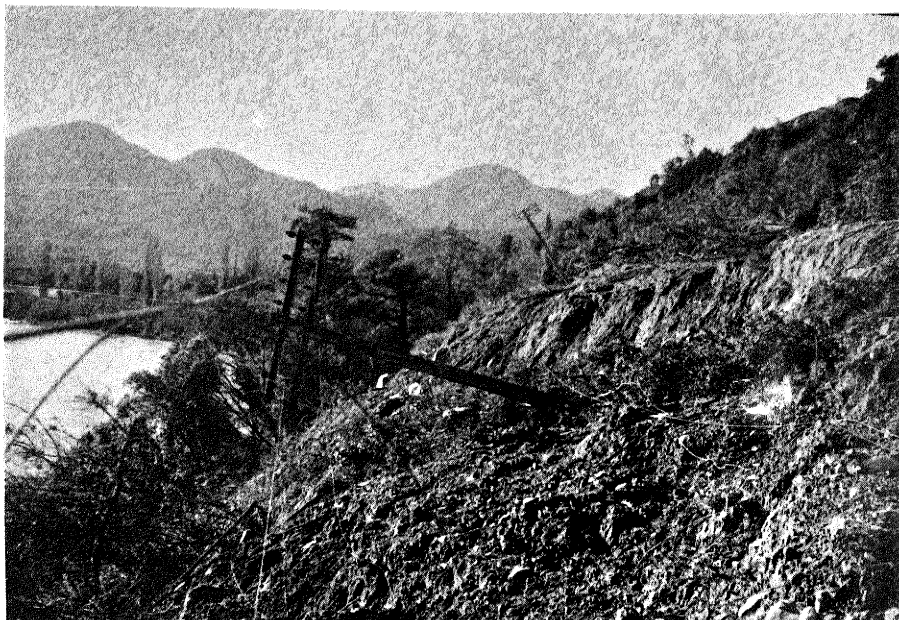
Fig. 2. Typical damage to poles near New Creek, at  $8\frac{1}{2}$  miles up the Buller Gorge from Inangahua Junction.

Major damage to Post Office plant occurred in the Upper Buller Gorge due to slips immediately following the earthquake and further slips due to heavy rain in the area.

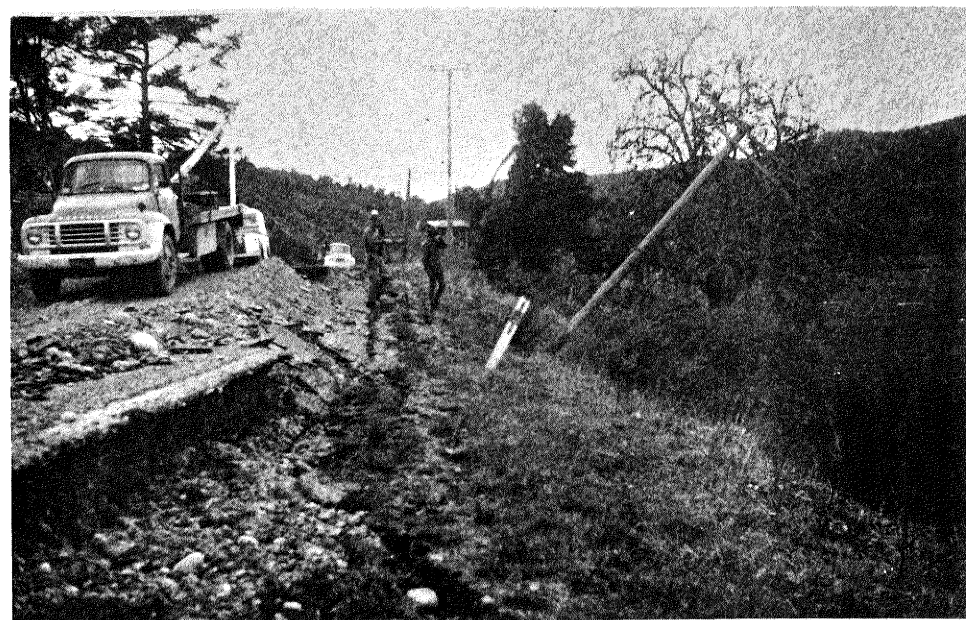
Fig. 4. Gang straightening poles which had fallen away with the ground next to the road at Three Channel Flat.

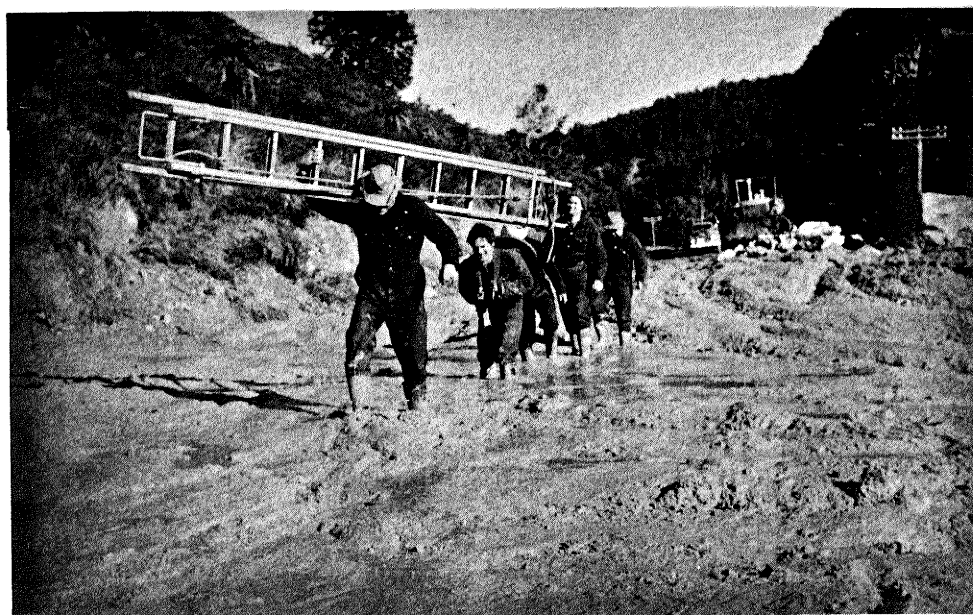
Fig. 3. Christchurch gang crossing a mud slip near Arnolds  
Site is at end of vehicle access

Because of the danger to men due to the unstable country a start was not made until Monday, 27 May when men commenced working from the Murchison and Inangahua Junction ends. Throughout Monday and Tuesday a helicopter was used from the Murchison end to ferry men and material from Murchison and Inangahua Junction past the numerous slips. Photographs enclosed show the conditions under which restoration work was carried out.

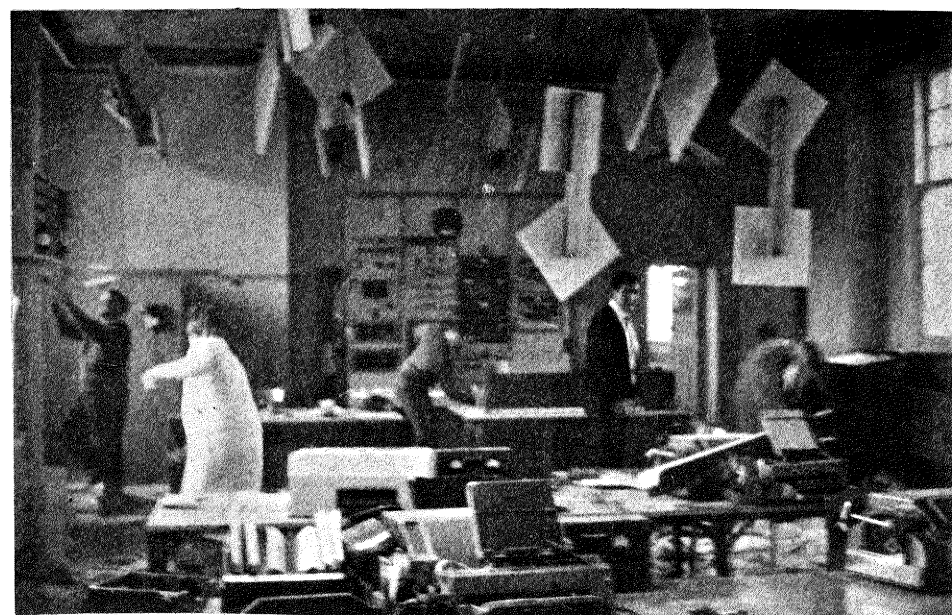
Fig. 5. Inside the Greymouth Telegraph Office showing damage to acoustic tiles on the ceiling.

Some minor damage (bolts wrenched from walls and ceiling) occurred in the Greymouth exchange building. Acoustic tiles fell from the ceiling in the Telegraph operating room on top of the teleprinters, but were quickly cleared away by 9 a.m.
