LANDSLIDES AND LIQUEFACTION GENERATED BY THE COOK STRAIT AND LAKE GRASSMERE EARTHQUAKES: A RECONNAISSANCE REPORT

**R. Van Dissen¹, M. McSaveney¹, D. Townsend¹, G. Hancox¹,
T.A. Little², W. Ries¹, N. Perrin¹, G. Archibald¹, G. Dellow¹,
C. Massey¹, S. Misra¹**

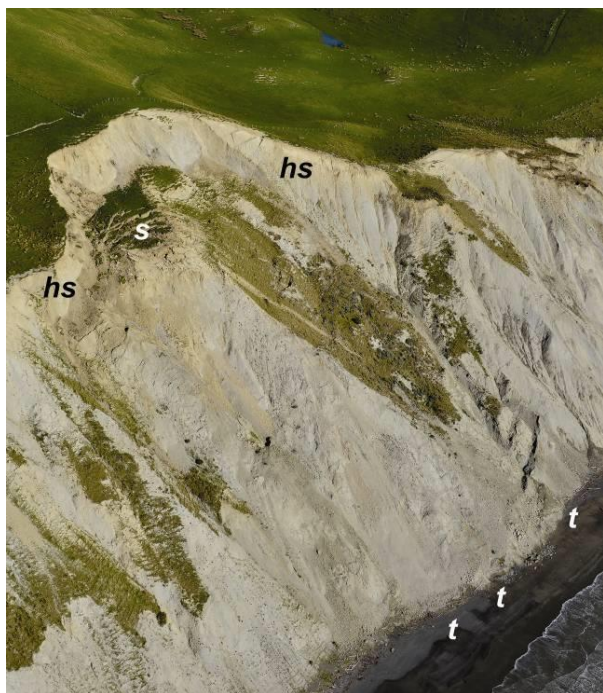
Figure 3: View of the largest landslide triggered by the Cook Strait earthquake on the coastal cliffs 1 km west of Cape Campbell. Height of cliff is ~120 m. Multiple fresh slump scarps (s) are visible below the ~20 m high head scarp (hs) at the top of this rotational landslide. Bulging at the convex toe (t) of the failure appears to have locally narrowed the beach. (photo: G. Hancox, GNS Science; taken 25 July, 2013).

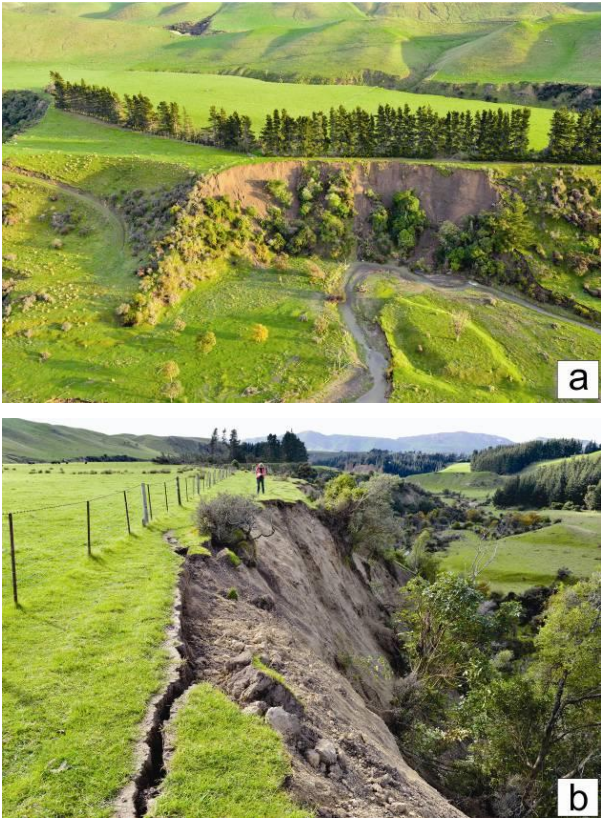
Figure 4: Landslides in the Needles Creek area triggered by the Lake Grassmere earthquake. a) Aerial view looking NNW. b) View looking ENE. (photos: D. Townsend, GNS Science; taken 2 September, 2013).

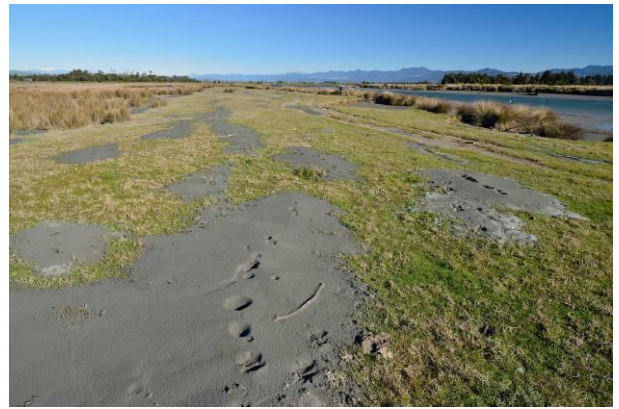
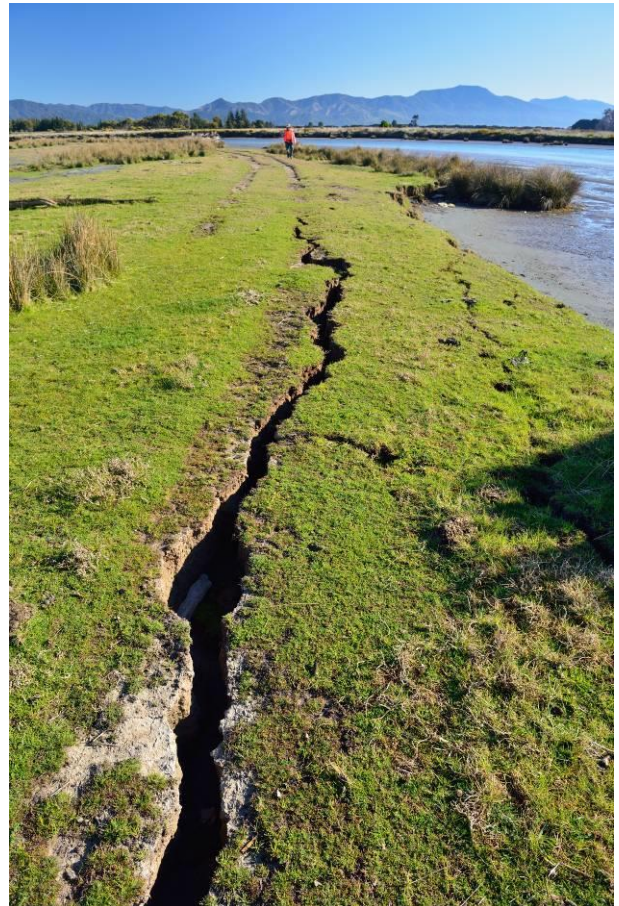
Figure 5: (above) Liquefaction and lateral spreading in the Opawa River area caused by the Lake Grassmere earthquake. (photos: D. Townsend, GNS Science; taken 3 September, 2013).

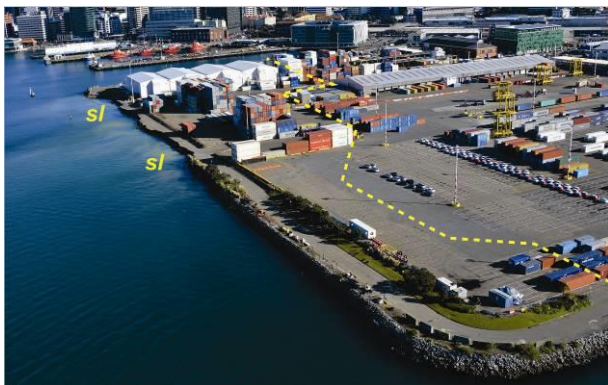
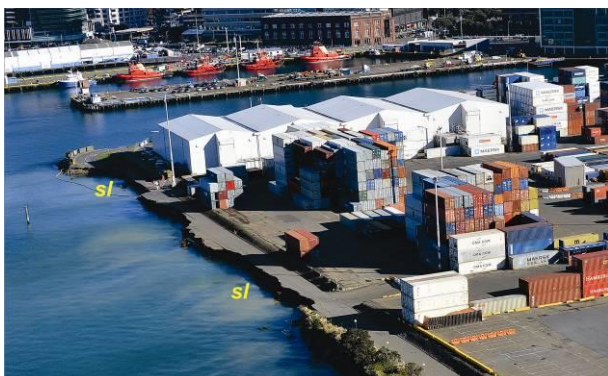
Figure 6: (left) Aerial views of the area of slumping (sl) and cracking (yellow dotted line) at the container storage area in Wellington Harbour caused by the Cook Strait earthquake. (photos: G. Hancox, GNS Science; taken 25 July, 2013).
