THE 2024 HUALIEN, TAIWAN EARTHQUAKE: NZSEE LEARNING FROM EARTHQUAKES RECONNAISSANCE REPORT

ABSTRACT

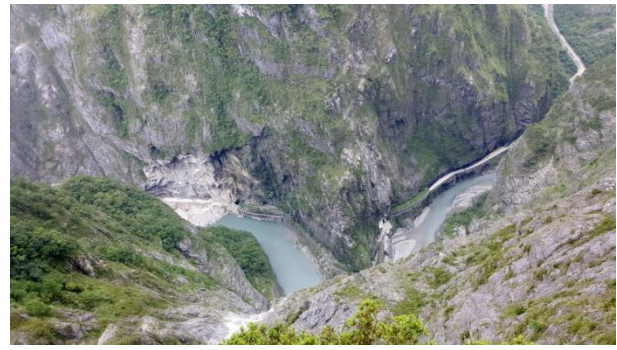
Figure 5: Steep incised topography of Taroko Gorge.

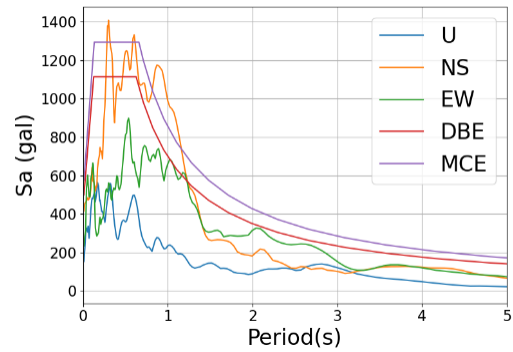
a) Acceleration record in Hualien City (Station HWA019).

b) Response spectra (5% damping) in Hualien City (Station HWA019).

Figure 9: Acceleration record and spectra in Hualien City at station HWA019 [17]. Note: 1 gal = 1 cm/s².

Locations for station HWA019 near Hualien Hospital (Longitude 121.61°E, Latitude 23.98°N) and station ETL near Taroko National Park Visitor Centre (Longitude 121.62°E, Latitude 24.16°N) are approximately shown on Figure 7. Figures 9 and 10 illustrate the strong ground motion records and corresponding 5%-damped response spectra for these two stations.

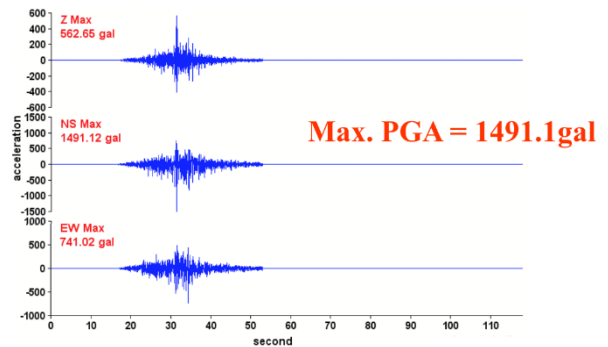
a) Acceleration record in Taroko National Park (Station ETL).

b) Response spectra (5% damping) in Taroko National Park (Station ETL).

Figure 10: Acceleration record and spectra in Taroko National Park at station ETL [17]. Note: 1 gal = 1 cm/s².

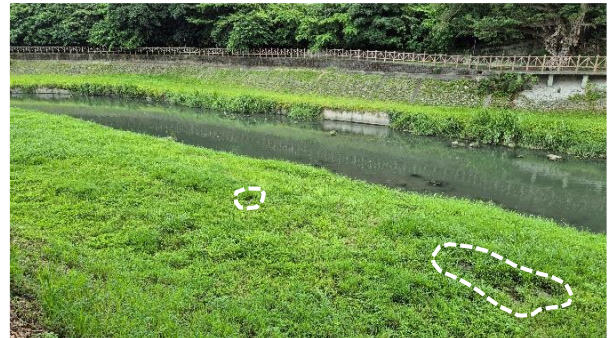
Ground damage within Hualien City was generally localised and minor [11]. Although sand boils and lateral spreading occurred at the riverbanks of the Meilun River during previous earthquakes in Hualien [20], the 2024 earthquake resulted in only very limited effects. Small, isolated sand boils were observed by the NZSEE LFE team along riverbanks (Figure 16). Minor ground surface cracking was also observed adjacent to coastal water bodies.

Figure 16: Localised sand boils along the banks of the Meilun river.

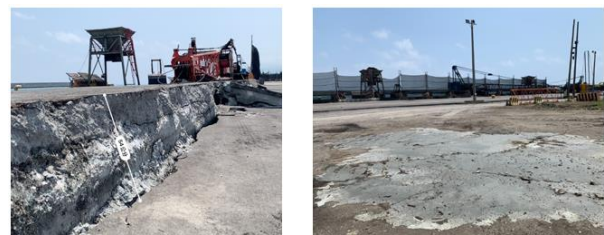
The most significant impact on the Port of Hualien was a widespread tectonic uplift of approximately 50 cm across much of the port area (Figure 19a). This vertical displacement disrupted docking operations, particularly for small commercial and tourist vessels such as whale-watching boats. Temporary repairs to some wharves were already underway at the time of the NZSEE reconnaissance visit, two months after the event.

Liquefaction-induced ground damage at the port was limited (Figure 19b). Local authorities reported isolated occurrences of sand boils and flotation of buried structures, though these were not directly observed during the field visit. The only ground deformation observed by the team included minor settlement, surface cracking, and lateral displacements on the order of 20–50 mm behind wharf structures and seawalls.

Figure 19: Damage to the port. a) Some of the port areas uplifted up to 50 cm. b) Sand boils and surficial signs of liquefaction.

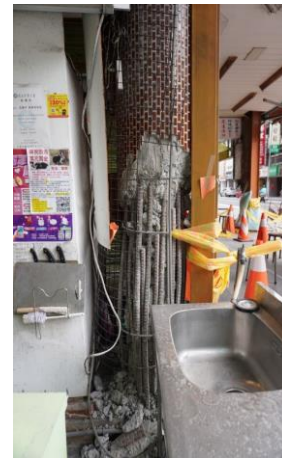
- Lap splices in plastic hinge regions (Figure 21).
- Buckling of longitudinal reinforcement because of lack of transverse reinforcement (Figure 21).
- Lack of beam-column joint transverse reinforcement (Figure 22).
- Hoop fractures probably caused by inadequate bend diameters.
- Improperly placed shear reinforcement, including hoops lumped together and longitudinal bars outside the transverse hoops (Figure 23).
- Use of 90-degree hooks with insufficient development length.
- Conduits and services running through reinforcement cages.
- Low compressive strength of concrete (<15 MPa), based on NZSEE team's measurements using a Schmidt hammer.

Figure 21: Lap-splices and lack of confinement and concrete cover at the base of column.

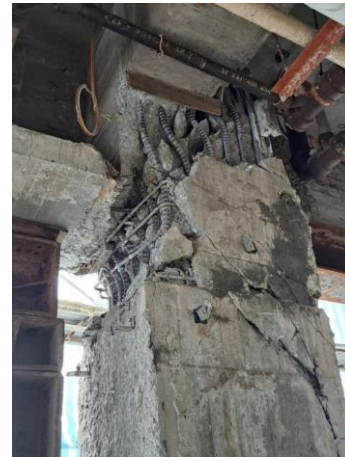
Figure 22: Lack of shear reinforcement in column and beam column joint.

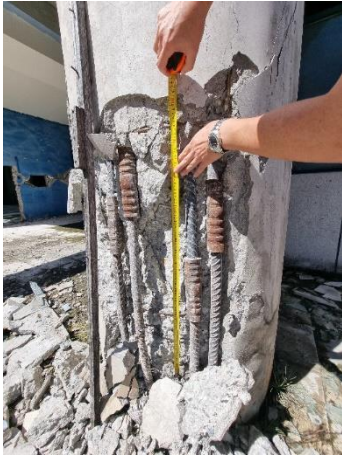
Figure 23: Longitudinal reinforcement bars spliced using mechanical couplers cast outside the spiral used as transverse reinforcement.

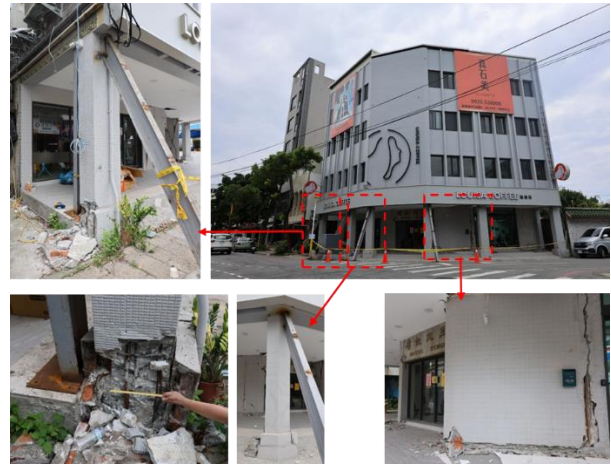
Structural damage was also frequently observed in buildings with plan irregularities, particularly at corner buildings where asymmetric mass and stiffness distribution caused torsional responses during the earthquake (Figure 26 and Figure 27).

Figure 26: Damaged Building – shoring added after mainshock.

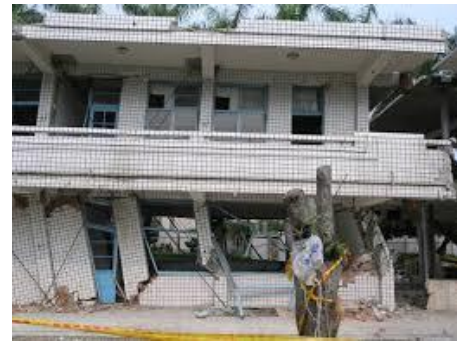
Figure 29: School building damaged in the 1999 Chi-Chi Earthquake) [29].

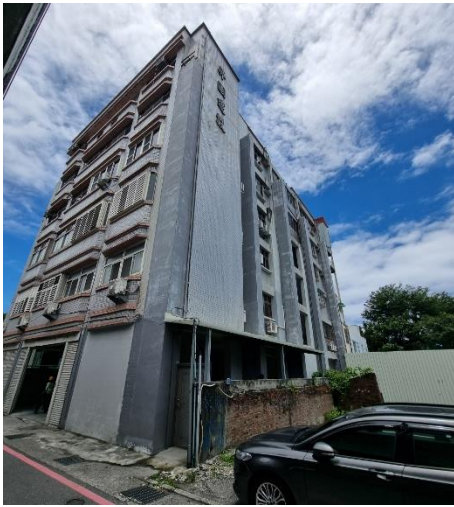
Figure 30: Retrofitted building – strengthened after the 2018 Hualien Earthquake, with no observed damage following the 2024 Hualien Earthquake.

A notable example of a retrofitted building under Plan B is the six-storey building shown in Figure 30. This building was retrofitted following the 2018 Hualien Earthquake. The building exhibited satisfactory performance in the 2024 Hualien Earthquake, with no observed damage.

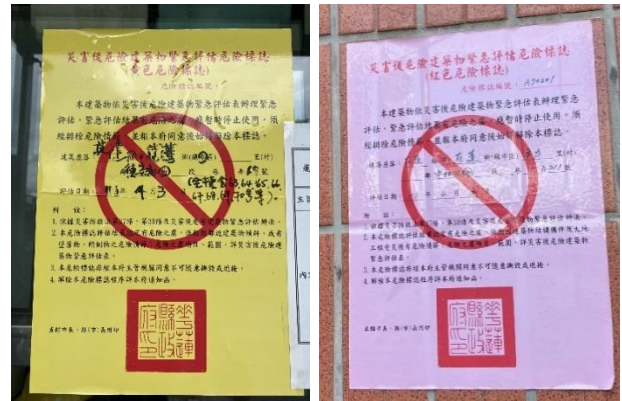
Figure 31: Examples of official post-earthquake building evaluation placards, showing yellow- and red-tag classifications.

In addition to search and rescue operations, Taiwan also activated its post-earthquake building evaluation system to assess structural safety across affected areas. This system relies on trained volunteers, including architects, civil engineers, and structural engineers, who undergo annual training and simulation exercises. Similar to New Zealand, Taiwan uses a placard system to categorise building safety, with red and yellow placards indicating restricted or prohibited access (Figure 31). However, Taiwan does not issue a green or white placard to explicitly confirm that a building has been cleared for unrestricted use.

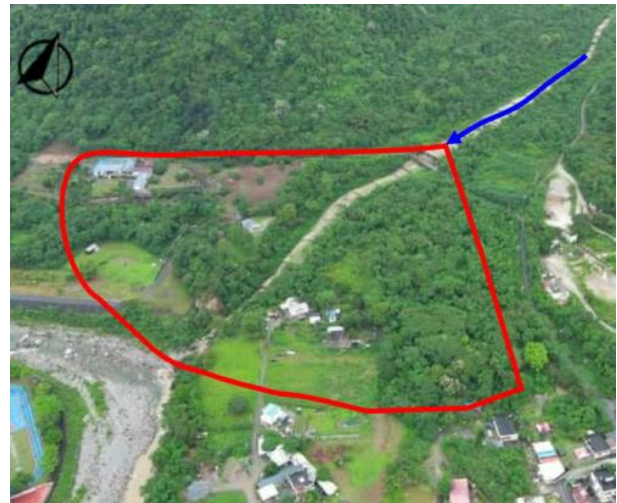
also demonstrates a robust, science-informed framework for managing cascading geohazards in mountainous terrain. Figure 32 illustrates a mapped debris flow risk zone in one of the newly assessed areas following the 2024 Hualien Earthquake. The red polygon delineates the potential flow-affected area, while the blue line indicates the likely debris flow path.

Figure 32: Debris flow risk assessment following 2024 Hualien Earthquake – site U113-6 [42].

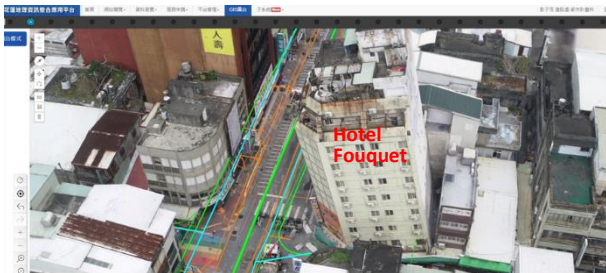
Figure 33: The use of Digital Twin for emergency response showing the severely damaged Hotel Fouquet in relation to the underground lifelines (electricity – orange lines, telecommunications – green lines, water – blue lines) immediately following the two large aftershocks on 23 April 2024 [45].
