## TECHNICAL NOTE

# COMPARISON BETWEEN THE EMERGENCY RESPONSES TO THE 2010-11 CANTERBURY EARTHQUAKES AND THE 2024 NOTO PENINSULA EARTHQUAKE

Ben Exton<sup>1</sup>

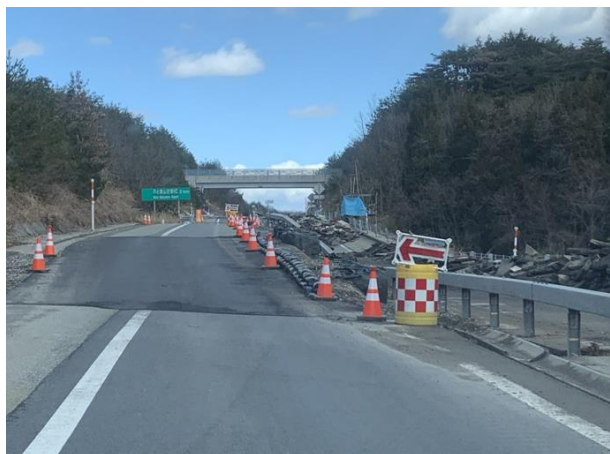
In the aftermath of the Noto Peninsula Earthquake, road damage was widespread, exacerbated by seasonal snow and moisture. Slips revealed a thin layer of organic material over smooth bedrock, which acted as a slip plane. Impressively, road crews had already smoothed many approaches and abutments with asphalt within the first fortnight, even where large level variations had formed as shown in Figure 2.

*Figure 2: An example of the main highway being converted to a one-way single lane up the peninsula. A 'B-road' was utilised for the reverse direction of travel down the peninsula.*

A particularly effective strategy in Noto involved creating a traffic loop using one lane of the A-road (main highway) in one direction and one lane of the B-road (secondary highway) in the other. This allowed traffic to flow around damaged sections, eliminated the risk of any head-on collisions, and facilitated smoother repairs and traffic management.

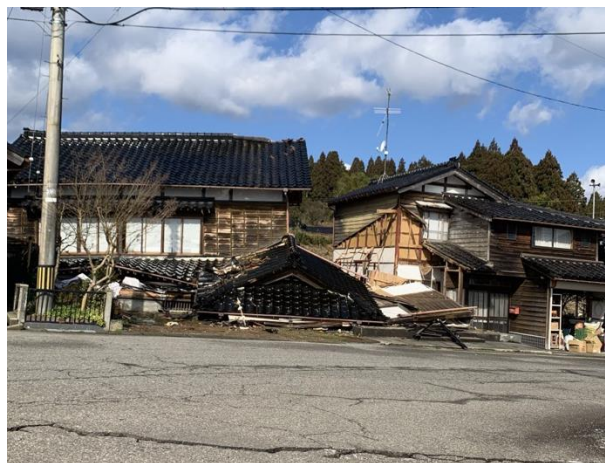
Damage to residential structures in Noto was severe, particularly among older, traditional-style houses with timber framing and heavy tile roofing. These homes were built before key seismic requirements were introduced by Japan's Building Standards Act in 1981. Many homes had experienced soft-storey collapse, reduced to rubble, in. In several cases, the ground floor collapsed while the upper floor remained relatively intact, with porch roof tiles and framing visibly resting on the pavement. Figure 3 shows a number of the damage mechanisms mentioned in this paragraph. It

*Figure 3: Typical building damage to traditional housing stock. Left hand side shows a two-storey home in which the ground floor has collapsed (soft-storey) such that the porch roof is now level with the ground. In the foreground is a single-storey home which has separated from the adjacent building to the right in a soft-storey mechanism.*

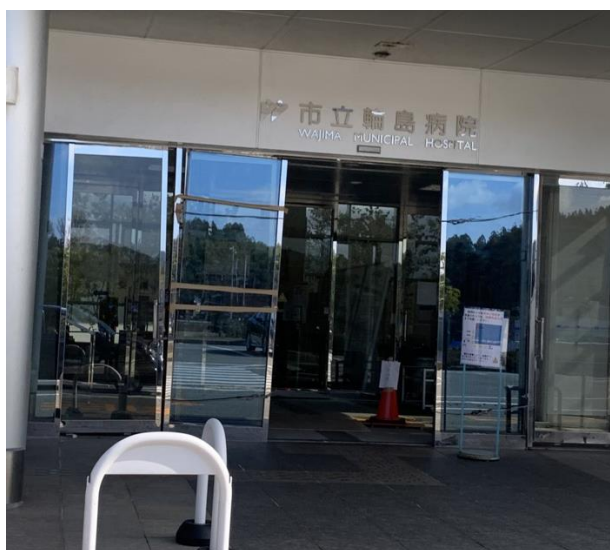
Wajima Hospital's structure was intact and functioning, but its doors were severely damaged and permanently strapped open - an issue in winter conditions that highlights the need for improved non-structural element resilience (Figure 4).

**Figure 4: Non-structural damage to the hospital doors causing them to be strapped open in sub-zero temperatures. A great example of the need for displacement capacity in critical non-structural elements.**

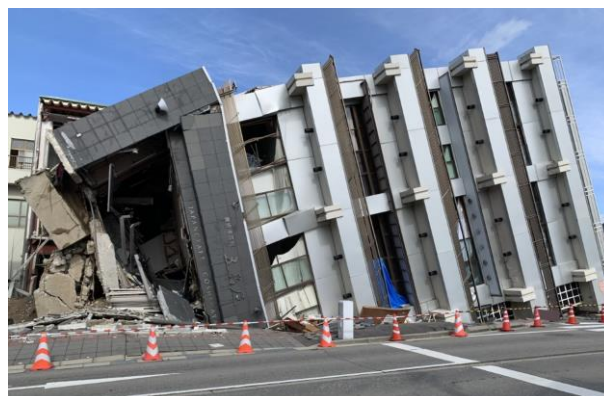
Foundation failures were observed in many buildings, including two mid-rise buildings in Wajima, one of which is pictured in Figure 5. Subsequent analysis has suggested that the performance of the liquefiable soils was not adequately allowed for in the pile design of these buildings.

**Figure 5: Pile cap failure in a 5-storey apartment building in Wajima.**

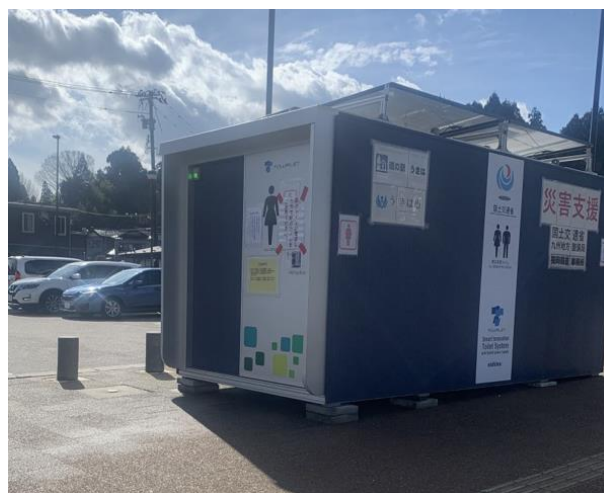
Temporary tents, portaloos, drop-in toilet buildings, and food depots were set up quickly, and a large military presence was actively engaged in support operations. These elements are stockpiled by the government in four locations across Japan ready for rapid deployment following an event – examples are shown in Figures 6 and 7. All elements ultimately make their way to the disaster site, but the closest site can respond first and then the rest follow.

**Figure 6: One of the portable emergency toilet blocks stored in bulk in four locations around Japan, ready for deployment in an emergency.**

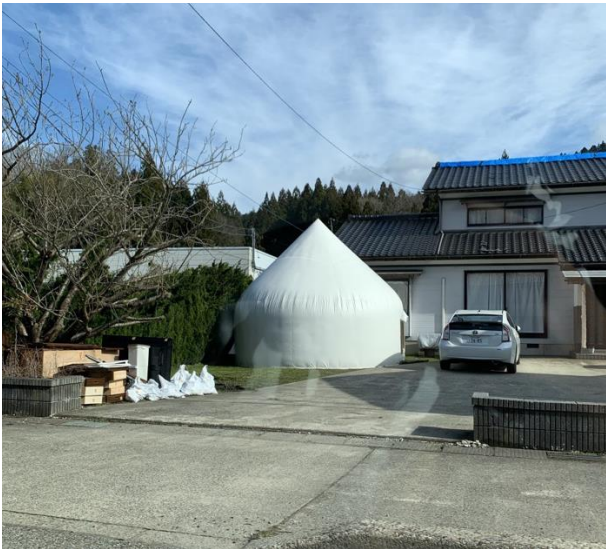
Insulated, white tents were distributed and used in the interim, providing essential warmth in snowy conditions, prior to the flat-pack villages being opened. Camper vans were also

**Figure 7: Thermally insulated emergency tents for red placarded homes, deployed from bulk storage in four locations around Japan.**

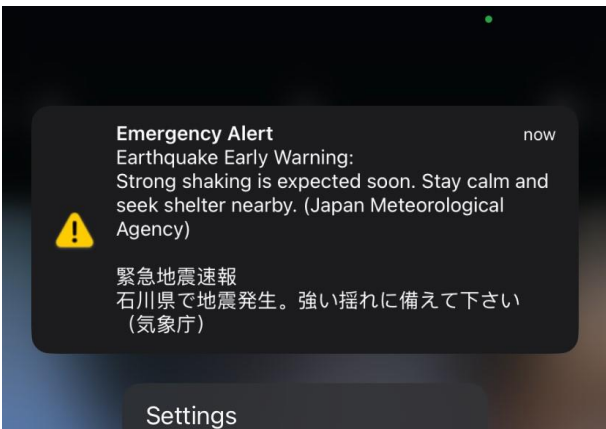
Earthquake alerts were received via text and read out (automatically translated to the primary device language so accessible to people not fluent in Japanese) prior to aftershocks, and town-wide sirens also sounded. An example alert is shown in Figure 8.

**Figure 8: Earthquake early warning alerts automatically translated into the primary language of each mobile device. This one arrived approximately 10-15 seconds before shaking commenced.**

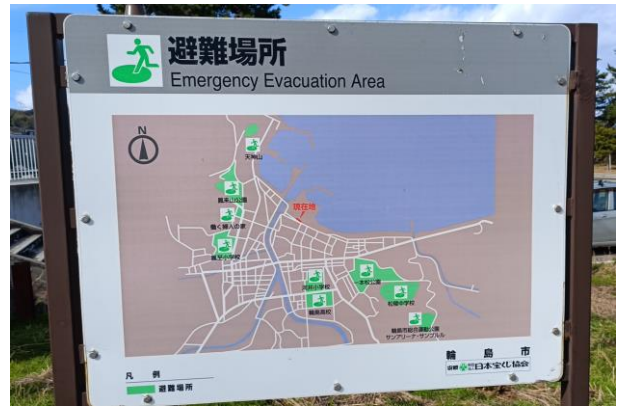
Tsunami signage (Figures 9 and 10) was clear and consistent throughout coastal areas, although no tsunami occurred in the regions of the Peninsula visited.

**Figure 9: Typical tsunami evacuation signs dotted every 200-300m around the coastline.**

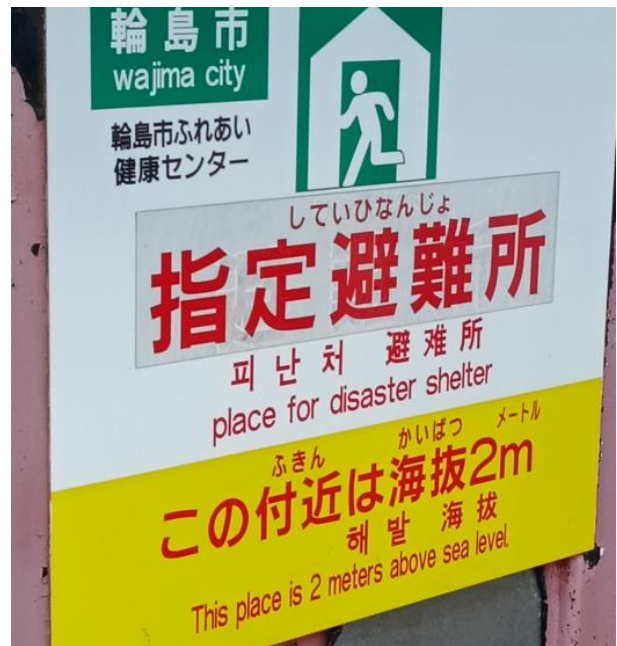
**Figure 10: Typical disaster shelter signage at shelter locations.**
