# CHARACTERISATION AND SEISMIC VULNERABILITY ASSESSMENT OF UNREINFORCED MASONRY BUILDINGS IN DUNEDIN CBD

Najif Ismail<sup>1</sup>, Kieran McGrannachan<sup>2</sup> and Glen Hazelton<sup>3</sup>

## SUMMARY

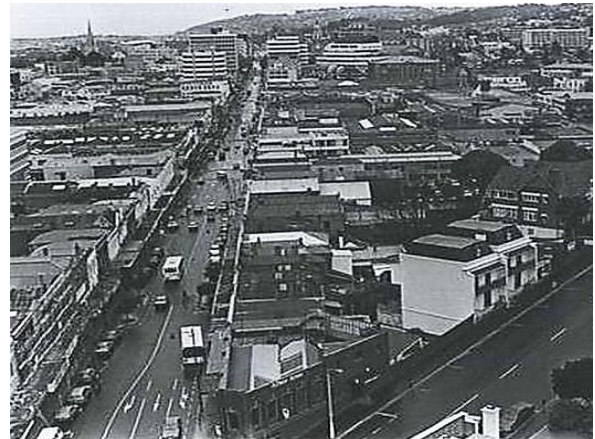
(b) George Street in 1994

*Figure 3: Panoramic views from Knox Church (Source: Hocken Collections).*

redevelopment in the Dunedin CBD has been limited (see Figures 3a and 3b). Many subsequent developments have involved only renovation of existing buildings [7] that may or may not include any strengthening intervention, leaving the city with a significant number of URM buildings built between 1860s and 1900s (i.e. built prior to the introduction of seismic building codes) . This has seen the city left with a legacy of Victorian architecture that still provides the city much of its character today and has become one of the famous tourist attractions.. Typical examples include, the former Excelsior Hotel building (see Figure 4a) and Bendix Hallenstein’s Drapery and General Importing Company building, that has now been adapted for the Dunedin Public Art Gallery (see Figure 4b).

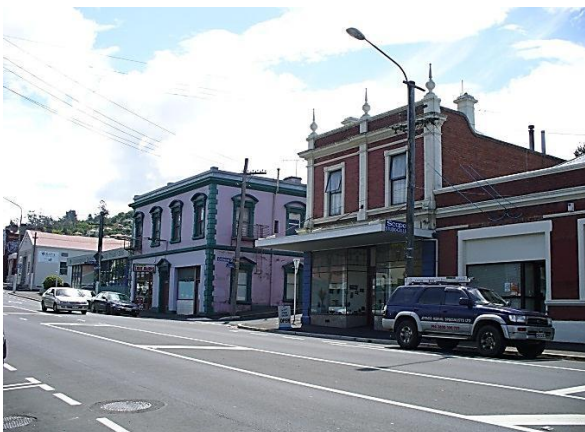
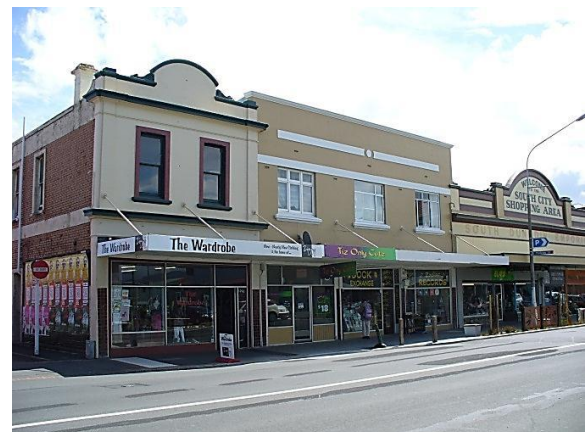
(c) URM buildings in Caversham

(d) URM buildings in South Dunedin.

Early settlements built during the gold rush in outlying areas around CBD (including South Dunedin, Mosgiel, Port Chalmers, Green Island and Caversham) all have groups of URM buildings that are typically single or double storey and used for retail businesses (see Figures 4c and 4d). These surrounding areas developed shops as part of an economic and social infrastructure to cater for the needs of residents without them having to travel in to the city center. This development in South Dunedin resulted in the city's second major retail area, along King Edward Street, around the intersection with Hillside road (formerly known as Cargill Street) towards Caversham.

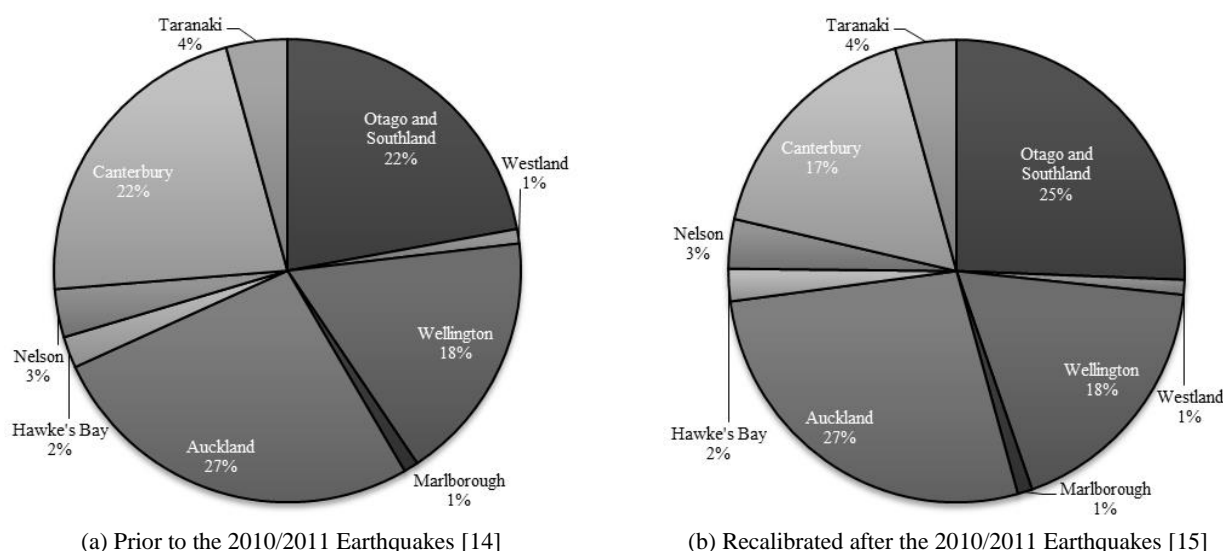
Figure 6: URM building distribution in New Zealand.

Russell and Ingham [14] estimated a total of 4,000 URM buildings to exist in New Zealand prior to the 2010/2011 Christchurch earthquake series, with their population distributed across the New Zealand as illustrated in Figure 6a. Recently, an updated recommendation on the number of URM buildings in Otago and Southland was presented at the Canterbury Earthquakes Royal Commission [15] based upon recalibration after better data was obtained on the number of URM buildings in Christchurch (see Figure 6b). The same research identified seven typologies to represent the non-residential URM building stock in New Zealand). One photograph of a representative building for each of these seven typologies are shown in Figures 7a to 7g, along with their description and their prevalence rank in a national context (RNZ) and in Dunedin (RDN) noted in the captions.

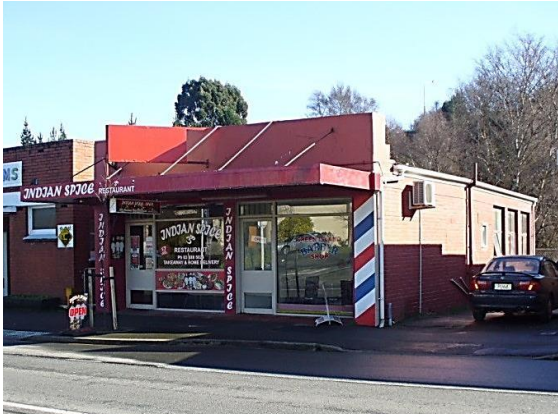
(a) Typ. A: single storey isolated (RNZ =4 & RDN =7)

**Figure 7: Typologies representative of non-residential URM buildings in New Zealand, where RNZ = prevalence rank in New Zealand and RDN = prevalence rank in Dunedin.**

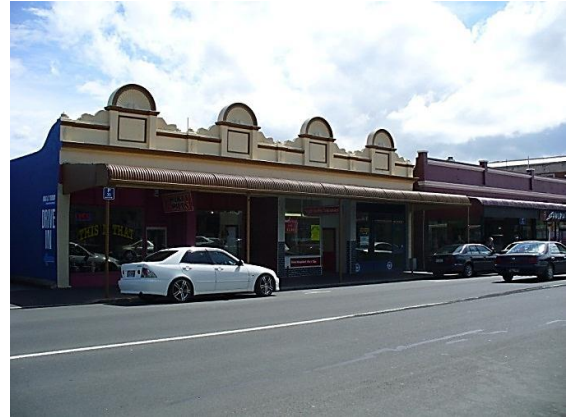
(b) Typ. B: single storey row (RNZ =3 & RDN =3)

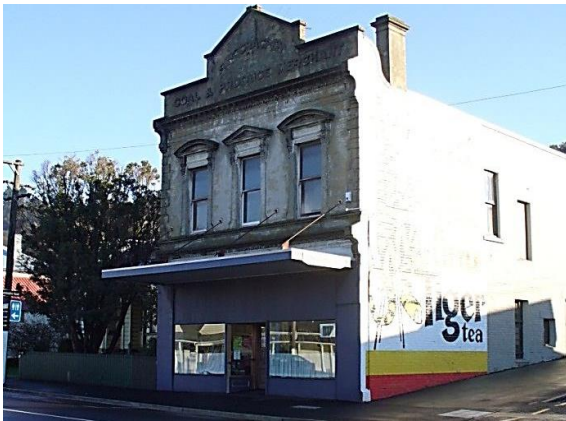
(c) Typ. C: two storey isolated (RNZ =2 & RDN =4)

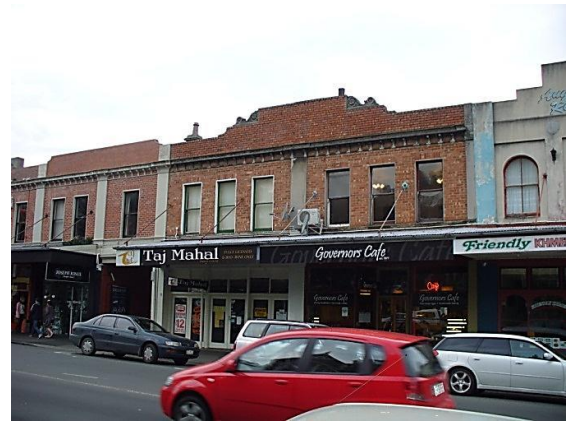
(d) Typ. D: two storey row (RNZ =1 & RDN =1)

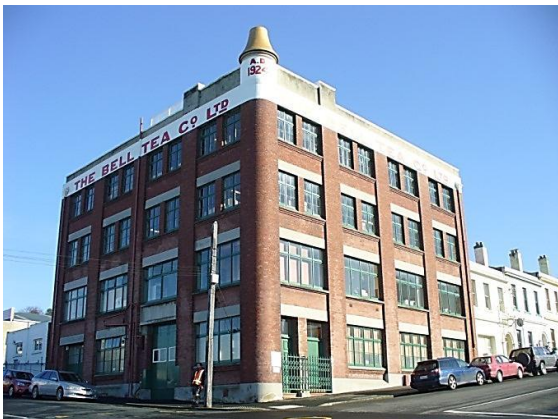
(e) Typ. E: three+ storey isolated (RNZ =7 & RDN =6)

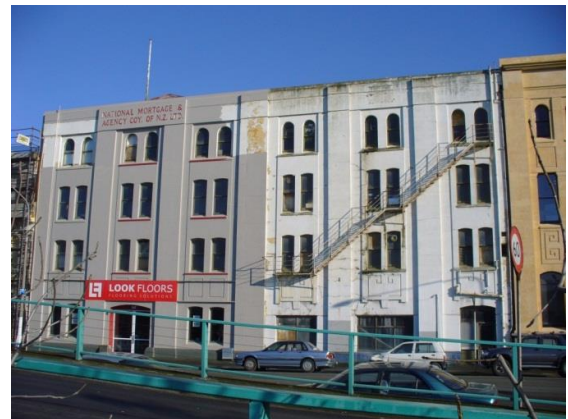
(f) Typ. F: three+ storey row (RNZ =6 & RDN =2)

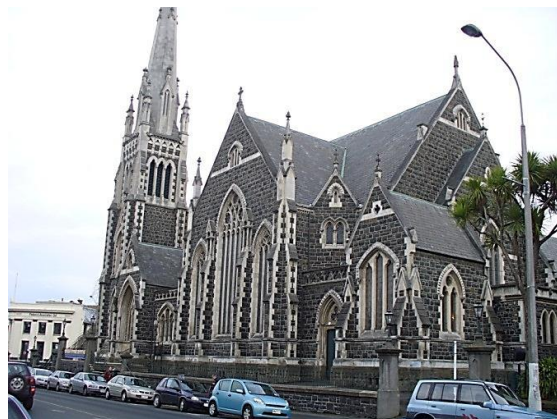
(g) Typ. G: religious institutional, or industrial (RNZ =5 & RDN =4)

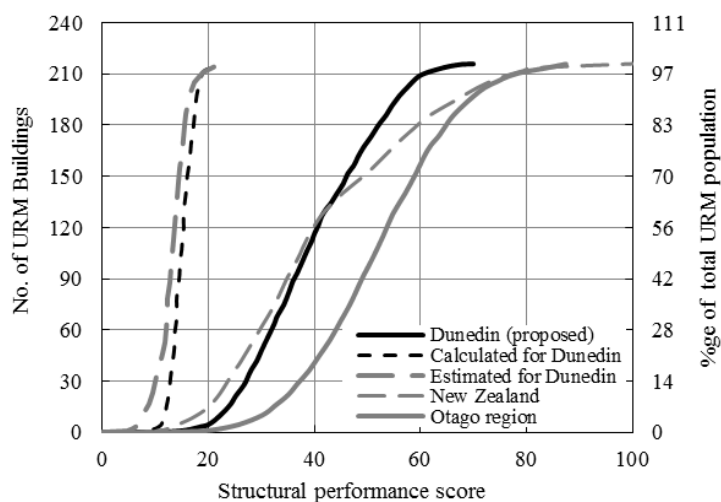
Figure 9: Seismic vulnerability of URM building stock in local and national context.

The results of the proposed risk index based analysis are also shown in Figure 9. It could be argued that the IEP process has little value for URM buildings, given it is unlikely to deliver results in excess of 33% for any URM building, even where this performance could be higher. However, it is also important to remember that the IEP is a course screening tool and is intentionally conservative. Therefore, there is value in IEP assessments, as they are the first step along the path to ensuring that the country's historic buildings are safe in the event of an earthquake. Given the experience of the 2010/2011 Christchurch earthquake swarm and the increased level of awareness in the industry perhaps it would be worthwhile to investigate and calibrate the IEP method for URM buildings.

The two IEP assessment models, although conducted quite differently, produced similar results. This confirmed that same typology buildings would behave similarly in the event of earthquake. As there is no link between the scale based risk assessment and the IEP scores these cannot easily be compared. However the results of the risk assessment may be used as a means to prioritise detailed assessments. Aspects of assessment, or at least the risk categories used in the proposed risk based scheme, may provide a useful addition to the current URM IEP, which does lack in some areas e.g. the site soil class is typically not accounted for, which as indicated above increases the design load on a structure by a factor of up to 1.58, which is a larger increase than an increase from importance level 2 to 3.
