WELLINGTON CENTRAL POLICE STATION

BASE ISOLATION MAINTENANCE

SUMMARY

This paper describes investigations into the continuing serviceability of the base isolation parts, and the remedial maintenance required.

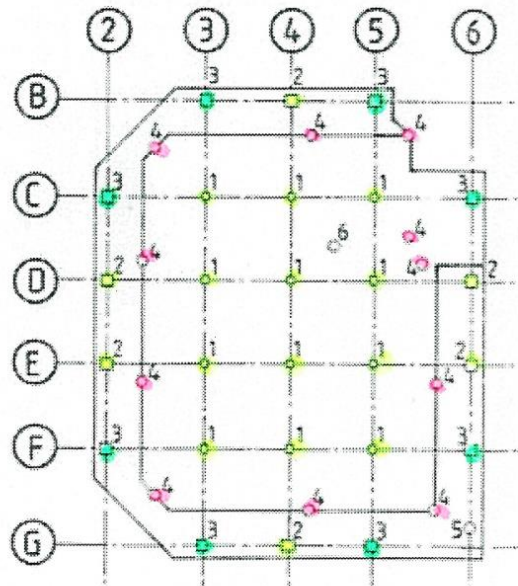
Figure 1: Tower block, view from Victoria Street. Pile types 1, 2, and 3 have spherical bearings of slightly different designs near their upper ends. Plan is an excerpt from MOWD drawing 5/1132/1 7002 207/5.

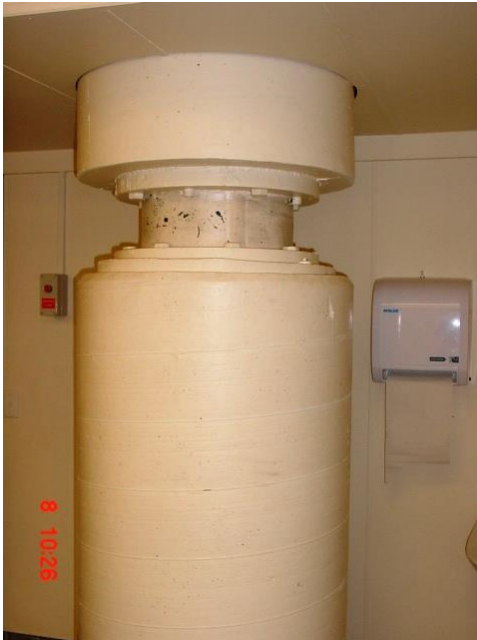
Figure 2: *Left - type 1 column, showing spherical bearing in painted sleeve; Right - type 3 column in which spherical bearing is located below basement floor level near the top of the hollow casing.*

Near the upper ends of the base isolation columns are spherical journals (upper part) and bearings (lower part), made as steel castings, shown in Figures 2 and 3. In order to spread the weight of the building as evenly as possible on the bearing surface, the castings were required to fit precisely together with a smooth surface finish. This metal cutting task was accomplished in PEL's mechanical workshop using techniques originally developed for making spherical surfaces of tools used for grinding optical lenses and mirrors.

The author recommended that a 50 millimetre square be removed from the painted rubber sleeve shown in Figure 2 (or one like it) and a sample of lubricant be removed for examination. Evidence of changes in the lubricant adjacent to the steel surfaces would be looked for. At the time the client declined to accept this recommendation, but since the earthquakes of July and August 2013 has accepted it.

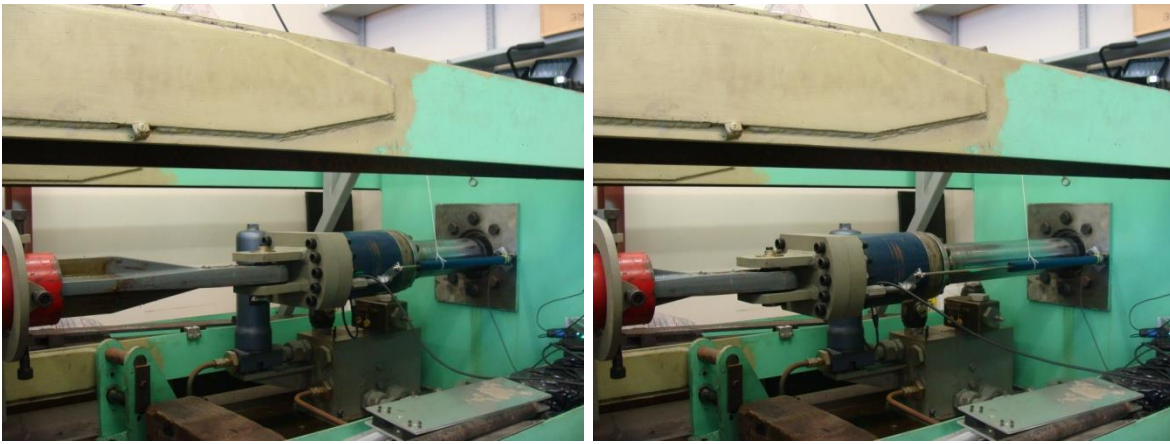
Figure 7: Maximum extension (left) and maximum compression (right) on first test cycle. Figure 8 shows that the forces just before and after the photograph at left was taken were substantially greater than those designed for.

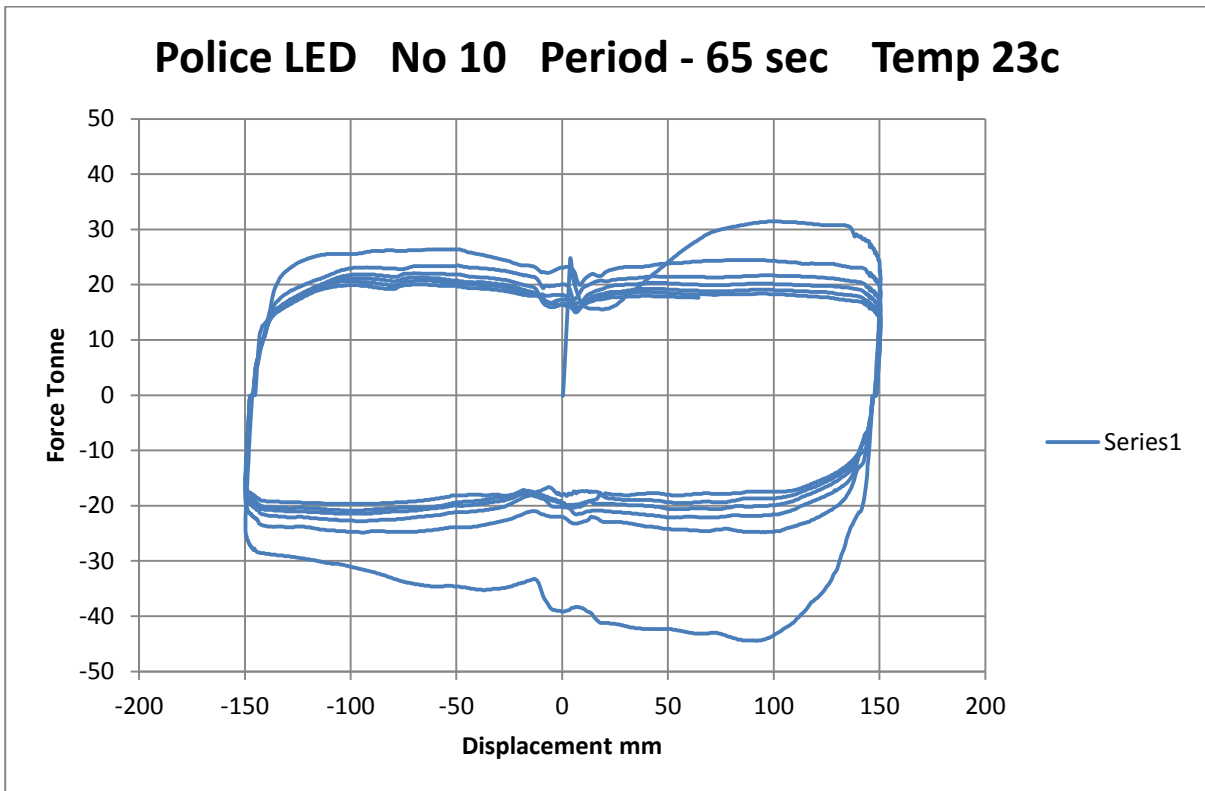
The initial test consisted of six extension and compression cycles each ± 150 millimetres with the instruments automatically recording force and movement. The machine cycled less rapidly than would be expected of a large earthquake and corrections for this are discussed later.

Figure 8: Hysteresis loops for the first six cycles. The trace starts at the zero - zero position and then circulates in a clockwise direction. The first cycle shows larger than design forces (+32 and -44 tonnes) but on the second cycle the forces fall to design (about 25 tonnes). The force decreases on subsequent cycles as the lead increases in temperature and becomes softer. (Note that 25 tonne force is almost identical to 250 kN.)

and allowed the lead to form some sort of bond with the surrounding steel cylinder. To break this supposed bond, an attempt was made to inject new grease at high pressure, slightly expand the cylinder, and so allow grease to spread between the lead and the surrounding steel. It is probable that this attempt failed.

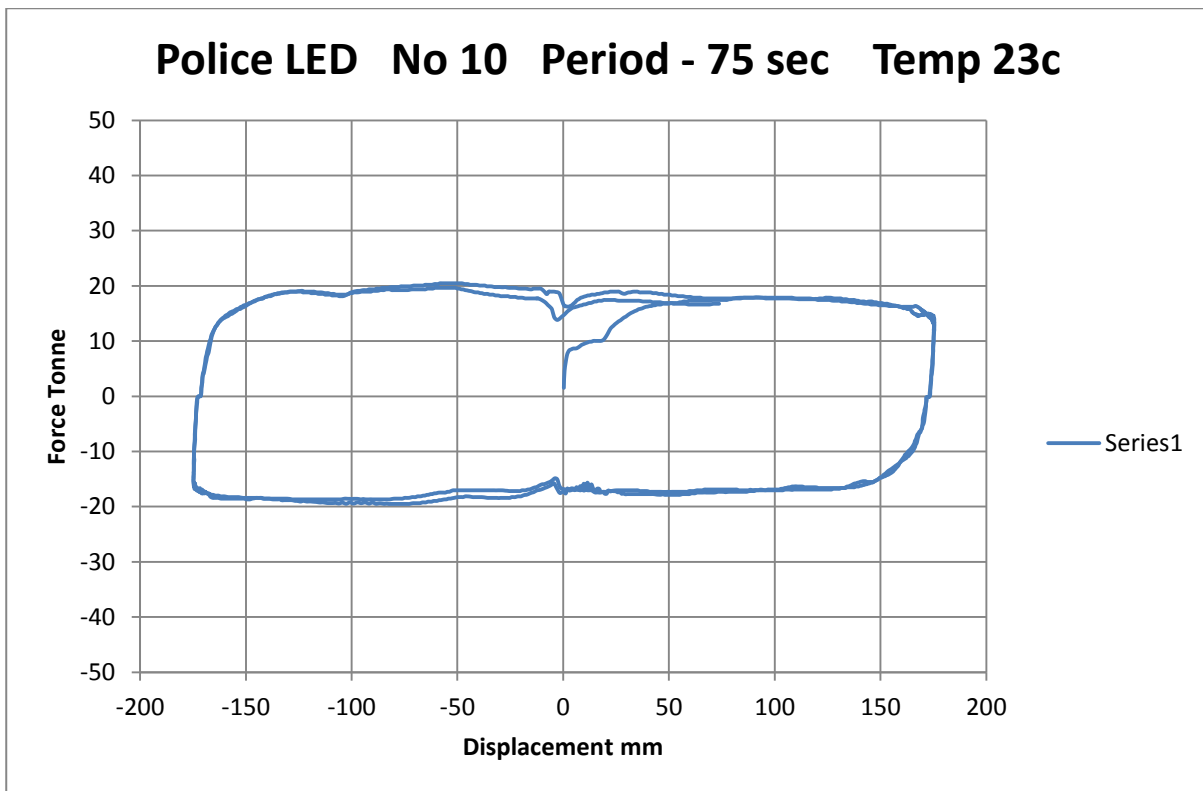
Twenty four minutes after the first six cycles were completed the test rig was set to give an increased stroke of ± 175 millimetres. The purpose of this was to look for evidence of an

undesirable sudden spike in force as the damper moved past its previous limit.

Figure 9: *Hysteresis loops from a second series of tests. The behaviour shown is excellent, with no spikes in force, but a reduced maximum (20 tonnes) as would be expected from the lead core having a higher initial temperature.*

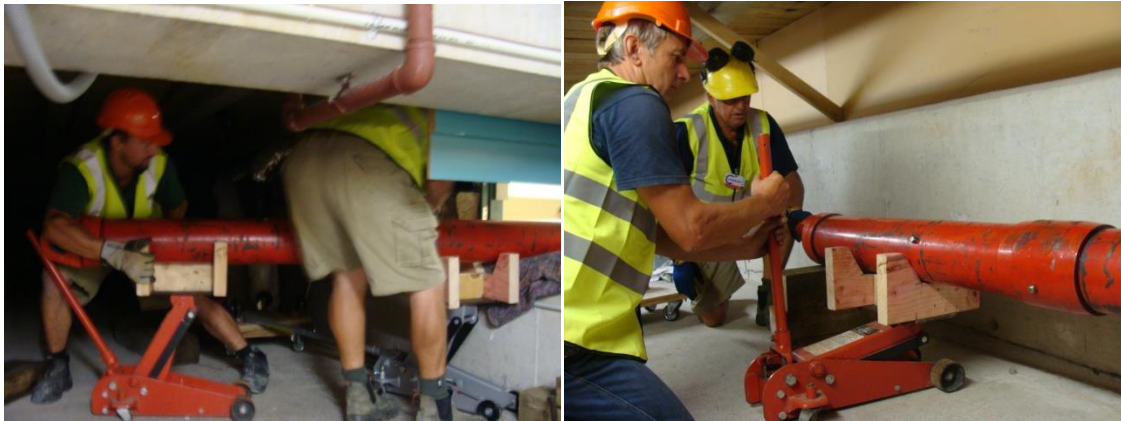
Figure 11: *Left, damper No. 10 being rolled in through hatch. Right, damper turned parallel to installation position. In both pictures the damper is supported on wooden blocks fastened to floor jacks.*

The exchange, executed on 7 February 2013, is best described pictorially.

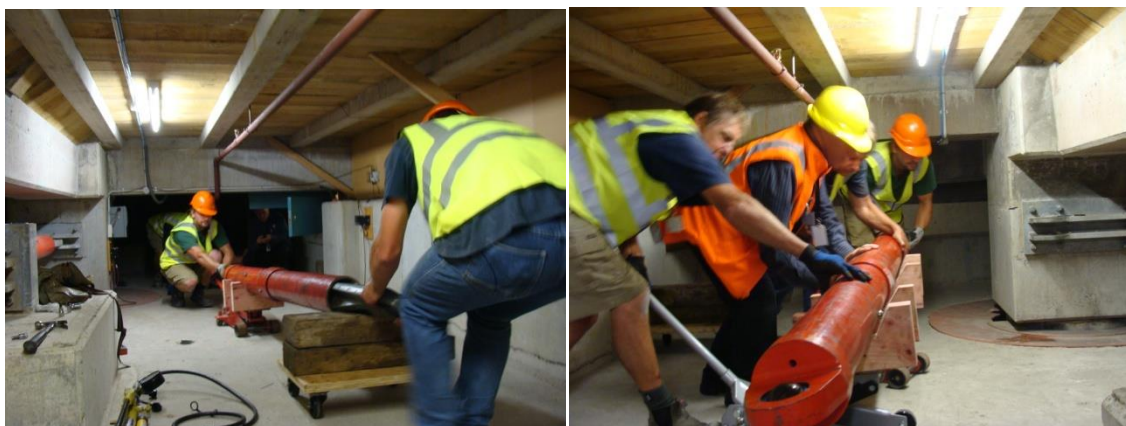
Figure 12: *Left, damper being transferred to trolley. Right, damper returned to floor jacks ready to be lifted to correct height and rolled into position.*

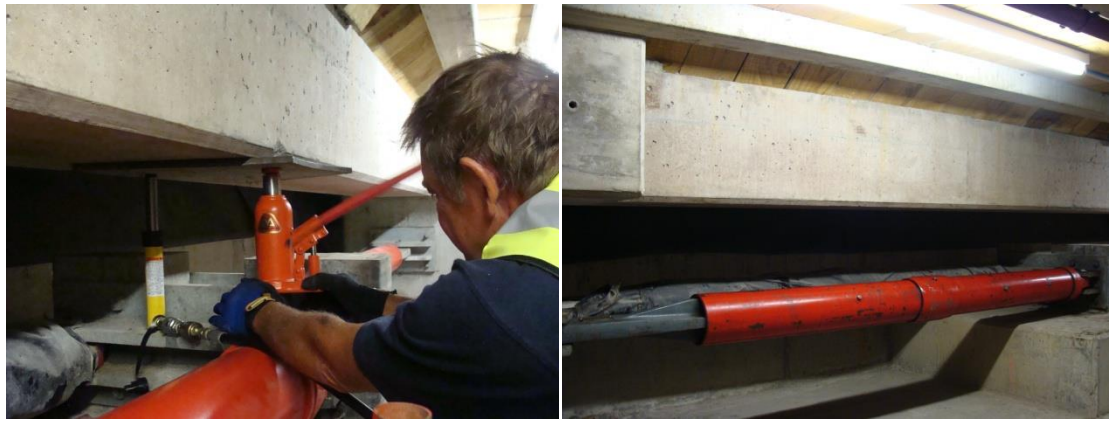
Figure 13: *Left, equipment improvised to extract pin at right hand end from No. 21 damper. Right, No. 10 "spare" damper in place previously occupied by No. 21.*

Extracting and inserting the pins was worthy of note. The pins made for the 2012 tests could be tapped in and out with light hammer blows with no load on the damper, but this was not expected to be possible for a damper with 24 years' service history for two reasons:

With the left pin out, there could be no residual force on the damper, and it was expected the right pin would move easily. This proved not to be the case. At the right hand end the jack had to be on the edge of the beam above, and when a small piece of concrete spalled away the crew found it necessary to improvise the system shown on the left side of Figure 13. A piece of flat steel plate about 10 mm thick protected the concrete edge and provided a small overhang to give a secure position for a truck-type jack. With this arrangement the pin moved in a series of jerks, each requiring 100 - 200 kN, and each accompanied by a loud 'bang' which caused some anxiety to staff on the floor above.

The crew found it impossible to insert the old pins into damper No 10. Hence they substituted the new pins made for the 2012 tests – these featured a taper at their lower ends, and were able to be inserted with light taps of a hammer. Copious quantities of WD 40 penetrating oil helped.

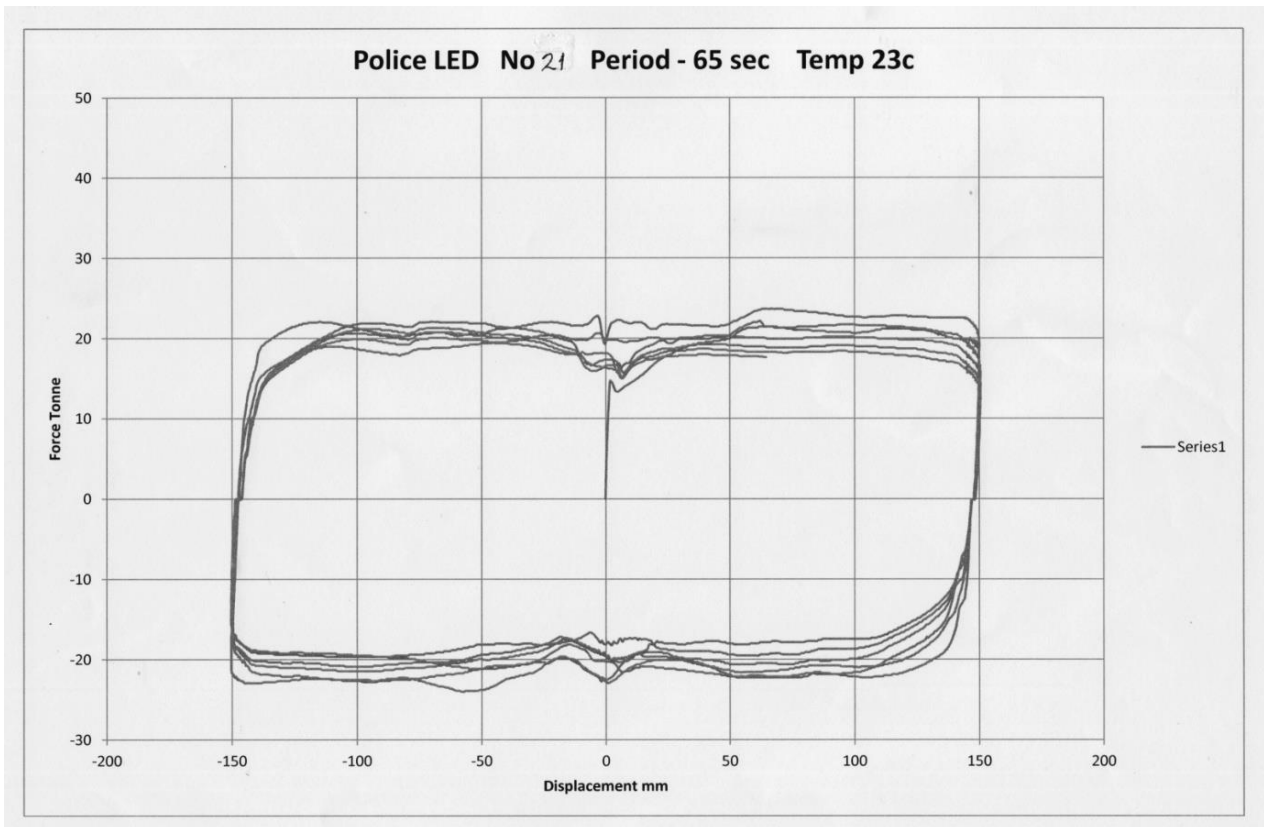
Figure 16: Force-displacement hysteresis loops from first test in 2013 on damper No. 21, showing "as-new" performance. The damper heats up during cycling, thus softening the lead, and so each successive loop occurs at a slightly lower force.

Following the successful demonstration of the efficacy of greasing damper No. 21, the Police accepted the author’s recommendation to leave spare damper No. 10 in position, to keep “used” damper No. 21 at Robinson Seismic, and to grease the other 23 dampers whilst they remained in place.

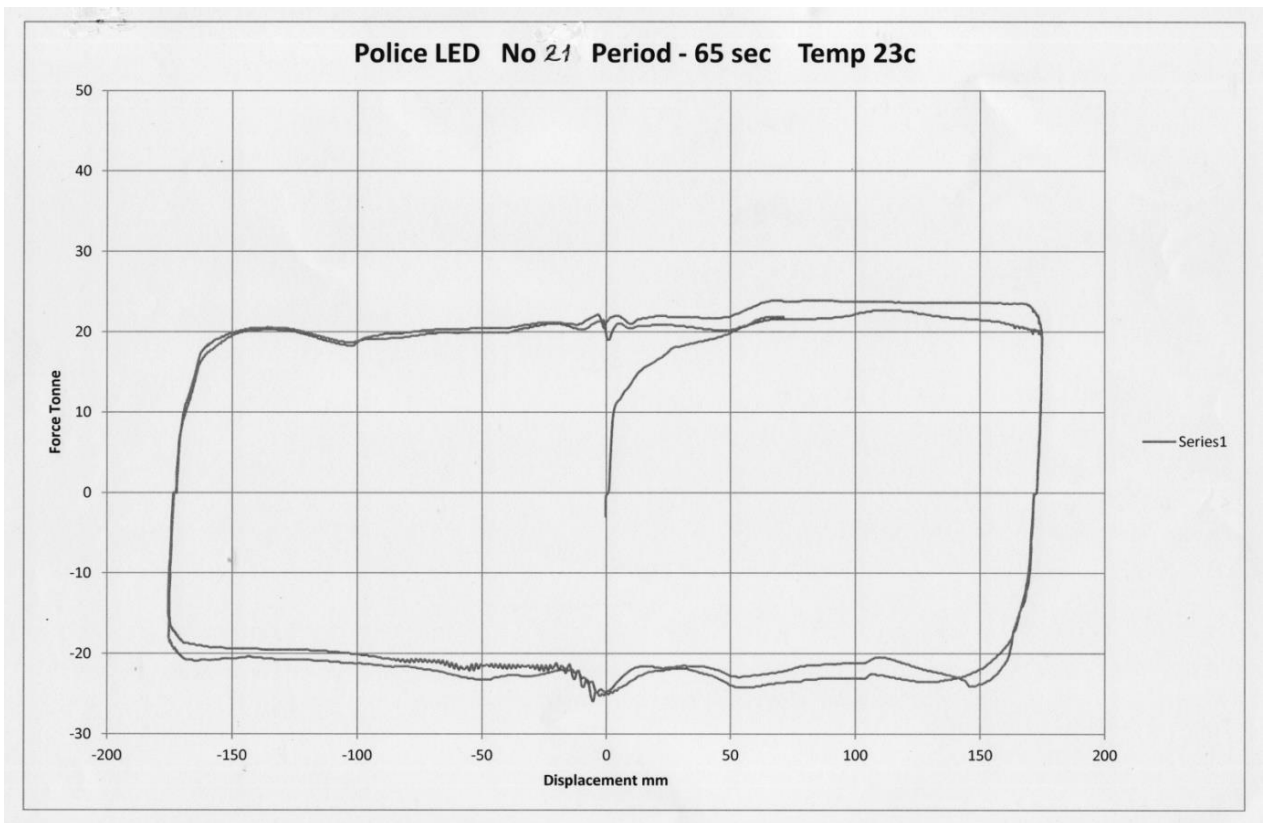
Figure 17: Force-displacement hysteresis loops from second test on damper No. 21. The test machine was set to change direction at ± 175 mm for this test, thus simulating a severe aftershock.
