FERRYMEAD BRIDGE – FROM WIDENING AND SEISMIC UPGRADING TO REPLACEMENT, A CASUALTY OF THE CHRISTCHURCH EARTHQUAKE

D. Kirkcaldie¹, P. Brabhakaran¹, M. Cowan¹,
C. Wang¹, G. Hayes¹ & L.Greenfield²

This paper was presented at the NZSEE Technical Conference and AGM in Wellington,
April 26-28 2013.

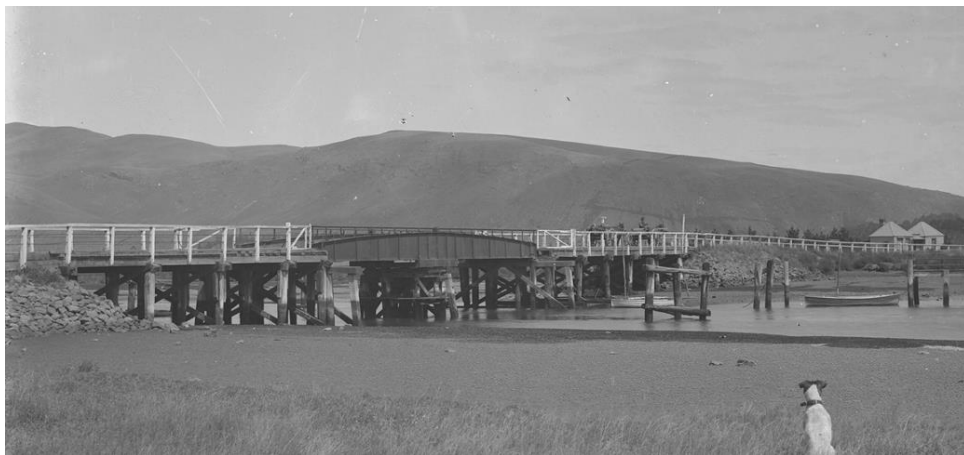
Figure 2: The 1864 Swing Bridge at Ferrymead (JN Taylor photograph, WA Taylor collection, Canterbury Museum).

The first bridge at the site completed in 1864 (Figure 2) was a timber structure with a rotating steel centre section to allow for navigation. This rotating section was retained after demolition shortly after 1907 and is now a single span bridge further upstream at Bowenvale. The second timber structure completed in 1907 (Figure 3) included a bascule bridge, parts of which are incorporated into a tram bridge at the nearby Ferrymead Historic Park. The third structure that was completed in 1967 comprised a 3 span prestressed concrete structure shown in Figure 4 and carried approximately 30,000 vehicles per day until it was recently demolished. The structure was also part of the over-dimensioned overweight

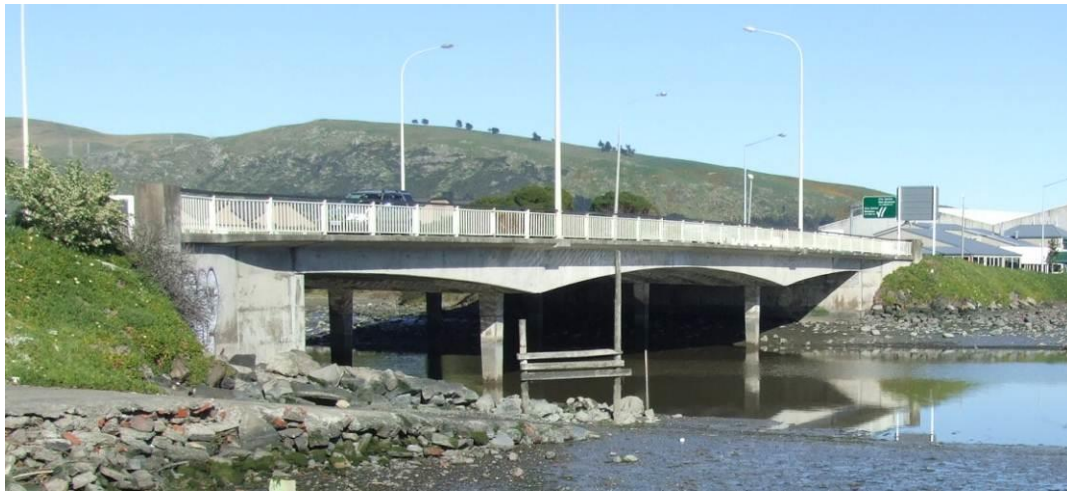
Figure 4: The recently demolished 1967 Ferrymead Bridge.

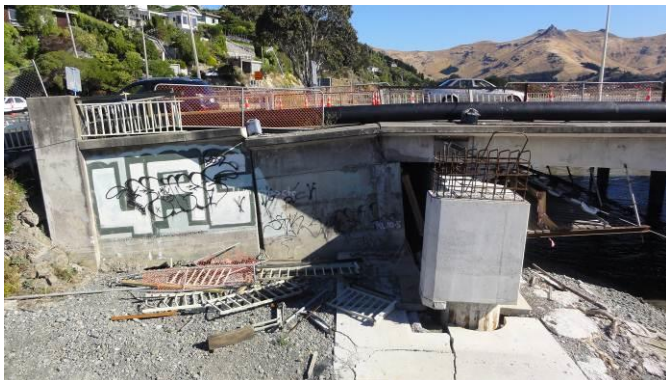
Figure 5: *The Mt Pleasant abutment, displaced forward and rotated backwards about its raked piles founded on the bedrock; new bridge widening piles displaced outwards by lateral spreading.*

Damage to the existing structure and approaches was very much as expected with liquefaction generating distortion, cracking and settlement of the approaches and damage to the water mains and pumped sewer main. Lateral spreading generated abutment rotation and pier pile cap displacement towards the centre of the river, as can be seen in Figures 5 and 6, and liquefaction caused settlement of those piles not founded on rock. The bridge was immediately closed pending assessment.

Significant damage to the widening and strengthening works also occurred due to lateral spreading displacing the already completed abutment piles and their partly completed headstocks.

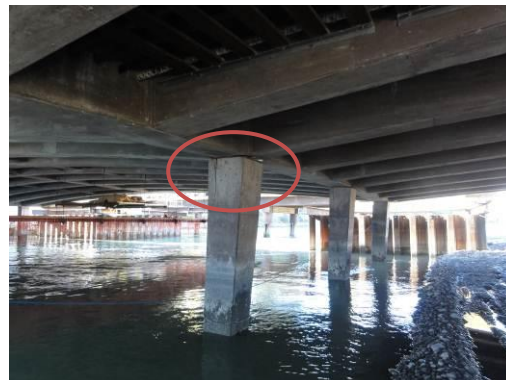
Figure 6: *Pier columns rotated due to inward displacement of their supporting pile caps.*

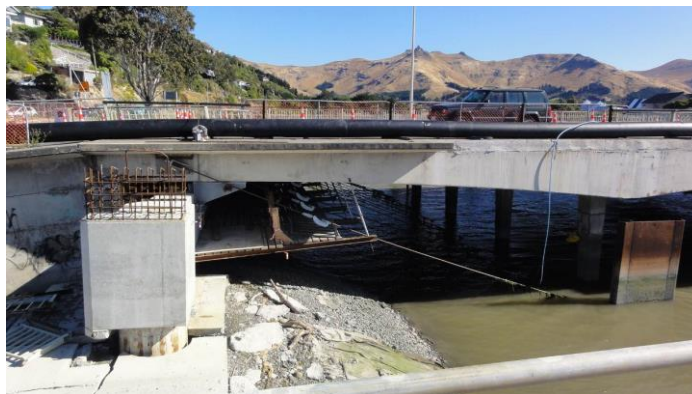
Figure 7: *Tie rods installed to restrain the pier pile caps against further inward displacement.*

In addition, two measures were taken to secure the pier pile cap against further displacement. Firstly, the material directly contributing to lateral spreading behind the pier pile cap was removed, and secondly, tie bars were introduced to restrain the pile cap as shown on Figure 7.

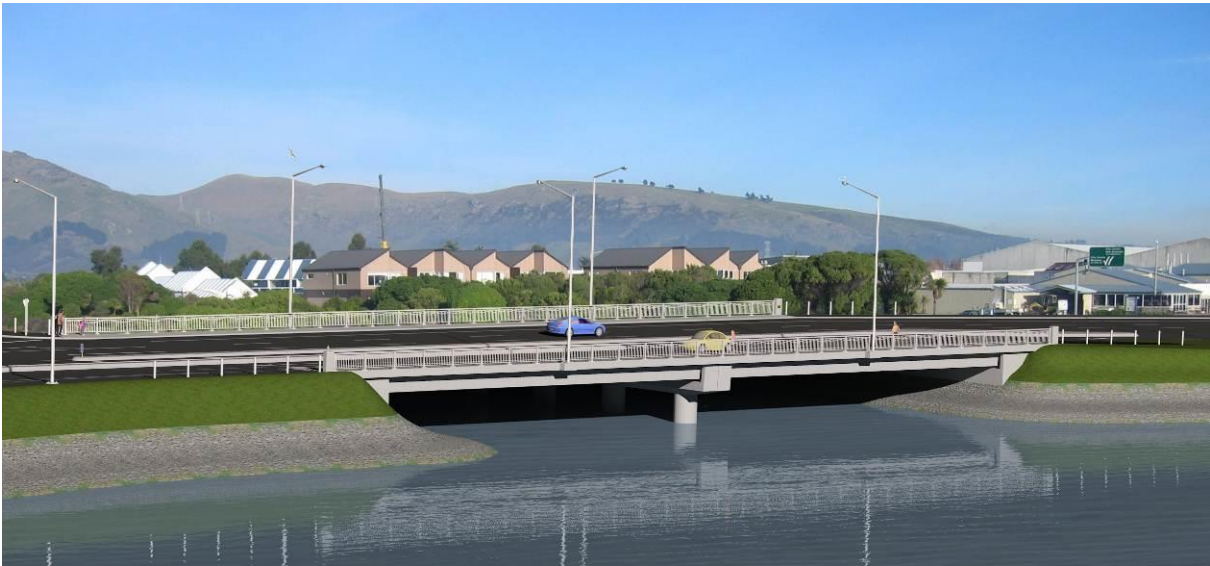
Figure 9: Photo-montage of the proposed replacement Ferrymeade Bridge.

bridge solution, with a two span solution expected to result in less out of balance loading acting on the pier piles from soil lateral spreading. Precast prestressed concrete and steel superstructure options were considered, with a two span bridge comprising precast prestressed super-T beams being selected as the preferred solution giving consideration to cost, durability and maintenance requirements in the coastal environment of this bridge (refer Figure 9).
