EXPERIMENTAL IN-PLANE PERFORMANCE OF INSULATED CONCRETE AND BRICK MASONRY WALL PANELS RETROFITTED USING POLYMER COMPOSITES

Najif Ismail¹, Tamer El-Maaddawy², Amanullah Najmal³ and Nouman Khattak⁴

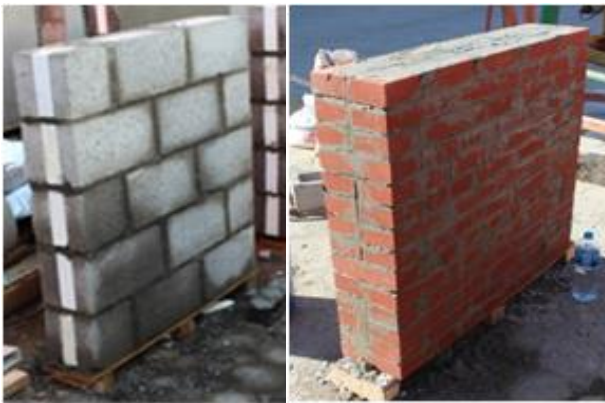
(a) IMU unit

(b) IMU test wall

(c) URM test wall

Figure 2: Photos of test wall panels

buildings i.e. those built prior to the introduction of seismic resistant provisions. The second type of masonry tested was insulated concrete masonry (IMU), which has been widely used in modern MIF buildings located in regions with hot climate owing to its perceived thermal insulating properties. The masonry test panels were constructed to replicate constituent material properties and construction details typically found in existing buildings. Figure 2a shows an IMU unit, and Figures 2b and 2c show photographs of an IMU panel and a URM test panel, respectively.

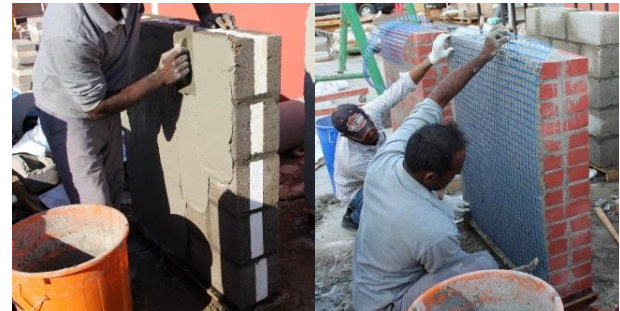
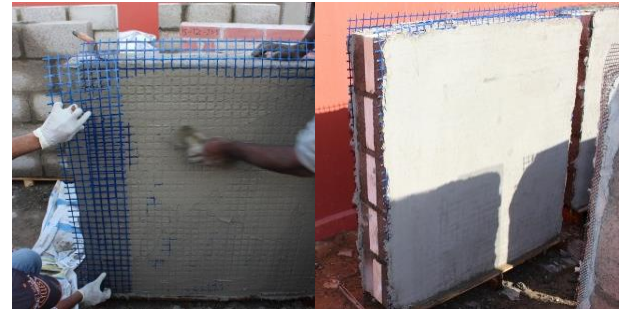
a) matrix application

b) fabric introduction

c) fabric overlap

d) finished test wall

Figure 3: FRCM strengthening of test walls.

fine-grained aggregates, special admixtures and synthetic polymers. Freshly prepared FRCM matrix was applied onto full surface of test walls (see Figure 3a) using a flat metal trowel, by keeping a uniform thickness of 3-5 mm. The reinforcement fabric was lightly pressed into the freshly applied matrix layer (see Figure 3b). The horizontal fabric rovings were kept parallel to the direction of masonry bed joints. Over this the final finishing matrix layer was applied (see Figure 3c) and the surface was trowelled to ensure a consistent thickness. Total thickness of the FRCM overlay was kept approximately 8-15 mm. As the FRCM fabric comes with a fixed width of 0.9 m, its application on different structures would require lap splicing. In this study, an overlap of 152 mm (as suggested by ACI-549.4 [19]) was used. Two specimens were provided with two layers of basalt fabric to see the effect of double layer of FRCM. Test walls were left for curing for 28 days in ambient conditions prior to testing. A finished FRCM strengthened test wall is shown in Figure 3d. Shown also is a photo in Figure 3e showing the FRCM being applied to a heritage URM building located in Auckland.

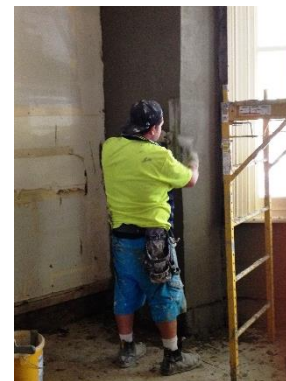
e) application of FRCM in a URM building in Auckland
