## **SURVEY OF IMPACTS ON THE ANDAMAN COAST, SOUTHERN THAILAND FOLLOWING THE GREAT SUMATRA-ANDAMAN EARTHQUAKE AND TSUNAMI OF DECEMBER 26, 2004.**

### **SUMMARY**

This report on the Sumatra-Andaman great earthquake and tsunami of December 26, 2004 describes the event and its impacts in southern Thailand. It includes the observations of the New Zealand Society for Earthquake Engineering Reconnaissance Team gathered one month after the event. The report covers the effects of the tsunami on the natural and built environment, and the recovery process in relation to social and economic issues. Lessons applicable to the understanding and potential mitigation of tsunami risk in New Zealand are presented and discussed.

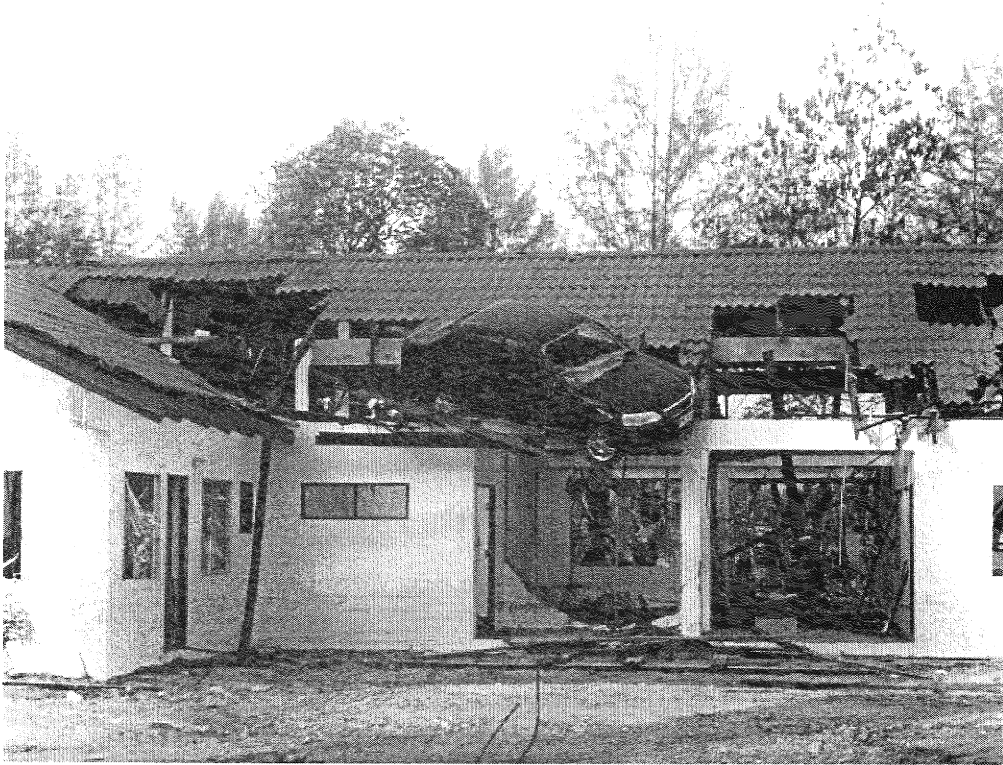
*Figure 4. Tsunami wave heights were inferred from strand-lines and watermarks on buildings. In this case a car was lifted above the roofline of a resort in Khao Lak (Photo Thai Meteorological Department).*

Khao Lak was hit by tsunami waves with measured run-ups varying from 4 m up to 14 m, suffering the most serious devastation in terms of people killed and hotel/resort damage (Figure 4 and 5). Few of the hotels or resorts in Khao Lak, which had a total of around 5,500 rooms, were left standing. It is estimated that more than 1,000 people died in Khao Lak and 80% of the coastal facilities suffered serious damage. It is estimated that the lethality ratio in the impacted coastal strip was around 25% of people (EEFIT, 2005). Penetration inland was up to 3 km in the widest part of the coastal strip at Pakarang Cape (Figure 3). In central Khao Lak, a police patrol boat off Bang Niang Beach was driven by the tsunami 1.2 km inland, narrowly missing a shopping complex (Figure 6). While damage was severe to resorts along the coastal strip, the town of Khao Lak and the main road farther inland suffered only moderate damage in low-lying areas and adjacent to rivers. The reason for the

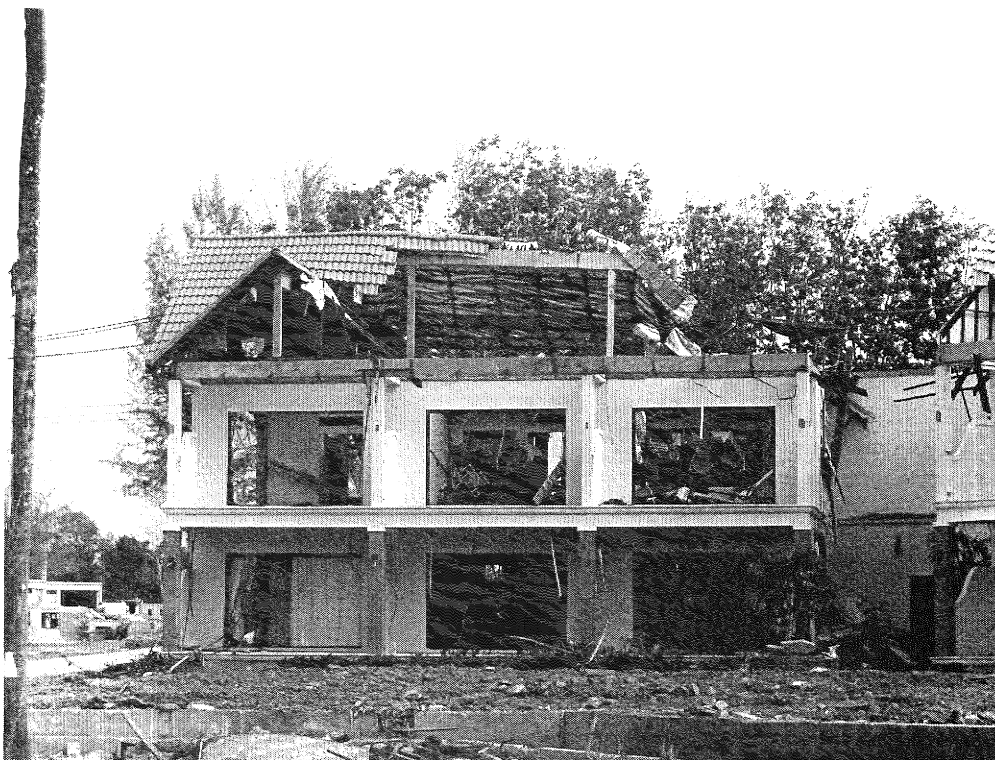
*Figure 5. Missing roof tiles indicate the tsunami torrent depth exceeded nine metres at this location in Khao Lak (Photo ED).*

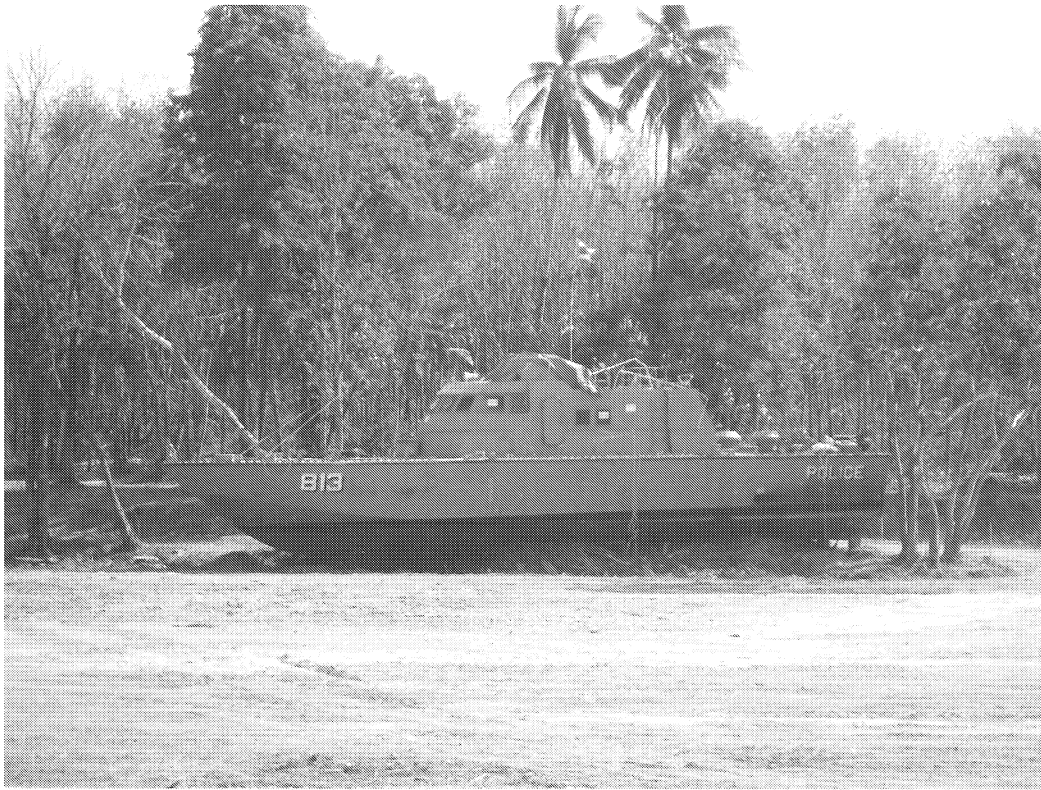
*Figure 6. One of two police patrol vessels caught by the first tsunami wave off Khao Lak – this one was carried 1.2 km inland narrowly missing a shopping complex; the other vessel rolled and sank near the coast. (Photo RB).*

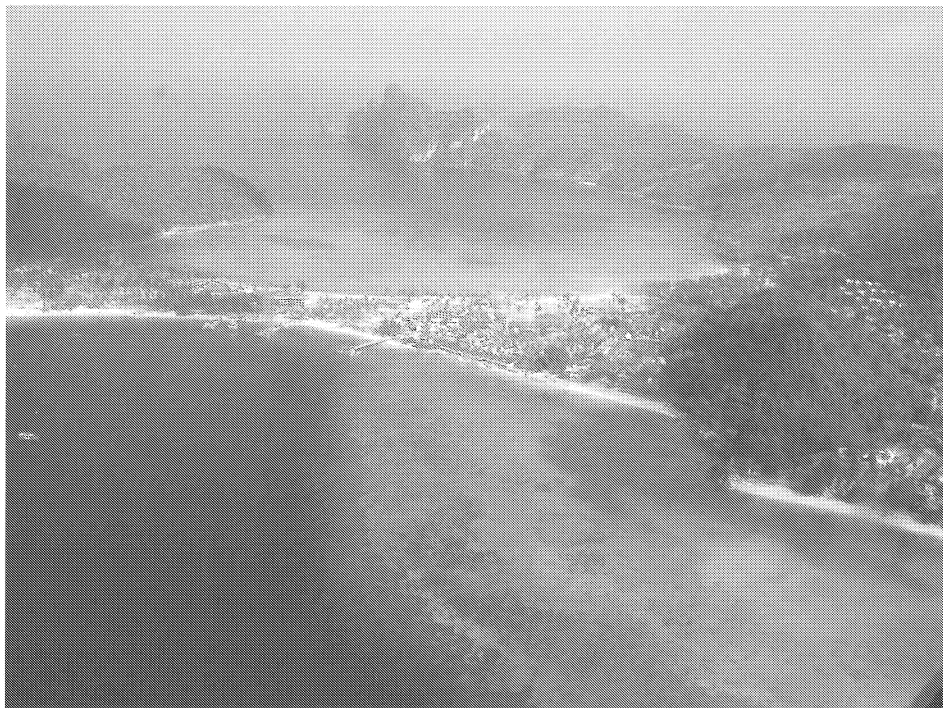
*Figure 7. Phi Phi Island viewed from the air as the team approached by helicopter from the southeast. The tsunami wave traversed the sand-spit at depths of up to nine metres, first from the north and a few minutes later again from the south (Photo ED).*

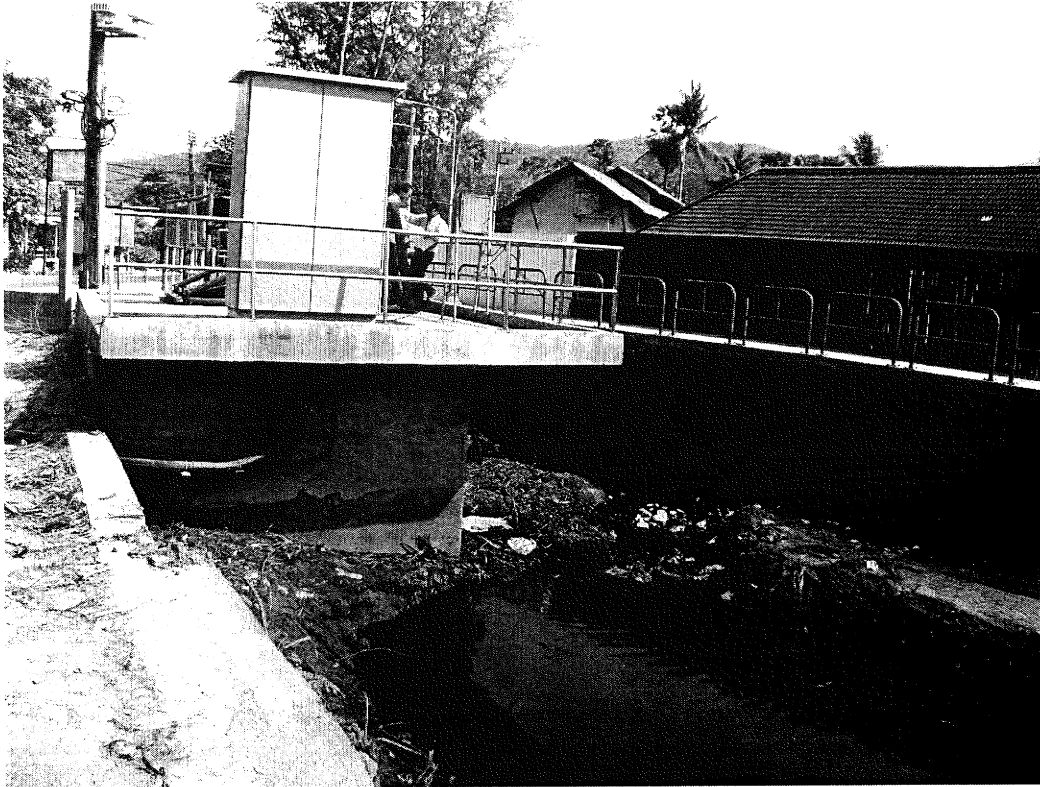
This was repeated at the many affected resort areas along the Thai coast. In some cases even though the plant (e.g. pumping stations) was not physically damaged, it was rendered inoperable by the tsunami having inundated the control electrics and mechanisms at various collection points (Figure 9a and 9b).

*Figure 9a and 9b. Inspecting damage to a sewerage pumping station at Kata Beach, Phuket Island. Electrical control systems were damaged beyond repair, causing sewer overflows into the adjacent stream, and discharge onto the nearby beach (Photos RB and HC).*

A month after the tsunami, minor sewer overflow discharges were still continuing at some beaches while authorities were waiting for repairs and replacement components. They were very aware of the need for speedy repairs to preserve the pristine image for the numerous resorts.

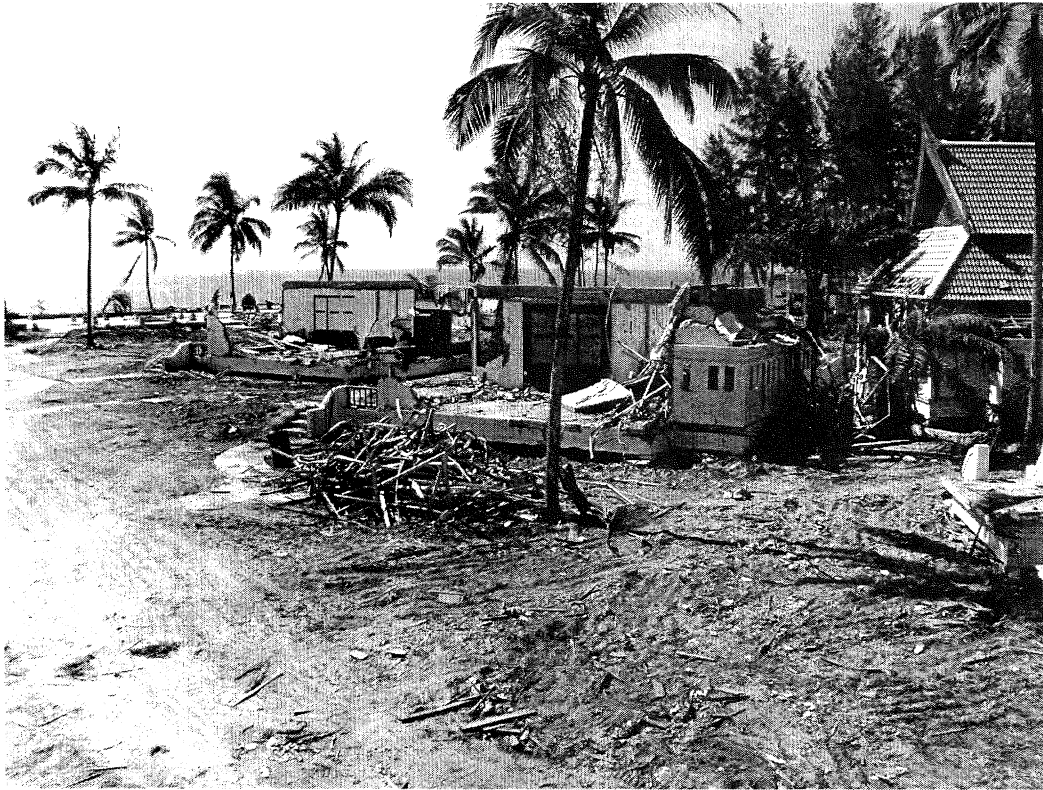
Most of the damaged and collapsed single storey buildings had been cleared by the time of the visit. The extensive areas of cleared sand gave an indication of the large number of buildings that had been destroyed. These buildings included detached bungalows, bars, restaurants and those associated with the resorts. Those that remained standing through the torrent appeared to have been either well sheltered by buildings in front or were very well tied at foundation and eaves levels, with numerous partition walls (Figure 11).

*Figure 11. View to seaward at one of the coastal resorts in Khao Lak. Foundations are all that remains of the single-storey buildings closest to the beach. A gradation in the severity of damage owed more to the protection afforded by adjacent structures than to the absolute distance inland (Photo HC).*

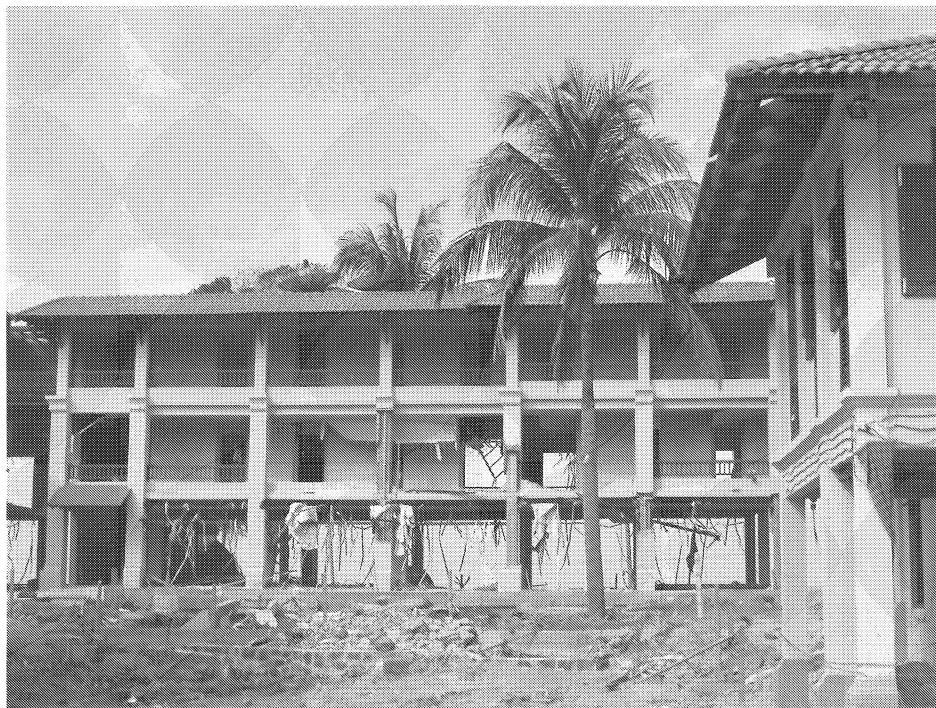
The multi-storey buildings were extensively damaged in the ground floors with walls facing the torrent blasted through (Figure 13). Once the tsunami was able to flow through the lower storeys the loadings on the building would have been significantly reduced and the remaining walls, generally in the direction of flow, were able to provide in-plane resistance. An extreme example of the difference of impact forces occurred at Kamala Beach School, Phuket where a new school two-storey block under construction with no ground storey infill walls survived while two completed similar buildings were destroyed.

*Figure 13. One of resorts at Khao Lak located a few hundred metres from the shoreline, where the highest tsunami run-up (12m) occurred. Water entered rooms even on the third floor, and in-fill block walls and windows on the first and second floors were punched out (Photo ED).*

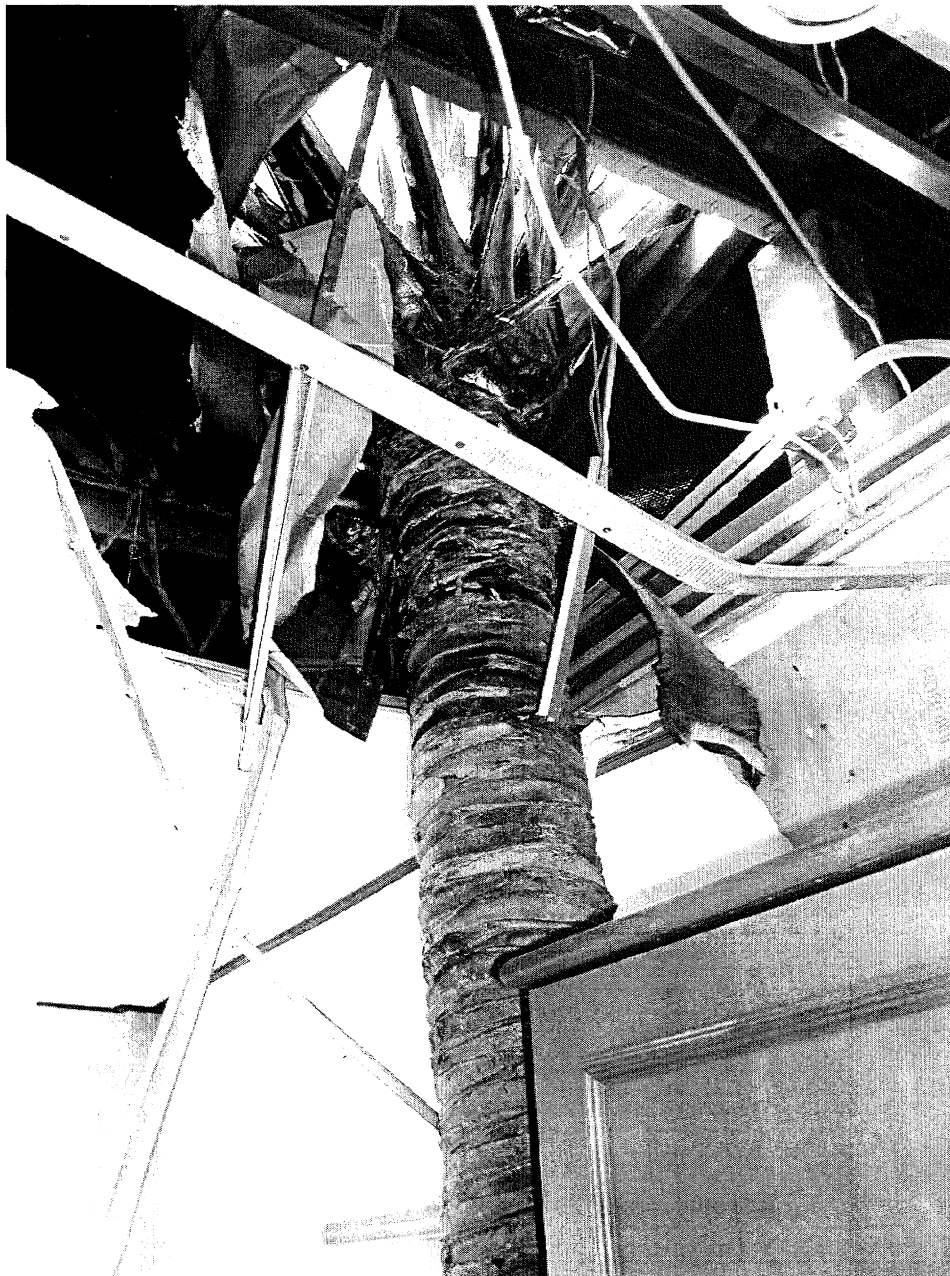
Ten to twelve metre run up heights in Khao Lak meant that for many buildings the inundation extended to the second, and locally the third, storey. While the damage to partition walls was significantly less in the higher storeys, ceilings and furniture and fittings were caught up in the torrent and damage was frequently initiated by the impact of projectile logs and other debris (Figure 14).

*Figure 14. Extraordinary volumes of debris were entrained by the tsunami and contributed to its destructive impact. This coconut palm trunk penetrated the roof and internal ceiling of a hotel on Koh Phi Phi (Photo ED).*

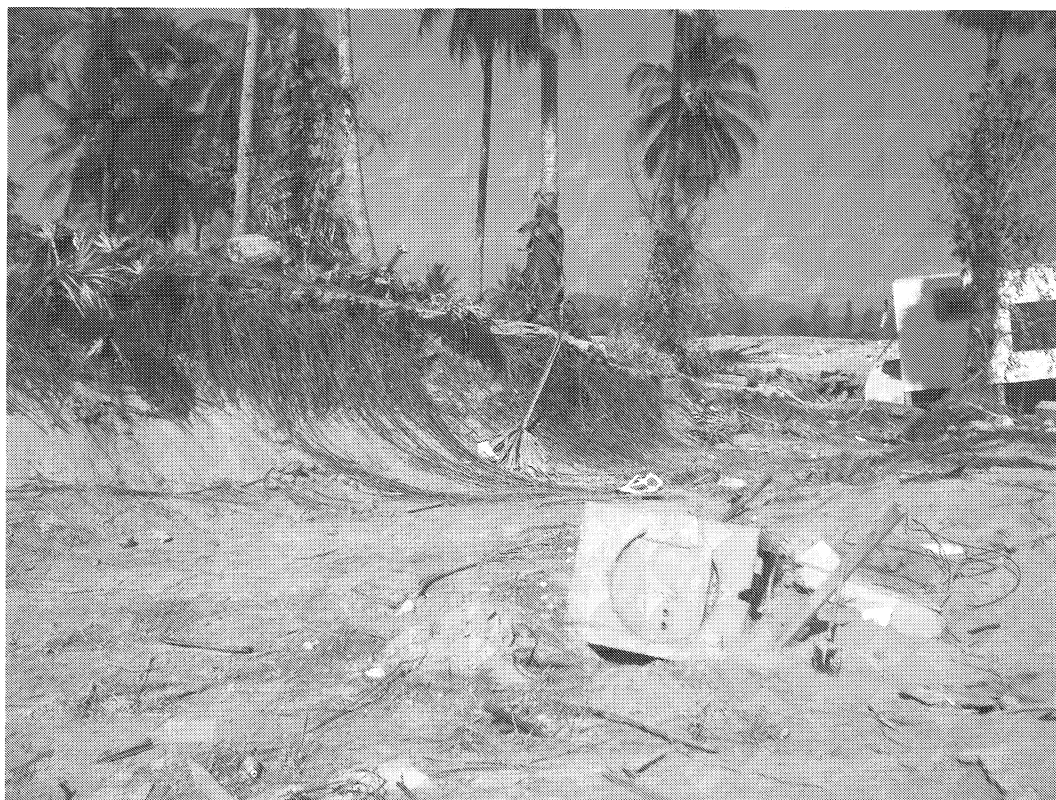
What had not been expected by our team was the extent of damage caused to buildings by the outwash flows in between incoming tsunami torrents. The inundations from the tsunami surge lasted for up to 10 minutes. After that the retreating water flowed to rivers, streams or the nearest low-lying area, scouring wide deep channels that undermined buildings, bridge abutments and roads (Figure 15a and 15b). While buildings on piles remained stable, in some locations the scouring undermined buildings that led to collapse, especially for those on spread footings. In other locations well connected new structures on spread footings were bodily moved up to six metres and were left partially collapsed and leaning at odd angles. In one instance, in-ground swimming pools were fully exhumed and unevenly displaced. The sand around some buildings showed signs of having liquefied leading to underground services tanks floating up above ground level (Figure 16).

*Figure 15a and 15b. The receding waters after each wave caused substantial scouring of small streams and low-lying depressions, as shown here at Khao Lak. The scoured “channel” (15a) is 50 m wide and up to 3 m deep, completely undermining the resort buildings (15b) nearby (Photos RB).*

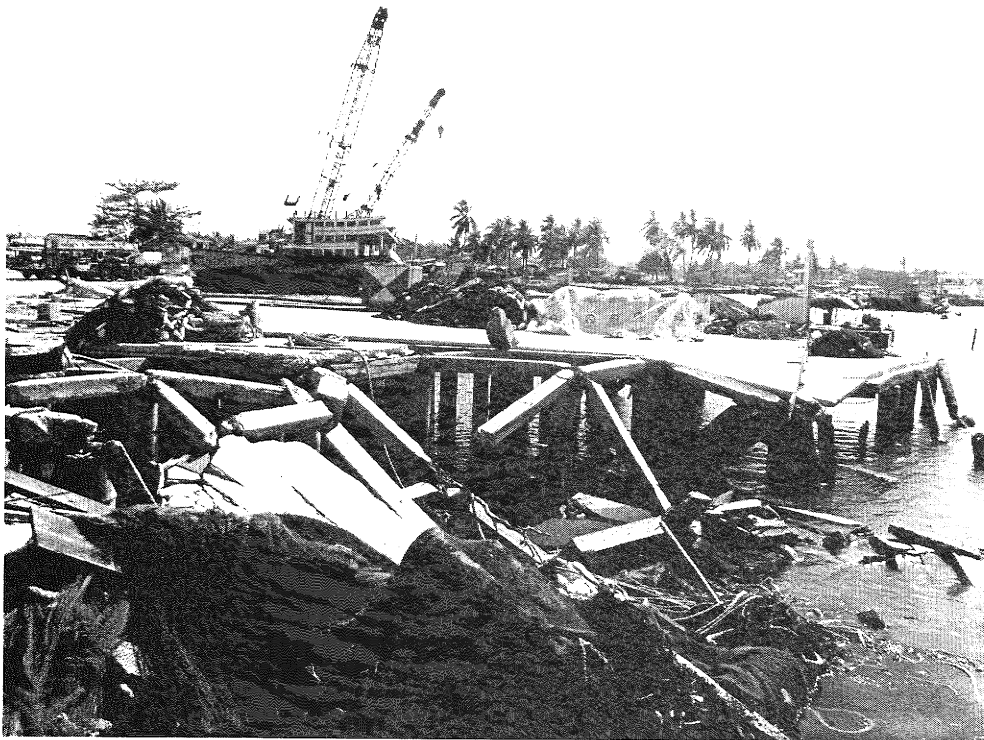
*Figure 17. Severe damage to the wharf piles and topping at Ban Nam Kem, a fishing port north of Khao Lak, where the tsunami height reached nine metres (Photo HC).*

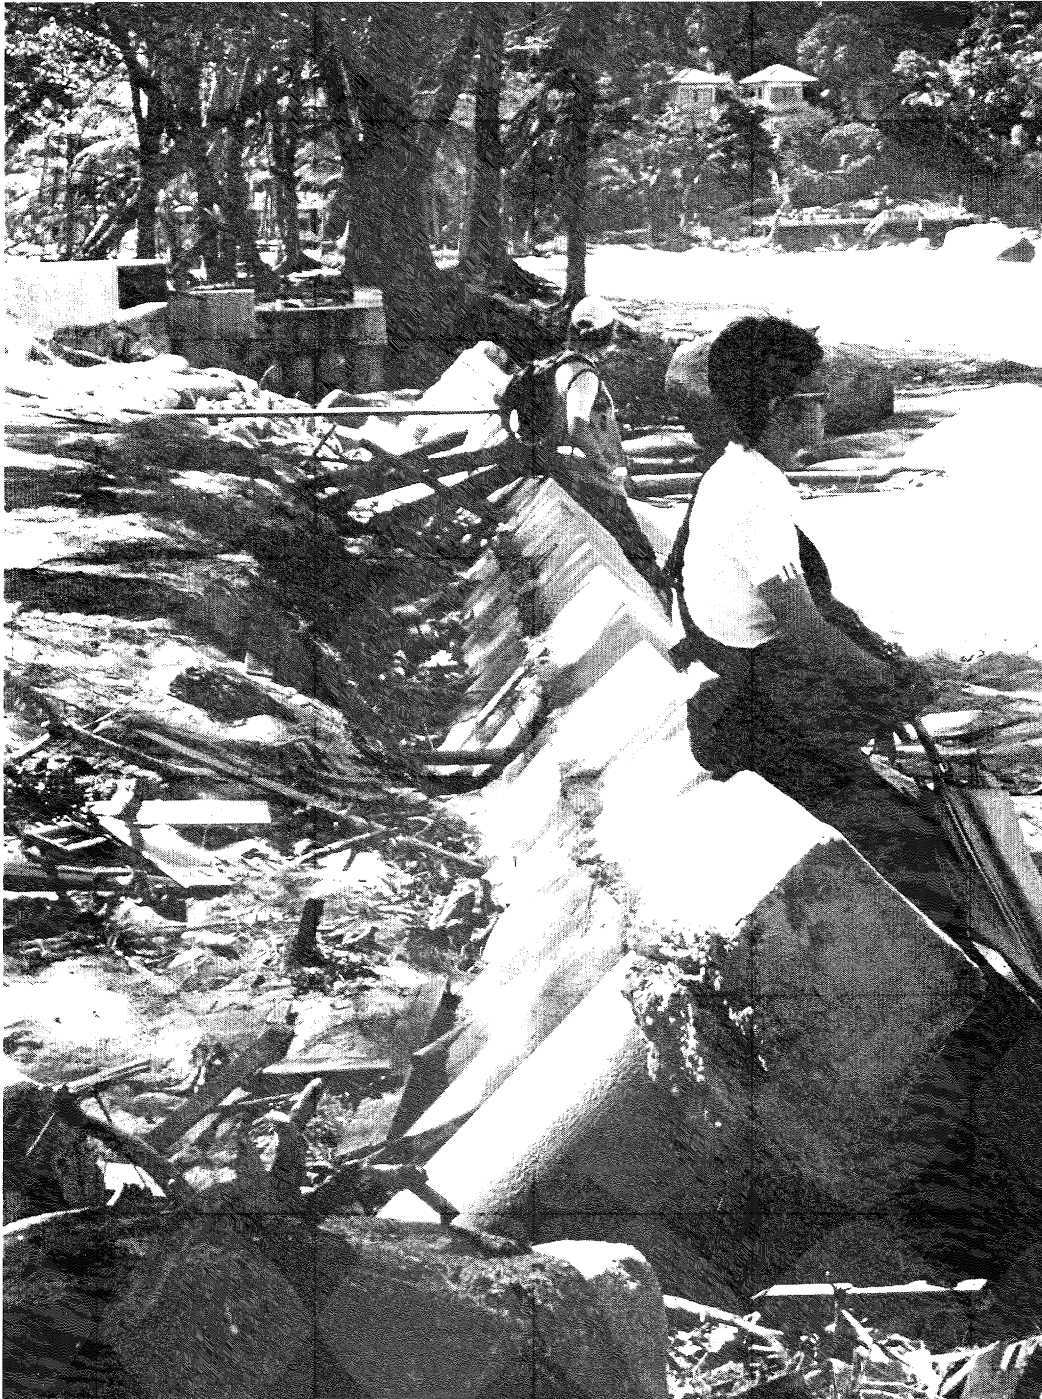
*Figure 18. Receding waters (out-rush) caused collapse of most seawall defences from behind due to scouring (Photo RB).*

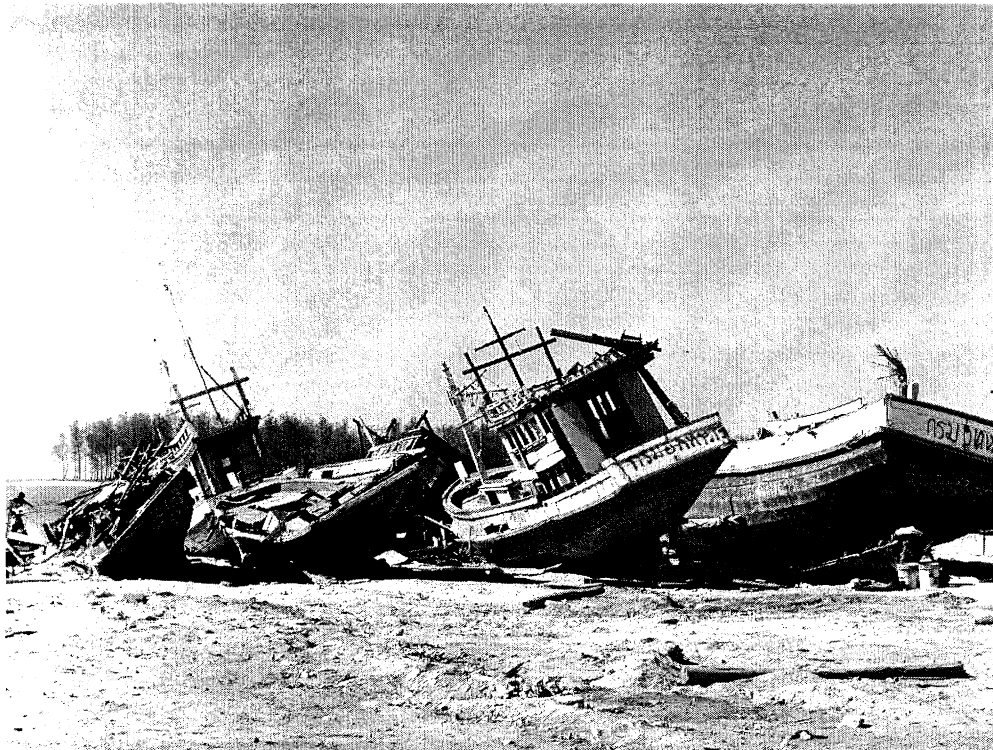
The tsunami also caused significant damage to the local fishing industry (Figure 19), with around 20% of officially registered boats suffering damage (EIU, 2005). The Department of Fisheries estimates that a total of 7,446 fishing boats were lost (UNDP, 2005a).

*Figure 19. At Ban Nam Kem, fishing and port facilities were destroyed, many lives were lost and the ecology of coastal fishing grounds altered. The economic recovery from the tsunami poses a significant challenge to this community and others like it along the Andaman coast (Photo ED).*
