**REPORT OF THE NEW ZEALAND RECONNAISSANCE  
TEAM TO THE AREA OF THE 17 JULY 1998 TSUNAMI AT  
SISSANO LAGOON, PAPUA NEW GUINEA**

**SUMMARY**

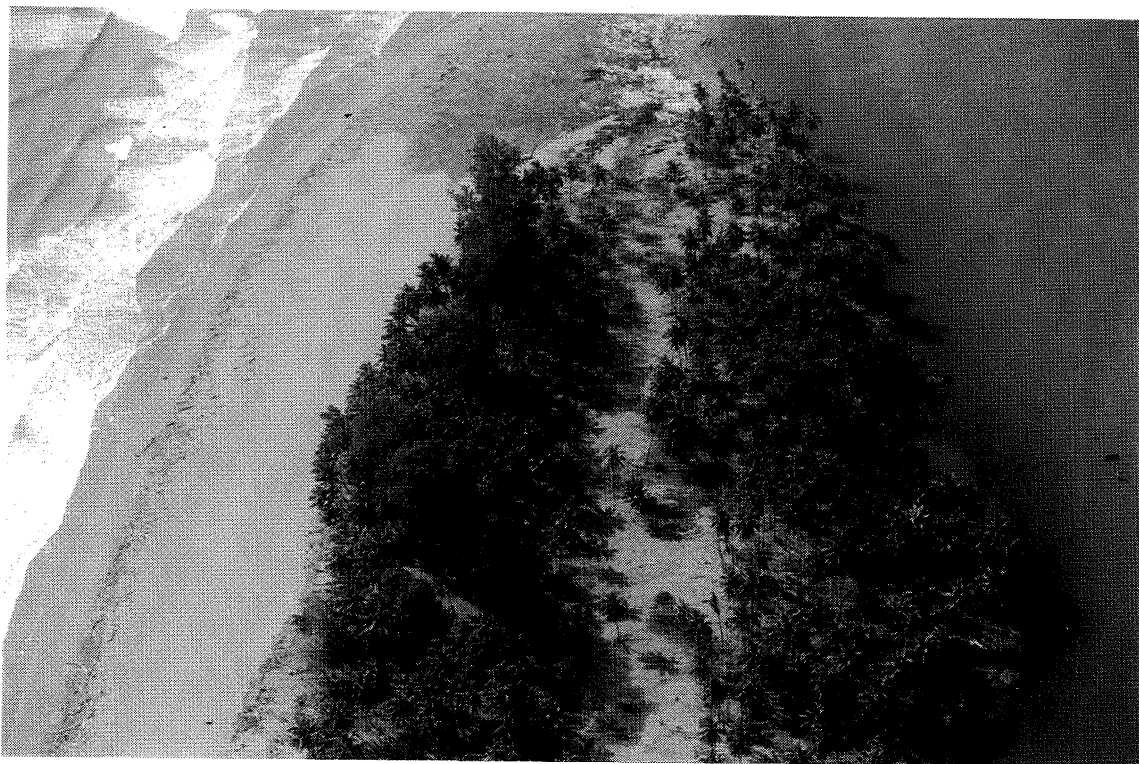
**Figure 2:** The former site of Warapu Village. Houses once lined the main street (centre). Profiles and heights of tsunami (Figure 9) were measured here.

The flights between Vanimo and Aitape passed over the damaged area and provided excellent opportunities to review the scene (Figure 2).

transects on the area of the spit that was the former site of Warapu village (Figures 1, 2 and 9). Sediment samples were taken along each transect and a 1.5 metre core (Figure 10) was taken at the lagoon edge. Results indicate a maximum wave height of up to 17.5 metres above sea level (Figure 9). The heights, however, are uncorrected for bending of the trees by the rushing water. Maximum heights varied locally by as much as 4 metres, possibly reflecting local reinforcement of the tsunami by incoming ocean swells.

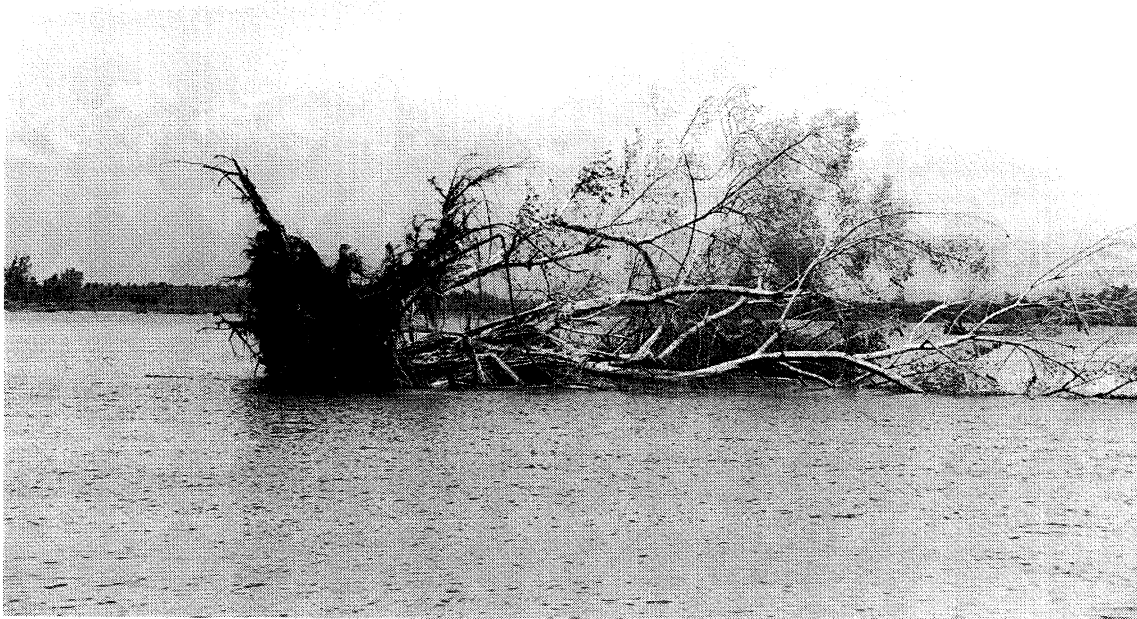
**Figure 4:** *Mature tree ripped from Warapu village and deposited more than a kilometre away in Sissano Lagoon. Note the shallowness of the water indicated by the grounded tree.*

General observations were made of damage to structures and lifelines. Dwellings, mature trees and people were plucked from the site and transported several kilometres into the lagoon (Figure 4).

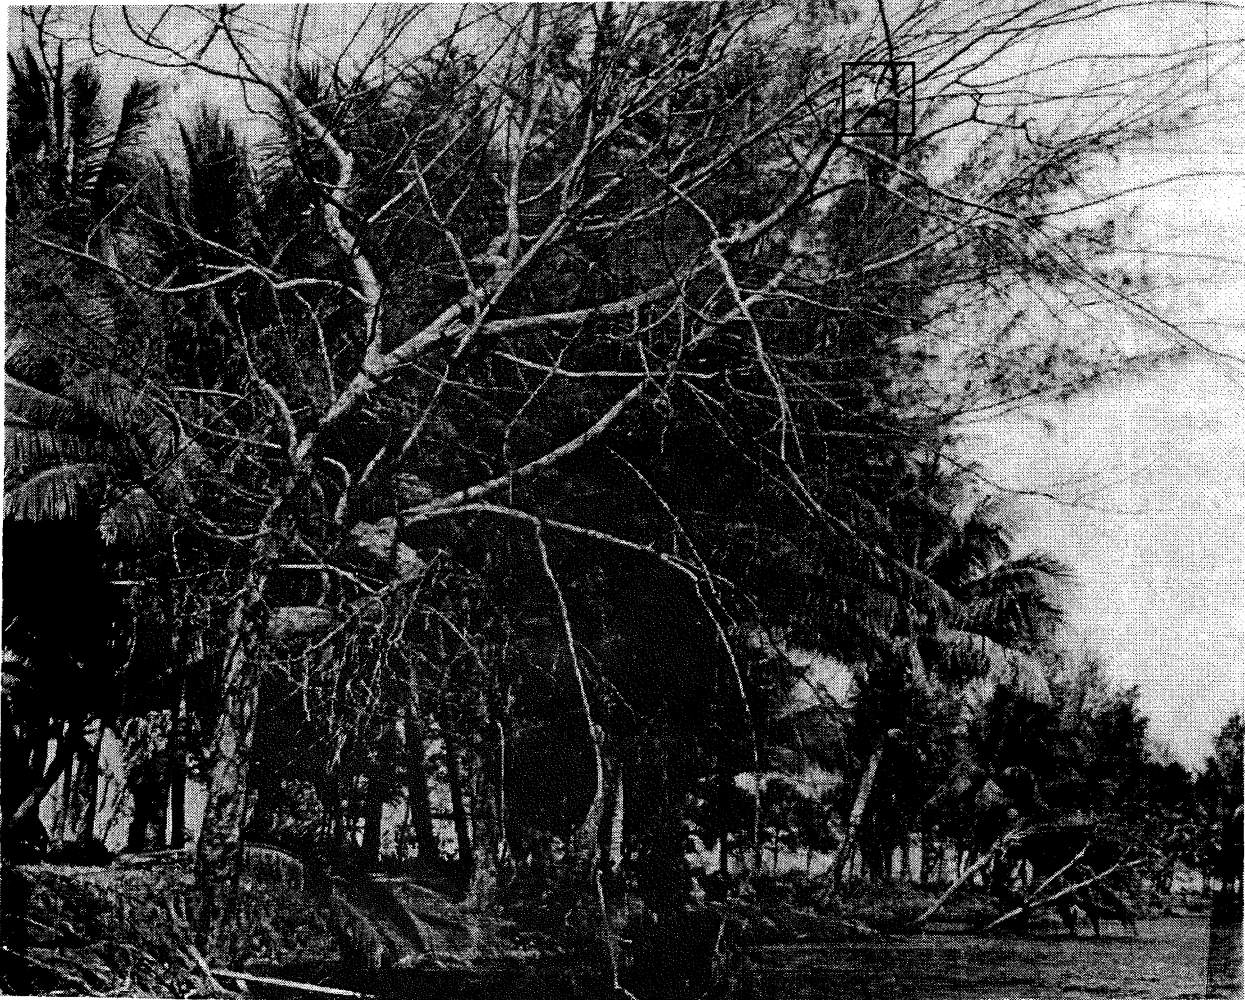
**Figure 5:** *Tree drowned at the lagoon edge due to coseismic subsidence of the seaward shore of Sissano Lagoon at Arop village. Note bucket (boxed) caught in branches indicating height reached by tsunami. Scour during backflow out of the lagoon has undercut several coconut palms at the lagoon edge in the background.*

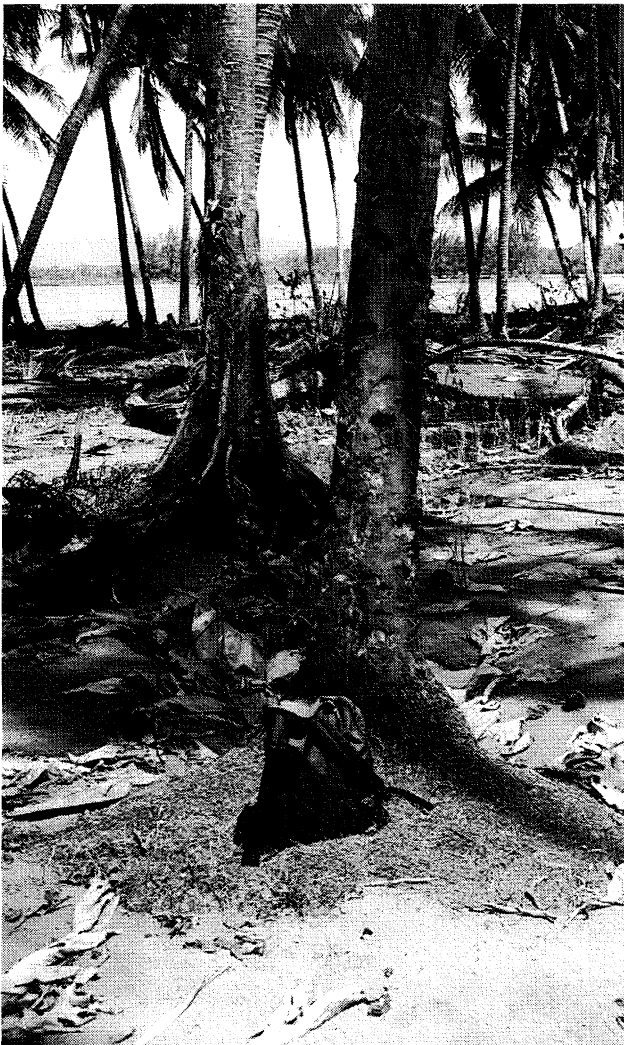
Figure 6: Coconut palm trunk abraded by sand during the tsunami impact at Warapu village.

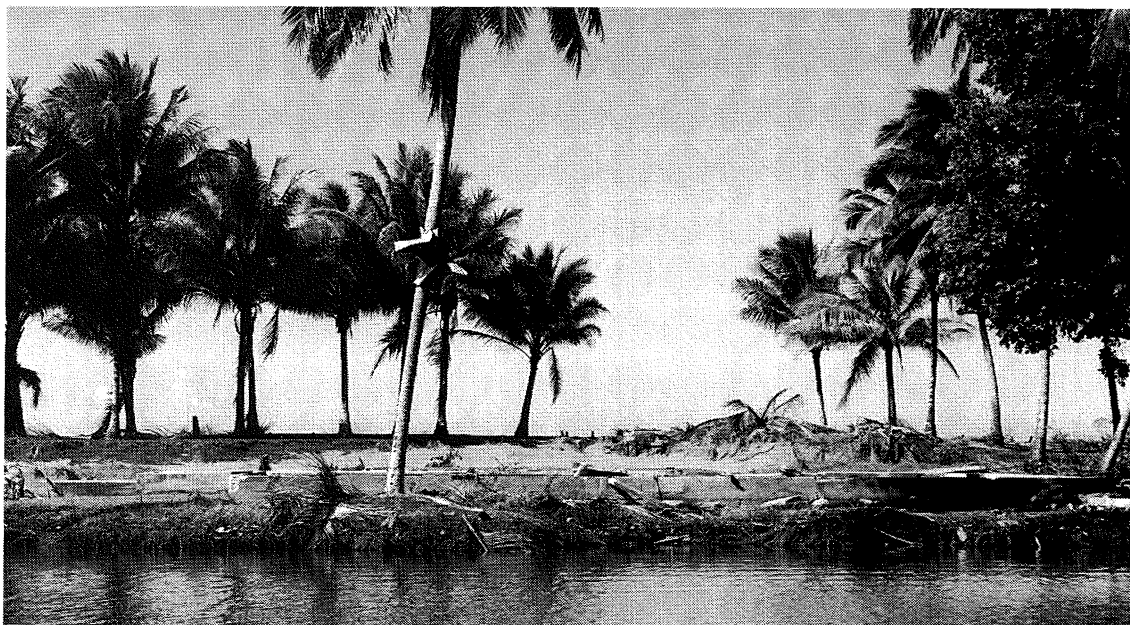
*Figure 7: A sheet of ridging iron wrapped around a coconut palm indicates the minimum height of the tsunami on the spit at Arop village. The concrete foundation below is all that survives of an iron-clad, timber-frame building.*

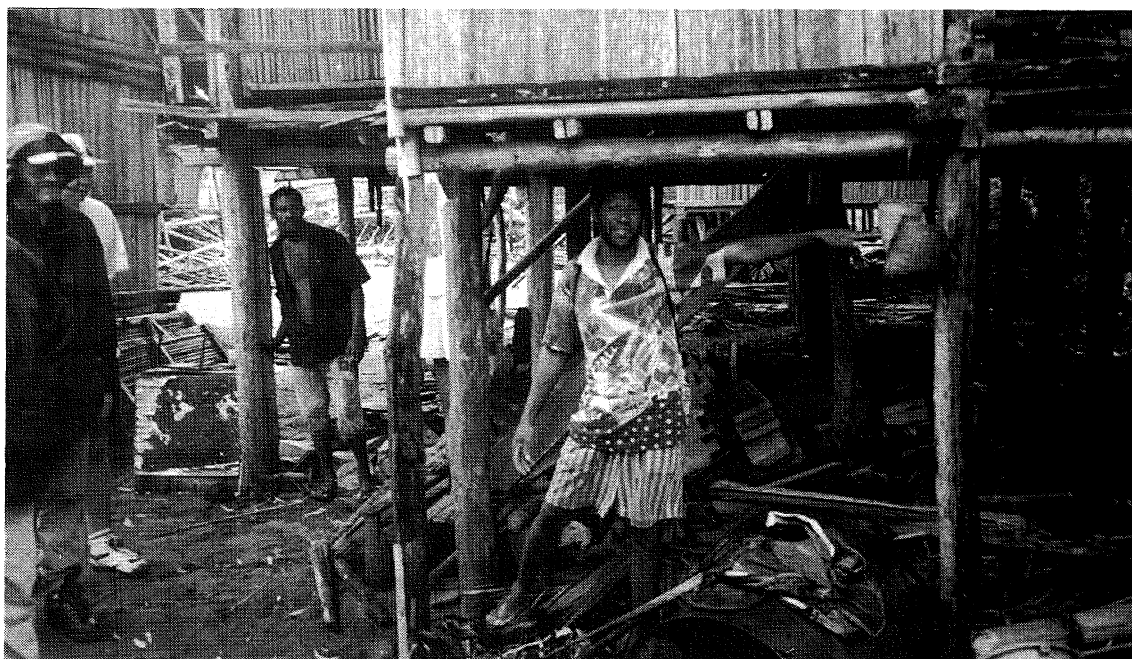
*Figure 8: A Malol villager indicates the height he saw water reaching to when the tsunami swept by beneath his home.*

At Malol, water up to 2 metres deep swept through the village, but the destruction was very patchy. Buildings appear to have been destroyed quickly where the force of the water pushed on walls, or where sufficient debris snagged around foundation piles (Figure 16), but elsewhere buildings of relatively light construction survived intact where only the foundation poles were inundated (Figure 8).

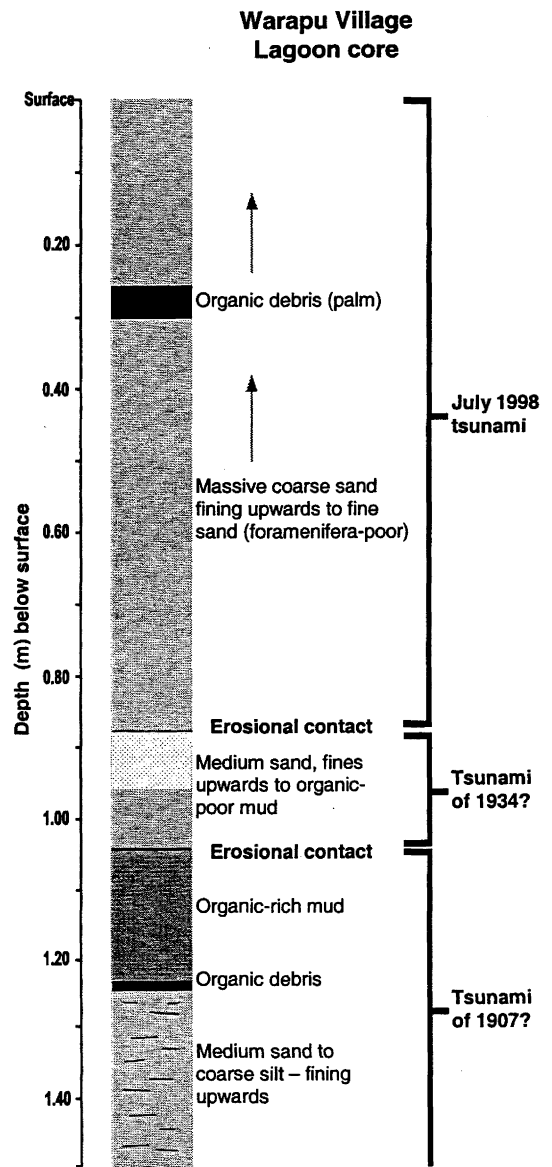
Figure 10: Log of sediment core taken from the edge of Sissano Lagoon at Transect 3, Warapu Village. Dates of earlier tsunami are unverified field estimates.

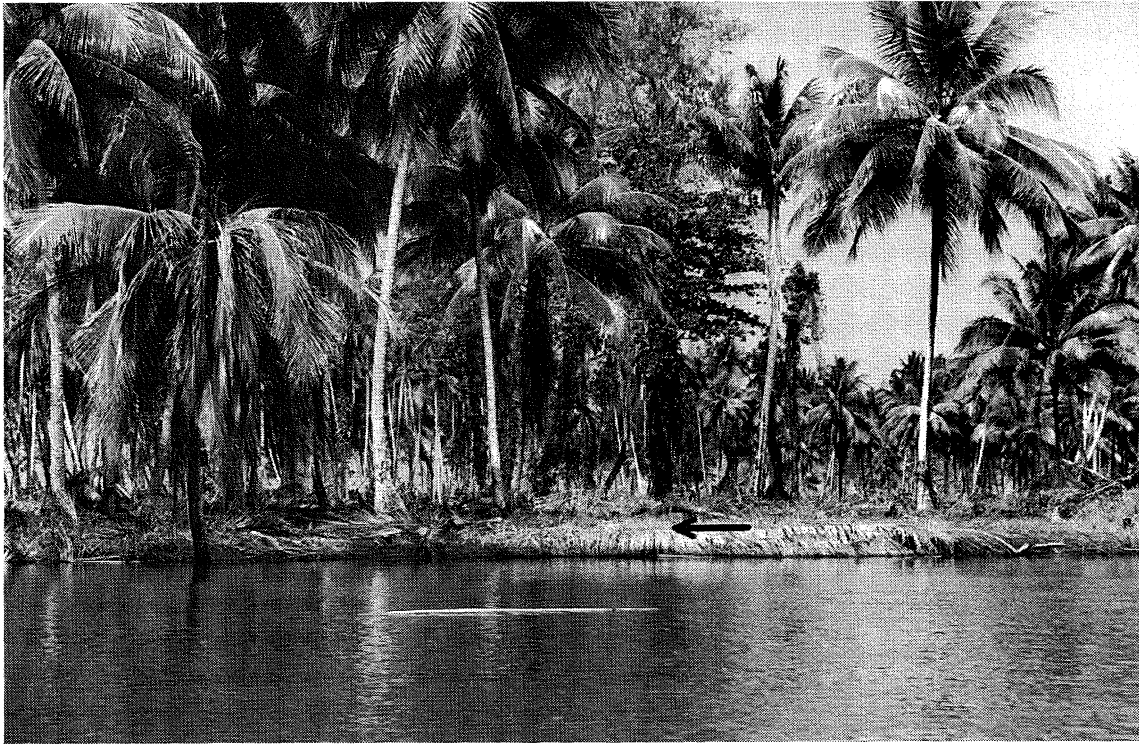
*Figure 11: Grass (arrowed) flattened at the new high-tide level on the inner margin of the spit at Sissano Lagoon where Arop Village once stood.*

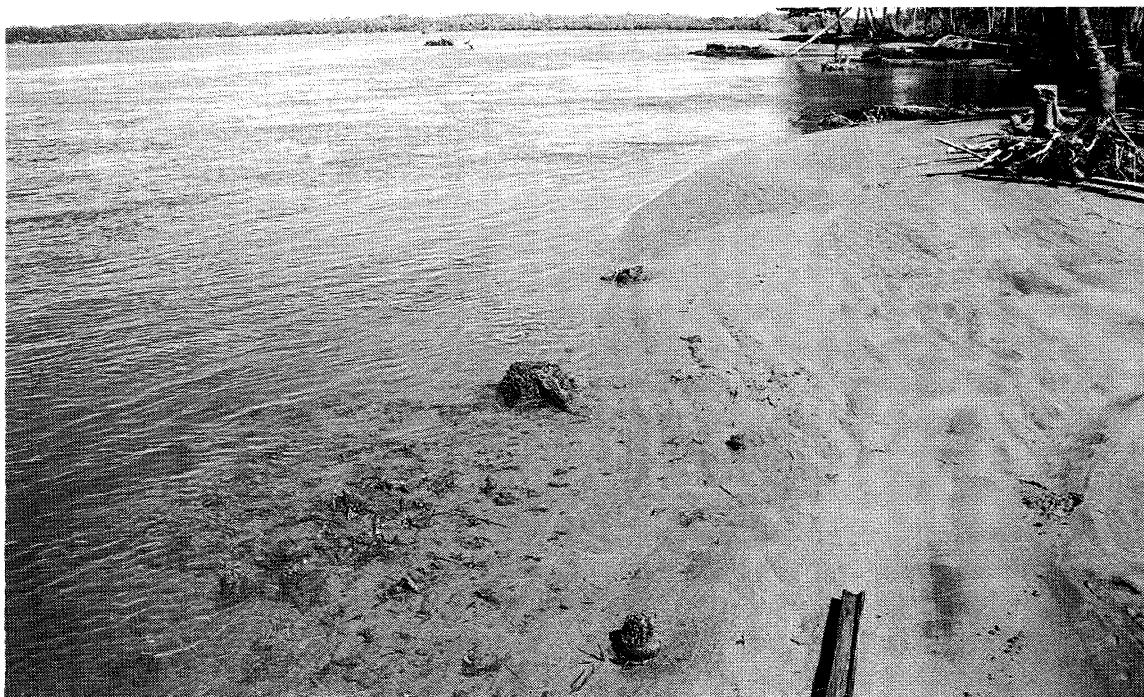
*Figure 12: Stumps rooted in place at low-tide level in Sissano Lagoon beside Warapu Village record an earlier episode of subsidence of the lagoon. They appeared to be too well preserved and not submerged enough to be from the 1.8-3.4 metres of subsidence in 1907, so we reasoned that they might date from unreported subsidence associated with the earthquake of 1934. We were unable to test this hypothesis.*

We saw a number of ancient, worm-bored *in situ* stumps of drowned trees in Sissano Lagoon adjacent to Warapu Village (Figure 12). They and their associated submerged former shoreline step indicate an earlier episode of minor subsidence. It did not appear to be submerged enough to be from 1907: we suggest that it may have occurred during the earthquake of 1934, although no ground deformation is reported for that event. The average return period for subsidence may be as short as 30-40 years.

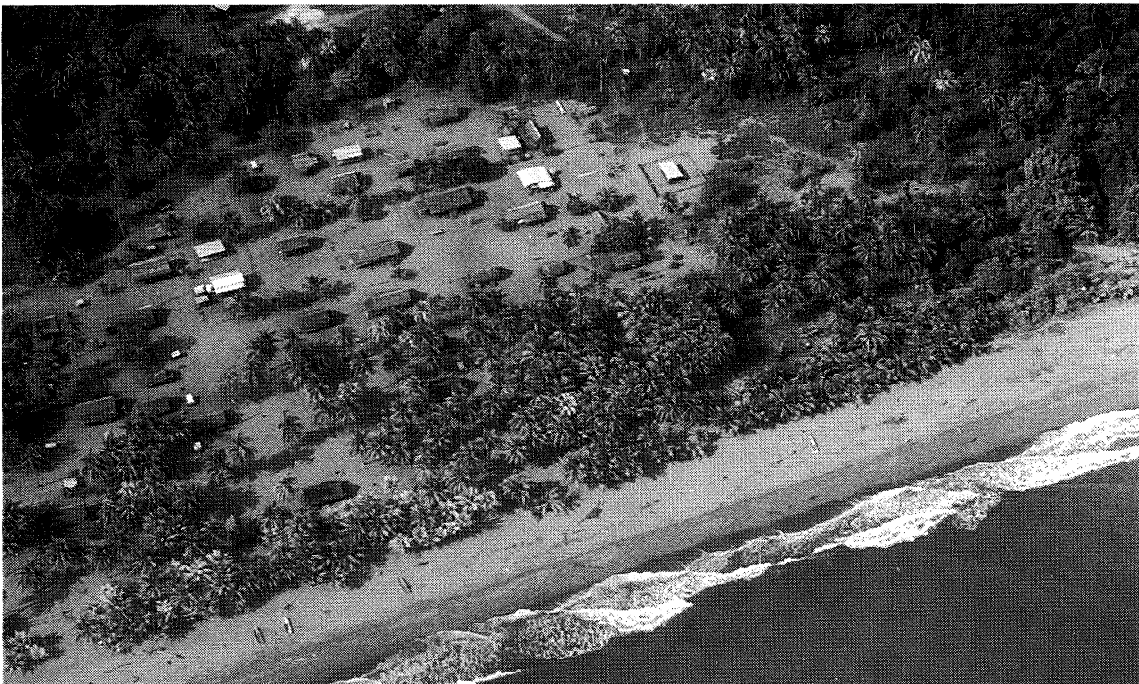
*Figure 14: A typical village along the northern coast of Papua New Guinea outside the region of significant tsunami damage. The destroyed villages of Arop and Warapu probably had similar proportions of traditional and iron clad dwellings.*

Prior to the tsunami, the villages of Malol, Arop and Warapu were typical of villages along the northern coast of Papua New Guinea (Figure 14). Buildings were largely of simple traditional design: thatched roof, wooden structures with unsophisticated connections, and little or no bracing (Figure 8, 15, 16). A number of buildings were however, analogous to light timber-frame constructions in New Zealand, built on concrete piles or reinforced-concrete slabs on ground (Figure 14, 15, 17).

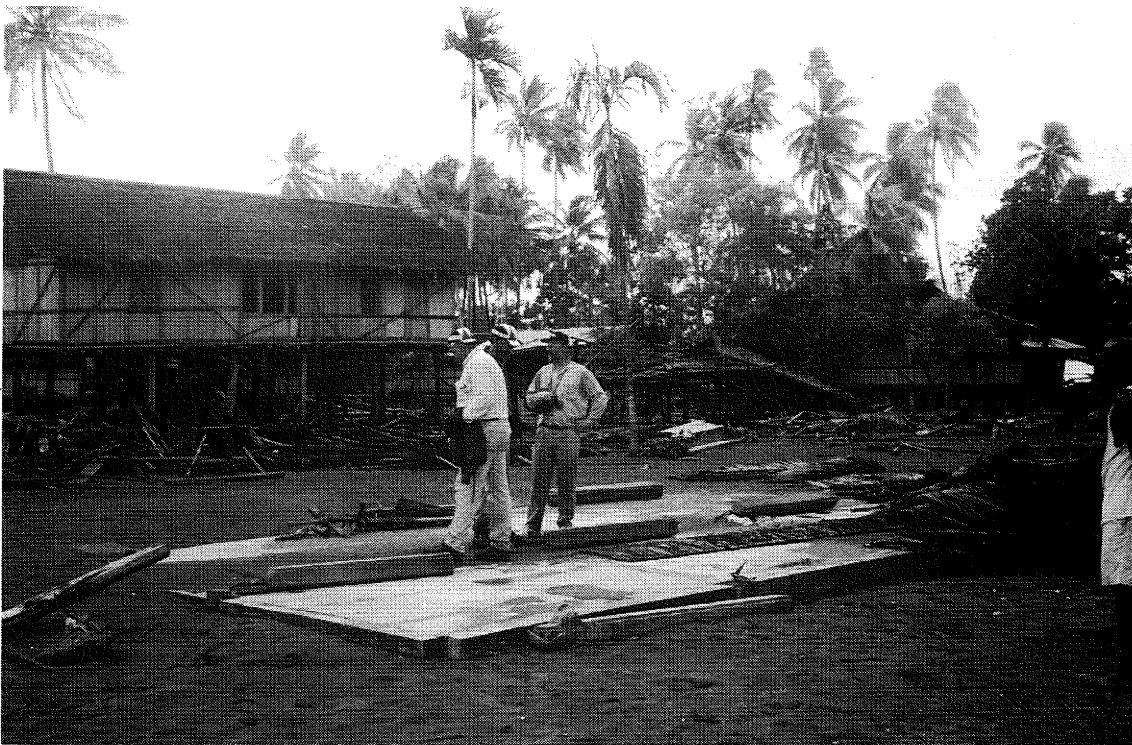
*Figure 15: Three members of the reconnaissance team inspect damage at Malol Village. Here tsunami damage was only intermittent along the coast, where ocean swells boosted the tsunami over the beach berm.*

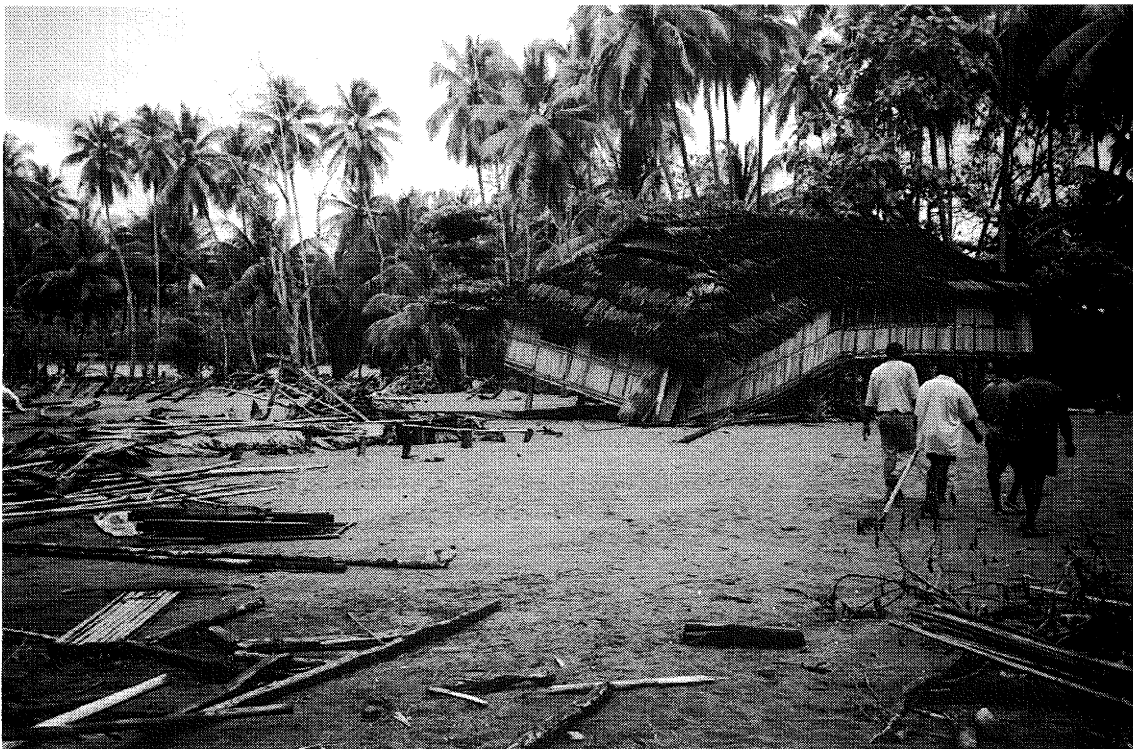
*Figure 16: On the lateral edge of a local damaged zone in Malol Village, this traditional style dwelling might have survived intact on more adequate piling. Clusters of tilted piles (left centre and background) indicate sites of destroyed dwellings.*

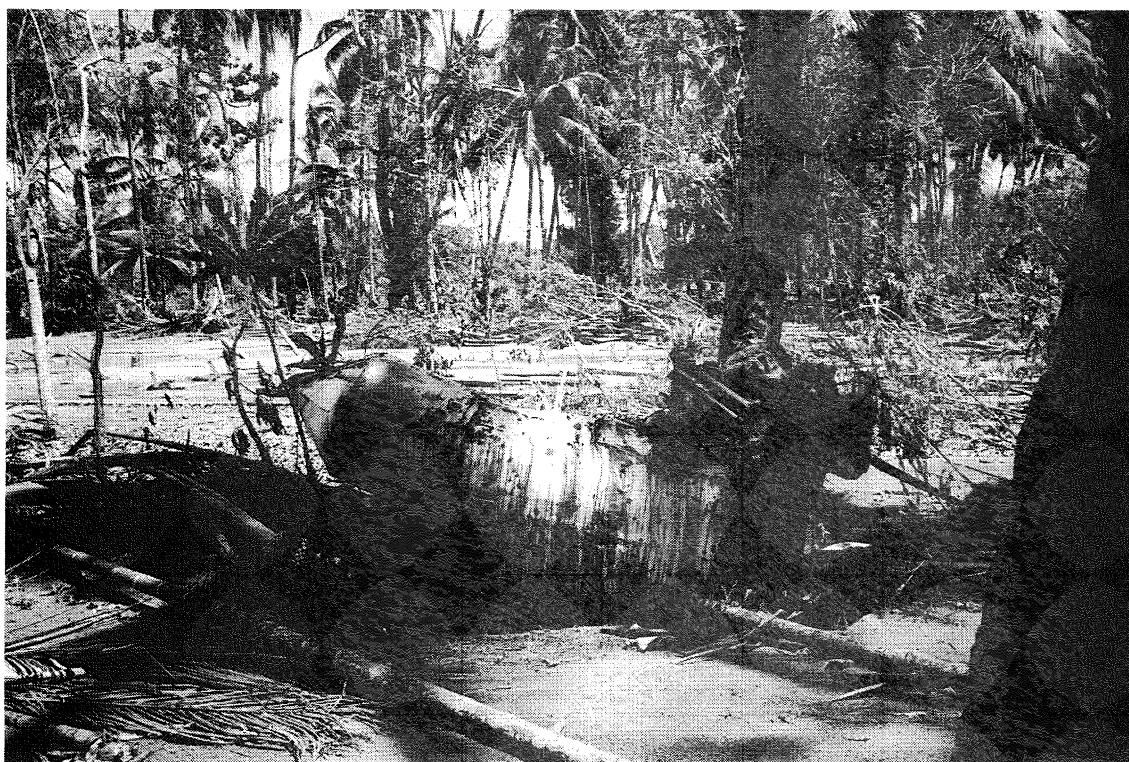
*Figure 19: A heavy steel pontoon 1.5 metres in diameter was wrapped around a coconut palm.*

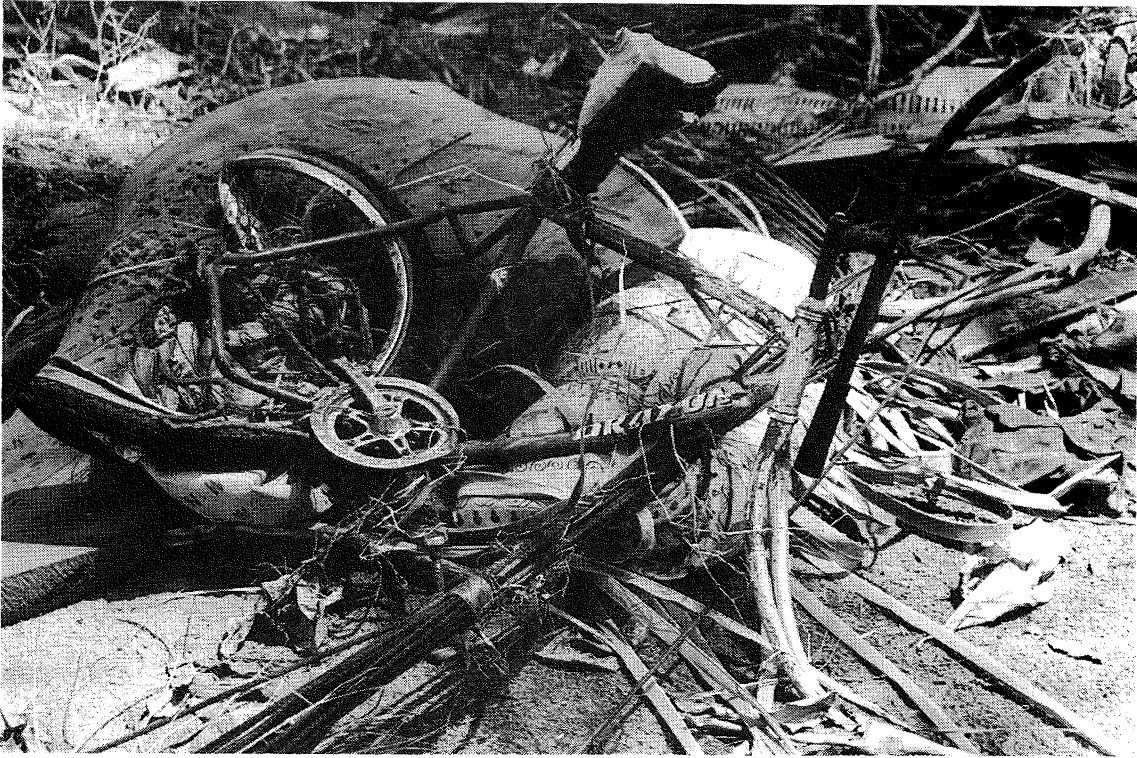
Figure 20: Every major part of this child's bicycle was deformed as it was tossed around in the tsunami.

The most compelling observation was that in the central disaster area along the spit fronting the lagoon, all structures, irrespective of degree of sophistication, suffered the same fate: none withstood the tsunami. The more traditional structures simply washed away (Figure 2, 17), sometimes largely intact. Timber piles 100 mm x 100 mm were snapped off just above ground level. Concrete piles 150 mm x 150 mm were similarly snapped (Figure 15), or uprooted. Concrete piles reinforced with metal rods had the concrete stripped off them. At least one concrete slab had the concrete stripped back to the central reinforcement. A steel pontoon of 1.5 m diameter was simply bent in half around a tree (Figure 19) and a child's bicycle was totally wrecked, with no major part left unbent (Figure 20).
