RESILIENCE AND FRAGILITY OF THE TELECOMMUNICATION NETWORK TO SEISMIC EVENTS: EVIDENCE AFTER THE KAIKŌURA (NEW ZEALAND) EARTHQUAKE

This paper provides an overview on the physical and functional performance of the New Zealand telecommunication network following the 14 November 2016 Kaikōura earthquake (Mw 7.8). Firstly, the paper provides an overview of the New Zealand telecommunications infrastructure. Secondly, the paper presents preliminary information on the impacts of the Kaikōura earthquake on the telecommunication network following the format proposed by [1] for post-earthquake assessment and resilience analysis of infrastructure systems, namely: extent of earthquake-induced physical impacts on the components of the telecommunication networks, identified according to a proposed taxonomy; main observed dependency issues; identification of resilience attributes and strategies that allowed an effective and rapid reinstatement of the telecommunication service. Finally lessons learned and research needs are discussed.

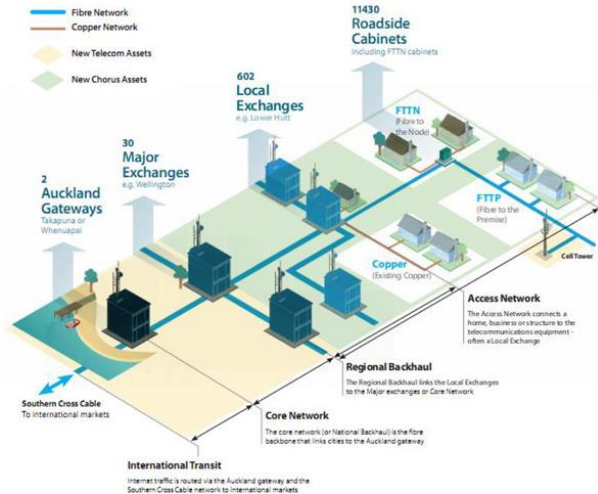
Figure 1: Schematic structure of telecommunication transport network in New Zealand (courtesy of Chorus).

The New Zealand telecommunications infrastructure is largely based on a series of *interconnected fibre-optic networks*, as depicted in Figures 1 and 2. The up- and down-stream traffic from each of the 1.22 million connections is transported around the country by a *core network of fixed lines and exchanges* (Figure 1) before being handed over to retailer service providers – such as Spark, Vodafone, Orcon, 2degrees and many others – at different locations around the country [7]. Specifically, the *National Backhaul* links the Gateways, which provide international connectivity via undersea cables, to the *Major Exchanges* located in large cities throughout the country. *Regional Backhaul* networks connect these *Major Exchanges* to smaller *Local Exchanges* in the surrounding region. Most homes and businesses connect either directly to a local exchange or via a roadside cabinet (Figure 2). This “last mile” connection has traditionally been copper. The local copper networks are all still in place throughout New Zealand, however they are increasingly being replaced with fibre in the

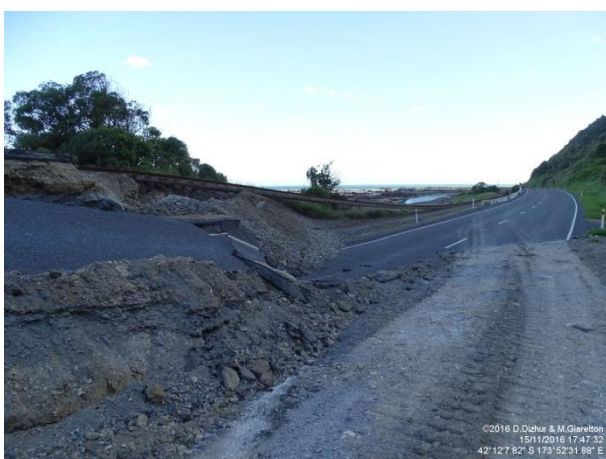
Figure 4: Example of a fault rupture on State Highway 1 that severed the East Coast fibre-optic cable. Photo: Dizhur & Giaretton.

As far as telecommunication is concerned, further to some damage induced by the ground shaking, fault ruptures, that crossed State Highway 1 at multiple locations, resulted in damage to the buried fibre cables that ran alongside the roadway (Figure 4). Further co-seismic impacts to the telecommunications network were a result of landslides [17] and liquefaction/lateral spreading-induced damage. Cables crossing bridges, which were damaged due to differential movements between the superstructure and the approaches, sustained damage because of spreading and slumping. Poles close to riverbanks affected by lateral spreading, moved or tilted, stretching overhead cables. Further details are provided in the subsequent section.

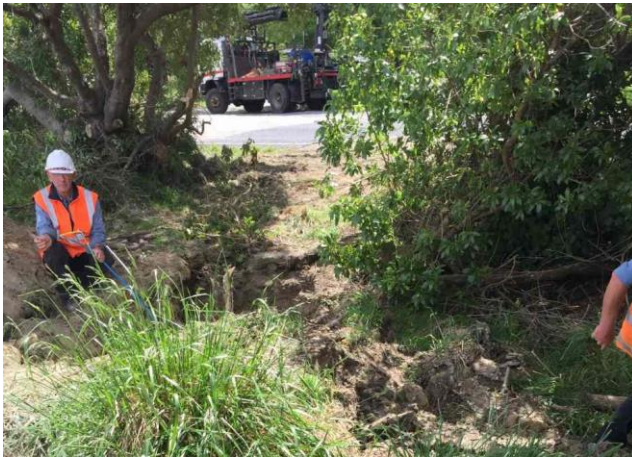
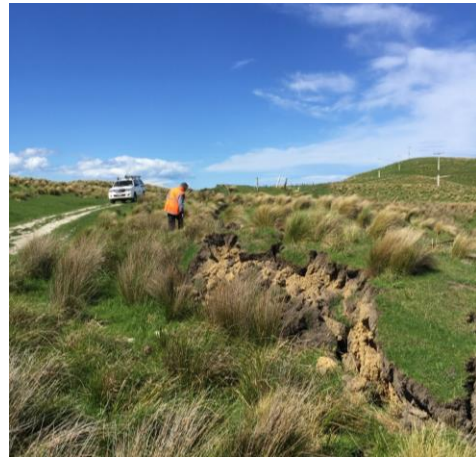
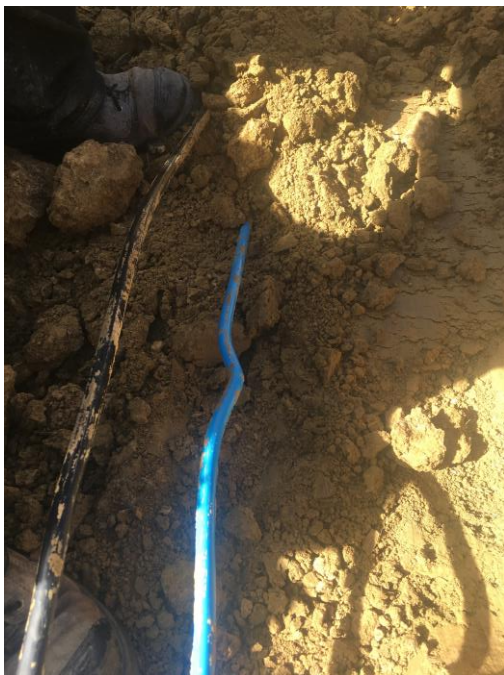
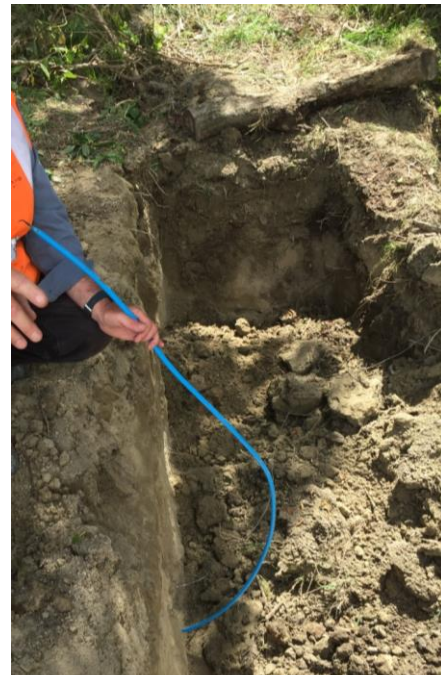
Figure 5: Damage of cables after the Kaikōura earthquake: a), b) Instances of permanent ground deformation and fault ruptures at cable locations; c) example of stretched cable; d) example of broken cable (Photos courtesy Rob Ruiter, Chorus).

- *The East Coast Link*, a major fibre optic cable, was severely damaged. Six breaks were identified along the East Coast Link cable [18].
- *Cables* many (mainly copper) were severely damaged. Overall, most of the damage identified on the network was on cables and it was due to cables being stretched and broken as a result of both transient ground motion, permanent ground movements and fault rupture at cable locations (Figure 5). Where cables were stretched, faults

were identified not only in the immediate vicinity of ground cracking, but also in some cases 100 m plus along the cable length away from the main source of the displacement. This was due to the internal wires being stretched. In some instances, the extent of stretching was to a degree that changed the cable characteristics quite markedly.

As for the time required to repair/replace cables, spot repairs in damaged cables usually took around half a day and included digging, putting a joint in and filling. For cables that were stretched or damaged at multiple locations and had, therefore, to be replaced, the temporary replacement cables were run on the ground and each replacement could take a full day of work even for a relatively short cable length (e.g. 200-metre cable). The timeline was similar for repair/replacement activities related to fibre optic cables.

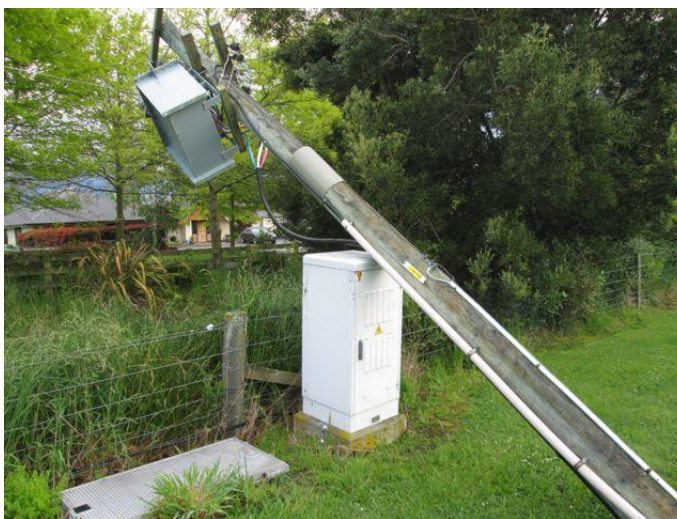
(a)

One roadside cabinet was damaged with a power pole falling on to it (Figure 6a); others had instances of electronic card dislodgement (rattled) while the cabinet itself remained undamaged.

Figure 6: Damage of above-ground components after the Kaikōura earthquake: a) power pole falling on a roadside cabinets; b) effect of the ground-shaking on one of the remote radio terminals where the radio transceiver card has dislodged from its rear connector causing service loss (Photos courtesy Rob Ruiter, Chorus).

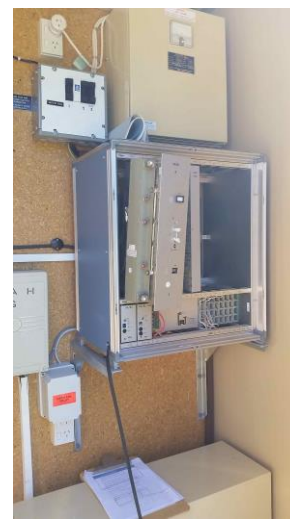
(b)

Instances of toppled cell sites were observed (Figure 6b). Also multiple cell sites were immediately impacted by power

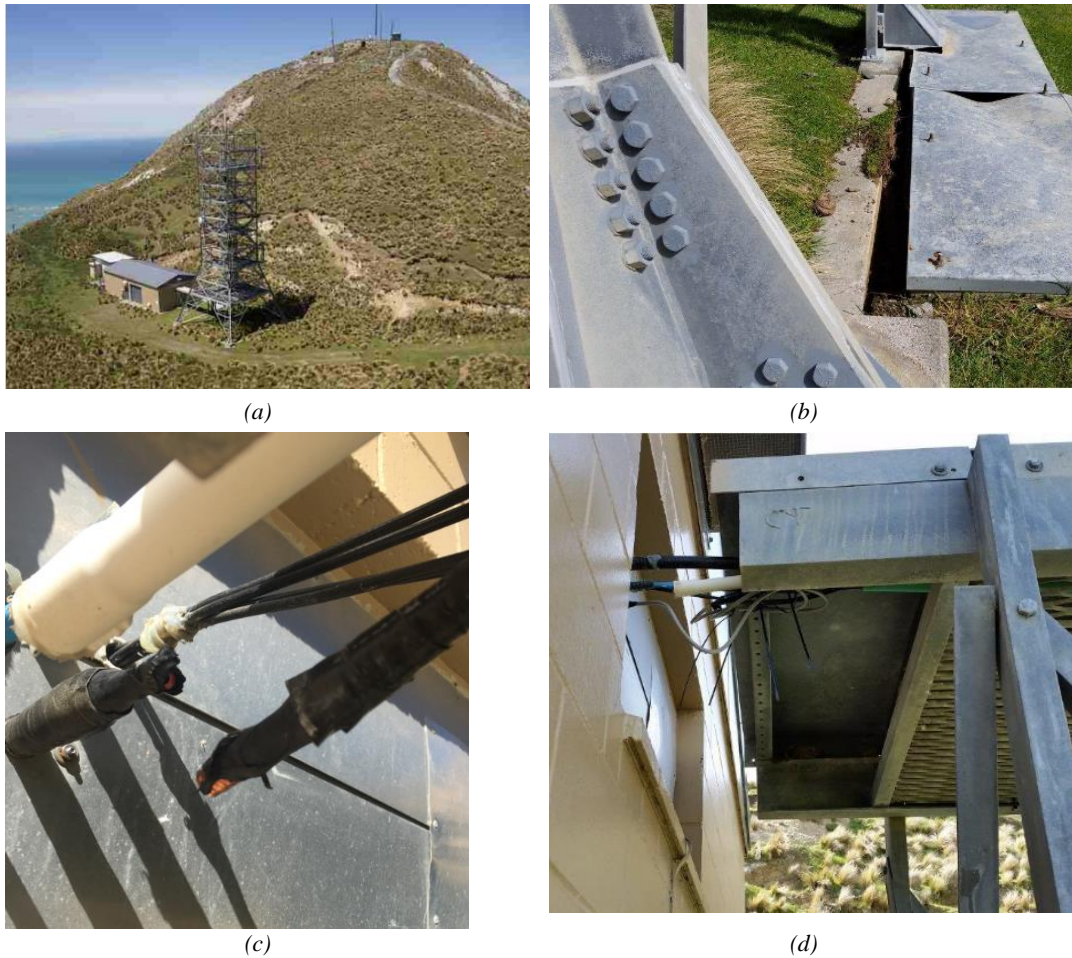
Figure 7: Microwave Station building at Weld Cone, damage: a) building, tower and waveguide bridge between the two; b) permanent ground movement at the tower base; c) broken original coax cable; d) temporary fix for the coax cable (the thin grey cable splicing between the ends of the failed coax cable) and extent of the separation between the building wall and the waveguide bridge caused by earthquake (Photos courtesy of Brent Jones, Chorus).

There was one instance of failure at Weld Cone near the town of Ward (Figures 7) due to ground displacement between the microwave tower and the equipment building. A coaxial cable was broken with associated loss of service. As shown in Figures 7c and d, the coaxial cable between the DMR (Digital Microwave Radio) indoor unit in the Microwave Station building at Weld Cone and the DMR outdoor unit (attached to the rear of the parabolic antenna) up the lattice microwave tower stretched and failed near the “waveguide window”. Lateral movement between the building and the tower had been so significant that there was insufficient slack in the coaxial cable between its captive point at the waveguide window and where the coax was clamped via “hangers” on the waveguide bridge out to the tower. There were no problems with antenna alignment [20]. An instance of tower misalignment was observed in one small station called Mt Lyford (north of Waiiau) where land slumping occurred at the radio site, causing the tower misalignment and some deterioration but no actual loss of service (Figure 8).

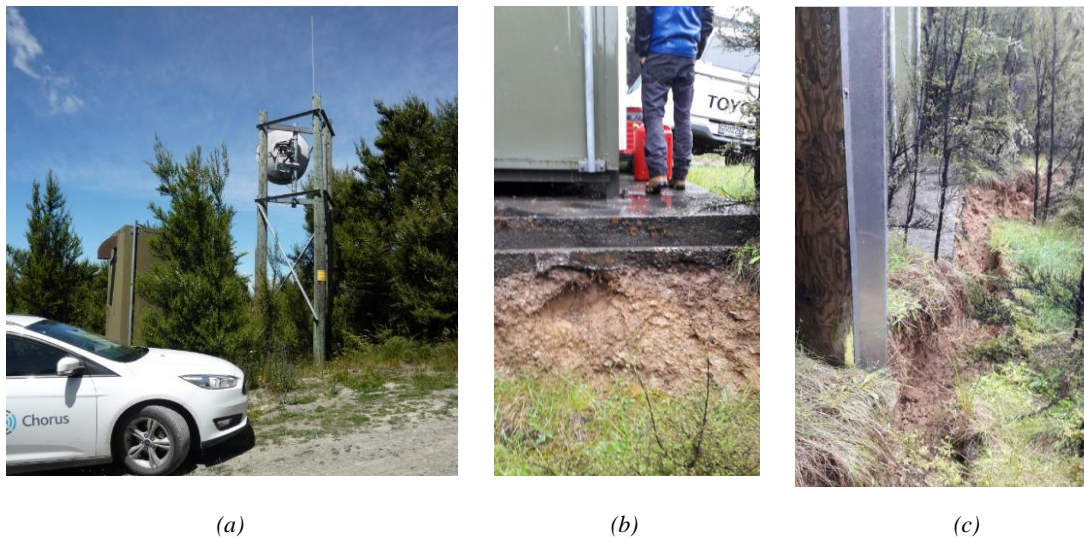
Figure 8. Mt Lyford Microwave tower: a) Mt Lyford microwave tower and portacom hut; b) c) ground slump at the southern edge of the microwave tower base and edge of the concrete base of the portacom hut.
