BUILDING CONFIGURATION: THE ARCHITECTURE OF SEISMIC DESIGN

Christopher Arnold*

Presented at the Third South Pacific Regional Conference on
Earthquake Engineering, Wellington, May 1983.

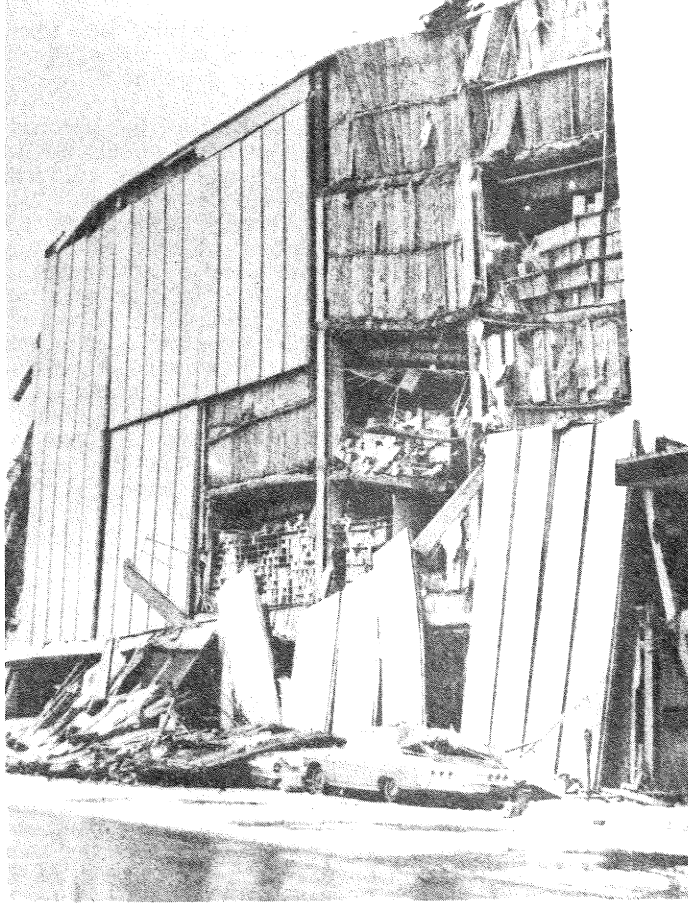
Figure 2: Penney Department Store, Alaska, 1964.

In plan, the most dangerous forms have proven to be those in which there is a wide variation of strength and stiffness between various building elevations. The performance of the Penney Department Store in the Alaska earthquake of 1964 was a notable example of the poor performance of these forms (Figure 2). In the area of vertical structural discontinuity, the problem of the 'soft first storey' and in particular a sub-class of this configuration, the discontinuous shear wall, have been revealed as the most vulnerable. The performance of Olive View Hospital in the San Fernando earthquake of 1971, and the Imperial County Services Building in Imperial County, 1979, are text book examples of the problems associated with these configurations. Both these types of vertical configuration are characteristic of modern building style and are 20th century inventions only made possible by modern steel and reinforced concrete structural technology.
