## GHAENAT (IRAN) EARTHQUAKE OF NOVEMBER 14, 1979

### SYNOPSIS:

This paper is a concise report of Ghaenat (Iran) Earthquake of November 14, 1979 in which 280 people died and several villages were destroyed. Observations from earthquake effects on the ground as well as buildings are briefly discussed.

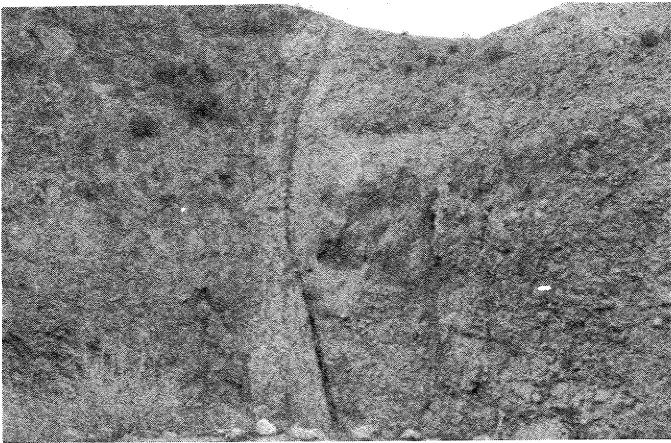
Several devastating earthquakes have hit the Ghaenat area during past centuries. This area has also seen major earthquakes during the present century. An earthquake of magnitude 6.75 Richter hit Ghaen and Dowlatabad on September 23, 1947 which took the lives of 400 people. Figure 1 shows a clear section of an ancient fault in the Ghaenat area.

Figure 1. — Ancient Fault Trace

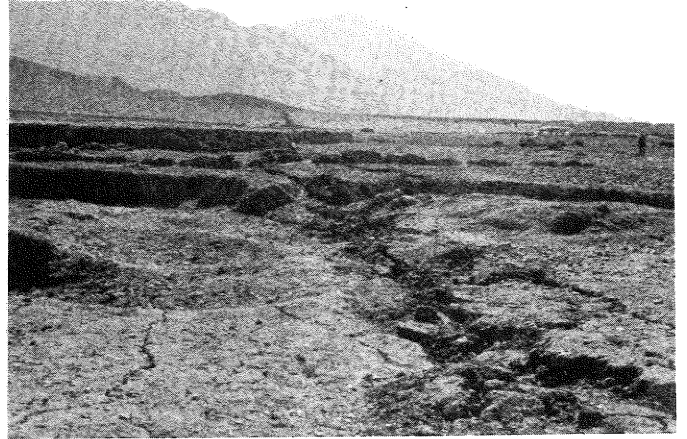
Fault trace on the ground surface was observed along 15 kilometers (Figure 2). Maximum horizontal and vertical displacements on the ground surface were about 1.0 and 0.5 meters, respectively. Figure 3 shows the place of maximum vertical displacement.

Figure 2. — Fault Trace.

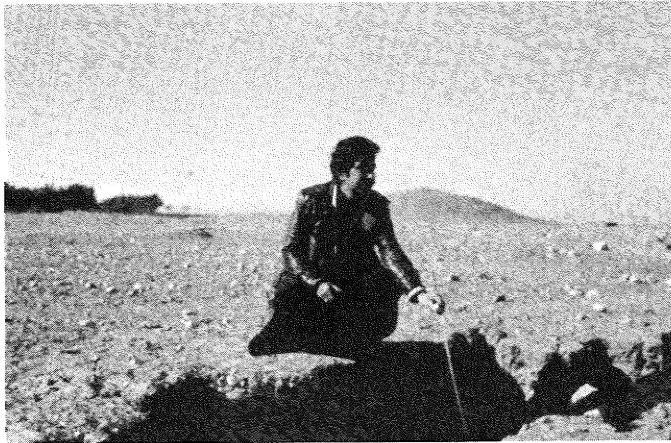
Figure 3. — Maximum Vertical Displacement.

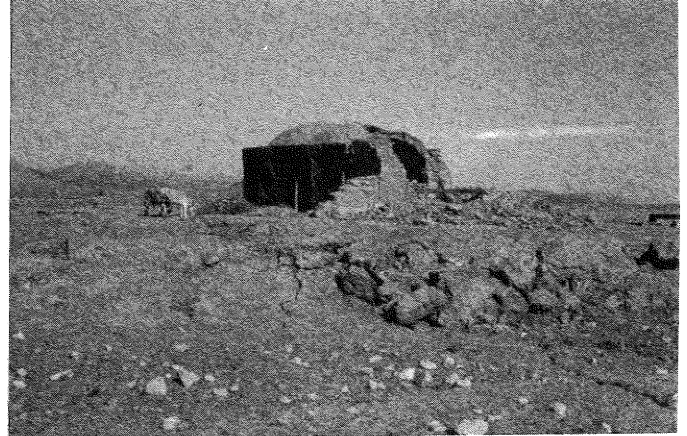
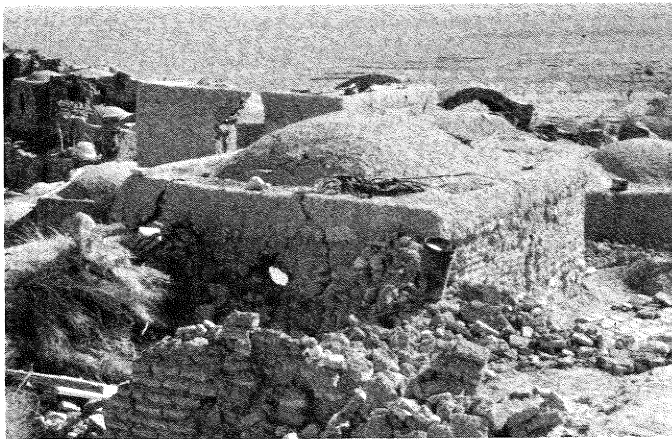
Almost all of the buildings in the earthquake affected area are adobe brick buildings. These buildings are made from sun-dried clay bricks. Figures 4 and 5 show the typical damage pattern of adobe buildings with domed roofs. Due to the horizontal earthquake vibrations, walls specially at the top tend to move horizontally and separate from the roof, resulting in the collapse of the walls and the roof. Figure 6 shows the interior of a newly built adobe building.

Figure 4. — Damage to domed adobe building.

Figure 5. — Damage to adobe buildings.

In general, most newly built single-storey building performed relatively better than old and two-storey buildings. Construction of two-storey adobe buildings to resist earthquake forces is not practical. However, it is possible to

strengthen single-storey adobe buildings by using buttresses at each corner of the building, tying the adobe walls together by employing angle iron at each corner and steel straps, and by reinforcing the well built adobe walls at their intersections and using a tie beam at the top of the walls.

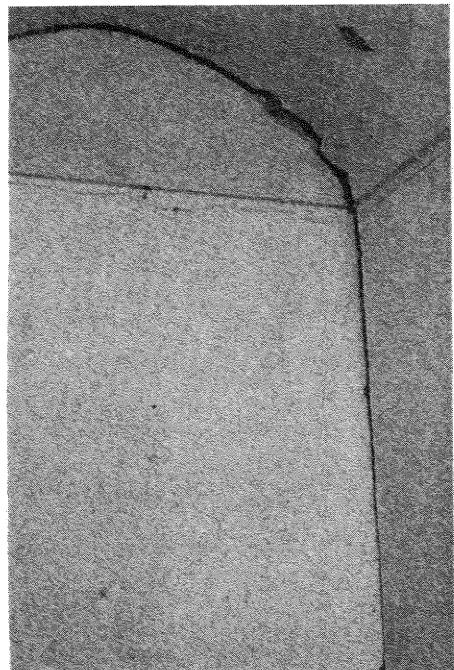
Figure 6. — Damage to newly completed adobe building.

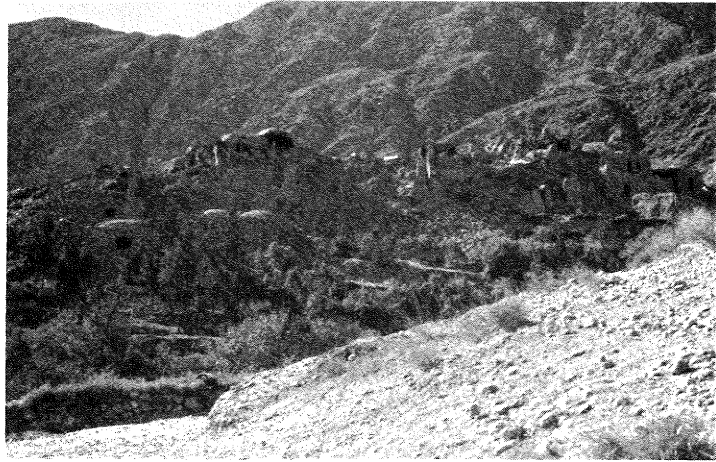
Figure 7 shows one of the damaged villages built on a hill. Severity of buildings damage decreases from the top to the foot of the hill. It seems that the amplitude of earthquake waves amplifies at the top of the hill due to the reflection of earthquake waves and superposition of reflected waves with original waves. As a result, buildings located at the top of a hill are shaken by a greater force than buildings located on the flat ground.

Figure 7. — Damaged village on hill.

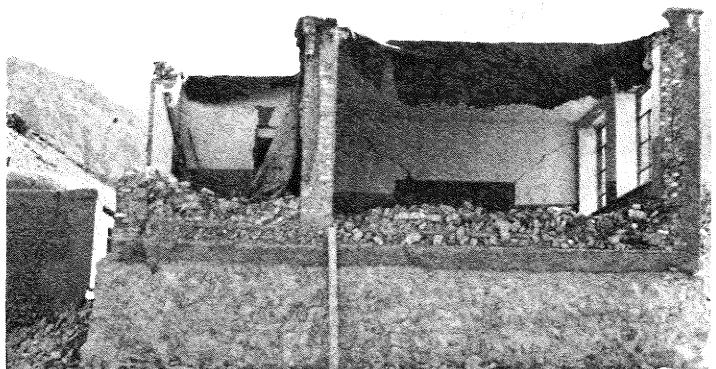
Figures 8 and 9 show a school building made of brick walls and Jack arch roof with steel beams. There is no tie beam at the top of the walls and most of the openings are located in one of the longitudinal walls. If a continuous tie beam had been built on the top of the walls and walls were connected to the tie beam and concrete foundation by dowels, the collapse of the part of the buildings as seen in the figures could have been prevented.

Figure 8. — Damaged brick school.

Figure 9. — Damaged brick school.
