IMPROVING THE RESISTANCE OF STRUCTURES TO EARTHQUAKES

R. Park¹

Hopkins Lecture - 16 August 2000

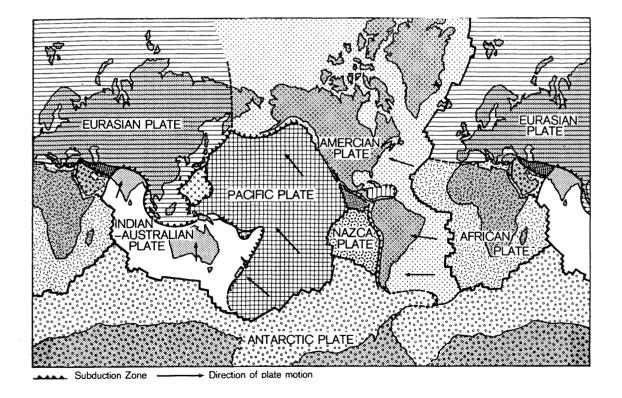
Fig. 1: Coastal plate boundaries of the earth [1].

Scientific observation gives us further explanation. The crust of the earth is broken up into number of rigid plates of rock between 15 and 100 kilometres thick which are moving very slowly at about 20-120 mm per year relative to each other (see Fig. 1). This jostling between the plates causes stresses to build up in the edge regions of the plates. Earthquakes generally occur due to a sudden release of energy when the accumulated strain at some part near the edges of plates becomes so great that rupture of the rock occurs along the plane of a fault. The resulting sudden movement along the fault causes the transmission of the complex set of shock waves through the earth that we describe as an earthquake (see Fig. 2). The fault can break through to the earth's surface. The place of initial rupture on the fault is known as the focus of the earthquake. The epicentre of the earthquake is the point on the earth's surface directly above the focus. Most of the world's earthquakes occur in the edge regions of the plates but intraplate earthquakes can also occur at faults away from the edges of the plates.

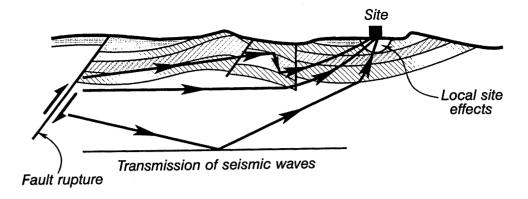
Fig. 2 Transmission of seismic waves from the focus of an earthquake to a site.

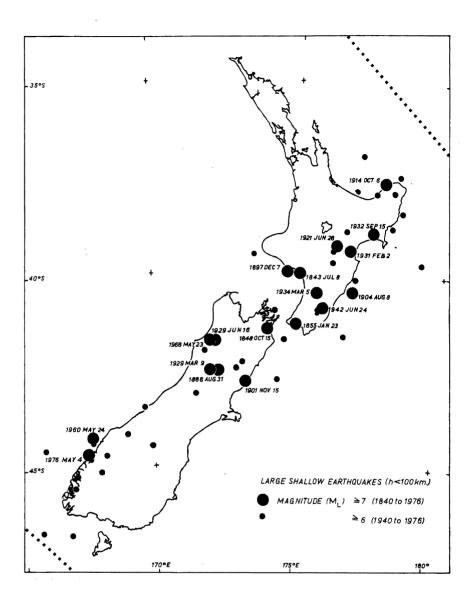
Fig. 3: Large Shallow Earthquakes, which have occurred in New Zealand during 1840-1976 [2].

New Zealand was subjected to a number of major earthquakes in the early years of European settlement, as is evident from Fig. 3 and Table 2. Figure 5 shows some typical damage to buildings in Wellington as a result of the 1848 Marlborough earthquake, which had a Richter magnitude of 7.1. These early warnings that special building precautions were needed for earthquake resistance went largely unheeded by settlers who had come from non-earthquake countries and had brought traditional European building procedures with them.

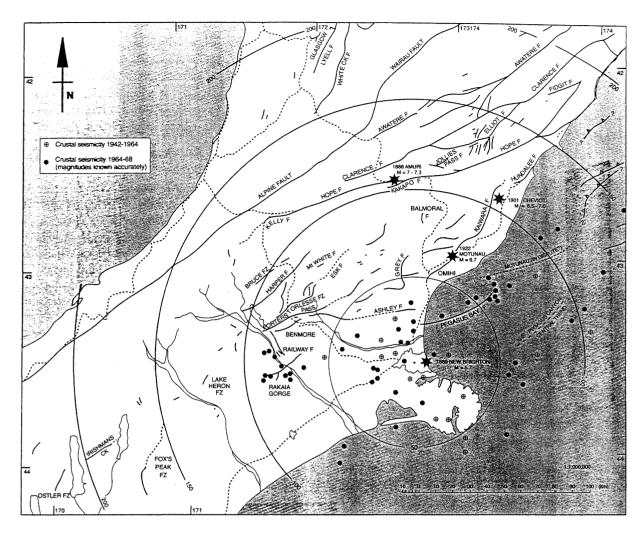
Fig. 4: Active faults within 200 km of Christchurch [5].

Known active faults in Canterbury are shown in Fig. 4. The Christchurch Engineering Lifelines Group in 1997 [5] after a study of the information on the seismicity of Christchurch, mainly by Elder et al [6], concluded that a major earthquake with a felt intensity of VIII to IX (causing considerable damage to ordinary buildings) could be expected for Christchurch with a return period of about 150 years. Such shaking would most likely be caused by a moderately-large to large earthquake in the Canterbury foothills or North Canterbury. A very large earthquake on the Alpine fault would also be likely to produce these shaking intensities or greater.

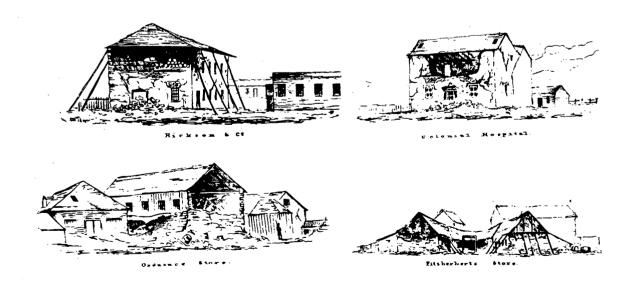
Fig. 5: Sketches of some damaged buildings in Wellington as a result of the 1848 Marlborough Earthquake (Alexander Turnbull Library, Wellington).

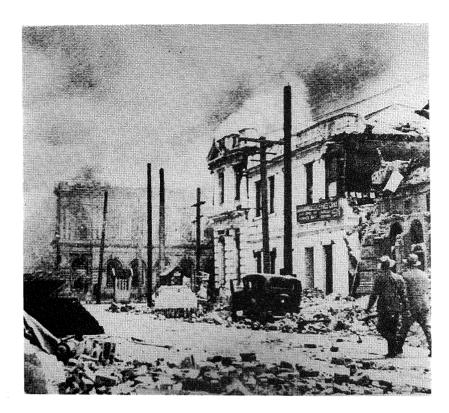
Fig 6: Damage at Napier as a result of the 1931 Hawke's Bay Earthquake (Alexander Turnbull Library, Wellington).

Figures 6 and 7 show close-up views of some of the business centres of Napier after the earthquake and fire and give an impression of the resulting devastation. Whereas load bearing masonry structures performed badly in the Hawke's Bay earthquake, buildings with reinforced concrete or structural steel frames on the whole suffered less structural damage and withstood the earthquake with remarkable success. In New Zealand this led to a shift in emphasis of building type from load bearing brick to framed buildings.

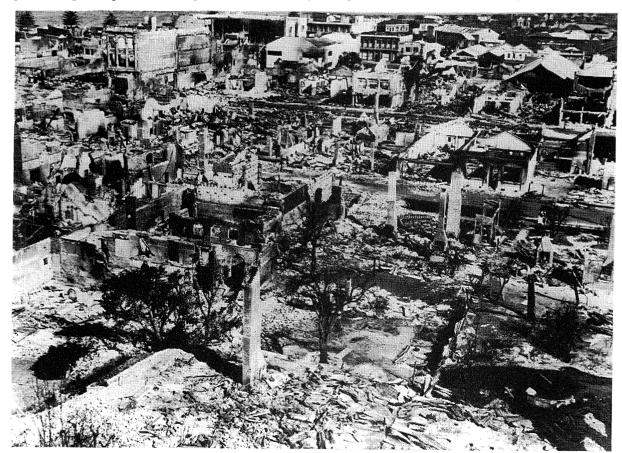
Fig 7: Damage at Napier as a result of the 1931 Hawke's Bay Earthquake (Alexander Turnbull Library, Wellington).

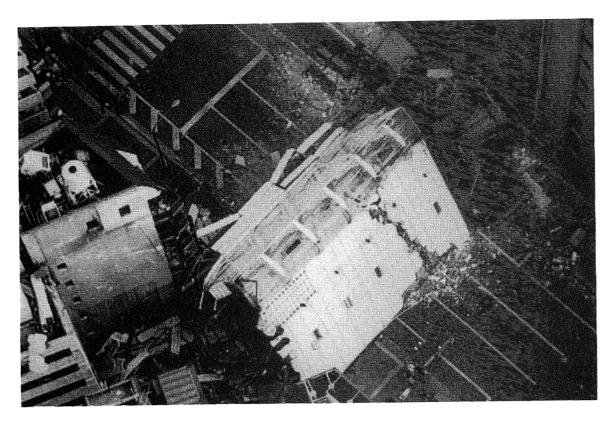
Fig. 8: Overturned building lying across a street (Kobe, 1995).

Tilting of buildings, and even overturning (see Fig. 8), occurred in some cases in the most devastated areas of the city. The columns of the overturned buildings parted from their foundations.

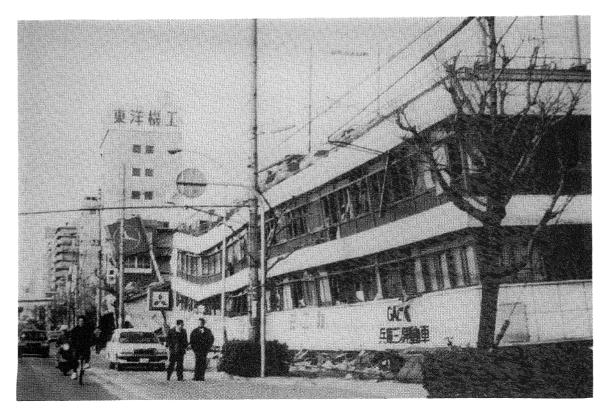
Fig. 9: Soft storey collapse of the first storey of a departmental store (Kobe, 1995).

The predominant mode of collapse of pre-1981 buildings was of the soft storey type due to failure of the columns of one storey. Many soft storey collapses were due to failure of the first storey columns (for example, see Fig. 9). These failures occurred due to strong beam-weak column behaviour of moment resisting frames, lack of ductility of columns and failure of brace to frame connections in braced systems.

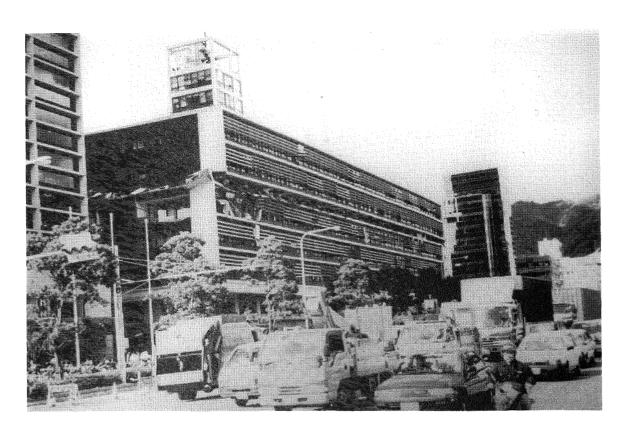
Fig. 10: Soft storey collapse of an intermediate storey of a municipal building, (Kobe, 1995).

However, many soft storey collapses also occurred due to the failure of columns in an intermediate storey up the height of the building (see Fig. 10). A particularly tragic example was the Municipal Hospital in the west of Kobe which had a soft storey failure in the 5th storey and 49 people were killed in that storey.

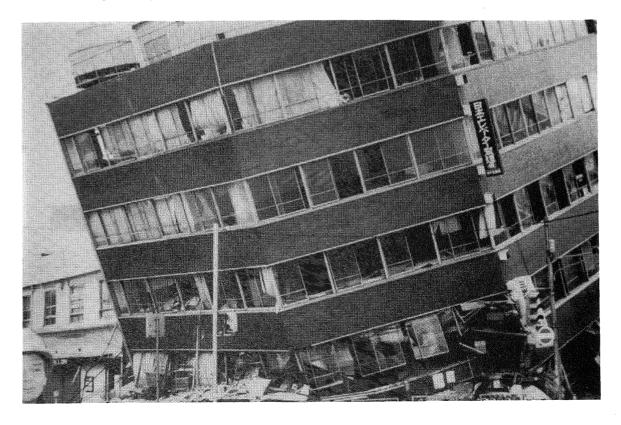
Fig. 11: Collapse of a building with an unsymmetrical structural configuration (Kobe, 1995).

Other general types of failure observed were due to torsion (twisting) of structures on street corners which were unsymmetrical in structural plan, such as due to walls only along two adjacent sides of the building (see Fig. 11) and pounding of adjacent structures of different stiffnesses.

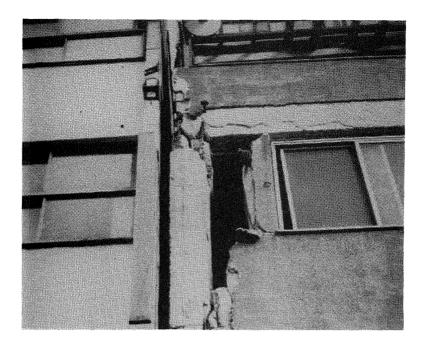
Fig. 12: Failure of reinforced concrete beam-column connection regions (Kobe, 1995).

For reinforced concrete structures the particular problems for structural elements and connections were due to poor detailing of reinforcement leading to shear failures, brittle compression failures of concrete, buckling of compressed longitudinal reinforcement, and anchorage failure in columns and beam-column connections (see Fig. 12).

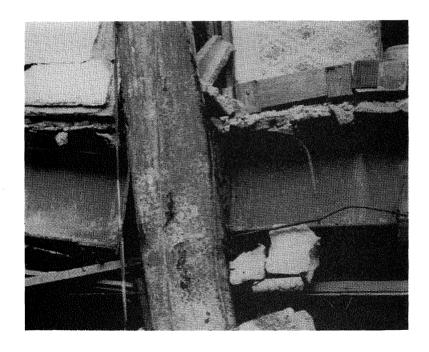
Fig. 13: Failure of a structural steel beam-column connection region (Kobe, 1995).

For structural steel the particular problems for elements and connections were due to inadequate welding leading to fracture of the welds, fracture of brittle steel members, buckling of compression members, and inadequate provision of a load path through beam-column connections (see Fig. 13).

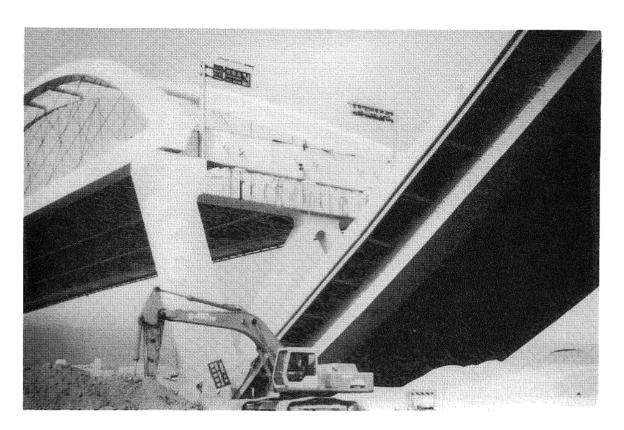
Fig. 14: Loss of approach span of the Nishinomiya-ko Bridge (Kobe, 1995).

Major revisions were made to the Japanese highway bridge design code in 1980. Elevated bridge structures designed to the 1980 bridge code generally performed well during the Kobe earthquake. Many elevated bridge structures designed prior to the 1980 code performed badly. For example, major damage occurred to bridge bearings, seismic restrainers and road joints. Some spans fell due to liquefaction causing lateral spreading of piers located adjacent to waterways (see Fig. 14). Bridge piers were often heavily damaged and collapsed in a number of regions of the city (see Fig. 15). Tilting of some piers occurred due to movement of the foundation.

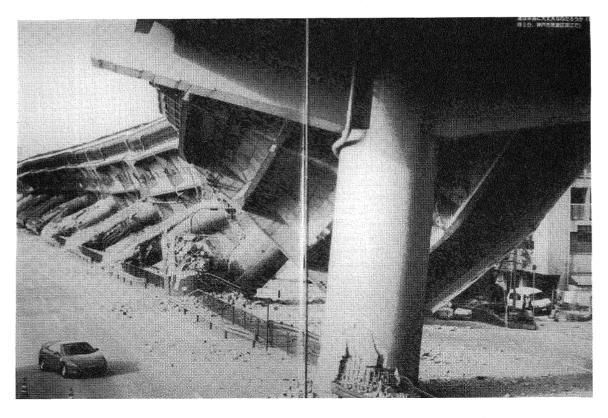
Fig. 15: Failure of columns of the Hanshin Expressway near Ashiya (Kobe, 1995).

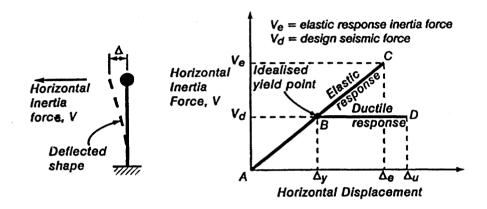
Fig. 16: Elastic and ductile response of a simple structure responding to an acceleration pulse of a severe earthquake.

maintain force carrying capacity while being displaced into the post-elastic range. For example, Fig. 16 shows the elastic and ductile response of a simple structure. If the structure is able to resist the horizontal inertia force $\,V_c$ corresponding to elastic response it will not need to enter the post-elastic range. However, this force V_c in New Zealand can be as high as 1.0g. For many years a much smaller force V_d has been used in design (for example, 0.1g was recommended in the 1935 Standard Model Building By-Law). In order to survive the earthquake without collapse, when a design force V_d which is less than V_c is used, the structure must be able to yield in the post-elastic range in a ductile manner to horizontal displacement Δ_u .

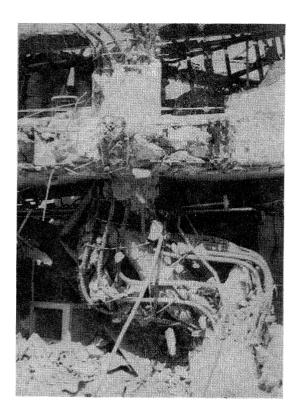
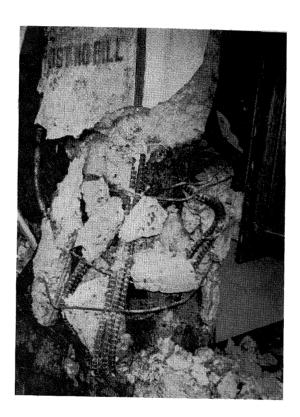
Fig. 19: Examples of brittle behaviour of reinforced concrete columns due to inadequate transverse reinforcement.

regions. Transverse reinforcement will not be effective if not properly anchored and/or of insufficient quantity. End hooks should preferably be bent through at least 135°. 90° end hooks are definitely inadequate for perimeter hoops, since spalling of cover concrete will result in loss of anchorage. 90° end hooks could be tolerated in limited ductility design when used for interior legs of hoops or ties which pass through the core concrete and are bent around intermediate column bars. Anchorage failure and/or inadequate quantities of transverse reinforcement will result in a reduction in the flexural ductility of members due to lack of concrete confinement and a lack of restraint against buckling of longitudinal bars and/or shear failure due to lack of adequate shear reinforcement (see Fig. 19).

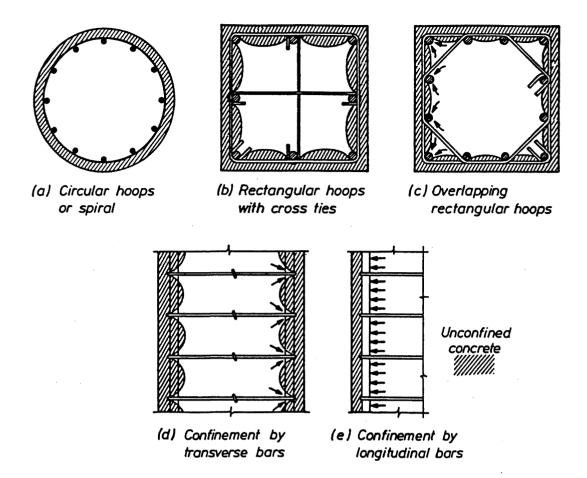
Fig. 20: Arrangements of reinforcement which confine the concrete and prevent premature buckling of longitudinal reinforcement of columns.

or spirals should not exceed the smaller of one-quarter of the least lateral dimension of the column cross section or 6 times the diameter of the longitudinal bars. Methods are given for calculating the area of transverse reinforcement required for the prevention of shear failure, to confine the concrete and to restrain buckling of longitudinal bars.

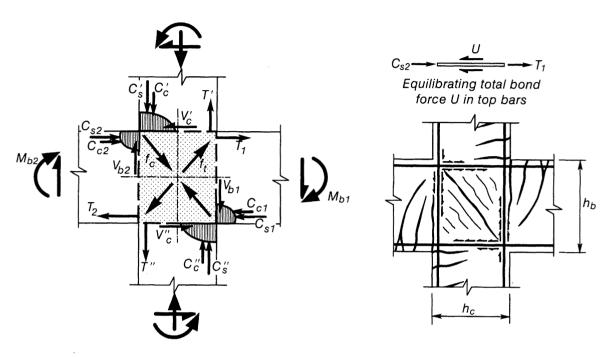
(a) Forces from beams and columns acting on the joint

(b) Crack pattern and bond forces after diagonal tension cracking initiates in joint core

(d) Truss mechanism of concrete diagonal compression field and horizontal and vertical reinforcement needed for equilibrium after diagonal tension cracking

Fig. 21: Forces acting on an interior beam-column joint during an earthquake and the resulting cracking and mechanisms of force transfer.

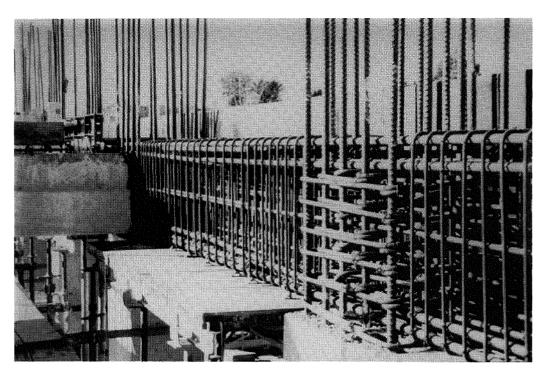
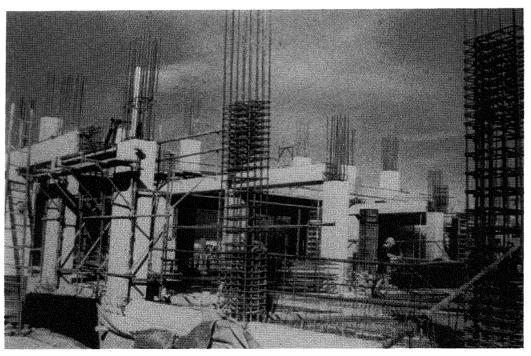
(a) Beam

(c) Beam-Column Joint

(c) Columns

Fig. 22: Typical reinforcement for ductile moment resisting frames in New Zealand.

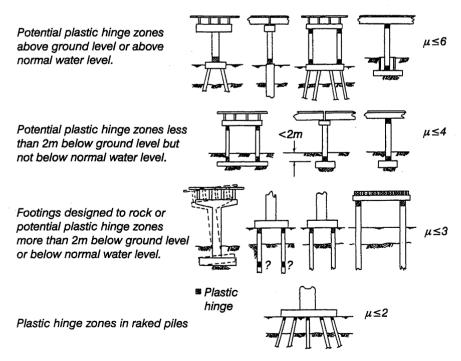
Fig. 23: Examples of maximum values of the displacement ductility factor μ permitted by the Bridge Manual of Transit New Zealand [19].

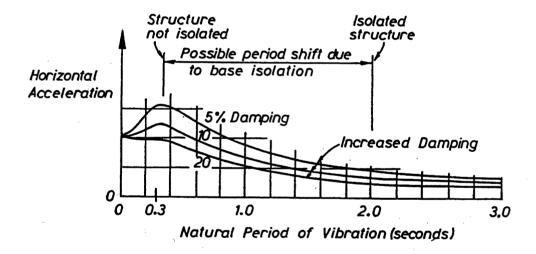
Fig. 24: Typical design elastic response spectra illustrating effect of increased period of vibration and damping.

For example, Figure 24 shows a typical elastic response spectra for horizontal acceleration used in seismic design. If the natural period of vibration of the structure is increased from 0.3 seconds to about 2.0 seconds, the horizontal acceleration is reduced by about 70%. Increasing the damping further reduces the acceleration.

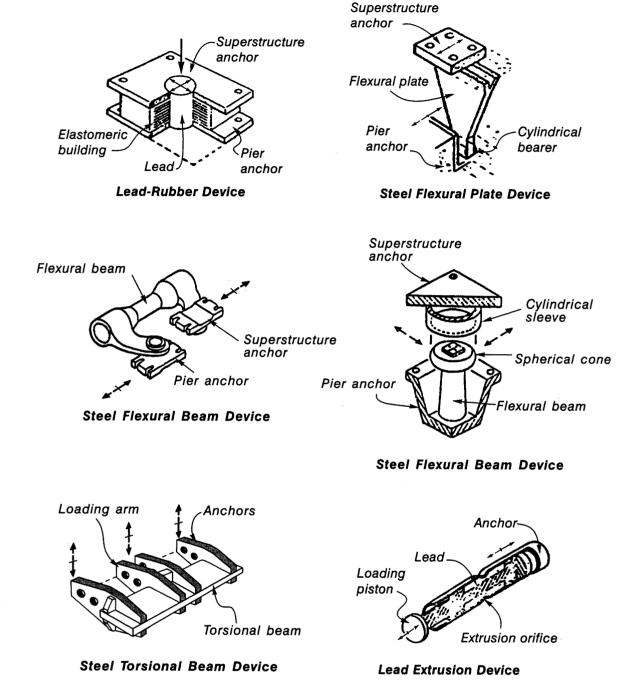
Fig. 25: Mechanical energy dissipating devices [21].

energy dissipation devices may take the form of steel elements which bend or twist, lead extrusion or lead shear devices. Figure 25 shows a range of possible energy dissipating devices which have been developed. Some of these devices are suitable for insertion between the foundations and the structure of buildings or the supporting structure and deck structure of bridges. The mechanical energy dissipating devices result in a decrease in the seismic forces in the structure during a severe earthquake and hence the strength and/or ductility requirements are reduced.

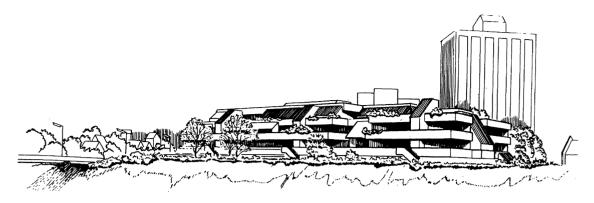
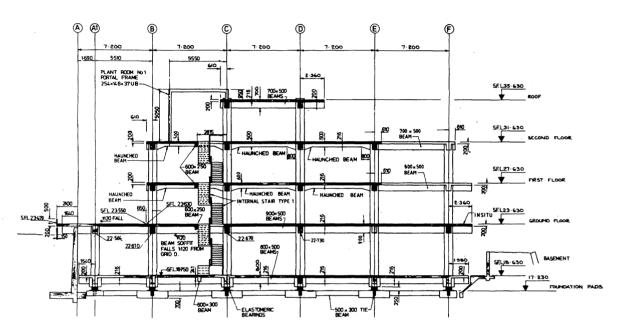
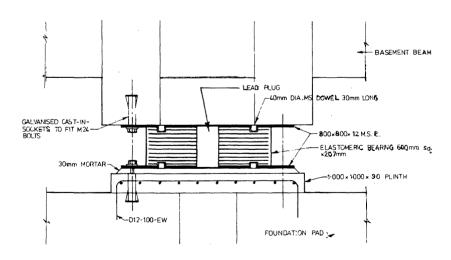
(a) Perspective of the building.

(b) Typical elevation through the building.

(c) Elevation through lead-rubber bearing.

Fig. 26: William Clayton Building [23].

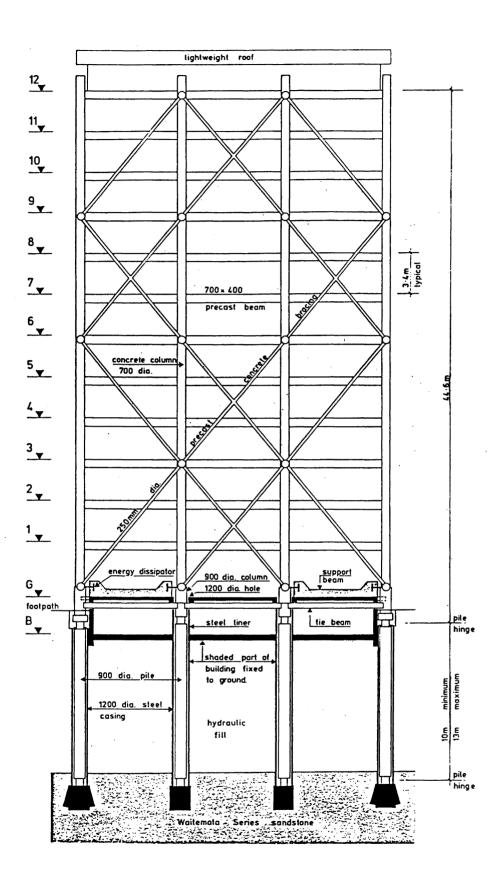
Fig. 27: Elevation of perimeter frame of Union House [24].

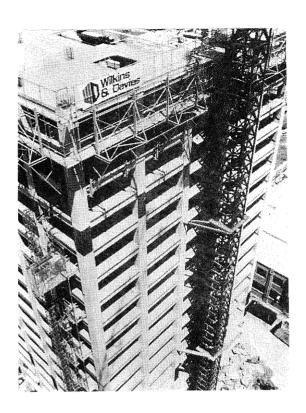
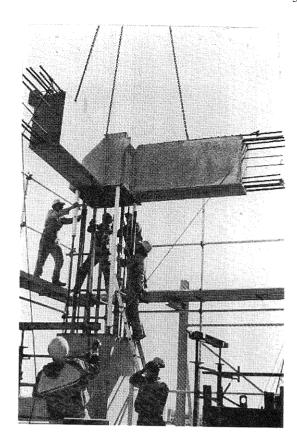
$Fig. \ 30: \ \ Construction \ of the \ Price \ Waterhouse \ Building \ in \ Christchurch \ using \ System \ 2.$

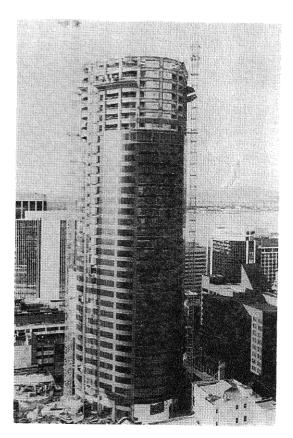
Fig. 31: Construction of the 152 m tall ANZ Building in Auckland using System 2.

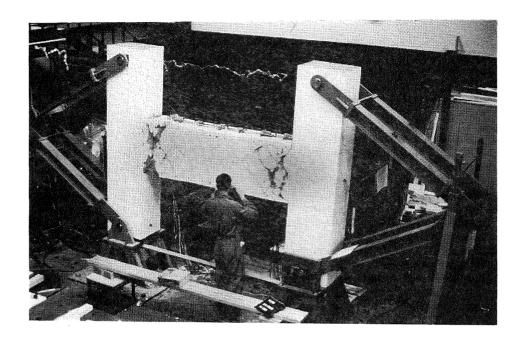
Fig. 32: Simulated seismic load test on a mid-span connection between precast concrete elements [28].

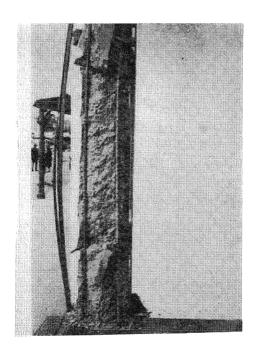
Fig. 33: Reinforced concrete column with poor transverse reinforcement damaged in the 1931 Hawke's Bay Earthquake.

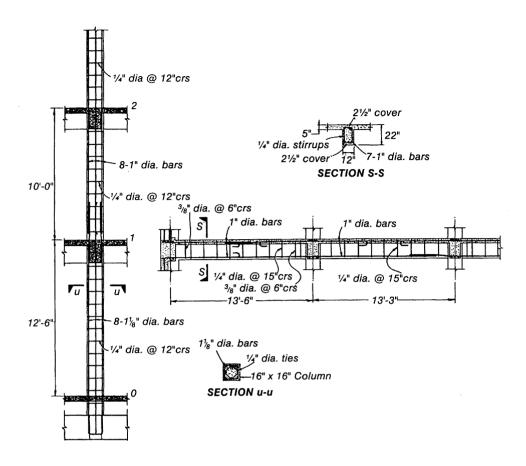
Fig. 34: Details of typical reinforcement in a reinforced concrete moment resisting frame designed in the late 1950's in New Zealand.

As an example, Figure 34 shows typical details of beam and column reinforcement in a building frame, which was constructed in New Zealand in the late 1950's. As with many building structures designed to early codes, the reinforcing details are adequate for gravity and wind loads but some of the details are inadequate for earthquake forces if ductile behaviour is required. All of the previously listed shortcomings are present in various parts of the structure shown in Figure 34.

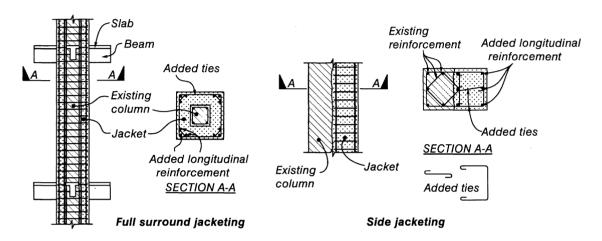
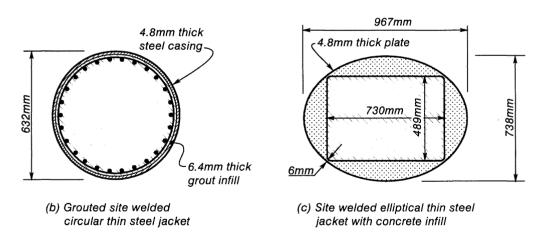
(a) Reinforced Conrete Jackets

Fig. 35: Some methods for retrofitting columns.

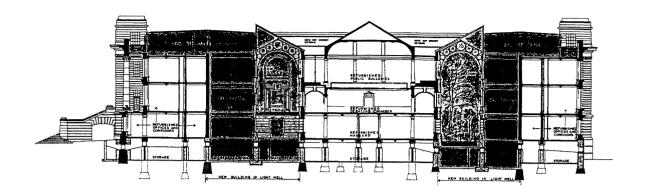
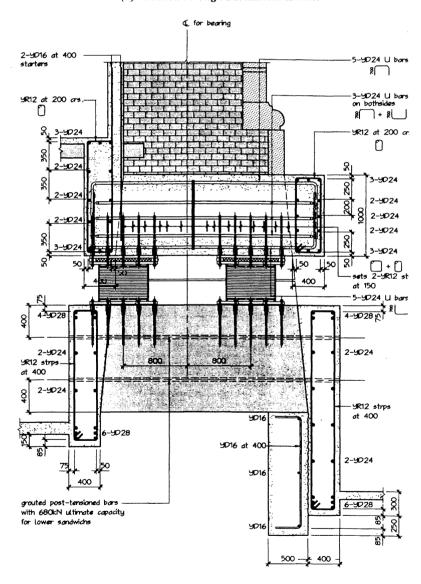
(a) Section through Parliament House.

(b) Lead-Rubber bearings at north wall.

Fig. 36: New Zealand Parliament House [36].
