## EXPERIMENTAL STUDIES OF A TYPICAL SPRINKLER PIPING SYSTEM IN HOSPITALS

Zhen-Yu Lin<sup>1</sup>, Fan-Ru Lin<sup>2</sup>, Juin-Fu Chai<sup>3</sup> and Kuo-Chun Chang<sup>4</sup>

### ABSTRACT

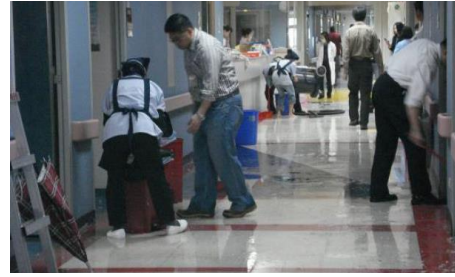
Figure 1: Flooding at a hospital due to an earthquake.

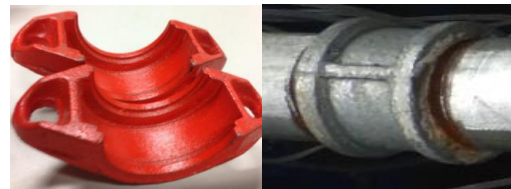
Figure 3: Couplings and screwed fittings.

This study aims to investigate the seismic behaviour of mechanical joints including couplings and small-bore screwed fittings to effectively improve the seismic performance of sprinkler systems. According to NFPA13 [4], flexible joints are regarded as seismic resistance devices for piping joints and as substitutions for screwed fittings to accommodate excessive motions induced by strong earthquakes. One of the common flexible joint types is a coupling (Figure 3). Hence, this study conducted pure bending tests for couplings and small-bore screwed fittings (i.e., 1" screwed fittings) to investigate their flexural capacity. Based on the case studies of several hospitals in Taiwan [8], paired couplings with three common galvanized steel pipe dimensions (1", 4" and 6") were studied through monotonic and cyclic loading tests (Table 1). Furthermore, the vulnerability of small-bore piping joints observed in earthquakes and previous research [2] [3] [9] was considered by conducting flexural-shear tests for 1" screwed fittings and couplings to identify the difference between flexural and flexural-shear failure modes.

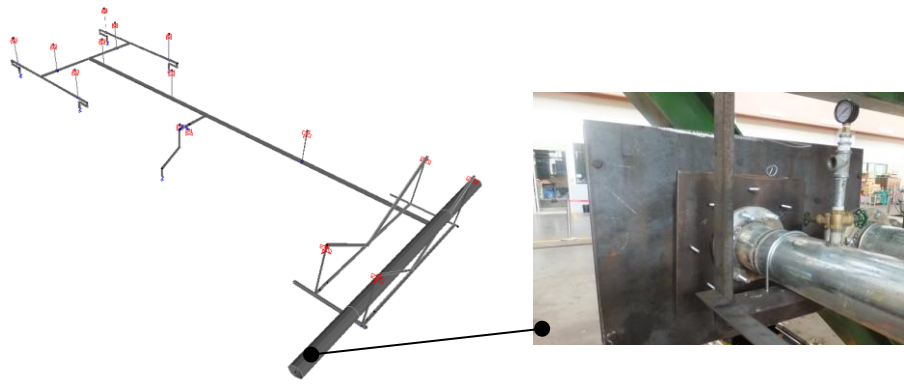
Figure 18: The numerical model of the test specimen.

Limited to the scale of the shaking table, only a part of the sprinkler piping system was duplicated in the laboratory, including branches in the area of the patient room and a part of the cross main pipe along the corridor (Figure 18). To obtain a reasonable assumption about the boundary conditions of the tested segment of the cross main in shaking table tests, preliminary numerical models of the complete piping system at the 6<sup>th</sup> floor and the test specimen were both established according to the *in-situ* investigation on the configuration and restraint conditions in the hospital and that of the actual test specimen (

Figure 17 and 18). Comparing the system identification results of ambient vibration tests and numerical analysis, it was found that the restraint conditions of boundaries might be different under ambient vibration or strong motions. For example, to obtain the fundamental frequency in the transverse direction of the cross main pipe, the restraints of sprinkler heads adjacent to ceiling systems are assumed to be hinges. However, it is more reasonable to regard sprinkler heads as free ends of pipes while the mineral fibre ceiling board ceiling boards are torn during strong earthquakes.

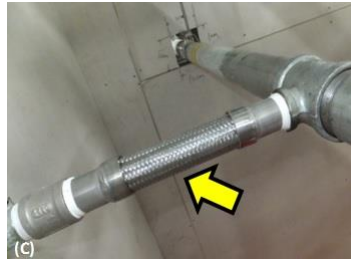
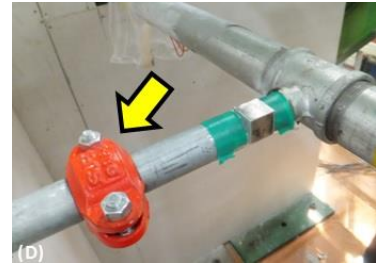
Figure 21: Test configuration and seismic restraint devices.

The objective of this test was to identify the failure modes of a typical sprinkler piping system in hospitals and to propose the appropriate improvement strategies for higher seismic performance (Figure 20, Figure 21A). It was attempted to reproduce the same damage that occurred in the 2010 Jiashian earthquake for the test with the original configuration of screwed fittings. In addition, the modified configurations with proposed seismic restraint devices including braces, flexible hoses and couplings were also arranged at the proper positions to verify their improvement efficiencies (Table 4 and Figure 21). The tested subsystem was hung by a rigid steel frame, which was designed to be stiff enough to transfer the motion of the shaking table without significant effects. Figure 21 and Figure 23 depict two types of horizontal motions measured in tests near hang points on the steel frame. The purpose of the Type A motion was to verify whether seismic restraint devices satisfy the requirement of the building code in Taiwan [13], while that of the Type B motion was to simulate the floor response in the hospital during the Jiashian earthquake. Figure 24 shows the layouts of instruments including accelerometers, magnetic transducers, and strain gages in the DBF testing case. With the assumption that ceilings moved with the floor in this experiment, the rigid frames accommodating ceiling boards were installed on the reference frame directly (Figure 19).

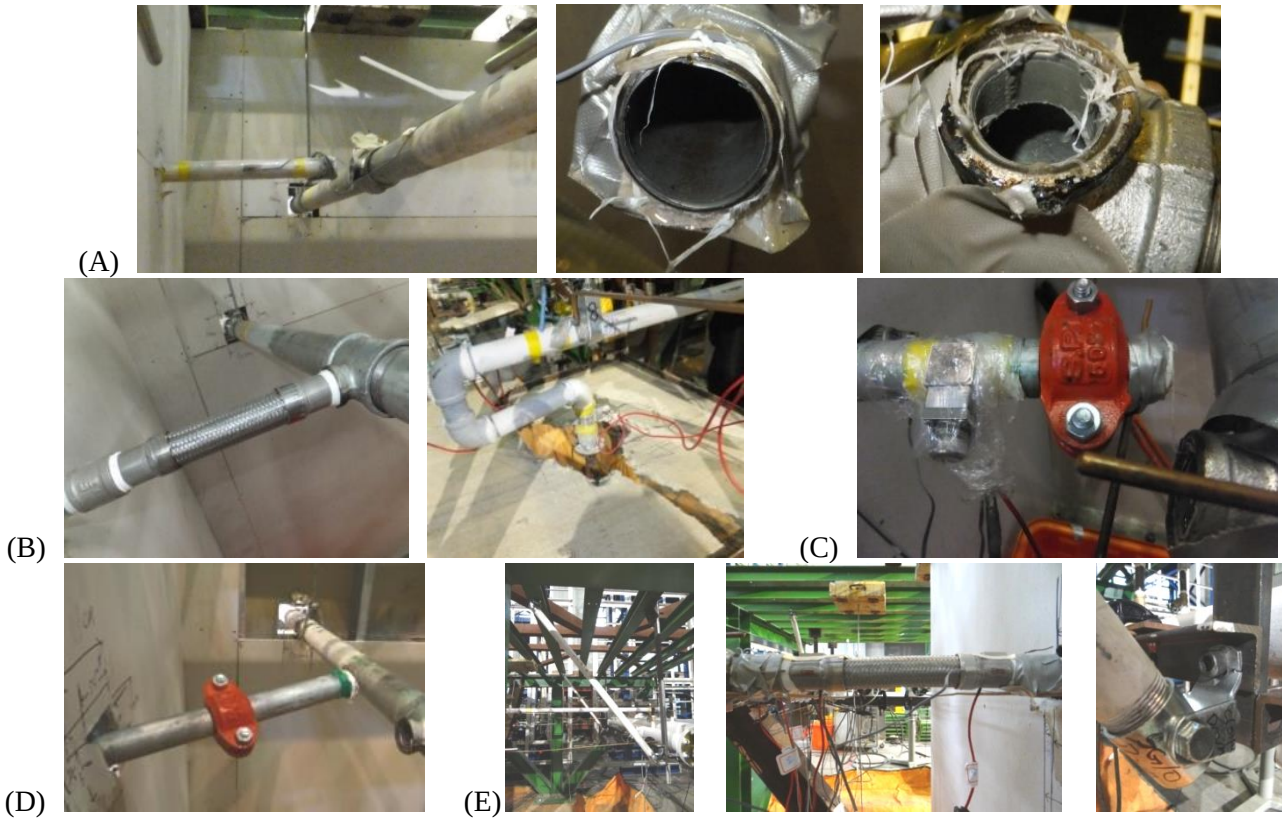
**Figure 26: Damage states of each test configuration: (A) OC; (B) FH; (C) CT; (D) CB; and (E) DBF.**

due to seismic interactions, three performance indexes were examined during and after each test: (1) the damage of the piping segments; (2) enlarged diameters of the reaming on ceiling boards and partition walls due to impacts caused by sprinkler heads and piping segments; and (3) the leakage of contained water. The test results of the original configuration showed that the screwed fitting of a 1" drop at the tee branch was the most vulnerable part of the tested piping system and was damaged at a 100% intensity of the Type B test (Figure 26A). Although there was no leakage in the tests of the configuration with the flexible hose (FH, Figure 27), all ceiling boards were broken and could seriously damage the medical services (Figure 26B and Figure 28). On the other hand, due to the brittle failure caused by the screwed fitting and couplings, the mechanical behaviour of both devices should be further studied (Figure 26C and Figure 26D). The optimum improvement strategy to achieve a higher nonstructural performance for the piping system is to strengthen the main pipe with braces and decrease moment demands on the small-bore piping at the tee branch by a flexible hose. However, well designed attachments of braces were needed to avoid the damage observed in the DBF tests (Figure 26E).

impact effects on the 1" drop (Figure 30). The strain responses of the 1" drop in the DB, FH, and DBF configurations (Figure 31A) proved that using both braces at the main pipe and flexible hoses at the drops near partition walls can effectively decrease the internal force of small-bore pipes and reduce the possibility of leakages. However, it should be noted that the braces and related attachments in the DBF configuration were subjected to more seismic forces than those in the DB configuration due to less restraint offered by the partition wall (Figure 31B). Better and more-detailed design of the attachments of braces is required to avoid the damage observed in the Type A test of the DBF configuration (Figure 26E).
