GEOLOGY

Earth deformation accompanying the Inangahua earthquake

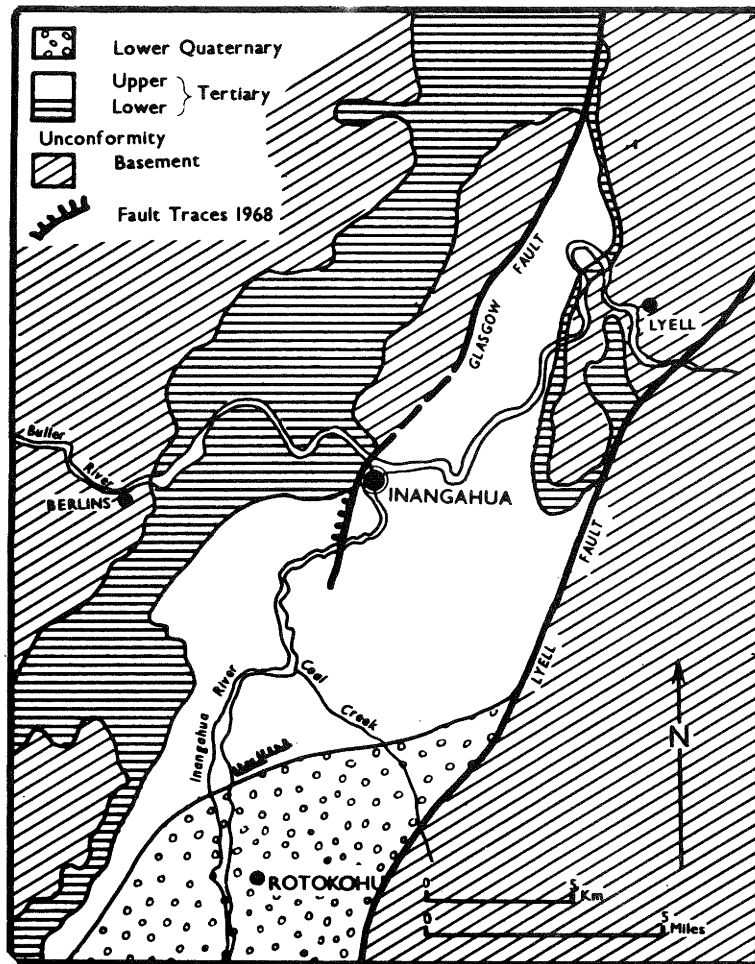
Fig. 1. Map showing the distribution of lower Quaternary, Tertiary and Basement rocks, the major geological faults and the Inangahua and Rotokohu surface traces.

Faulting took place at two localities (Fig. 1), near Inangahua Junction railway station and about three miles north of Rotokohu. In both places movement comprised horizontal, vertical and thrusting components.

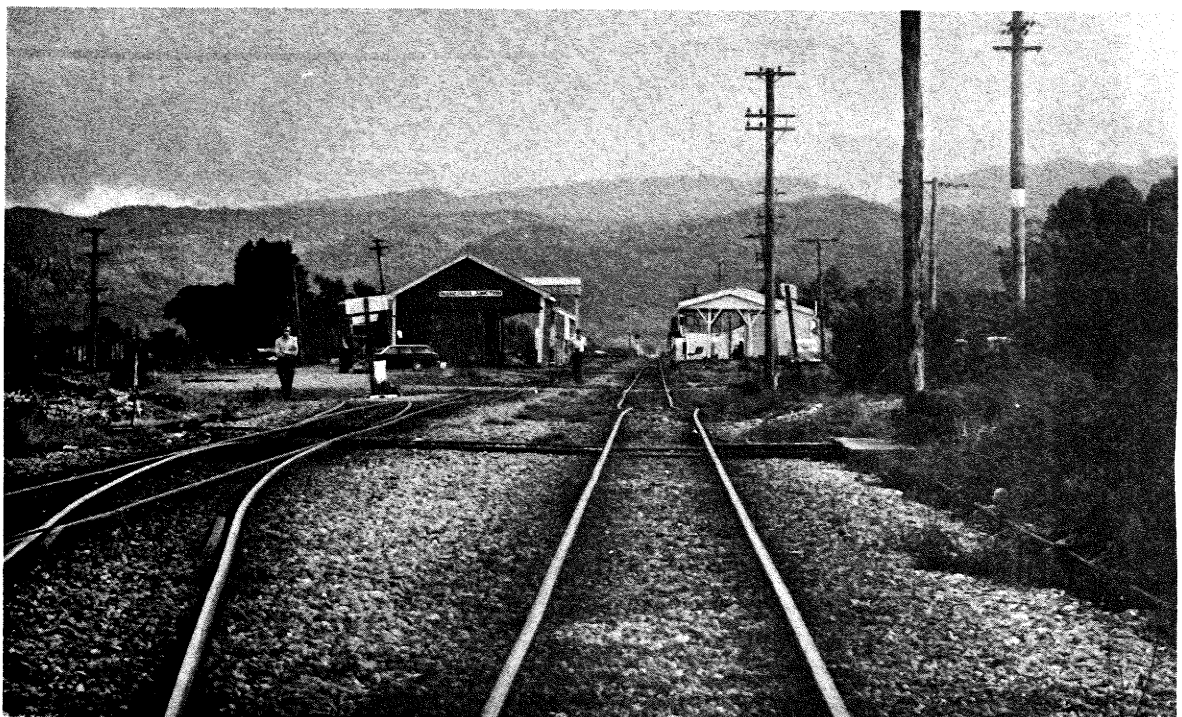
Fig. 2. Looking southward along the railway line and taken from the upthrown side of the Inangahua trace, and showing horizontal sinistral offset of railway line.
photo NZGS L. Homer

The Inangahua trace marks the rejuvenation of a fault that had already displaced a terrace surface at least twice since that surface was formed, probably in late Otira (Last) Glacial time, about 20,000 years ago. It is thought to lie on the southerly extension of the major Glasgow Fault, which 2 miles to the north of this trace at the Buller River separates Upper Tertiary sediments from Lower Tertiary and basement rocks. The trace was most clearly seen at the railway line (Fig. 2) and diminished to a small roll in the turf about $\frac{1}{4}$ mile to the south. Northwards it was followed for $\frac{1}{2}$ mile, diminishing in prominence and splaying into two smaller traces which trend between north and 020° . The maximum displacement is about 16 inches both horizontally in a sinistral sense and vertically. Overthrusting amounts to at least several inches.

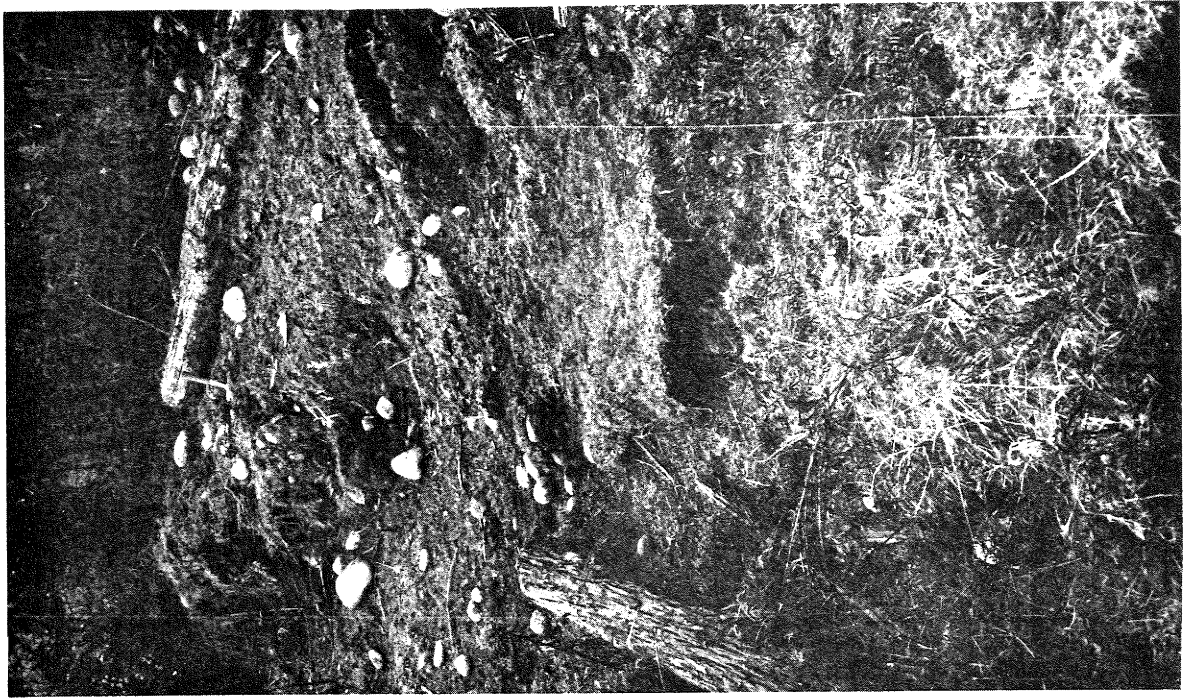
Fig. 3. "Moletrack" features of compression rolls and tension cracks on Rotokohu traces. photo NZGS L. Homer

50 ft wide parallel to and including the fault, however, the horizontal displacement amounts to about 6 ft. Shortening across the fault is about 2 ft. The traces are marked by "mole track" features consisting of compressional rolls and tensional cracks that in detail deflect the line of the scarp (Fig. 3). The traces are parallel to the strike of the underlying Upper Tertiary sediments as judged by observations at the Inangahua river bank to the west and, rather further away, in Coal Creek to the east. The traces are at a sharp anticlinal bend and are thought to be bedding faults resulting from failures on bedding planes between different lithologies. They indicate continued folding within the Grey-Inangahua Depression.

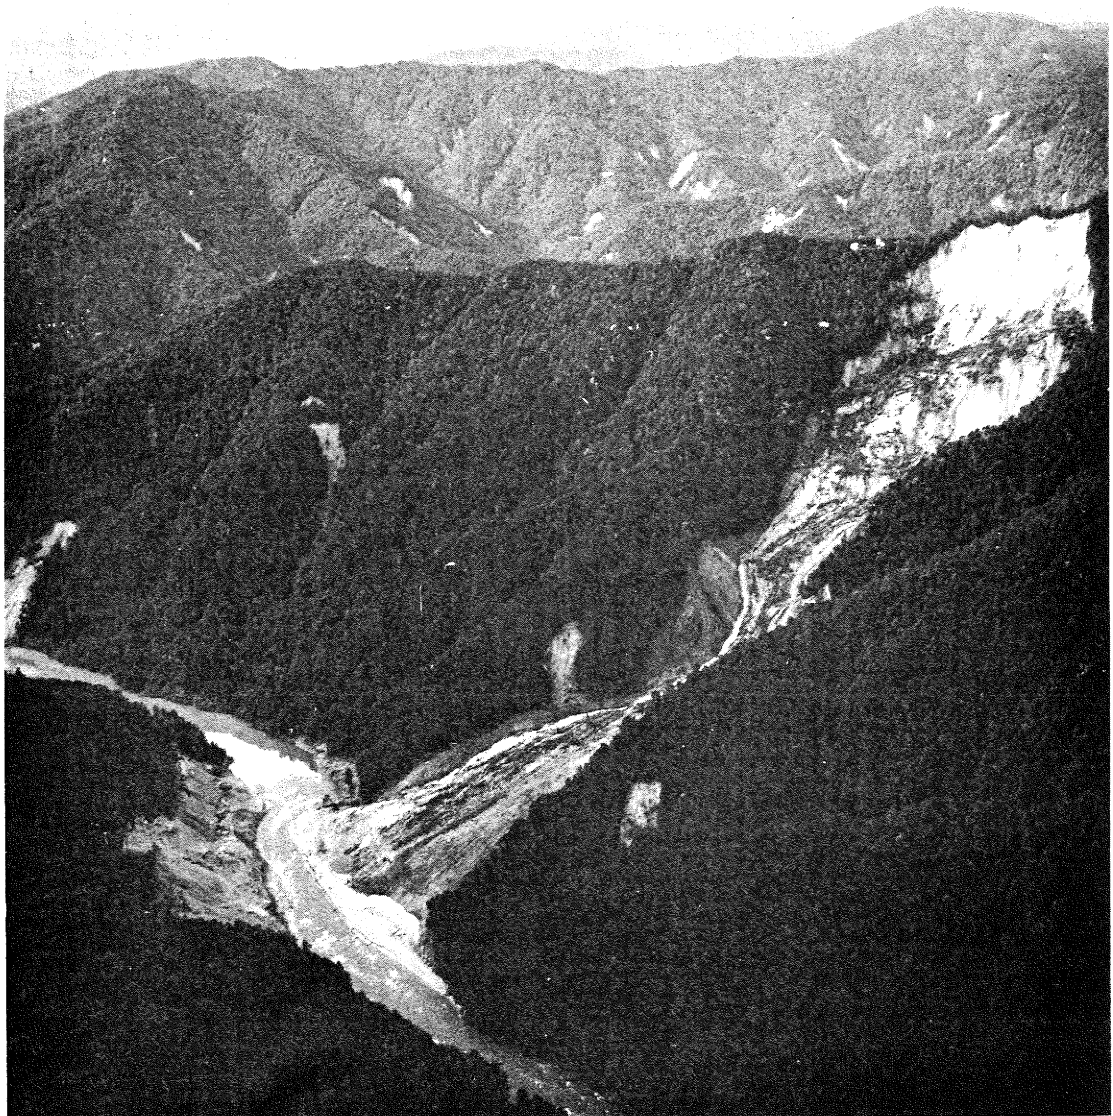
Fig. 4. Avalanche in granite consisting of granite blocks and near surface weathered material that temporarily blocked the Buller River. L. Homer

Despite the consequent irregularities of distribution, most of the landslides affecting the natural landscape were within a 10 mile radius of Inangahua, with rather fewer to the north and north-west within that radius. Much particular damage by landslides was clearly related to road cuttings and fill. Rockfalls predominated at the near-vertical limestone bluffs west of Inangahua. Slides on bedding occurred in Upper Tertiary sediments, a remarkable example being at Oweka where a mass of some 3 million cu. yds moved bodily on a plane dipping less than $3\frac{1}{2}^{\circ}$. Slides on joint surfaces were common in the granite, but much of the more spectacular slipping, including the slide that temporarily blocked the Buller River (Fig. 4), was of blocky and weathered near-surface material on very steep slopes. Prominent near Inangahua Junction were earth-flows of weathered Upper Tertiary muddy sandstone-water-saturated weathered material that in sliding disrupted a small amount of underlying unweathered sediments. A few rotational slides occurred in Upper Tertiary sediments; upstream of the Buller railway bridge rotation raised the river bottom above river level at the toe of one slide. Debris slides in surface material at weak crush zones in granite were numerous, for example along the Glasgow Fault north-west of Lyell.
