RAPID REPAIR OF RC COLUMNS WITH POST-TENSIONED EXTERNAL CLAMPS

ABSTRACT

A recent technique for repair of damaged reinforced concrete (RC) columns is reviewed. The technique involves the application of external post-tensioned clamps. The clamps are composed of steel angles and high-strength steel rods. The pairs of angles are placed on the corners of the cross-section, and they are connected with steel rods to each other. To evaluate the effectiveness of the repair technique, four large-scale RC columns with insufficient transverse reinforcement were subjected to lateral displacement reversals and constant axial load. The tests were conducted in two phases: initial testing of columns with none to light transverse reinforcement, followed by the application of clamps on the damaged columns and further testing. The study focused on the efficacy of the clamps to a) restore the lateral-carrying capacity of damaged RC columns, and b) increase drift capacity. Variations in lateral expansion of the column core and their plausible correlations with damage and 'repairability' are examined. Within the conditions investigated, two key requirements are proposed for safe column repair: 1) the c

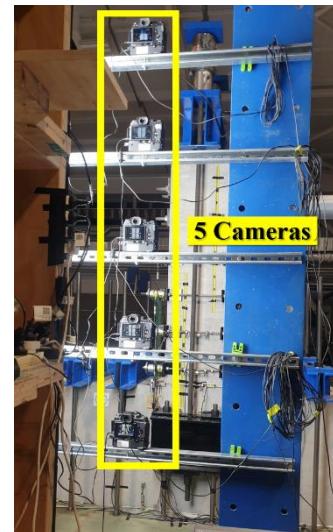
Figure 7: Experimental setup for PTT.

For the experimental setup (Figure 7), five Fujifilm X-T2 cameras equipped with XF 18–55 lenses were positioned approximately 2 metres from the specimen. Photographs were captured at a resolution of 6000x4000 pixels, while PTT resolution ranged from 0.163 mm/pix to 0.166 mm/pix. Red particles, approximately 4 mm in diameter, were painted onto the concrete surface without following a specific pattern. During tests, an image was captured by each camera at each displacement step of the loading protocol.

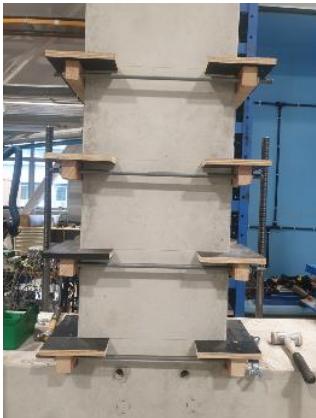
Figure 9: Supports made of wood to help installation of steel clamps.

- Placement of temporary supports to facilitate clamps installation, as shown in Figure 9. These supports are useful when a single person executes the installation.
- Installation of clamps by positioning welded pairs of steel angles (Figure 4) on the four corners of the column and connecting the pairs of angles to each other with steel threaded rods (Figure 10). The clamps were equipped with 150-kN load cells. A machined plate was added to fit the

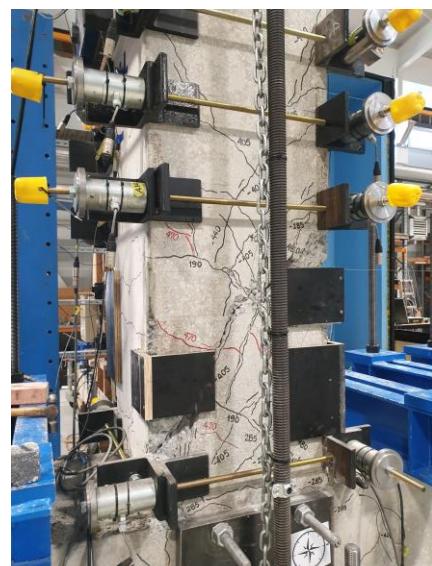
Figure 26: Repair of C13 – Stage C.

In this stage, column C13 underwent a second round of repair and additional loading. The failure in the clamps resulted in the loss of lateral confining pressure on the column and damage to the concrete cover. Reconstruction of the corner areas was

necessary before the installation of new clamps (Figure 26). The damaged corners were repaired using SikaGrout 212 HP, a high-strength cementitious grout. After a curing period of two days, the compressive strength of the grout was measured to be 24 MPa, obtained from the average of three 50-mm-side cubes.
