# GEOMETRIC CHARACTERISATION AND OUT-OF-PLANE SEISMIC STABILITY OF LOW-RISE UNREINFORCED BRICK MASONRY BUILDINGS IN AUCKLAND, NEW ZEALAND

## SUMMARY

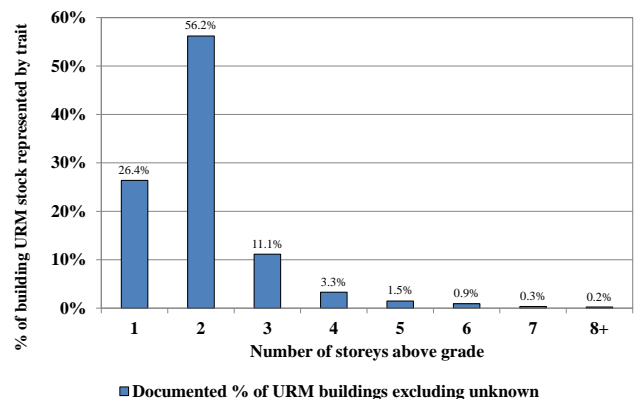
Figure 1: Proportions of documented commercial URM buildings in Auckland by number of storeys above grade.

In the amalgamated database, 879 URM (out of 901) buildings have been documented with a particular number of storeys above grade and the associated percentage groupings are illustrated in Figure 1. As discussed later, for typological groupings to include multiple attributes (e.g., structure type, number of storeys and age of construction), buildings have been grouped into categories of 1 - 3 storeys and 4 - 7 storeys, consistent with previous typological groupings used in New Zealand [16]. Two buildings were identified as having eight storeys above grade, but both buildings have frame systems supporting most or all of the gravity loads while the masonry is expected to provide the primary lateral load resistance.

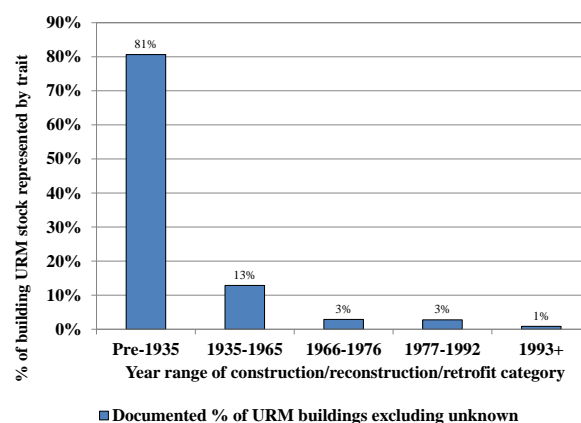
**Figure 2: Proportions of documented commercial URM buildings in Auckland by year of construction, reconstruction, or seismic retrofit.**

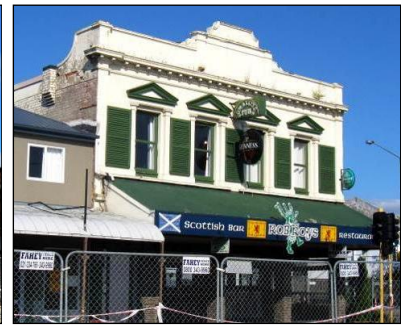
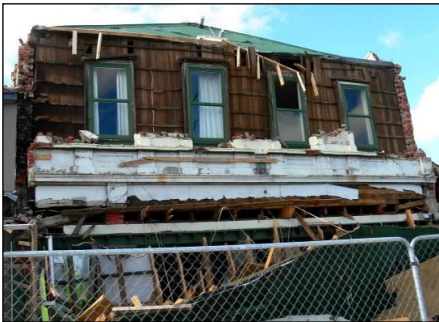
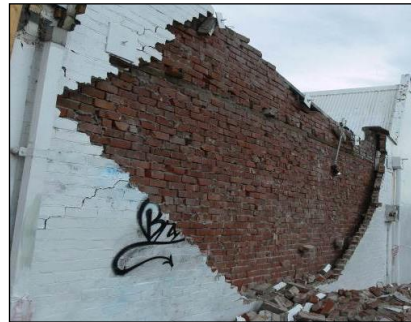
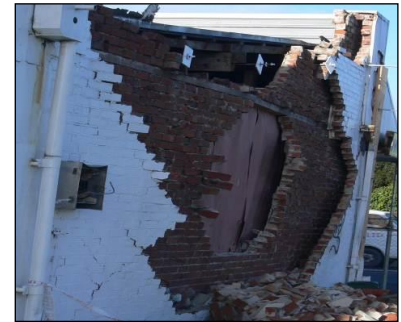
(a) Building A parapet condition in October 2010.

(b) Building A parapet condition in March 2011.

(c) Building B facade condition in October 2010.

(d) Building B condition in March 2011 – collapse of façade.

(e) Building C post-22nd February 2011 – collapse of outer leaf of cavity wall.

(f) Building C post-13th June 2011 – collapse of inner leaf of cavity wall.

**Figure 4: Post-earthquake observations of out-of-plane failures to URBM buildings in Christchurch.**

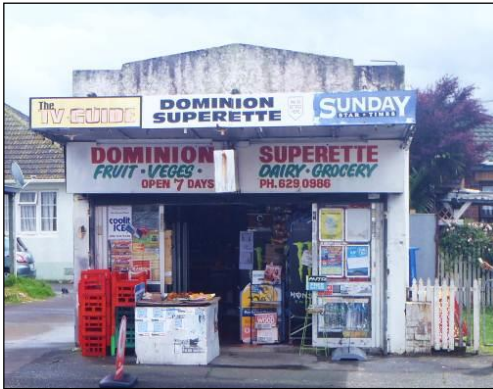
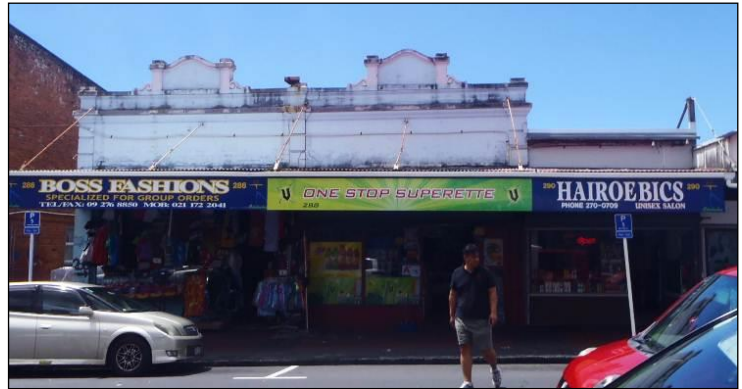
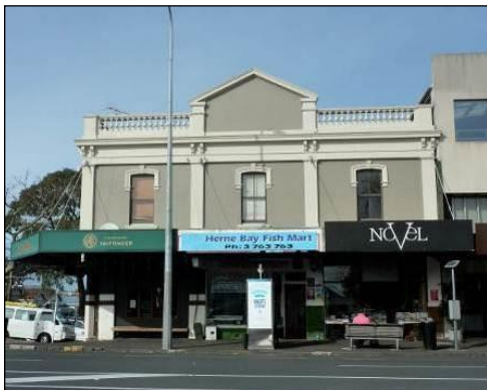
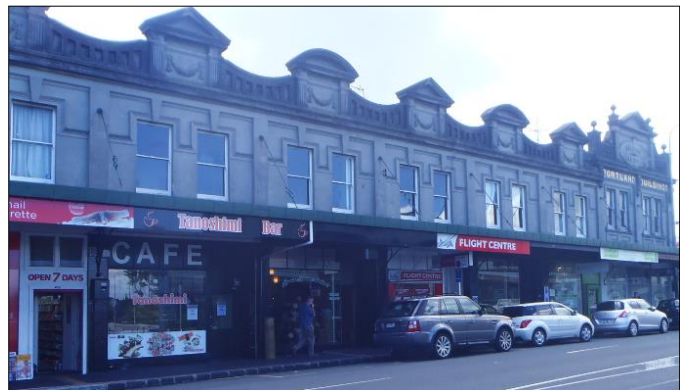
(a) Typology A - one-storey isolated building.

(b) Typology B - one-storey row building.

(c) Typology C – two-storey isolated building.

(d) Typology D – two-storey row building.

Figure 5: Most prominent sub-typologies documented from the CDEM study as classified by Russell and Ingham [13].

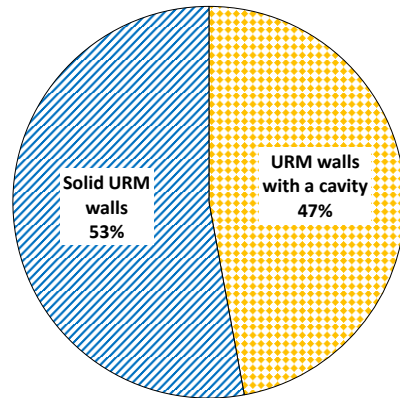
(a) Proportions of URBM buildings documented for the CDEM study within each sub-typology per Russell and Ingham [13].

(b) Proportions of URBM buildings documented for the CDEM study by presence of a cavity within the load-bearing wall.

Figure 6: Summary of typological proportions from CDEM study.

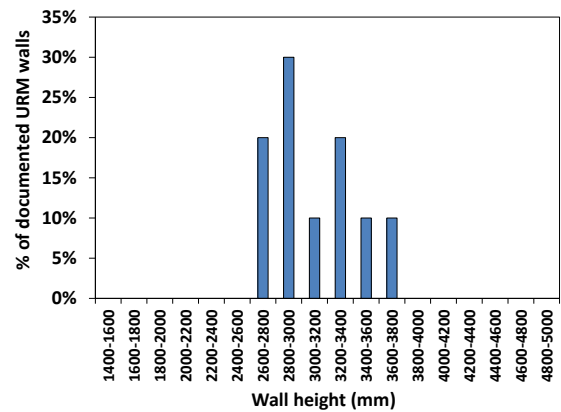
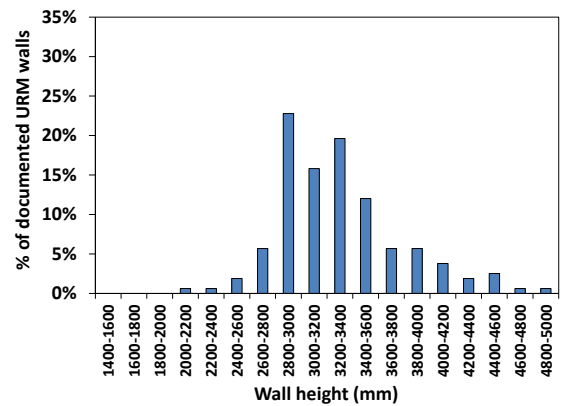
(a) Parapets.

(b) Walls of second elevated floor.

(c) Walls of first elevated floor.

(d) Walls of ground floor.

Figure 8: URM wall heights and corresponding proportions of those walls documented for the CDEM study.

In the present study, wall thickness measurements at the ground storey of the buildings, including the cavity where applicable, were found to be between 230 mm and 470 mm, with the vast majority of solid walls documented as being 350 mm thick (i.e., three leaves thick). The typical construction of a two-storey wall includes an inset ledge (and hence, reduced thickness) at the upper storey floor levels to permit floor bearing. A cross section of typical cavity wall construction (reproduced from AS 3700:2011 [30]) is included in Figure 7, although diaphragm-to-wall ties were rarely observed within the study group. The distributions of wall and parapet heights across the portfolio of 206 inspected buildings are illustrated in Figure 8.

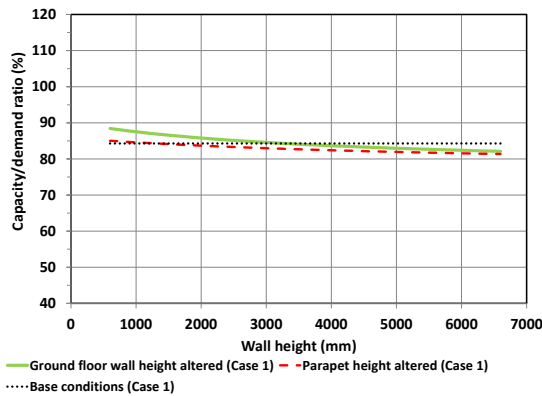
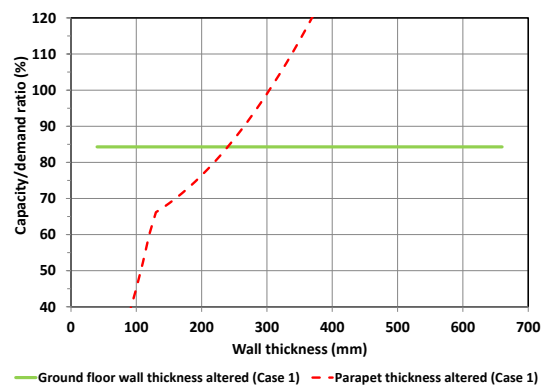
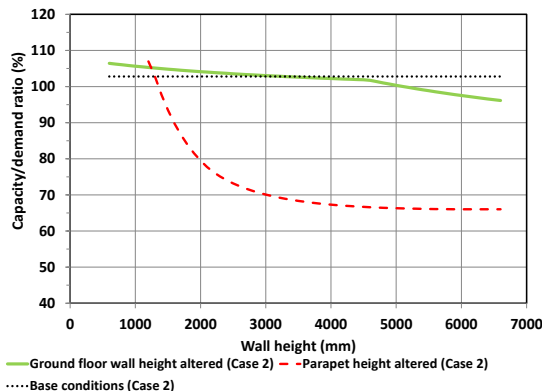
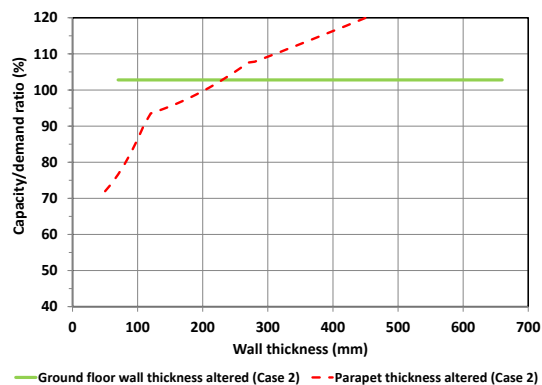
(a) Influence of wall height on wall stability (Case 1).

(b) Influence of wall thickness on wall stability (Case 1).

(c) Influence of wall height on wall stability (Case 2).

(d) Influence of wall thickness on wall stability (Case 2).

**Figure 11: Sensitivity of capacity/demand ratio to different conditions (50<sup>th</sup> percentile performance,  $PGA = 0.173g$ , Derakhshan et al. 2014 [25] “parts and components” spectrum).**

For Case 2 in Figures 11(c) and 11(d), the most influential geometric characteristics are parapet height (negative correlation) and parapet thickness (positive correlation). Ground floor wall height is only slightly influential (negative correlation) and ground floor wall thickness is non-influential within this range. Given that the wall below the roof level is restrained laterally top and bottom in Case 2, whereas the parapet still acts as a cantilever, these sensitivities are appropriate. Once again, these relative sensitivities are applicable only to buildings similar in geometry to the base building. A building with unusually high or thin (i.e., unrestrained cavity) walls below the parapet will be more sensitive to changes in wall dimensions. Furthermore, relative differences in geometries between wall and parapet may alter the governing limit state (i.e., whether the wall or the parapet collapses firstly).

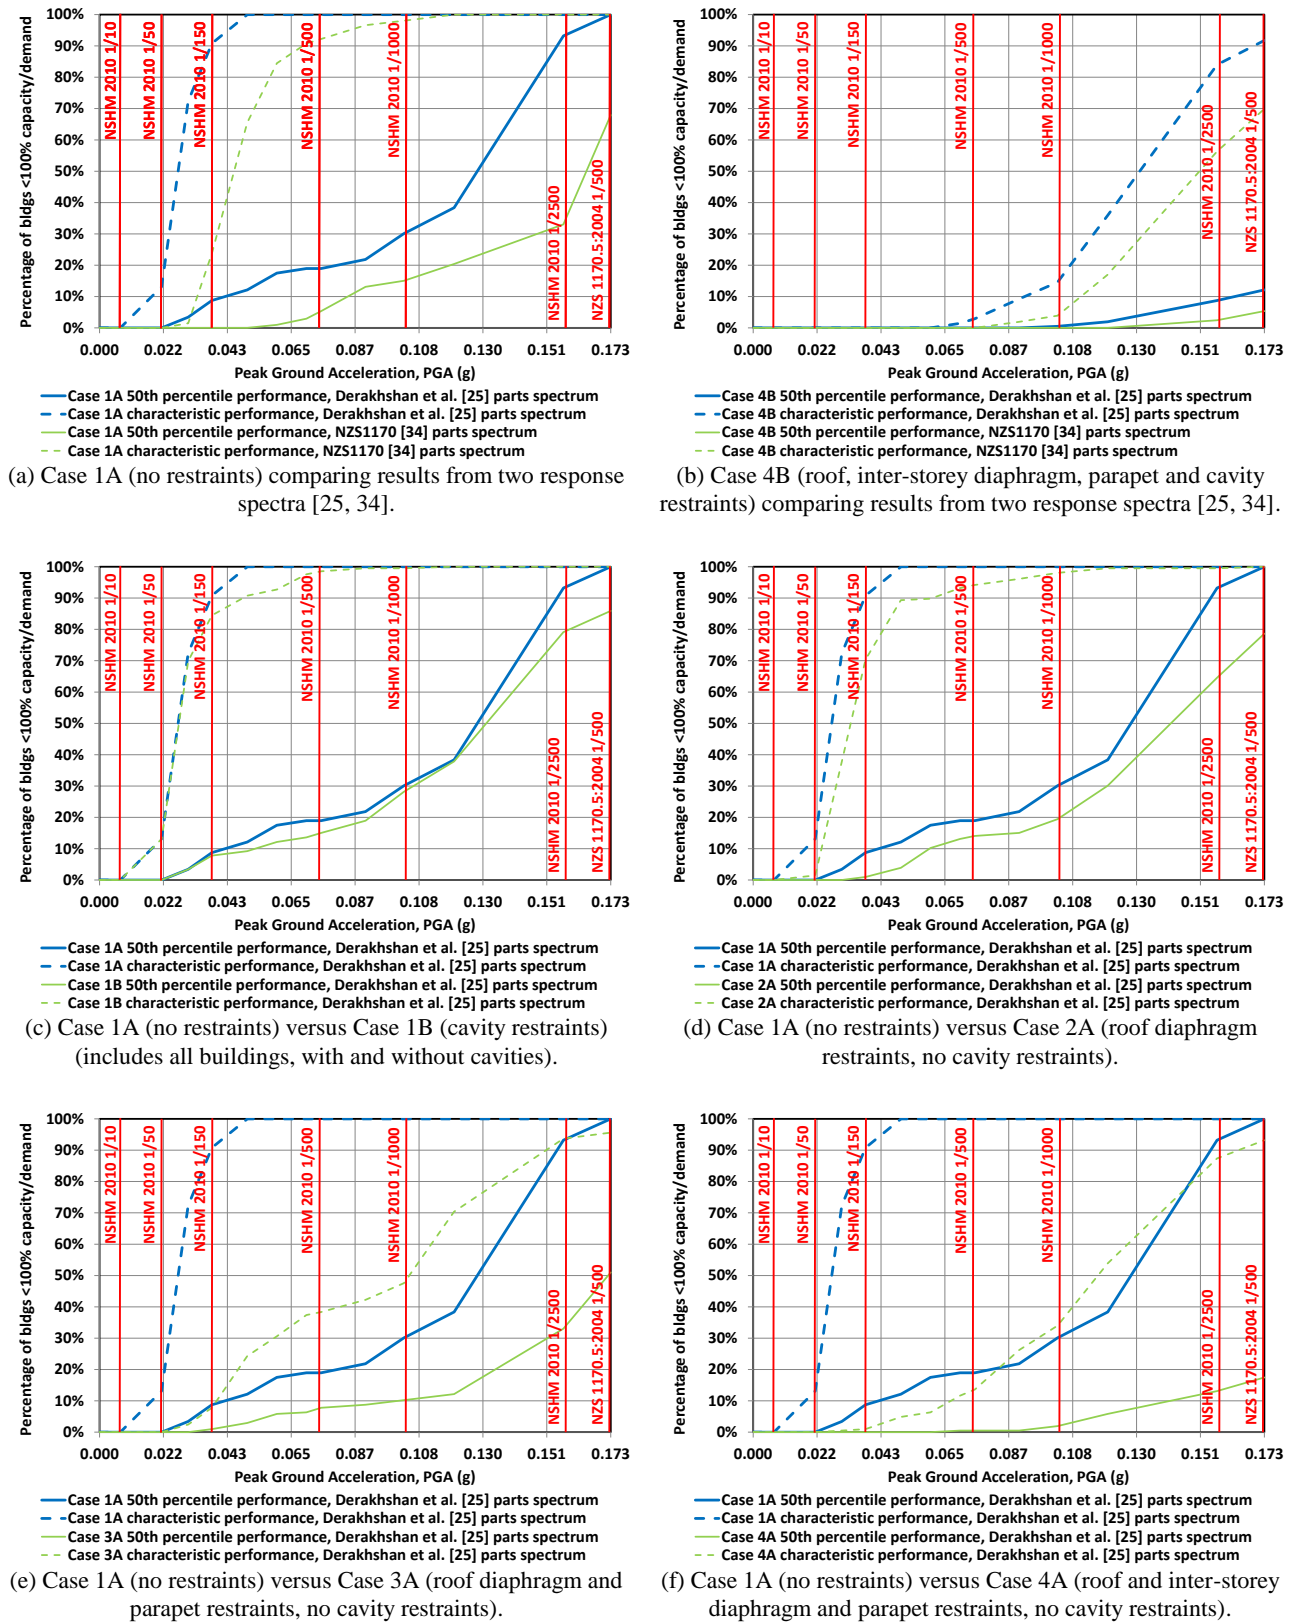
Figure 12: Percent of URBM buildings failing (i.e., capacity/demand < 100%) when subjected to varying PGAs, considering different restraint cases, capacity reduction factors and return periods (latter indicated by vertical red lines).

Summaries of the expected performance of the URBM buildings inspected in the CDEM study considering the two most extreme restraint cases (Case 1A with no restraints and Case 4B with all restraints, including cavity restraints) are included in Figures 12(a) and 12(b). Results produced using both response “parts and components” spectra [25, 34] are included in Figures 12(a) and 12(b) as a reference for engineers completing detailed seismic assessments of URBM buildings in Auckland with reporting intended to be used for regulatory purposes.
