# SEISMIC ASSESSMENT AND RETROFIT OF WAIKANAЕ AND PAKURATAHI RIVER BRIDGES

J.H.Wood<sup>1,2</sup>, H.E. Chapman<sup>2,3</sup>, G.C. Gregg<sup>3</sup> and  
D.K. Kirkcaldie<sup>4</sup>

*This paper was presented at the 2007 NZSEE Annual Conference in Palmerston North.*

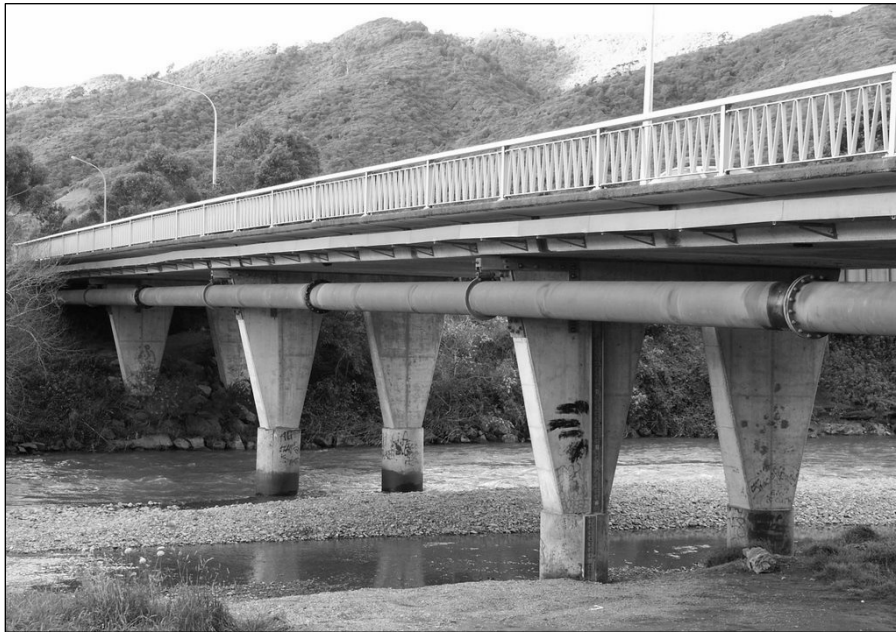
The five-span bridge was designed in 1962 and opened to traffic in 1964. It carries the two lanes of State Highway 1 across the Waikanae River, about 55 km north of Wellington City. The superstructure is a solid prestressed concrete slab continuous over the 80 m length of the bridge. Each of the four piers is supported on two 1.2 m diameter bored piles founded on rock. The abutment seating beams are founded on four steel H piles driven to rock. Details of the bridge are shown in Figure 1.

*Figure 1. Waikanae River Bridge*

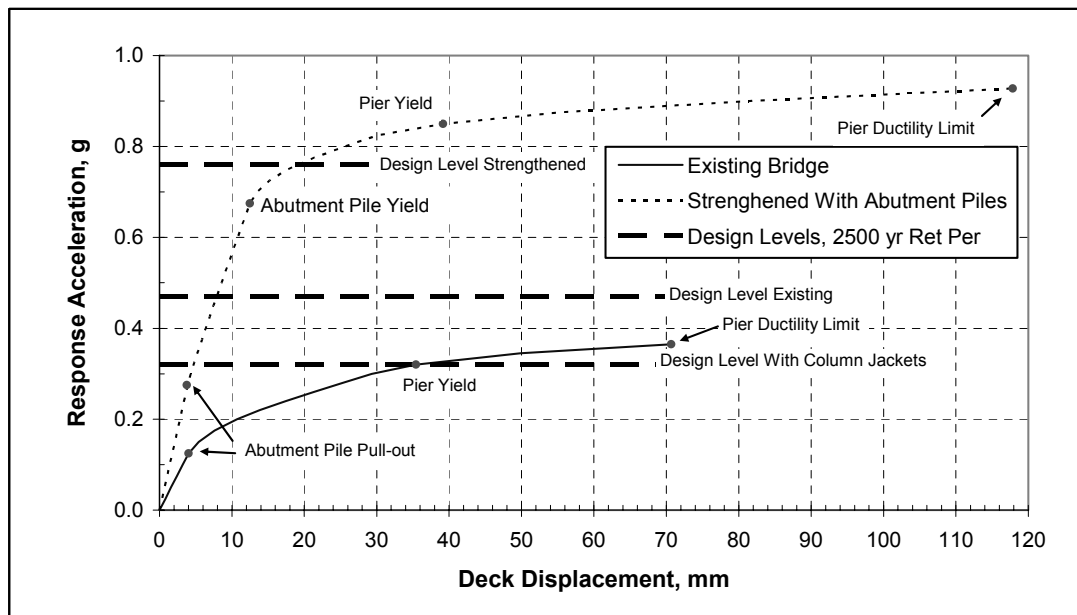
Response acceleration versus deck displacement for loading in the longitudinal and transverse directions is shown in Figures 2 and 3 respectively. A summary of the response acceleration levels that caused damage or failure of the lateral load resisting elements is presented in Tables 1 and 2.

Figure 2. Performance of existing and strengthened bridge for longitudinal loading.

The longitudinal and transverse displacement response curves for the strengthened bridge are shown in Figures 2 and 3 respectively. In the longitudinal direction the displacement response is similar to that of the existing bridge except that the displacement at the pier ductility limit increases to about 140 mm. For this direction a response curve is shown for the option of installing large diameter bored piles at the abutments in addition to the proposed work. These piles would significantly enhance the performance with reinforcement yield in the piers unlikely.

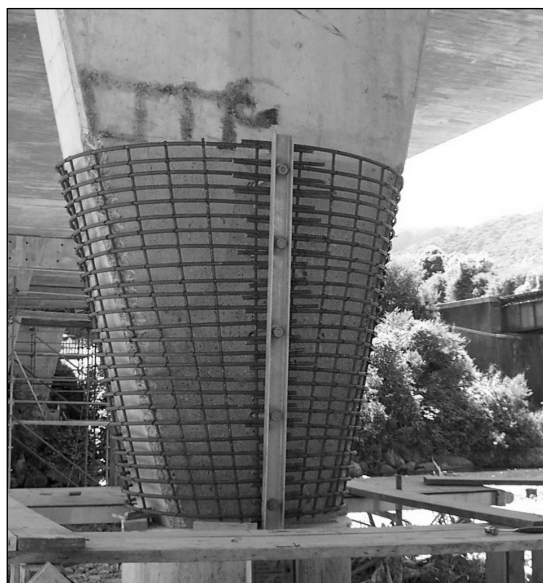
The ductility of the piers was improved by specifying 8 mm thick elliptical shaped steel jackets extending to a height of 2 m above the base of the pier columns. The construction contractor submitted an alternative proposal for confinement using a reinforced concrete jacket with sufficient hoop reinforcement to provide the same confinement pressures as the steel jackets. This alternative was accepted and details are shown in Figure 4.

*Figure 4. Reinforcement in concrete jacket.*

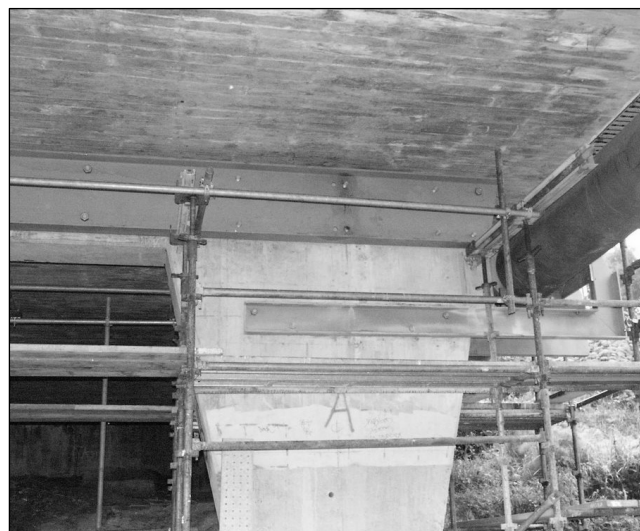
The shear strength of the pier cross-beams was improved by bolting steel channel sections formed from 610 mm deep Universal Beam sections across the width of the pier top as shown in Figure 5.

*Figure 5. Steel channel strengthening on pier cross-beam.*

Infilling the area between the pier columns with a 200 mm thick reinforced concrete wall was also considered but the steel channel option was preferred as it strengthened the pier top against the splitting forces from the deck slab connections.

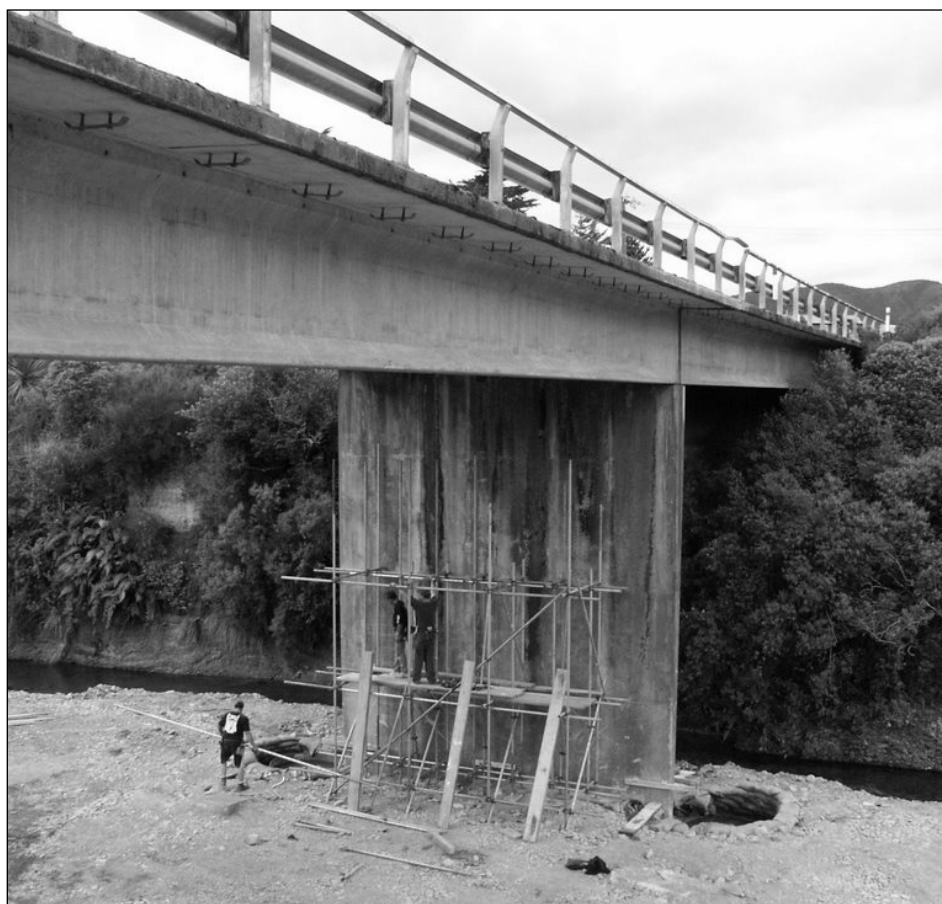
The three-span bridge was designed in 1965 and was opened to traffic in 1971. It carries the two lanes of State Highway 2 across the Pakuratahi River, about 15 km north of Upper Hutt. The bridge superstructure consists of simply supported post-tensioned I beams with a reinforced concrete deck and conventional linked joints at the piers and abutments. Details of the bridge are shown in Figure 7.

*Figure 7. Pakuratahi River Bridge*

The 8.5 m high tapered rectangular wall piers have a hinge joint at the base making them effectively pinned top and bottom for longitudinal response. Because the piers are 7 m wide the pinned connection to the pile cap provides significant re-

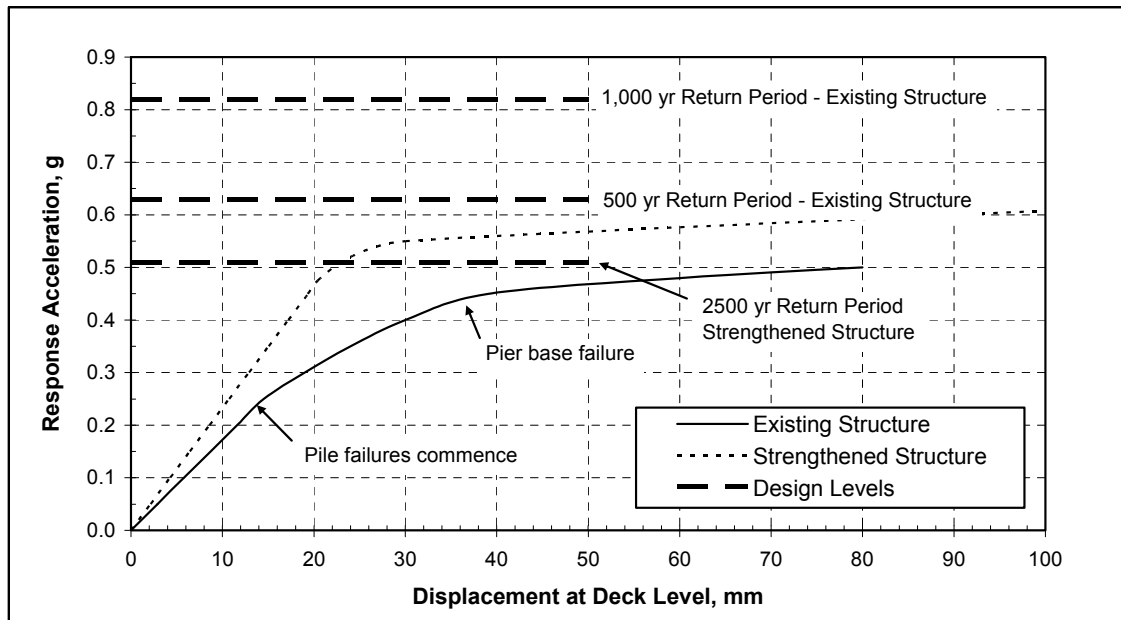
The transverse loading analysis (Figure 9 and Table 4) showed that the existing bridge did not meet the 2,500 year return

Figure 9. Performance of existing and strengthened bridge for transverse loading.

The transverse displacement response curve (Figure 9) for the strengthened bridge indicates satisfactory performance at the 2,500 year return period level with moderate inelastic deformations in the plastic hinges that form in the columns of the new frame members.

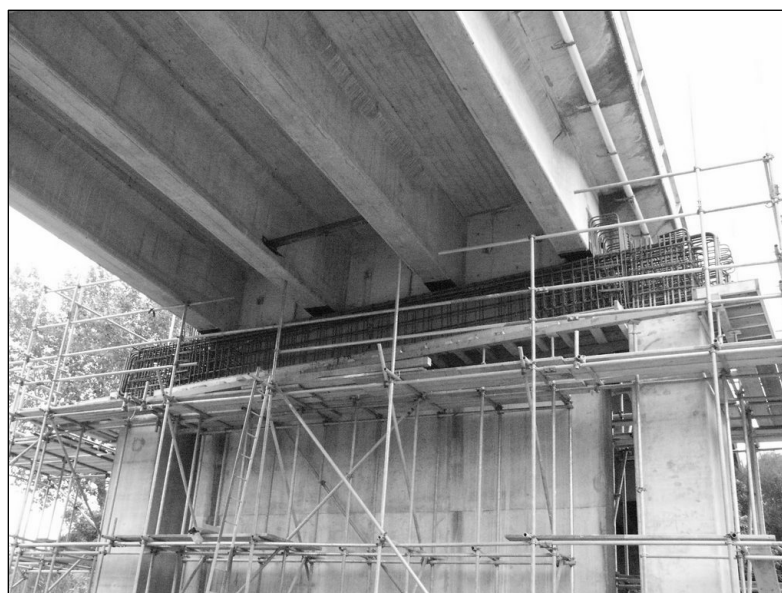
Options of strengthening either the abutments or the piers were considered. Strengthening the piers was the option adopted. Large diameter bored piles are to be installed at either end of the existing pile caps and a ductile reinforced concrete frame pier with tapered rectangular columns and a beam section on either side of the top of the existing pier wall constructed on top of the new piles. The new columns and beams are structurally separate from the existing piers but the beams have bearing contact in both principal directions to hold the existing piers rigidly to the new frame. Details of the new concrete frames are shown in Figure 10.

**Figure 10. Strengthening frame under construction alongside existing pier.**
