# SEISMIC PERFORMANCE AND LOSS ASSESSMENT OF LIGHT TIMBER FRAME RESIDENTIAL HOUSES IN NEW ZEALAND: STATE OF THE ART

**Kexin Wang<sup>1</sup>, Minghao Li<sup>2</sup>, Angela Liu<sup>3</sup> and Rajesh P. Dhakal<sup>4</sup>**

## ABSTRACT

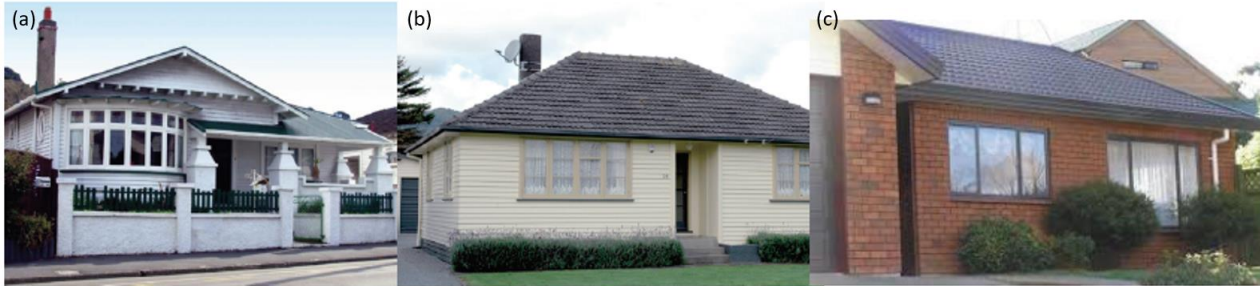
**Figure 1: Predominant residential housing typologies: (a) typical 1930s timber frame bungalow; (b) 1940-1960 timber frame house; (c) post-1980s brick veneer timber frame house [7].**

In New Zealand, there are three predominant residential housing typologies: the typical 1930s timber frame bungalows, the 1940-1960 timber frame houses, and the post-1980s brick veneer timber frame houses (as shown in Figure 1). They make up over 95% of the residential houses stock (by value and quantity) [7]. Aside from these three types, other typologies include the pre-1940 unreinforced masonry houses (which were

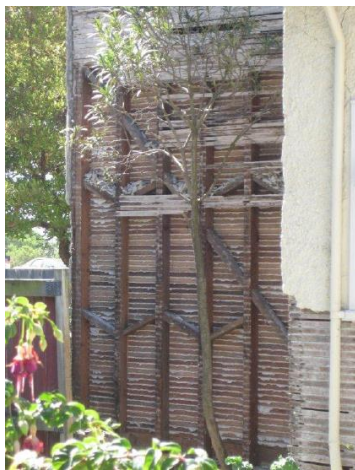
**Figure 3: A failure example of lath and plaster wall [5].**

plaster can only provide little lateral capacity and fail in a brittle mode at low loads. The main lateral load resistance comes from the diagonal braces. As shown in Figure 2, some braces are cut between studs, and some are fitted into slots cut into the studs. According to the Canterbury earthquake survey [5], the use of lath and plaster on the exterior of houses was common in the early 1900s houses. Some cases were observed where sheets of the plaster were detached from the lath, and both the plaster and the lath broke away from the wall (Figure 3).

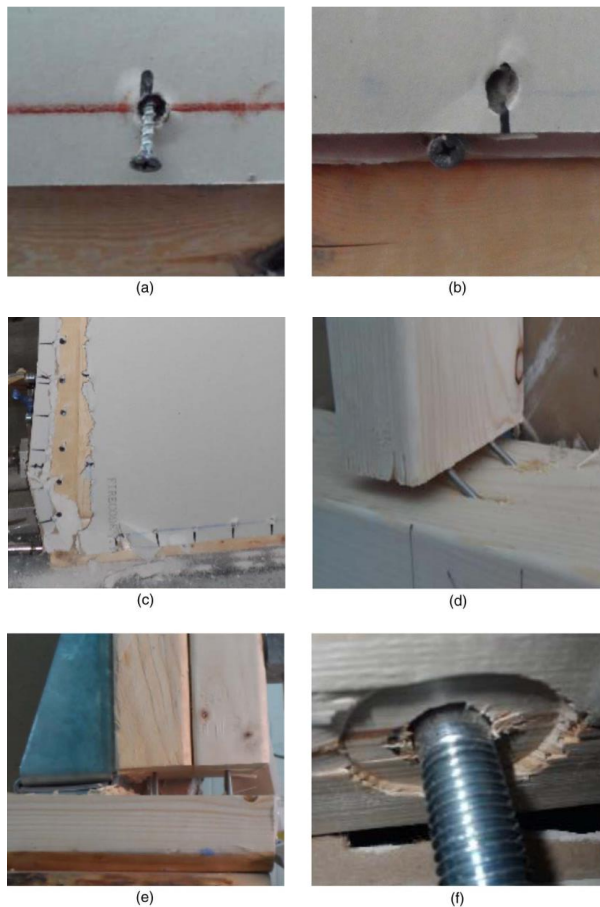
Figure 15: Typical plasterboard sheathed shear wall (overseas cases) failure modes: (a) fastener bending; (b) panel edge tear out; (c) plasterboard fissure failure; (d) end nails yielding and withdrawal; (e) hold-down deflection; (f) wood crushed by anchor bolt [15].

Lafontaine et al. [15] tested eight full-scale Type-X plasterboard sheathed shear walls under reversed cyclic loading to investigate the effect of fastening parameters. Typical failure modes included fastener bending, panel edge tear out, plasterboard fissure failure, end nails yielding and withdrawal, hold-down deflection, and wood crushed by anchor bolts (as shown in Figure 15). Common parameter variations in LTF plasterboard shear wall constructions that affect the response were found to be fastener type, panel orientation, shear wall length, joint compound type, and loading type.

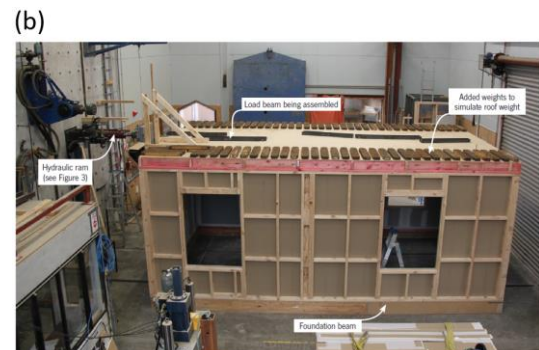
**Figure 18: Test building [41]: (a) plan view; (b) test setup.**

BRANZ tested another single-room one-storey building to determine stiffness degradation of LTF houses after earthquake shaking and the effectiveness of different repair methods [41]. As shown in Figure 18(a), the building was nominally 2.4 m high and incorporated windows and doors and two short internal walls. It had plasterboard bracing walls and a plasterboard-lined ceiling. Most of the plasterboard bracing walls were sheathed by standard plasterboards and did not have hold-downs except one wall labelled “BP10” sheathed by bracing plasterboards and with hold-downs. The test setup is shown in Figure 18(b). The structure was first loaded with three cycles of displacement amplitude of 1.65mm, 3.92mm and 7.29mm. Then it was repaired using one method and was retested. Following another repair method, the structure was tested again. The repair methods used in the different phases are listed in Table 2. The comparison between backbone curves

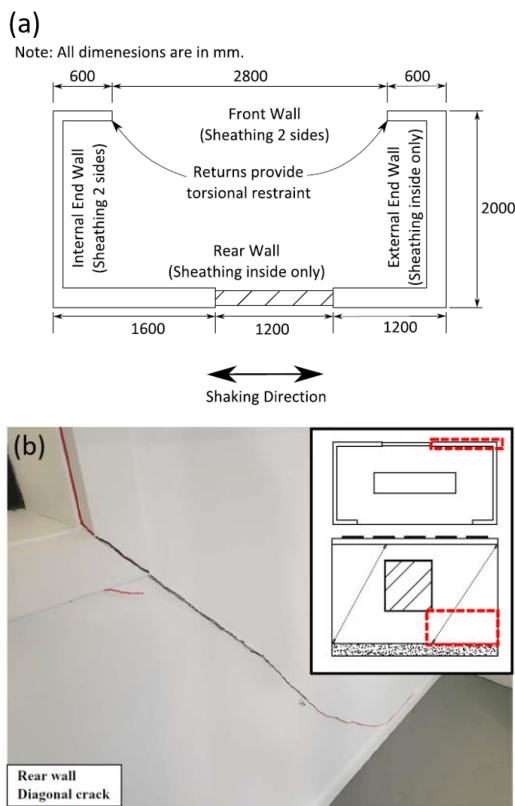
**Figure 20: Test structure [42]: (a) floor plan; (b) diagonal shear cracking around window opening.**

excited in the longitudinal direction only by three New Zealand earthquake records. The fundamental period of the test structure was found to be 0.1s. During low-intensity tests, only minor damage was observed with small cracks initiating from the large opening's corner on the front wall. During the full intensity run of the Darfield earthquake record, the peak inter-storey drift ratio reached 0.23% and more structural damage was observed, including cracks around the corners of the front wall and diagonal shear cracks around the window opening (as shown in Figure 20(b)). Meanwhile, the hold-downs and sill plates were found to be undamaged.

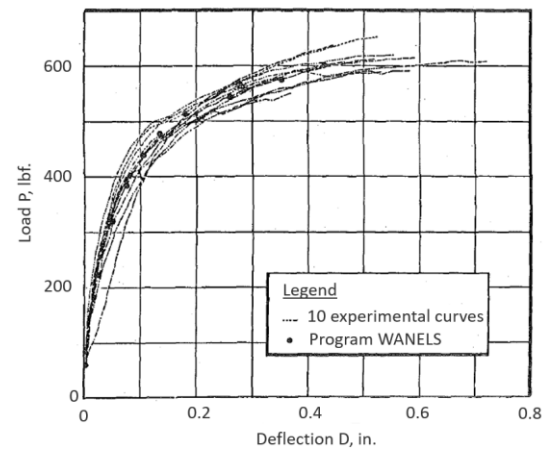
**Figure 22: Comparison between the simulation results of program WANELS and ten experimental results on a wall only sheathed by plasterboards on one side [56].**

displacement relationship of target walls with a high degree of accuracy well into the nonlinear range. Figure 22 shows the comparison between the simulation results of the program WANELS and ten experimental results on a wall only sheathed by plasterboards on one side.

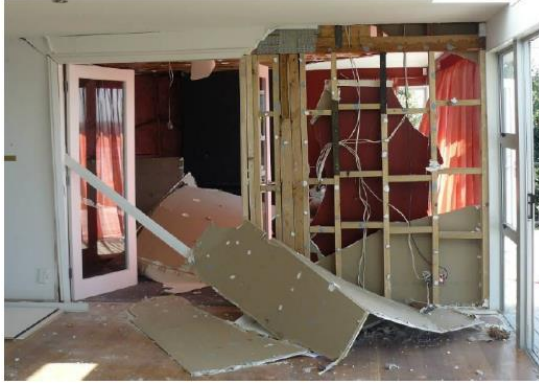
**Figure 38: A severe failure of the plasterboard internal linings after the 2011 Christchurch [5].**

southeast) to Christchurch City [69]. Many buildings in the CBD were severely damaged and some were even demolished. Buchanan et al. [5] reviewed the performance of houses after this earthquake and found that LTF houses generally performed well to meet the life safety performance target. Most timber houses envelopes and diaphragms successfully maintained structural integrity. Minor damage such as cracks in plasterboards was typically observed in the houses and some houses suffered more severe damage in bracing walls. Figure 38 illustrates a case where the plasterboard was completely detached from the wall frame.
