# SEISMIC PERFORMANCE AND LOSS ASSESSMENT OF LIGHT TIMBER FRAME RESIDENTIAL HOUSES IN NEW ZEALAND: STATE OF THE ART

## ABSTRACT

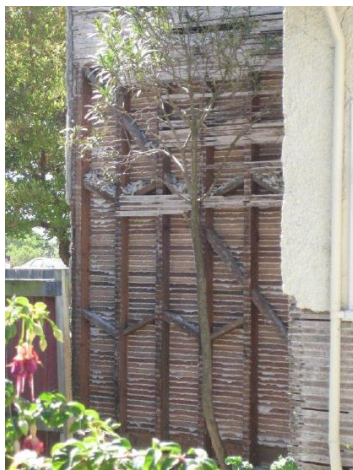
**Figure 3: A failure example of lath and plaster wall [5].**

plaster can only provide little lateral capacity and fail in a brittle mode at low loads. The main lateral load resistance comes from the diagonal braces. As shown in Figure 2, some braces are cut between studs, and some are fitted into slots cut into the studs. According to the Canterbury earthquake survey [5], the use of lath and plaster on the exterior of houses was common in the early 1900s houses. Some cases were observed where sheets of the plaster were detached from the lath, and both the plaster and the lath broke away from the wall (Figure 3).

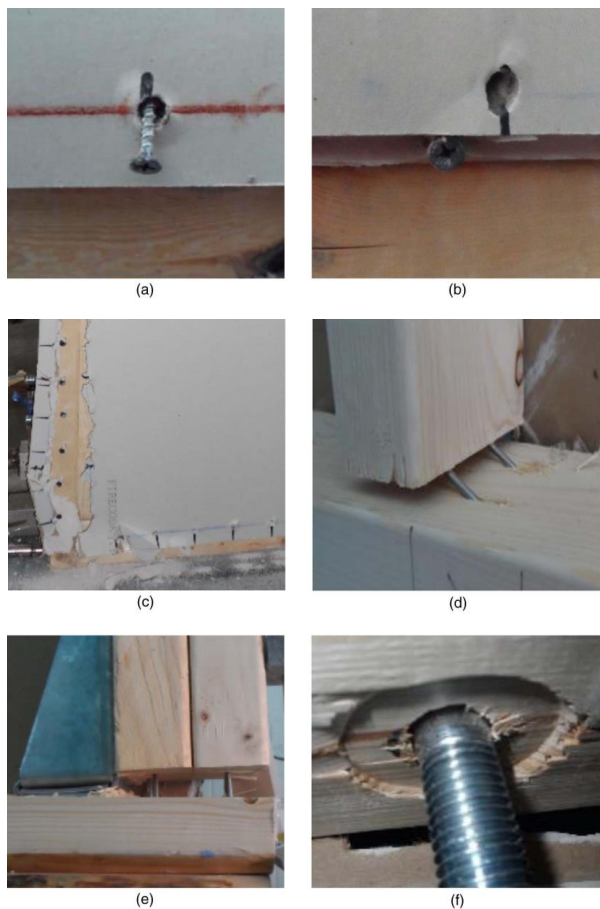
**Figure 15: Typical plasterboard sheathed shear wall (overseas cases) failure modes: (a) fastener bending; (b) panel edge tear out; (c) plasterboard fissure failure; (d) end nails yielding and withdrawal; (e) hold-down deflection; (f) wood crushed by anchor bolt [15].**

Lafontaine et al. [15] tested eight full-scale Type-X plasterboard sheathed shear walls under reversed cyclic loading to investigate the effect of fastening parameters. Typical failure modes included fastener bending, panel edge tear out, plasterboard fissure failure, end nails yielding and withdrawal, hold-down deflection, and wood crushed by anchor bolts (as shown in Figure 15). Common parameter variations in LTF plasterboard shear wall constructions that affect the response were found to be fastener type, panel orientation, shear wall length, joint compound type, and loading type.

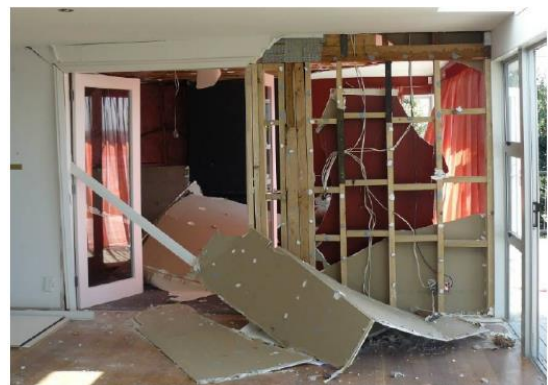
**Figure 37: A severe failure of the plasterboard internal linings after the 2011 Christchurch [5].**

The 2011 Christchurch earthquake was an Mw 6.3 aftershock of the 2010 Darfield earthquake. Although it had a lower magnitude, the epicentre was closer (approximately 6km southeast) to Christchurch City [69]. Many buildings in the CBD were severely damaged and some were even demolished. Buchanan et al. [5] reviewed the performance of houses after this earthquake and found that LTF houses generally performed well to meet the life safety performance target. Most timber houses envelopes and diaphragms successfully maintained structural integrity. Minor damage such as cracks in plasterboards was typically observed in the houses and some houses suffered more severe damage in bracing walls. Figure 37 illustrates a case where the plasterboard was completely detached from the wall frame.
