THE CHALLENGES OF RECONSTRUCTION AFTER THE OCTOBER 2005 KASHMIR EARTHQUAKE

This paper was presented at the NZSEE Annual Conference, April 11-13 2008 and has been peer reviewed.

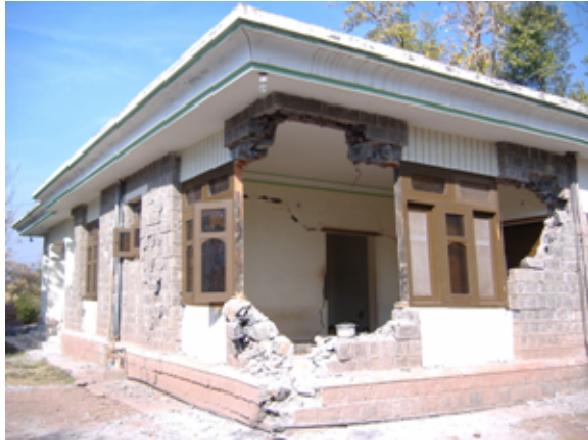
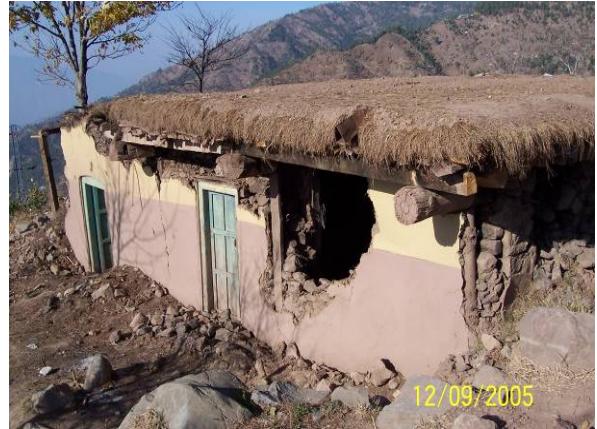
Figure 2. Typical stone masonry buildings.

Stone masonry (and its variations) is the most common building type in the area. The walls of these buildings are constructed of boulders, rubble stone, or dressed/semi-dressed stones in mud, lime or cement-sand mortar. Dry stone and mud-mortared construction is more common in rural areas and old settlements where affordability is less and accessibility to modern materials is a little difficult. If dry stone or mud is used as mortar, the roof is usually a heavy mud one, or of light corrugated iron sheet on a timber frame. If cement mortar is used, the common roof types are reinforced-concrete slabs and light metal on timber trusses. However, these classifications blur with time and space, affordability, and accessibility. Furthermore, after the earthquake the situation has significantly changed because of the distribution of corrugated iron sheets and government assistance. Cement-based mortar is more common in urban areas, market centres, and along the main transport corridors. These buildings are up to three storeys high. Mud-based mortar houses are sometimes two storeys high, although the common height is one storey in rural areas. Floors are constructed of timber of very large sections overlain by mud or reinforced concrete. Cement mortar is usually very weak and can be crumbled with the

a) A modern stone masonry building

b) A traditional stone masonry building

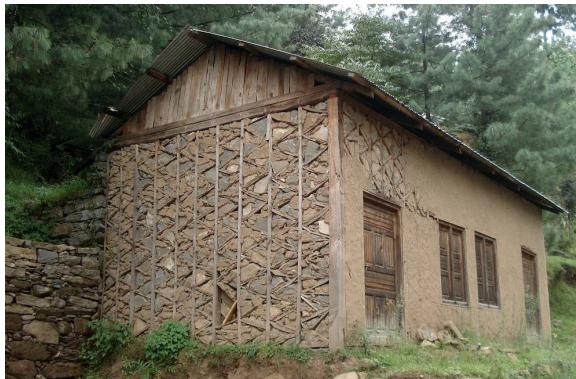
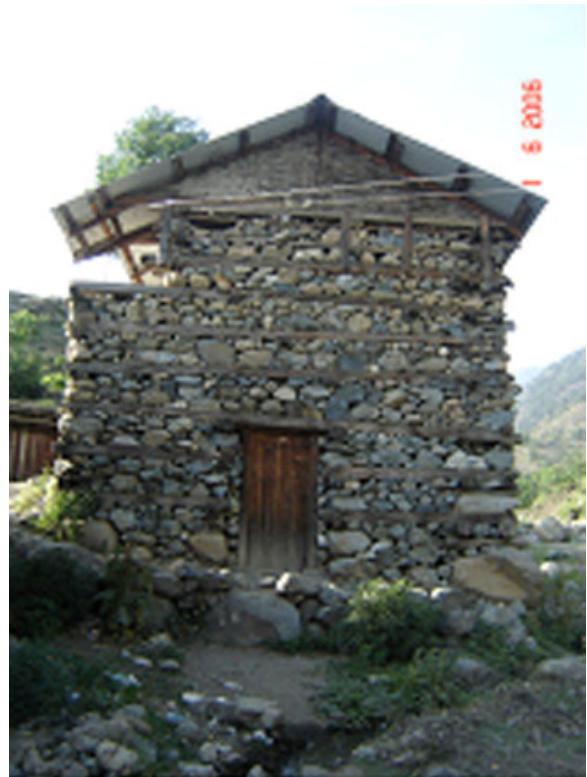
Figure 3. Excellent performance of traditional stone masonry buildings.

Beetar (Figure 3). *Dhajji* performed extremely well. The performance of *Batar* was a little inferior because of the large distances between timber bands, the use of short pieces of wood, a lack of cross timbers, and problems with joints. Despite their relatively better performance, these building types are slowly becoming obsolete because of the lack of wood and the attraction of modern materials - although the use of *Dhajji* has been revived after the earthquake.

a) Dhajji-dewari (survived earthquake)

b) Batar (survived earthquake)

Interestingly, a few of the local building types such as *Dhajji*, *Beeter* and *Batar* performed better than their modern counterparts such as reinforced concrete framed, and block or brick masonry buildings. Similarly, brick and block masonry buildings suffered out-of-plane failures and shear failure of walls. Reinforced concrete frame buildings suffered out-of-plane collapse and severe in-plane shear damage of walls; shear failure of columns and beams, lapping failure of reinforcement, anchorage failure of beam bars, opening of stirrups, cold joints and crushing of concrete (Bothara 2007). A few of these damage patterns are presented in Figures 2, 4, 5 and 7.

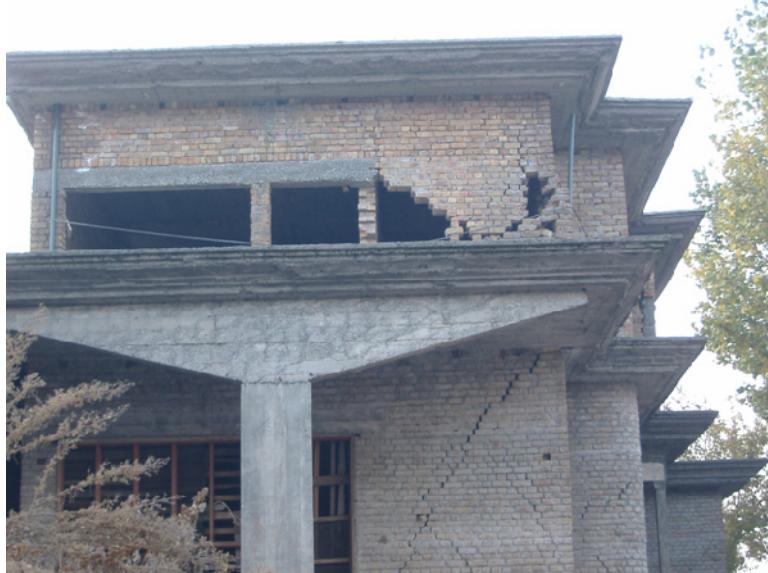
limited to government construction, and for affluent people. These buildings are common in urban areas and market centres along the main roads. The walls of these buildings are constructed of brick in cement-sand mortar. The walls are usually 230 to 350 mm thick, although people have started to use 110 mm thick walls after the earthquake. The roofs and floors are usually cast-in-situ, reinforced concrete slabs. Foundations are mostly of stone masonry. These buildings are usually limited to two or three storeys.

Figure 4. A typical brick masonry building.

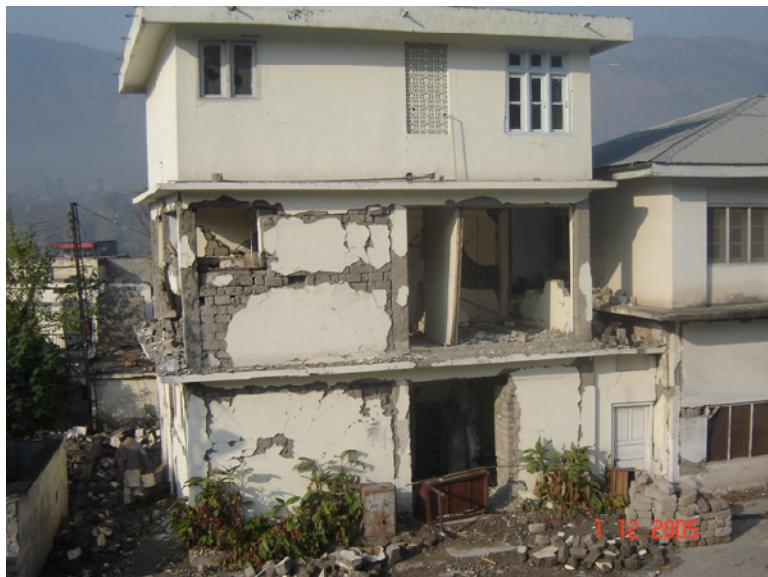
partition walls are usually a half brick thick (110 mm) or a block (150 or 200 mm) thick, and are neither tied into the frame nor reinforced. These infilled frames suffer from poor configuration, detailing, materials and workmanship problems.

Figure 5. A typical reinforced concrete frame building with concrete block infill wall.

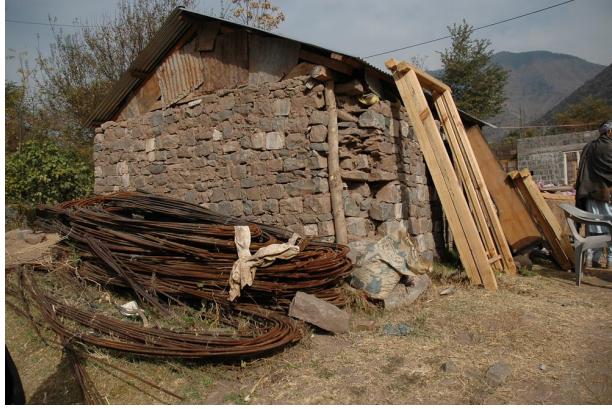
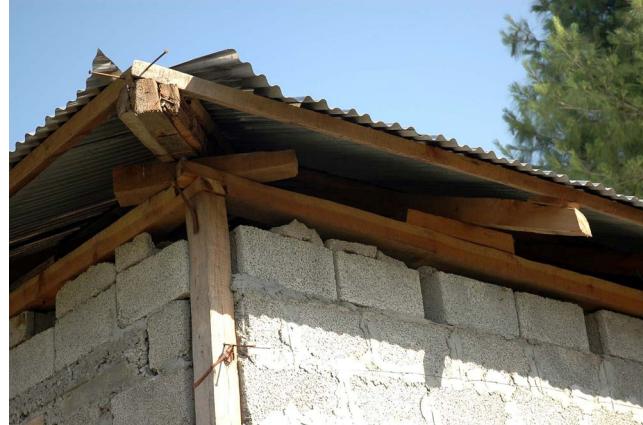
Figure 6. Changing building types.

a) A stone masonry building with light timber frame, damaged by earthquake.

In many instances, people adopted hollow concrete block to replace stones as these were cheap and helped rapid construction (Figure 6). In other instances, people opted for hipped metal sheet roof that they got as relief - replacing flat earth roofs.

b) A block masonry building with light timber frame constructed after earthquake (note change in walls after earthquake).

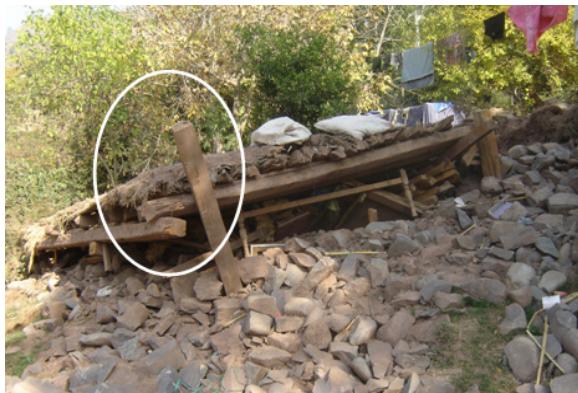
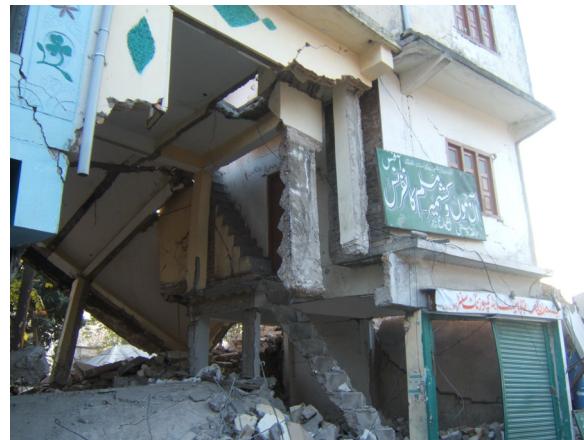
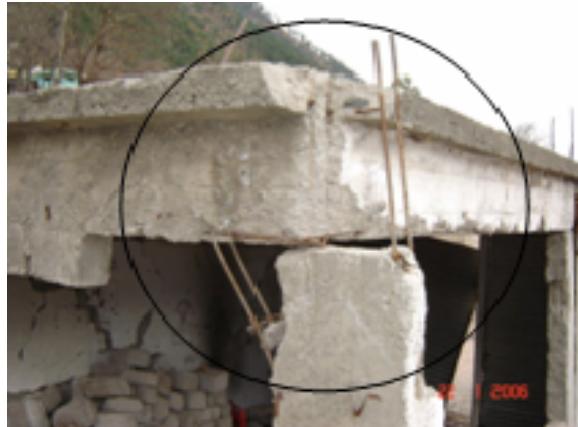
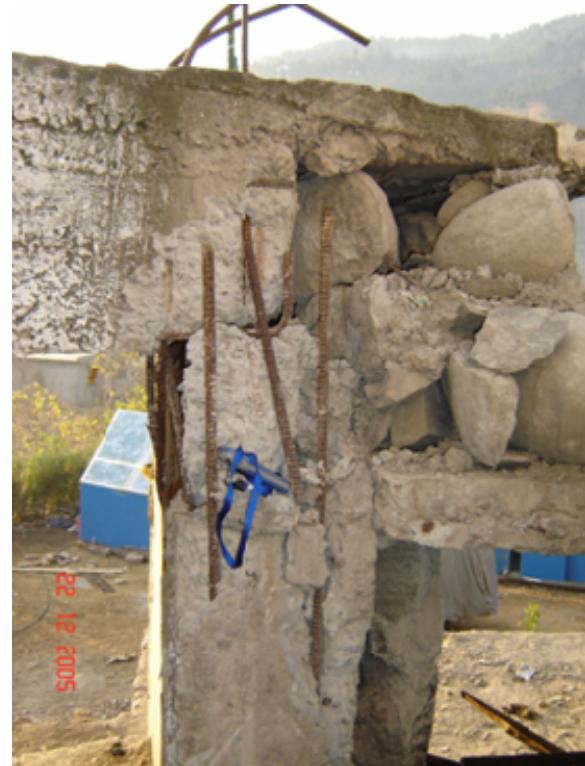
Figure 7. Typical failure modes of reinforced concrete frame buildings.

a) A heap of materials.

b) Reinforced concrete frame building on top of masonry building.

c) Cold-joint problem.

d) No stirrups in column.

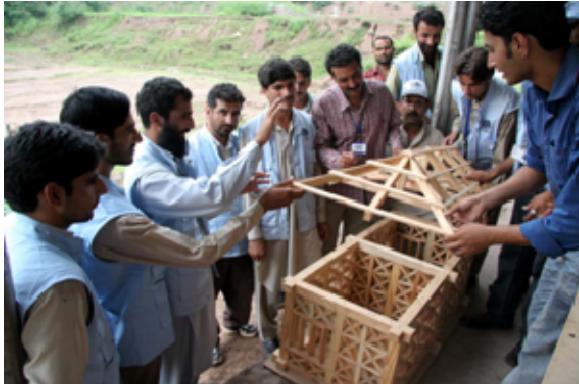
a) A demonstration model.

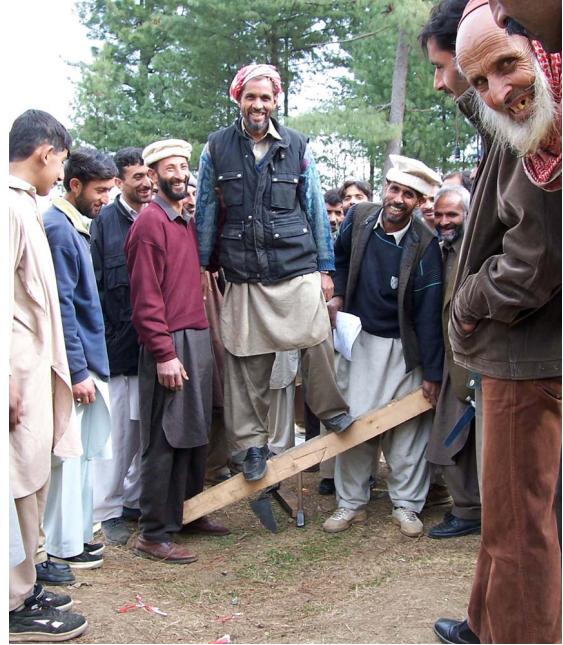
b) Testing strength of a timber joint (source: Kubilay Hicyilmaz).

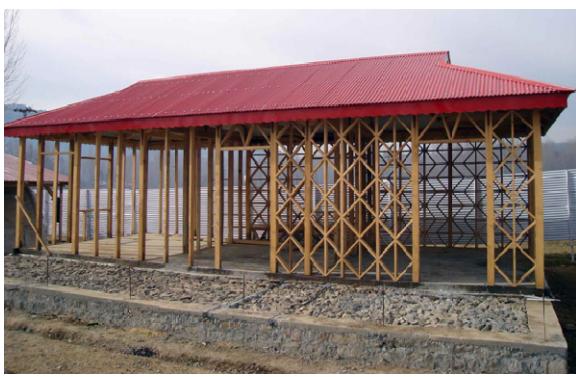
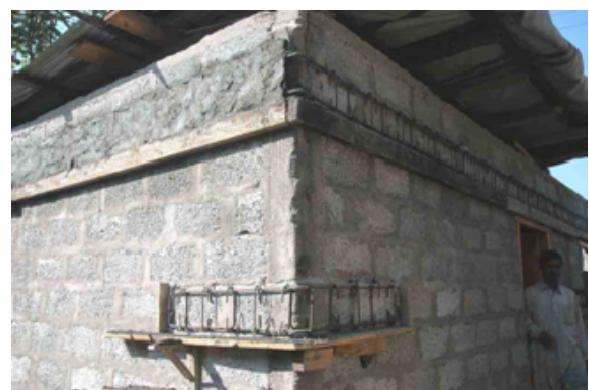
Figure 13. Reconstruction.

a) A Dhajji under construction.

b) Implementing remedial measure for seismic safety.
