# EFFECTS OF FLOOR SLABS ON THE FLEXURAL STRENGTH OF BEAMS IN REINFORCED CONCRETE BUILDINGS

Toshimi Kabeyasawa<sup>1</sup>, Toshikazu Kabeyasawa<sup>2</sup>  
and Hiroshi Fukuyama<sup>3</sup>

## ABSTRACT

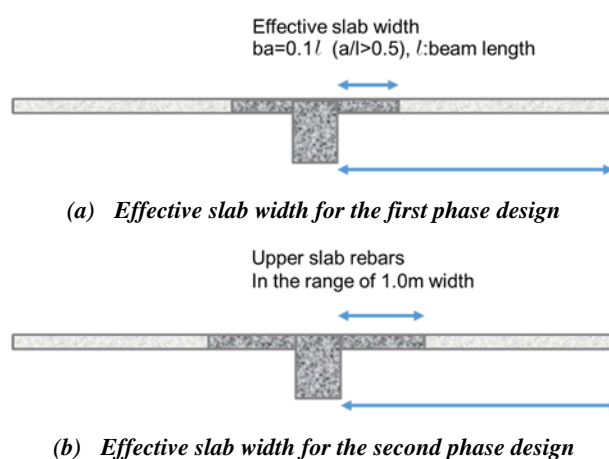
The effective slab width in the elastic analysis for the first phase design is prescribed in the AIJ guidelines [1] as approximately one tenth of the beam longitudinal length, as shown in Figure 1(a). The effective slab width is evaluated mainly to derive the equivalent stiffness of T-beam section in the frame model for linear analysis. The effects of slab reinforcing bars on the flexural strength of beam is normally neglected during the first phase design.

The effective slab width is taken as a constant length of 1.0 meter on each side of the beam for the pushover analysis in the second phase design [2], as shown in Figure 1(b). The slab reinforcing bars within the effective width may be taken into

Figure 1: Effective slab width for beams in the Japanese seismic design code of practice.

Most of these past tests on single members or assemblies indicated that the effective slab width could be very close to the full span width at the maximum strength. However, the design practices in Japan illustrated in Figure 1 have still been maintained, even after it has been concluded by the component tests that the ultimate strength calculated by the prescribed method is probably too conservative when compared to the observed maximum strength at the ultimate drift. This might be because the effective widths observed in the tests were gradually increasing with the inelastic drift amplitudes to attain the full widths, while the probable drift responses under design earthquake loading might be much less than the maximum strengths, especially during component tests. In some cases, maximum strengths were attained at relatively large deformations such as storey drifts of two to four percent radian, while the drift responses under very rare earthquakes are estimated to be around one percent radian in Japan. Also, the pattern of deformations in the test specimen, especially the inelastic axial elongation of the beam and slab, could be different from those in actual building structures.

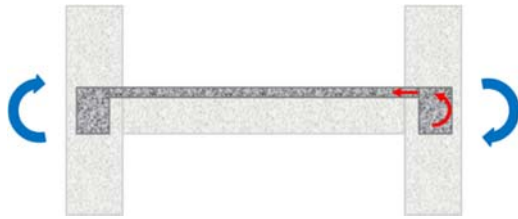
One span beam component tests were conducted with columns or loading blocks at the two ends, to which asymmetric moments were applied to induce the same rotations at both ends. Floor slabs were added to the longitudinal beam and anchored to the transverse beams at both ends, as shown in Figure 2. In this case, the effect of the slab would often be affected by the torsional rigidity and strength of the transverse beams. Axial elongation was constrained in some cases, which could cause other problems.

**Figure 2: Beam component test with slab being anchored to transverse beams.**

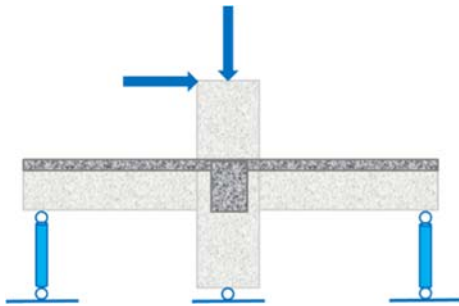
Some beam column joint assembly tests have been conducted with floor slabs, as shown in Figure 3. In this case the beam resistance with slabs became further complicated. Generally, the effective slab width is smaller during small drift amplitudes, which are often not much different with the design width prescribed as the guidelines. However, the effective width became gradually wider as the lateral drift increased, and could reach the full width of the slab at larger storey drifts. The resistance mechanism with slabs has been interpreted in literature [1] and as illustrated in Figure 4.

**Figure 3: Beam column joint assembly test with slab.**

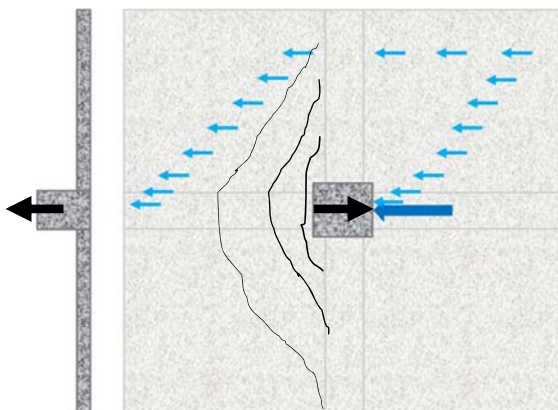
**Figure 4: Plan and shear transfer mechanism of slab in beam column joint assembly tests.**

Cracks in the slab face generally incline as shown in the figure, which means that the stress distribution at the side face of the transverse beam is not uniform. The stress becomes smaller as moving away from the column and the longitudinal beam. Even in the case with weak transverse beams, the slab bars at the far location could contribute to the flexural strength of the longitudinal beam owing to the shear transfer mechanism as follows. Torsional or horizontal deflections could be induced by yielding of slab reinforcement at the far location. However, it was found that the tensile forces in the slab reinforcement could be carried by the reinforcement on the other side and then transferred through the slab shear and concentrated to the compressive region on the column faces, as shown in the figure.

reaction of the beam compressive force. On the other hand, the effectiveness of the slab at the exterior beam would occur at larger deformation due to the skewed shear transfer mechanism, as shown in Figure 4.

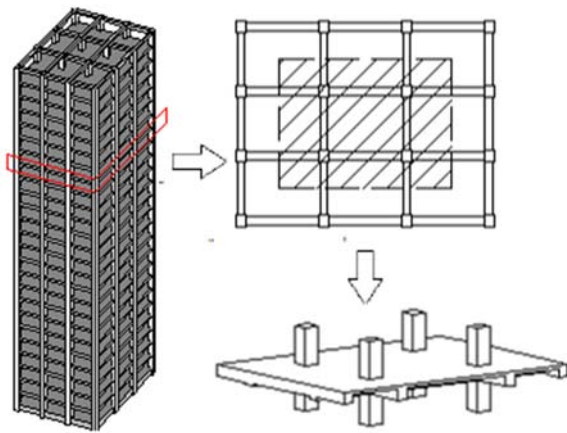
In the first 2010 project, a thirty-storey building was selected as a proto-type design for the test specimen, as shown in Figure 5. The specimens were designed and constructed representing part of interior frames with floor slab in a middle storey of the proto-type building. Four columns from lower mid-height to upper mid-height with beams and floor slab of one span and two half spans in each direction were extracted as shown in the figure.

Figure 5: Assembly model for the specimen representing partial floor slab of mid-storey in high-rise building frame.

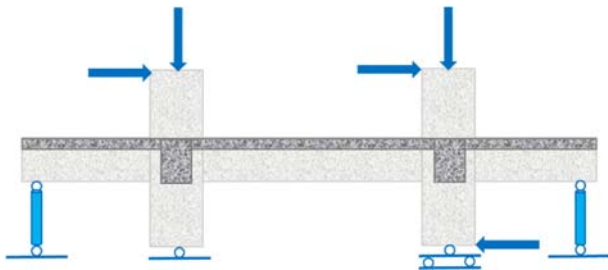
A series of three-dimensional frame tests were carried out under static cyclic lateral loading to investigate the contribution of the slab to the hysteretic behavior of beam-yielding frames [13]. A special loading set-up was developed to be used for the frame assembly. The four columns were loaded laterally and independently at mid-height of the upper storey and supported at mid-height of the lower storey with pin-fixed and pin-roller so that axial elongation of the beams and the slab would not be constrained by the lateral forces, as shown in Figure 6. Also, special consideration was made with respect to the boundary conditions at the mid-height columns so that the axial elongations in the beams were not constrained.

Figure 6: New component testing on serial beam column joint with slab allowing axial elongation.

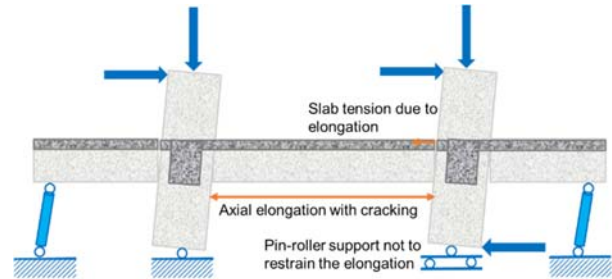
Beam resistance including the slab might be different at interior and exterior beams. It is expected at the interior beams that axial elongation would occur due to cracking, as shown in Figure 7, so that the slab reinforcement could be effective simultaneously with the beam reinforcement over the full width of slab as the

Figure 7: Expected mechanism of effective slab reinforcement at inner beam in the new frame testing.

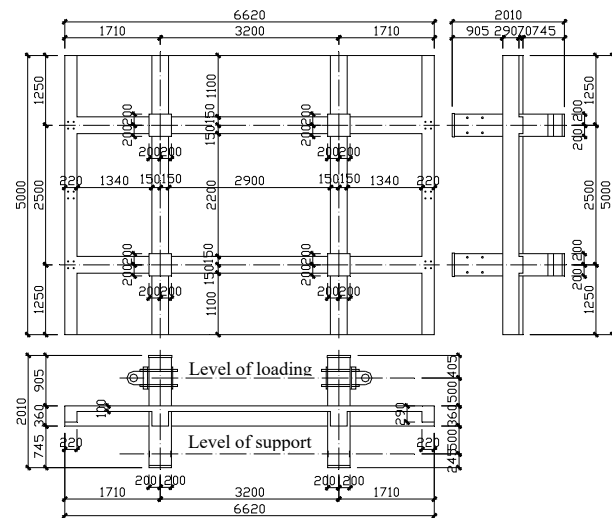
The specimens were reduced by two-fifth scale from the sections and reinforcement details of the original design of the thirty-storey proto-type building to make the reinforcement diameter and spacing as equivalent as possible. The geometric sizes of the specimen are shown in Figure 8.

Figure 8: Geometry of the specimen.

The height of the specimen was 2010mm with 1085mm upper columns and 925mm lower columns measured from the center of the beam, though the storey height was 1360mm between the lower to the upper mid-height for loading. In the longitudinal direction, the center-to-center middle span length was 3200mm, while the center-to-end half-span was 1600mm. In the transverse direction, the center-to-center middle span was 2500mm, while the center-to-end half-span was 1250mm. The column sectional dimensions were 400mm by 400mm. The width of the main beams was 300mm and the depth was 360mm in both directions. The transverse beams with sectional size of 220mm by 290mm were placed for loading at the two ends assuming the inflection point at the middle of the continuous beam span in both directions. The slab thickness was 100mm.

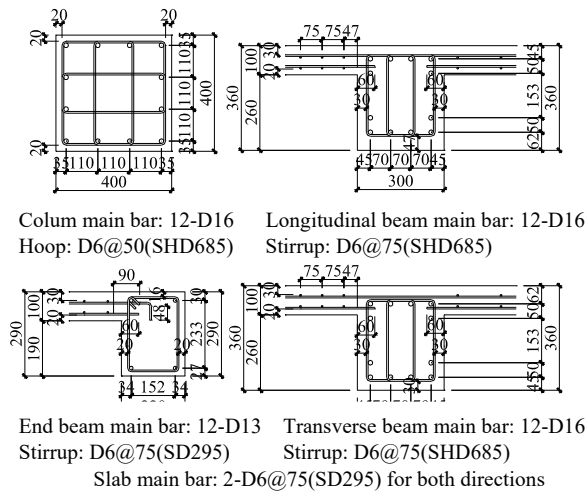
The reinforcement details are shown in Figure 9. Deformed bars with the diameter of 6mm (D6) and the nominal yield strength of 295MPa (SD295) were placed at the spacing of 75mm at both upper and lower chords (2-D6@75) in both directions, while 2-D6@150 in the first specimen (NO. 1). The main bars of the columns were 12-D16 (SD490) with the gross sectional ratio of 1.51% and the column hoops were 4-D6@50 (SHD685). The beams had 6-D16 at the top and 6-D16 at the bottom (SD490) as main bars with the gross sectional ratio of 2.23%, both arranged in two layers as shown in the figure. The stirrups in the beams were D6@50 (SHD685). The main bars of the columns and beams were welded to the steel plates at the ends. The concrete was cast in three stages, consisting of: 1) lower columns and joints, 2) beams and slabs, and 3) upper columns. The construction joints were placed about 75mm away from the column faces with wire mesh.

Figure 9: Reinforcement details in columns and beams.

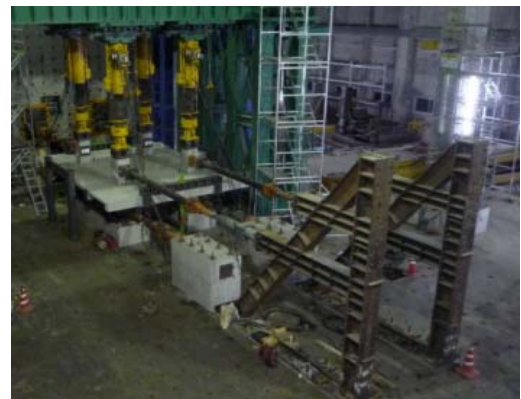
The loading setup is illustrated in Figure 10(a) and an overview photo is shown in Figure 10(b). The two columns on the south side were supported with pin ends assuming the inflection points as mid-height of lower columns, while the two columns on the north side were supported with pin-roller ends, so that the axial deformations would not be restrained by the axial forces caused by the beam and slab elongation increasing with the inelastic deformations. The transverse beams at both ends of the outside half-spans were supported in the vertical direction with the pin-end jacks and the load cells simulating the inflection points at the mid-span. H-shaped steel beams of 200mm by 200mm size were appended to increase the stiffness and strength at the top of both end beams additionally. A constant axial load of 900kN was applied at each top of the four columns using vertical actuators with pin-connected to the column at the bottom end and roller support at the top end of the actuators, which could move freely by four 2-D roller supports attached to two big steel beams on the top. Seismic loads were applied to the tops of the columns using four jacks and to the pin roller supports at north side were also loaded by two jacks. The pin supports were fixed to the concrete base.

Figure 10: Loading set up at structural testing laboratory, Building Research Institute, Tsukuba.

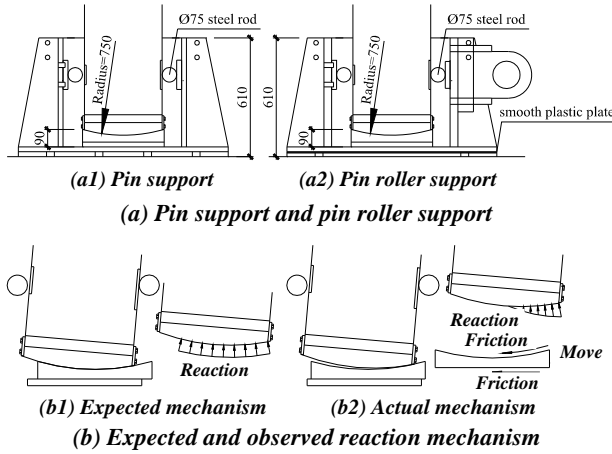
The details of the column pin and pin roller supports at the column bases are shown in Figure 11(a). The steel footing of pin support was fixed on the foundation, while the steel footing of pin roller support was just placed on a smooth plastic plate so that transversal movement was allowed. Steel rods of 75mm diameter welded on the steel footing were attached to the column faces to apply horizontal force or reactions. Two smooth steel face plates curved with a radius of 750mm were manufactured. One was connected to the column bottom, and

another one was just put under it and could move freely with the rotation of the column. However, during the test these supports did not work as well as anticipated due to: (i) unexpected movement in larger cyclic deformations, (ii) the friction, and (iii) the lack of precision in manufacture, which caused an eccentric reaction to the axial load, as shown in Figure 11(b). The correction of these errors is discussed later.

Figure 11: Pin support and pin-roller support

As indicated above in Figure 11, the column moments could be induced by the eccentric reactions at the bases, which were intended to be pin support. The fixing moments at the bases must be estimated and quantified anyhow, which are to be subtracted from the measured lateral resistance by the load cells, to identify the actual resistance of the specimen or the

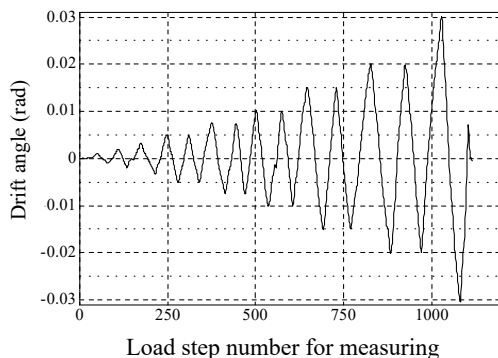
To simulate the vertical loads of high-rise buildings, an axial force of 900kN was applied to each column and kept constant automatically by the four vertical actuators. The averaged compressive stress in the column section was 0.084 times the concrete strength. Then static lateral cyclic forces were applied with six lateral oil jacks. The south jacks and the north jacks were operated independently. The north jacks of upper and lower storeys were operated to keep the same level but in the opposite directions by the common oil pressure, while the storey drift angles of the south columns were synchronized to those of the north columns controlled manually through the instantaneous feedback data from the lateral displacement gauges at the upper and lower loading level of each column. Number of cyclic loading was selected as common with the other component tests in the project. Enough large numbers, such as ten times of cyclic load reversals in 0.5 and 1.0 percent storey drift angles, were selected based on the simulation of the responses of high rise buildings under design long period of motion with long duration. However, the first specimen showed sufficient ductile behavior in flexural even under ten repetitions of cyclic loading. Therefore, for the second specimen reported here was loaded in accordance with the history shown in Figure 12, consisting of two cycles at each peak drift. The maximum drift was amplitudes of 0.06radian for the first specimen, while terminated at 0.03radian for the second specimen by observing the damage levels regarded as nearly the reparable limit state. Then the second specimen here was repaired and tested again in the ERI laboratory in the next year.

Figure 12: History of storey drift ratio.

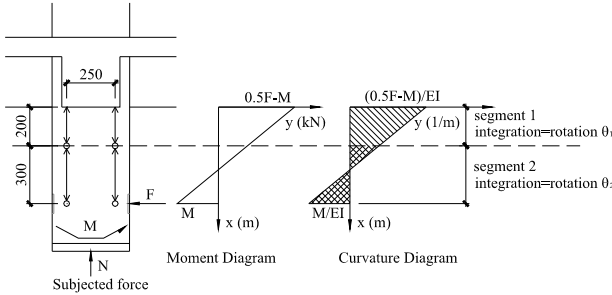
The strains measured in the lower column main reinforcing bars were no more than  $1026\mu$  both in tension and compression until 0.02 drift ratio. Therefore, elastic curvature distribution  $\phi(x)$  could be assumed in the columns, which were proportional to the moment profile. Referring to Figure 14, the moment profile along the column height  $M(x)$  is expressed by equation (2), using the shear force in the columns  $F$  and the column base moment  $M_B$ . The curvature may be calculated as shown in equation (3) in proportion to the moment using the elastic column bending stiffness  $EI$ . The rotation angles of the two segments  $\theta_1$  and  $\theta_2$  can be formulated by integrating the curvature distribution  $\phi(x)$  along the column as equations (4) and (5). The ratio of the upper and lower rotations can be given from the local deformations measured during the test as given by equation (6). Therefore, the base moment  $M_B$  can be derived from the measured local deformations.

Figure 14: Estimate model of base moment.

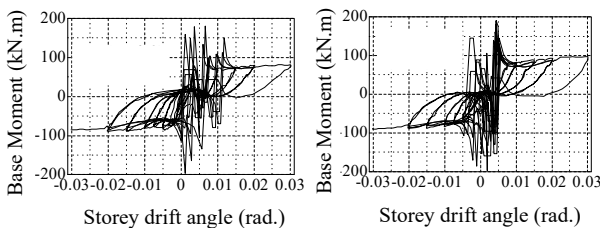
The base moments of the south-west and north-west columns were calculated as described above for the second specimen. The relation between the base moments and the lateral drift are shown in Figure 15(a) and (b). To confirm the accuracy of above estimation method, another method was also applied to compute the base moment using the measured strains of the column reinforcement. It was then confirmed that both methods of estimation would give similar base moments. After the determination of the column base moments, the whole moment distribution of the specimen could be identified. It should be noted that the upper bound of the base moment for one column is limited as  $0.5D_xN=0.5 \times 0.4 \times 900=180(\text{kNm})$ , when the reaction force is acting at the bottom end of the column.

(a) South column in west frame (b) North column in west frame

Figure 15: The additional base moment derived from measured local deformations for a column.

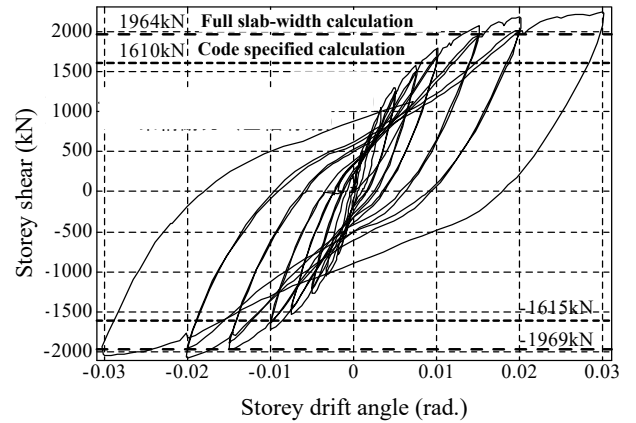
The overall hysteretic response is shown in Figure 16 as the relations between storey shear force and storey drift ratio. The shear force is the sum of the lateral shear forces of the four columns directly derived from the load cells at the column tops. Therefore, the resistance includes the additional strength due to the column base moment as described above. The maximum observed strength attained was equal to 2224(kN) at a peak drift angle of 0.03 radians.

The calculated strengths are also shown in the figure, which considers the additional base moment as described above. The ultimate strength calculated by the code specified design procedure of phase II was 1610(kN) using the design effective slab width of 400mm in 2/5 scale and corresponding to 1.0m for full scale on one side slab as illustrated in Figure 1(b) and shown in Figure 16 with a dotted line. In this case, only the upper chord slab reinforcing bars within the width were considered. The ultimate strength calculated by the same code specified design procedure of phase II was 1964(kN) assuming the full effective slab width of 1050mm on one side for 2/5 scale specimen and taking both the upper and lower chord slab reinforcing bars into account, which means all of the slab reinforcement was considered. In both cases, the material yield strengths in Table 2 and code specified design equations were used for calculation of the flexural strength of the T-shaped beam section, which provided close agreement with the flexural analysis. It should be noted that the observed resistance exceeded the code specified strength even at less than 1/100 storey drift and the full slab-width calculation at less than 1/75.

Figure 16: Overall hysteretic relations.

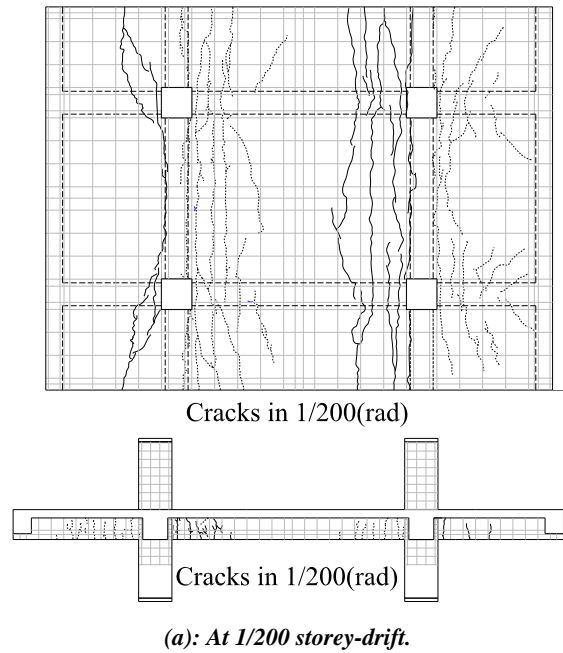
During the first loading cycle with an amplitude of 1/1000 radians, flexural cracks initiated vertically from the bottom at the south ends of the inner beams close to the joint face. The total storey shear force attained 193kN in the positive direction defined as from south to north direction. Similar cracks at the bottom of the opposite beam ends at -123kN in the negative direction. All of the initial cracks were observed at about 75mm away from the column face due to the construction joints. At the first peak of 3/1000 drift cycles, inclined cracks (shear type) were observed to have developed in the bottom of beam in the middle span. However, there were almost no obvious inclined cracks from the beam bottom on side half-spans in the whole loading process. This is because the inflection point of the inner span beam was moved to hogging moment side for slab participation, causing smaller shear span ratio that tend to generate shear cracks. The crack pattern observed in the east

beam side at the 1/200 cycle and 1/100 cycle are shown in Figure 17(a) and Figure 17(b), respectively.

**Figure 17: Cracks at 1/100 and 1/200 storey-drifts.**

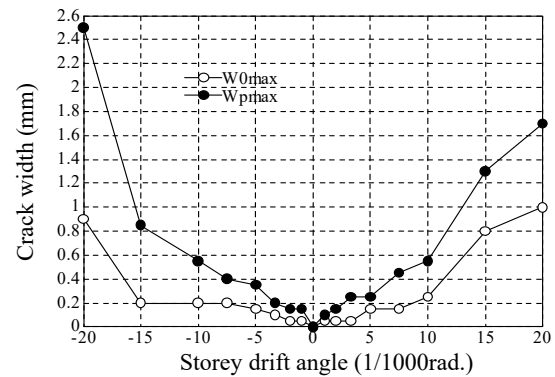
Maximum crack widths measured in the inner span beam at the peak drifts and the unloading points are shown in Figure 18 in relation with the positive and negative storey drift levels. The maximum crack widths measured at the peaks were roughly 0.3mm at the drift of 1/200rad, 0.6mm at 1/100, 1.3mm at 1/67, 2.5mm at 1/50. The crack widths were initially proportional to the storey drift, but increased more rapidly during larger drifts.

**Figure 18: Maximum crack widths for the inner span beam measured at peak drifts and unloading points.**

The crack widths measured at the unloading points are referred to as residual crack widths, although they are not exactly similar to the residual crack widths observed during dynamic responses with the same peak amplitudes applied in shake table tests and post-earthquake observations. The residual crack widths for the inner span beam measured at the unloading points are also shown in the figure. The residual crack widths were roughly half or one third of the maximum crack widths. Minor cracks were observed in the upper columns, but not in the lower ones, probably due to the unexpected fixing moment at base supports.

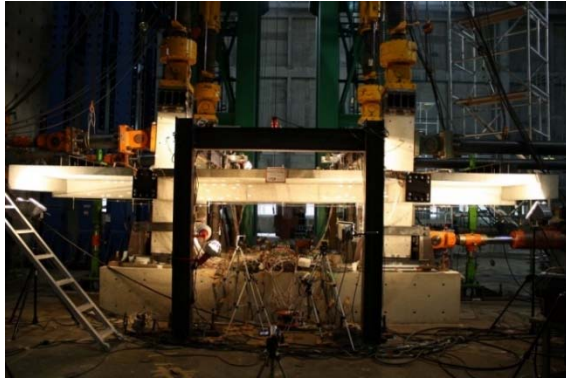
Detailed observation of other cracking may be applied in damage evaluation after earthquakes, although scale effects must be properly accounted for. The observed crack widths might general be larger than estimated from past test on beams, probably due to free axial elongations. The residual damages observed after the test, unloaded from the peak drift of 3/100, are shown in Figure 19(a) and Figure 19(b).

(a) East side view of the specimen after the test

Figure 19: Damages observed after the test (unloaded from the peak drift of 1/30).

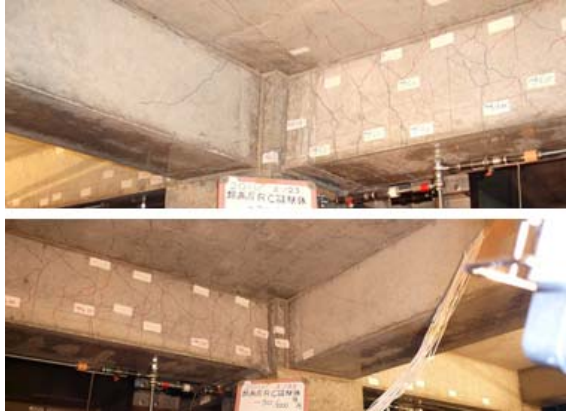
(b) Lower beam column joints after the test

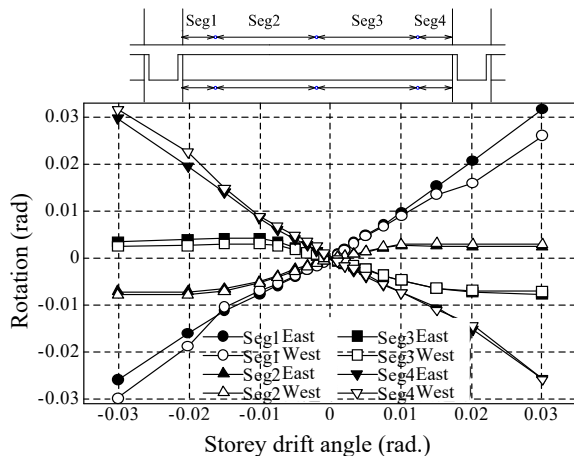
Flexural deformations of the inner beams, east and west, are shown with the storey drift in Figure 20. Axial elongations were measured at upper and lower faces to derive bending rotations of four segments (Seg1-Seg4) along the beam, as shown in the illustration above the plot in the figure. Similar distributions were measured in the east and west beams. The rotations at end segments (Seg1 and Seg4) increase in proportion to the storey drift, even after 1/100rad, while those at mid segments (Seg2 and Seg4) become constant after 1/100rad. The rotations at end segments were symmetric in positive and negative loading, with minor differences probably due to the dislocation or movement of the inflection point at the mid-span due to the large difference of the flexural strengths at the end with the effect of the slab.

Figure 20: Beam rotations measured at four segments in the inner beams.

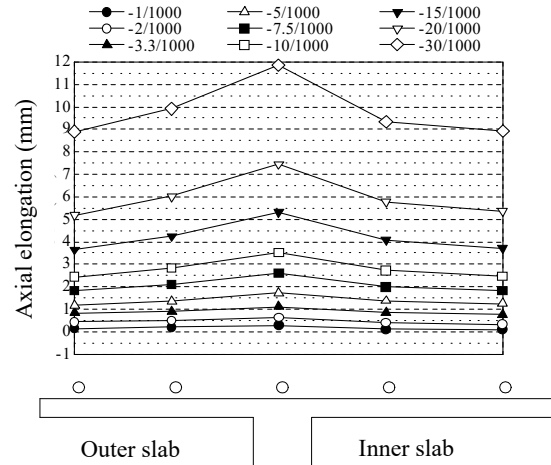
Distributions of the longitudinal elongations in the inner span measured on the slab surface of the south half span and the west half region are shown in Figure 21. The elongations are shown as unit length in mm at each negative peak drift when the slab is in tension. Maximum elongation was observed at the location of the beam and relatively smaller at the edge or at the center of slab, though 80 percent even at the edge, which may be regarded as nearly uniform distribution across the critical section. This is also the case through the transition from elastic to inelastic response, which indicates that the slab reinforcement could be uniformly effective at full span to the yield and ultimate strength of beam.

Figure 21: Distributions of axial deformations on the slab for south and west half span of the inner beam.

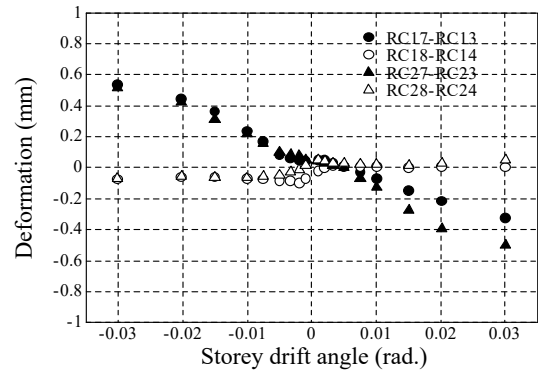
Deformations and strains measured for the columns are shown in Figure 22 and Figure 23, indicating that the column response was essentially elastic. This is an additional evidence for the accuracy to derive the fixed end moments, which have been discussed previously.

Figure 22: Deformation of columns.

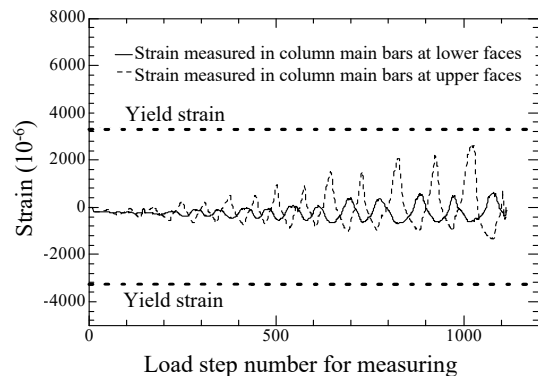
Figure 23: Strains measured in column main bars at the critical faces of the beam-column joints.

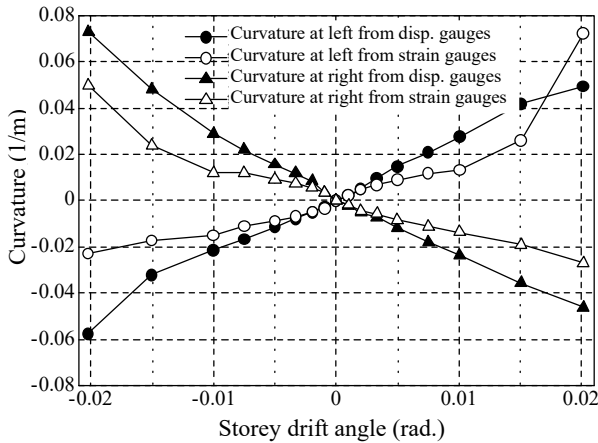
To verify the accuracy of strain measurements in the beam and slab reinforcement, which will be shown afterwards, the curvatures at the beam ends (Seg1 and 4) are compared for those derived from the strains measured in beam main bars, shown in white marks, and also those derived from the axial deformations shown with black marks in Figure 24. The strains may be smaller than average due to the effect of concrete bond, although reasonable correlations are generally observed. The strains measured in the beam reinforcement at the beam column joints were well below the yield strain and the damage to the beam column joints seemed to be minor with no diagonal cracks though it was difficult to observe directly due to the transverse beams.

Figure 24: Rotations of inner span beam and storey drift.

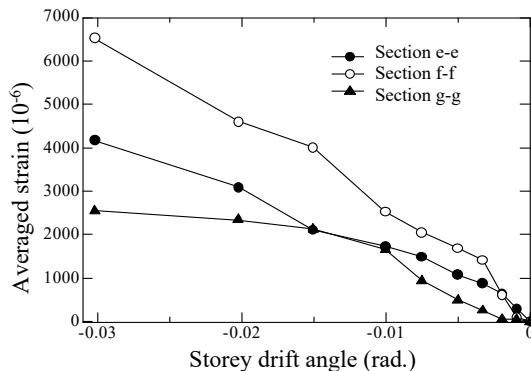
Strains measured in the slab reinforcement at the critical sections of the inner span beam are shown in Figure 25 at three different locations at the distance of 0mm, 150mm and 300mm inside from the critical section at the column face line, 50mm apart from the side face of the transverse beams. The slab reinforcement started to yield at a storey drift of 1/300rad. The yielding was also observed in the lower chord slab reinforcement, although it has been neglected in design due to an insufficient anchorage length of 10d. The strain and stress distributions at the section (f-f) for peak drifts are shown in Figure 26 and Figure 27, respectively. It may be concluded that most of the slab reinforcement attained near yield stress (371N/mm<sup>2</sup>) almost uniformly at the critical section until a storey drift of 1/100.

Figure 25: Strains averaged for the slab reinforcement at the critical sections of the inner span beam with the storey drift.

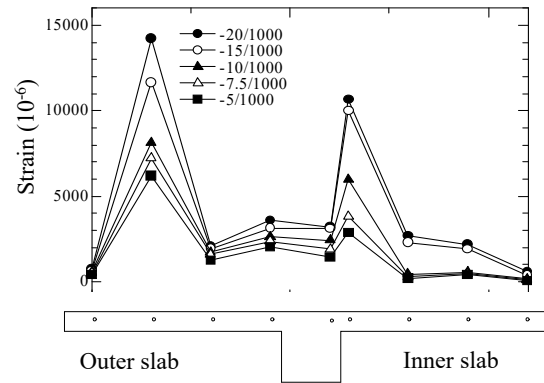
Figure 26: Strains measured in the slab reinforcement at the critical sections of the inner span beam at peak drifts.

The observations and measurement for local deformations and strains indicate that the slab reinforcement could probably be working at stress levels close or equal to the yield stress of the steel material along the critical section with the full span width even around the yielding deformation of the beams.

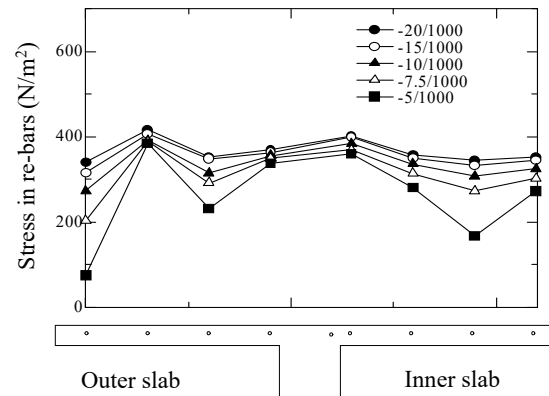
Figure 27: Stress distributions of the slab reinforcement along the critical section derived from strains measured at peak drifts.

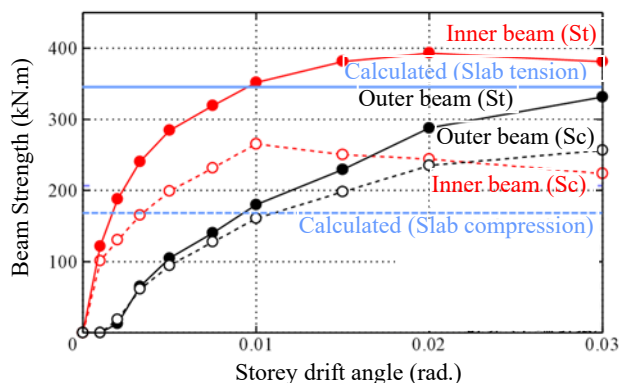
Flexural strengths calculated using the full width of the slab at each critical section of the beams were compared with the measured moment resistance identified from load cells and corrected with the additional column base moments, as shown in Figure 28. Four force deformation lines with circles show the measured moment resistance in positive direction: (1) the red solid line shows the moment at inner span with the slab in tension, (2) the red dashed line shows the moment at the inner span with the bottom edge in tension, (3) the black solid line shows the moment at the outer span with the slab in tension and (4) the black dashed line shows the moment at the outer span with the bottom edge in tension. In addition, the calculated strength using the full span width of the slab and all of the reinforcement is shown for both bending directions with the slab in tension (solid blue line) and the bottom edge in tension (blue dashed line).

The moment at the inner span with the slab in tension attained the calculated strength at a drift of 1/100, and also the moment at the inner span with the bottom edge in tension exceeded the calculated moment by 1.5 times. On the other hand, the moments at the outer span increased gradually. In particular, the moment with the slab in tension was much smaller at 1/100, although it finally reached close to the calculated strength at 3/100.

Figure 28: Measured and calculated beam flexural strengths.

These results might be due to the insufficient support conditions at the end of the outer slab. The transverse steel beams were placed on and beneath the outer span end, by which axial reaction forces were transferred to the transverse beams and the longitudinal beam ends. The beams were supported with one vertical jack and load cell at each end of the outer span. The two
