# RESIDUAL SEISMIC CAPACITY OF DUCTILE RC FRAME WITH WING WALLS BASED ON FULL-SCALE LOADING TEST

**Tomohisa Mukai<sup>1</sup>, Toshikazu Kabeyasawa<sup>2</sup>, Masanori Tani<sup>3</sup>,  
Haruhiko Suwada<sup>4</sup> and Hiroshi Fukuyama<sup>5</sup>**

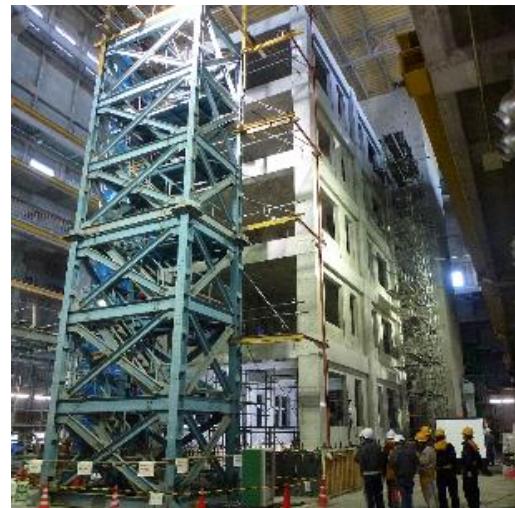
Figure 1: Panoramic view of the 5 story specimen.

A static loading test on a full-scale reinforced concrete building was carried out as described in the past paper [2]. The specimen is a full-scale five story reinforced concrete building with 2 bays in the loading direction and one bay in the transverse direction, and was constructed in a laboratory of Building Research Institute at Tsukuba. The elevation of the specimen is shown in Fig.1. The story height is 3.5 m and the total height of the specimen is 17.5 m (Fig.1). The span length is 6.0 m in both directions. There are two types of openings (2.0m×1.8m and 1.0m×1.8m) symmetrically positioned on the walls along the loading direction. There are structural gaps provided at the end of the openings as shown in Fig.2 (a). The vertical walls between openings are completely separated from the main frame by those gaps.

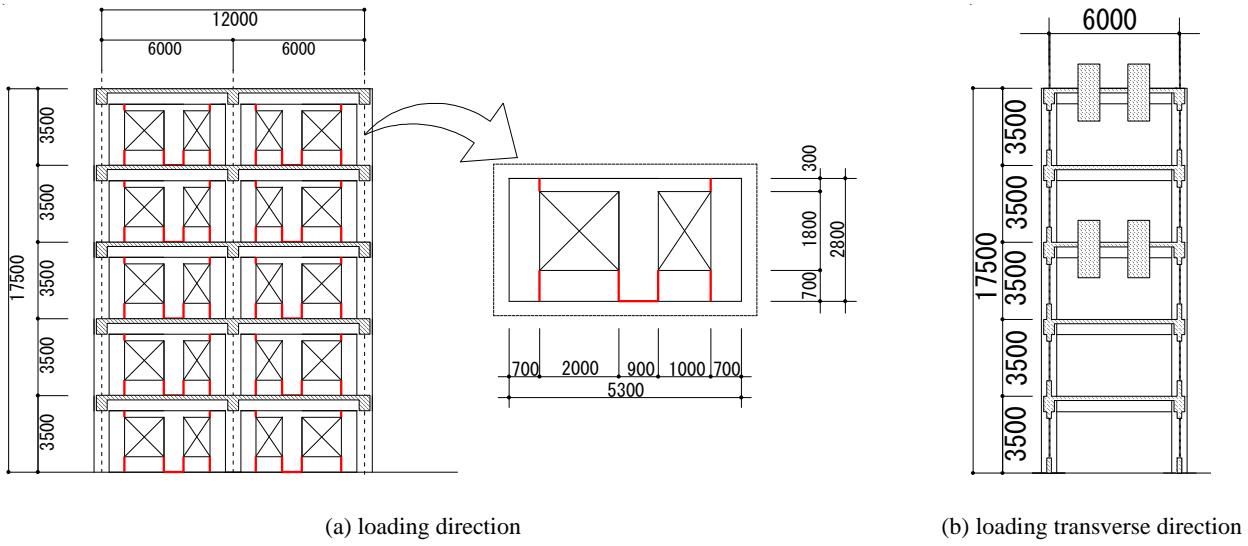
Figure 2: Elevation of the specimen.

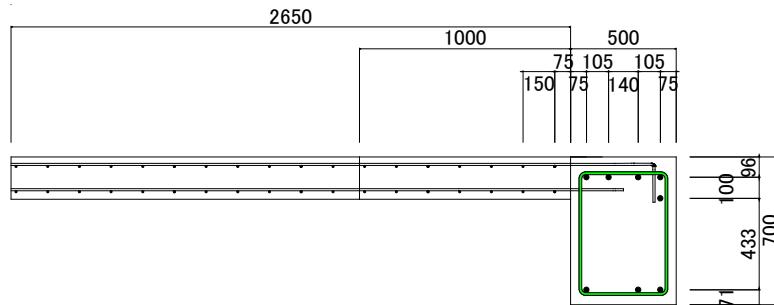
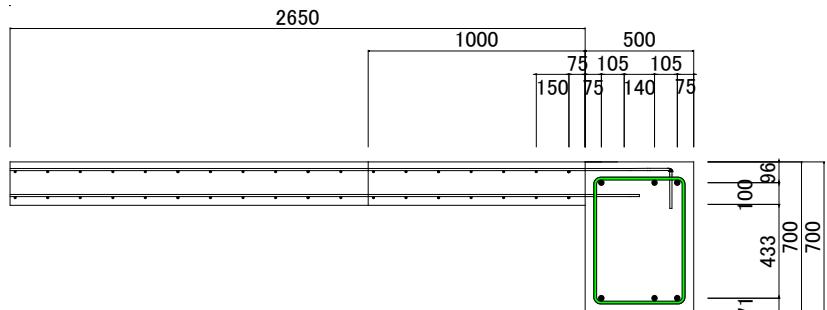
Longitudinal bar of beam at 2nd-4th floor	8-D25(SD345)
Shear reinforcement of beam at 2nd-4th floor	2-D13(SD295)@100
Slab reinforcement at 2nd-4th floor (loading direction)	2-D10(SD295)@150
Slab reinforcement at 2nd-4th floor (loading orthogonal direction)	D10(SD295)@150 for bottom reinforcement ※D13(SD295)@150 for top reinforcement alternates with D10

(a) 2nd to 4th floor

Longitudinal bar of beam at 5th-top floor	6-D25(SD345)
Shear reinforcement of beam at 5th-top floor	2-D13(SD295)@200
Slab reinforcement at 5th-top floor	Same as 2 <sup>nd</sup> to 4 <sup>th</sup> floor

(b) 5th to top floor

Figure 3: Section and reinforcement details of beams with slabs.

The beam cross-section is 500×700 mm with eight D25 bars (2<sup>nd</sup> to 4<sup>th</sup> floor), or six D25 bars (5<sup>th</sup> and top floor) as longitudinal reinforcement shown in Fig.3. Stirrups are D13 at 100 mm or 150mm spacing. All slab thickness is 200 mm, the top and bottom of the slab reinforcement are D10 bars at 150 mm spacing, but D13 is arranged alternatively with D10 bars for the top reinforcement in the transverse loading direction. The lap splice of the reinforcement is provided in the middle of the span, and the end of the top reinforcement is anchored to the transverse beams with 90-degree hooks. The anchorage length of the bottom reinforcement is 250 mm from the side surface of the transverse beam.

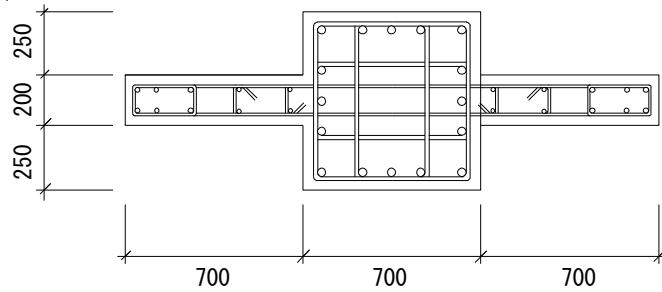
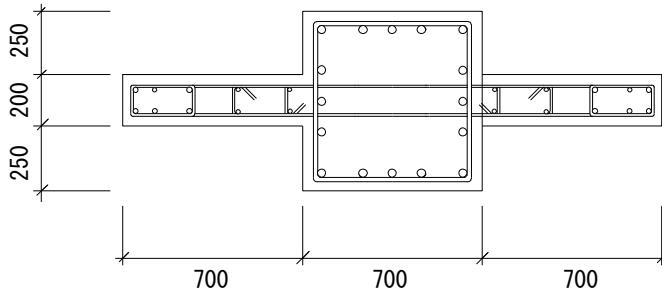
Longitudinal bar of column at 1 <sup>st</sup> floor	16-D25(SD345)
Longitudinal bar of column at 2 <sup>nd</sup> floor	16-D25(SD390)
Shear reinforcement of column at 1 <sup>st</sup> and 2 <sup>nd</sup> floor	D13(SD295)@100
Sub-tie of column at 1 <sup>st</sup> and 2 <sup>nd</sup> floor	D13(SD295)@100
Vertical reinforcement of wing walls at 1 <sup>st</sup> and 2 <sup>nd</sup> floor	2-D10(SD295)@200
Horizontal reinforcement of wing walls at 1 <sup>st</sup> floor	2-D10(SD295)@100
Horizontal reinforcement of wing walls at 2 <sup>nd</sup> floor	2-D10(SD295)@200
Longitudinal bar of wing walls at 1 <sup>st</sup> and 2 <sup>nd</sup> floor	6-D16(SD345)
Confinement reinforcement of wing walls at 1 <sup>st</sup> and 2 <sup>nd</sup> floor	D10(SD295)@100

(a) 1<sup>st</sup> and 2<sup>nd</sup> floor

Longitudinal bar of column at 3rd-5th floor	16-D25(SD390)
Shear reinforcement of column at 3rd-5th floor	D13(SD295)@100
Sub-tie of column at 3rd-5th floor	-
Vertical reinforcement of wing walls at 3rd-5th floor	2-D10(SD295)@200
Horizontal reinforcement of wing walls at 3rd-5th floor	2-D10(SD295)@200
Longitudinal bar of wing walls at 3rd-5th floor	6-D16(SD345)
Confinement reinforcement of wing walls at 1 <sup>st</sup> and 2 <sup>nd</sup> floor	D10(SD295)@200

(b) 3<sup>rd</sup> to 5<sup>th</sup> floor

Figure 4: Section and reinforcement details of columns with wing walls.

Columns are 700 mm square sections with sixteen D25 bars as longitudinal reinforcement shown in Fig.4. The hoops are two sets of D13 reinforcement and D13 sub-tie at 100 mm spacing (1<sup>st</sup> and 2<sup>nd</sup> story). Steel type of longitudinal reinforcing steel for columns excepting 1<sup>st</sup> story is SD390 and one at 1<sup>st</sup> floor is

SD345. Steel type of shear reinforcement is SD295. The length of the wing walls is 700 mm and the thickness is 200 mm shown in Fig.4. The end of the wing wall section is specially arranged with six D16 longitudinal bars confined by hoops to prevent buckling of the longitudinal bars. The

vertical reinforcement in the wall section is double layers of D10 bars at 200 mm spacing, which is confined by a set of horizontal reinforcements. The horizontal reinforcement (D10) in the wall section is anchored into the column section without hook and into the wing wall section with 180-degree hook. The spacing of this horizontal reinforcement is 100 mm for the 1<sup>st</sup> story, and 200 mm for other stories.

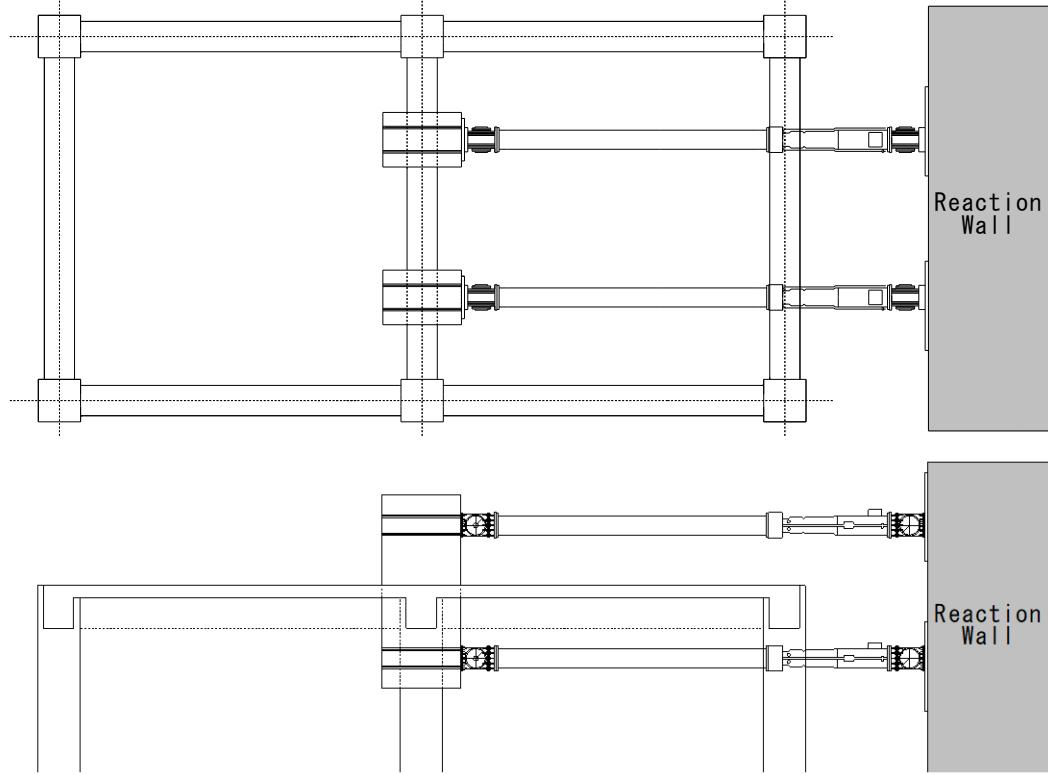
Figure 5: Loading set up on the roof level.

Fig.5 shows the attachment of the actuators on the top floor. Eight actuators are used during the test, with a series of 4 actuators located on the roof level and 4th floor level respectively. The maximum capacity of each actuator is 1000 kN with a stroke of  $\pm 500$  mm. The load distribution ratio of top floor and 4<sup>th</sup> floor is 1 to 2 to match the base shear and overturning moment at 1<sup>st</sup> floor under an inverted triangle

shape horizontal load distribution. The force of the actuators is measured by load cells. Two actuators at the top of the specimen are controlled by horizontal displacement at the top floor and the other actuators follow the load of those two actuators. Loading history is cyclic loading toward each target value of building drift angle, which is equal to horizontal displacement at top floor divided by total height. There is one cycle at each of 0.0625% and 0.125% drift, and two cycles at each of 0.25%, 0.5%, 1.0%, 1.5% and 2.0% drift. Story drift is measured by displacement transducers. Local displacements such as moment curvature and shear deformation are measured for the 1<sup>st</sup> story columns and 2<sup>nd</sup> floor beams. The strain in the reinforcement for beams, slabs, columns, and wing walls are measured by strain gauges. The maximum widths of every visible crack on structural elements are also measured by

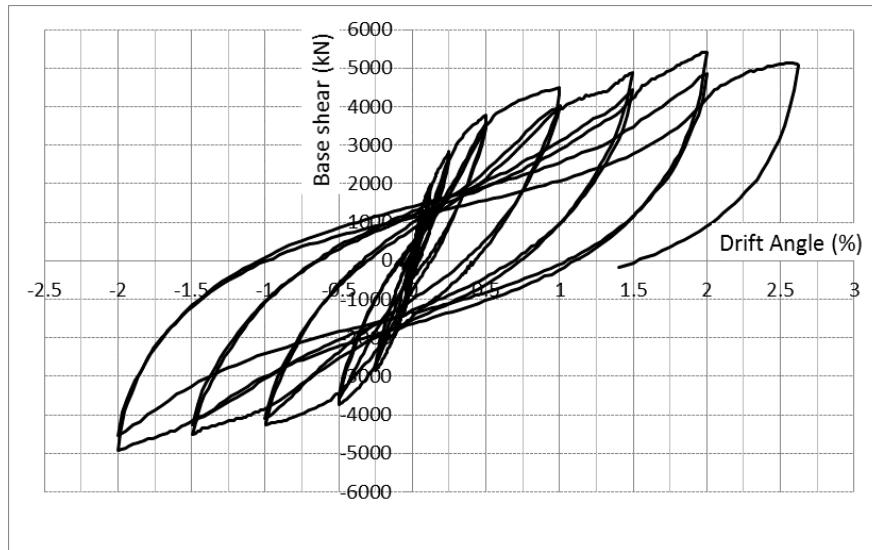
Figure 6: Load-displacement relation.

Fig.6 shows the load displacement relationship between the building drift angle and base shear. Increment of the base shear after  $1.0\%$  drift is gradual due to formulation of collapse mechanism for the system level. The columns with wing wall normally show strength deterioration after compression failure, which is defined as crush of core concrete, at the end of wing wall, but this frame shows ductile behavior until ultimate state, since the contribution of the beam members are dominant. The strength and stiffness increase locally due to the closing of the structural gap between center hanging vertical walls and spandrels after  $1.5\%$  drift. The inverted S-shape slip behavior appeared in  $2^{\text{nd}}$  cycle of loading. The maximum base shear due to beam side sway mechanism is 4654 kN in calculation, which is consistent with the maximum strength (4489 kN) before the conflict of center hanging walls

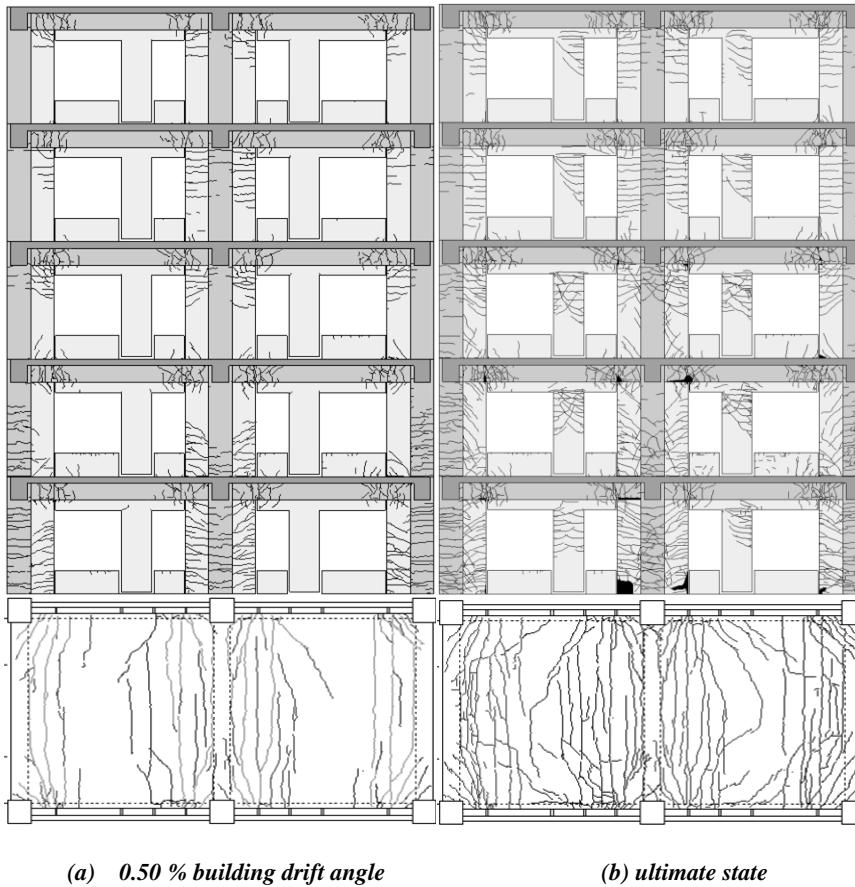
Figure 7: Cracking pattern on the specimen.

Fig.7 shows cracking patterns of the specimen at  $0.5\%$  drift and ultimate state. Representative cracking damage at each peak drift is as follows. Flexural cracking on beam and floor slab is observed around the gap, and flexural cracks are also observed in  $1^{\text{st}}$  story columns at  $0.125\%$  drift. Flexural cracks are observed at the bottom of  $2^{\text{nd}}$  story column, and at the top of the  $3^{\text{rd}}$ ,  $4^{\text{th}}$ ,  $5^{\text{th}}$  story columns at  $0.25\%$ . At  $0.5\%$  drift, flexural cracks on beams are observed and the width of those cracks increases, but the number of the cracks does not increase significantly from  $0.25\%$  drift. The compression failure of the wing wall concrete section is observed at  $1.0\%$  drift. Buckling of the longitudinal reinforcement for columns with wing wall are observed at  $1.5\%$  drift. Also, bending shear

cracks occur by the conflict of center hanging vertical walls and spandrels in  $1^{\text{st}}$ ,  $2^{\text{nd}}$ ,  $3^{\text{rd}}$  story at  $1.5\%$  drift. The same bending shear crack occurs in  $4^{\text{th}}$  and  $5^{\text{th}}$  story at  $2.0\%$  drift. The flexural cracks on beams are observed around the gap, and it does not develop to the beam column joint finally. This gap helps the frame form a beam side sway mechanism. The crack on the floor slab is parallel to the transverse beam. The cracks on the columns with wing wall concentrated at the bottom of the columns in  $1^{\text{st}}$  and  $2^{\text{nd}}$  story, indicating the inflection points of the column is relatively higher. On the other hand, the cracks are observed at the top of the columns in  $3^{\text{rd}}$ ,  $4^{\text{th}}$ ,  $5^{\text{th}}$  story, and it indicates the inflection points are lower. The gap width around center hanging vertical walls is designed not to contact the spandrels until  $3.0\%$  story drift, but they contact due to the flexural deformation of the beam members.

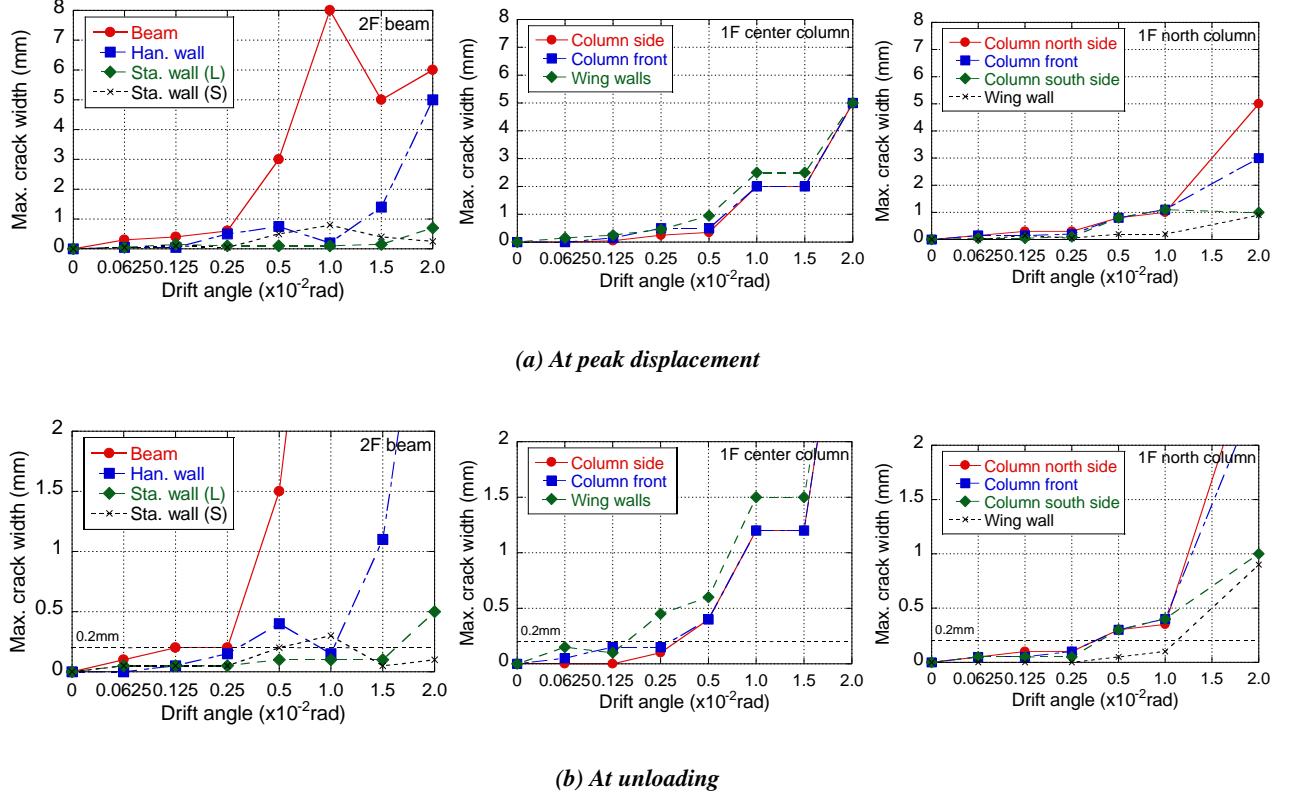
Figure 8: Maximum crack width.

Maximum crack widths of each member during each loading cycle at peak displacement and unloading are shown in Fig.8. Maximum crack widths for 2F beam at peak displacement and unloading rapidly increase during  $R=0.5\%$  cycle, since those cracks near a structural gap opened significantly due to yielding of beam longitudinal bar. Maximum residual crack width of beam reaches to 5.0 mm at  $R=1.0\%$  cycle. Maximum crack widths of spandrell walls are smaller than those beams. Regarding cracks observed at 1F center column, some difference between maximum crack width of column front face and column side faces is observed during small drift angle. However, crack width of column side faces become almost equal to that of column front face after  $R=1.0\%$  cycle, since the cracks of column front face connect to those of column side face as lateral deformation increases. Maximum crack width of wing walls is relatively smaller than that of column as shown in this figure.

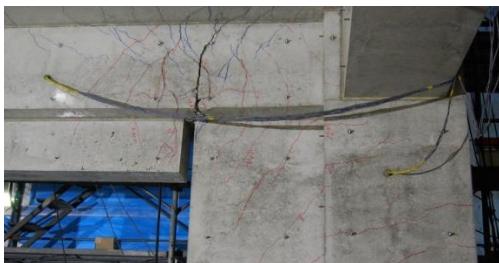
Figure 9: Beam end in the 3<sup>rd</sup> floor.

cycle, the damage class is judged as IV because of some significant cracks near structural gaps seen in Fig.9. Most cracks on spandrel walls are slight as their widths are less than 0.2 mm, which repair is not necessary, because of the effect of structural gaps. Regarding the damage of interior beam-column joint, any damage is not observed seen in Fig.10, since wing walls have hinge relocation function to beams.

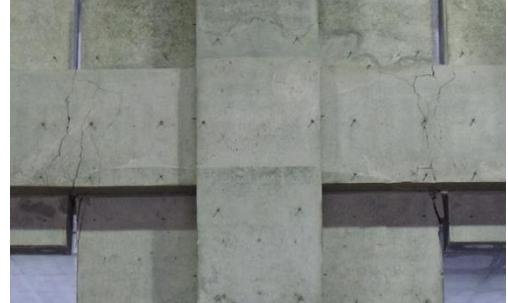
Figure 10: Interior beam-column joint in the 2<sup>nd</sup> floor.

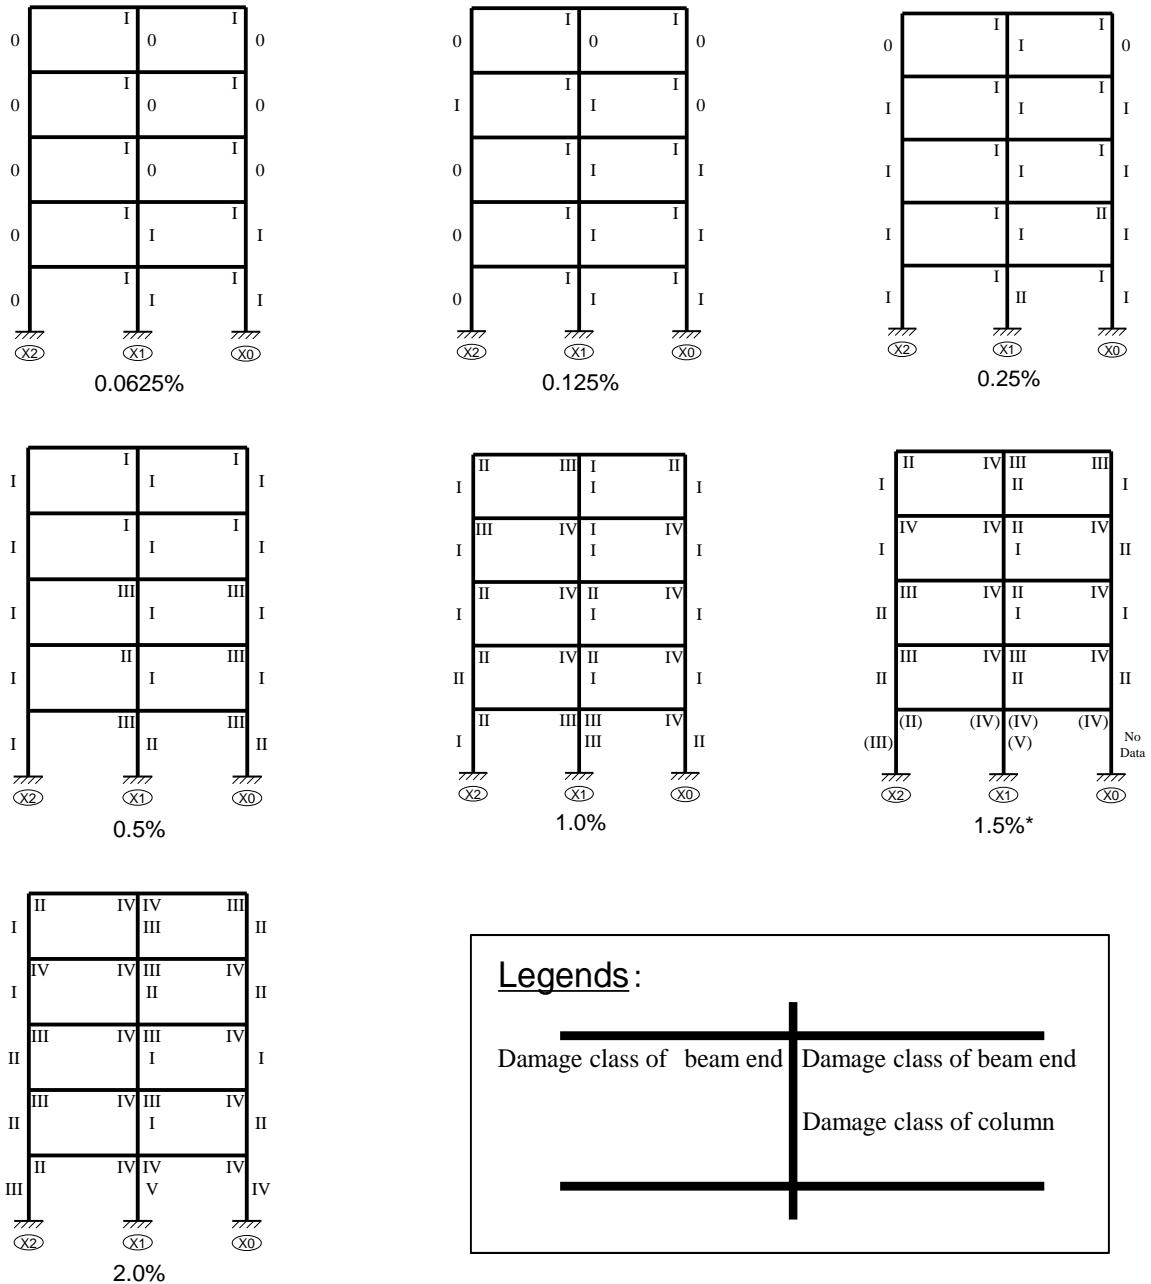
Figure 11: Damage class of each structural element.

Damage classes of columns with wing walls and beams at each loading cycle are shown in Fig.11. As shown in this figure, many beams show a much larger damage class than the columns connected to the beams, since beam deformation is concentrated to the structural gap around beam ends. There is not much difference between damage classes of columns and beams (0 or I) until  $R=0.25\%$  cycle. Damage classes of beams is greater than those of columns except the first floor column after the  $R=0.5\%$  cycle.

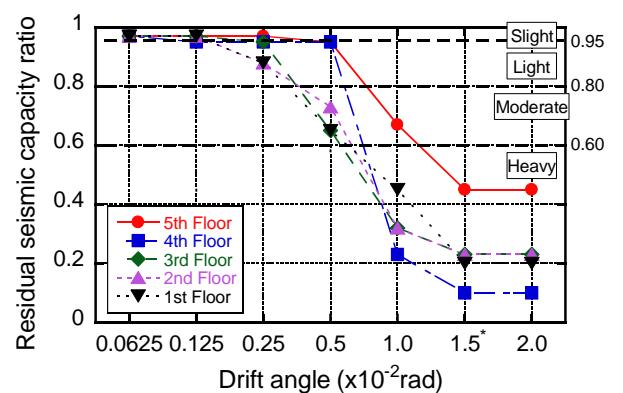
Figure 12: Residual seismic capacity ratio  $R$  for building level.

The ratio and damage rating of each floor are shown in Fig.12 and Table 5, respectively. The residual seismic capacity ratio and the damage rating of the first floor during the  $R=1.5\%$  cycle are shown as a reference with “\*\*”, because all cracks

were not measured in this cycle. As shown in Fig.12 and Table 5, damage ratings of all floors are “Slight” until the  $R=0.125\%$  cycle. Then, the damage rating increases in order from the lower floor as lateral loading increases. The maximum damage rating is “Light” during the  $R=0.25\%$  cycle, “Moderate” during the  $R=0.5\%$  cycle, and “Heavy” after the  $R=1.0\%$  cycle. After the  $R=1.5\%$  cycle, all floors are assessed as “Heavy”. The story shear force of the first floor is increasing during the  $R=0.5\%$  and  $1.0\%$  cycles, in which damage rates are moderate and severe. This damage rating method based on a domestic standard turned out to give a conservative result for this specimen. This implies that the method gives a conservative result for ductile buildings, such as relatively new buildings designed after 1981. In order to apply the method for new buildings, the damage evaluation method for structural elements should be advanced more in the future.
