## THE AUGUST 8, 1993 GUAM EARTHQUAKE Reconnaissance Report

### SUMMARY

*This report on the 1993 Guam earthquake summarises the earthquake and resulting damage to structures and lifelines. The particular interest in this event, which is considered to represent a serviceability limit state earthquake, was the response of relatively modern high-rise buildings.*

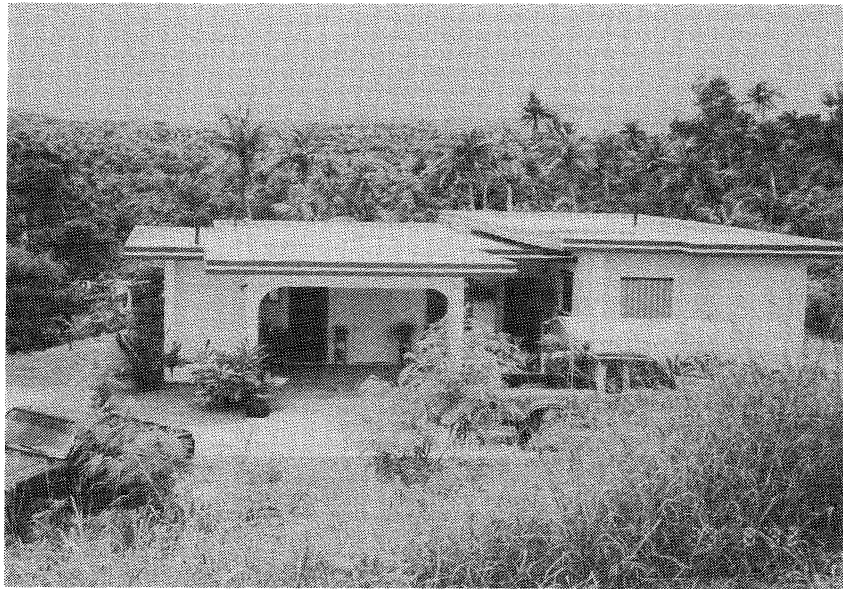
Figure 4 shows a typical house, with a near-flat reinforced concrete roof. Most roofs of such structures are concrete, as it is virtually impossible to get insurance for roofs of lightweight construction.

Figure 4 Typical house construction on Guam

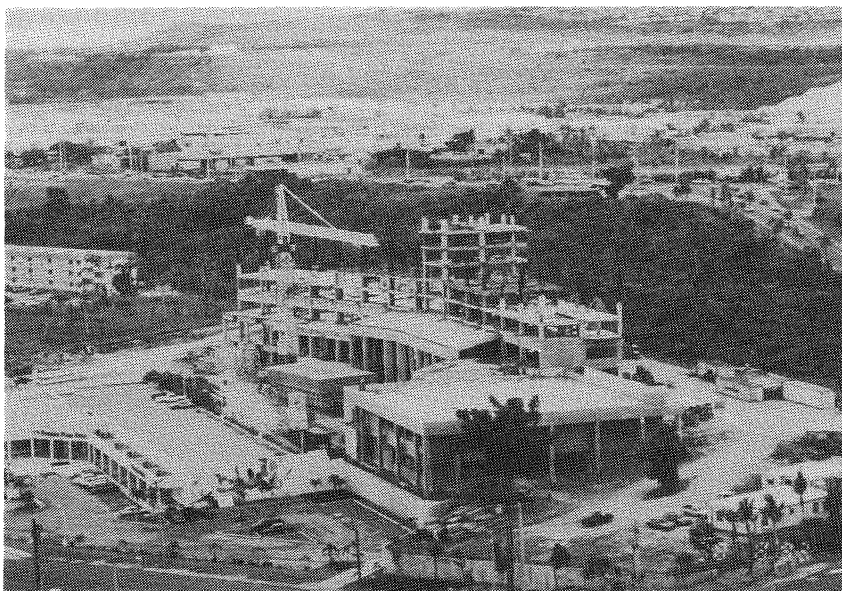
Figure 25 *Holiday Inn Hotel*

This building is still under construction (refer Figure 25), with work having stopped in 1991 due to funding difficulties. Five levels of this eleven storey frame structure had been completed prior to this halt, with the framing for the lightweight-walled service core having been continued for an additional three storeys (Figure 26).

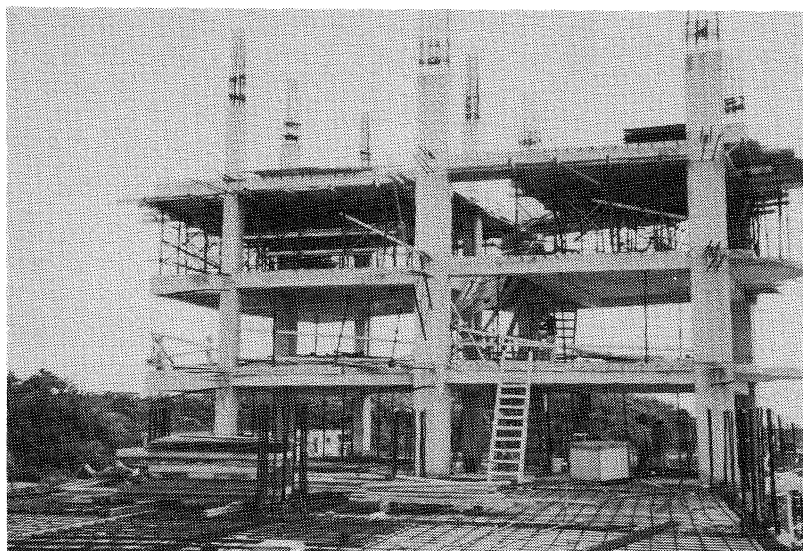
Figure 26 *Service core, Holiday Inn Hotel*
